Fatal man overboard while boarding the fishing boat *Constant Friend* (N83) at Kilkeel Harbour on 23 September 2017

SUMMARY

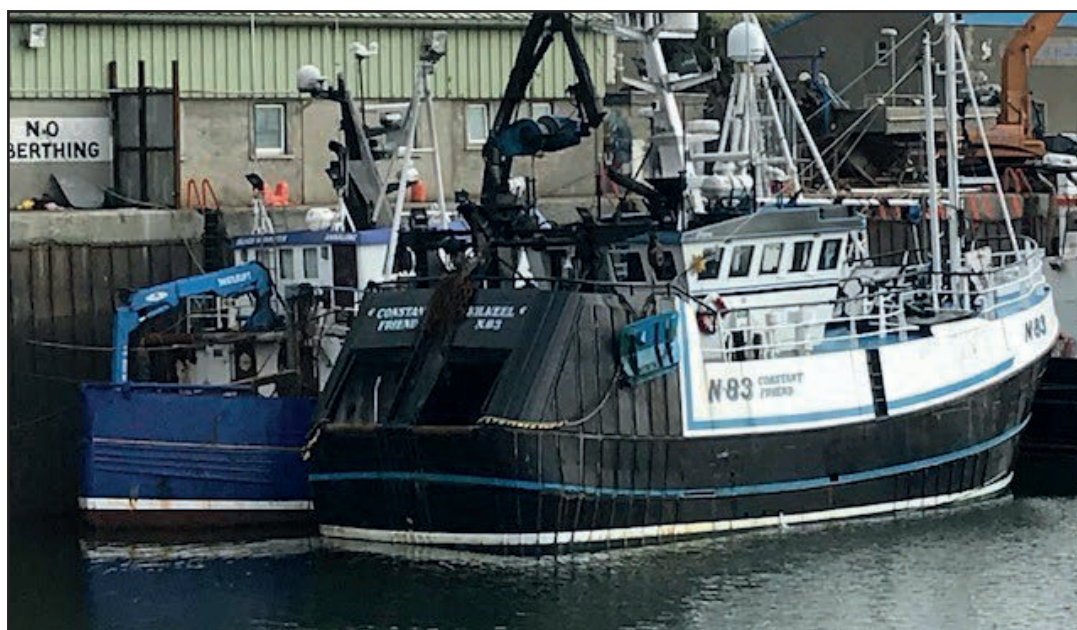
At approximately 2342 (UTC¹ +1) on 23 September 2017, a Filipino crewman from the fishing boat *Constant Friend* fell into the water at Kilkeel Harbour while attempting to board the boat from the fishing boat *Silver Harvester*. *Silver Harvester* was moored inboard of *Constant Friend* and alongside the quay adjacent to the fish market buildings in the harbour (**Figure 1**).

Figure 1: *Constant Friend* alongside *Silver Harvester*

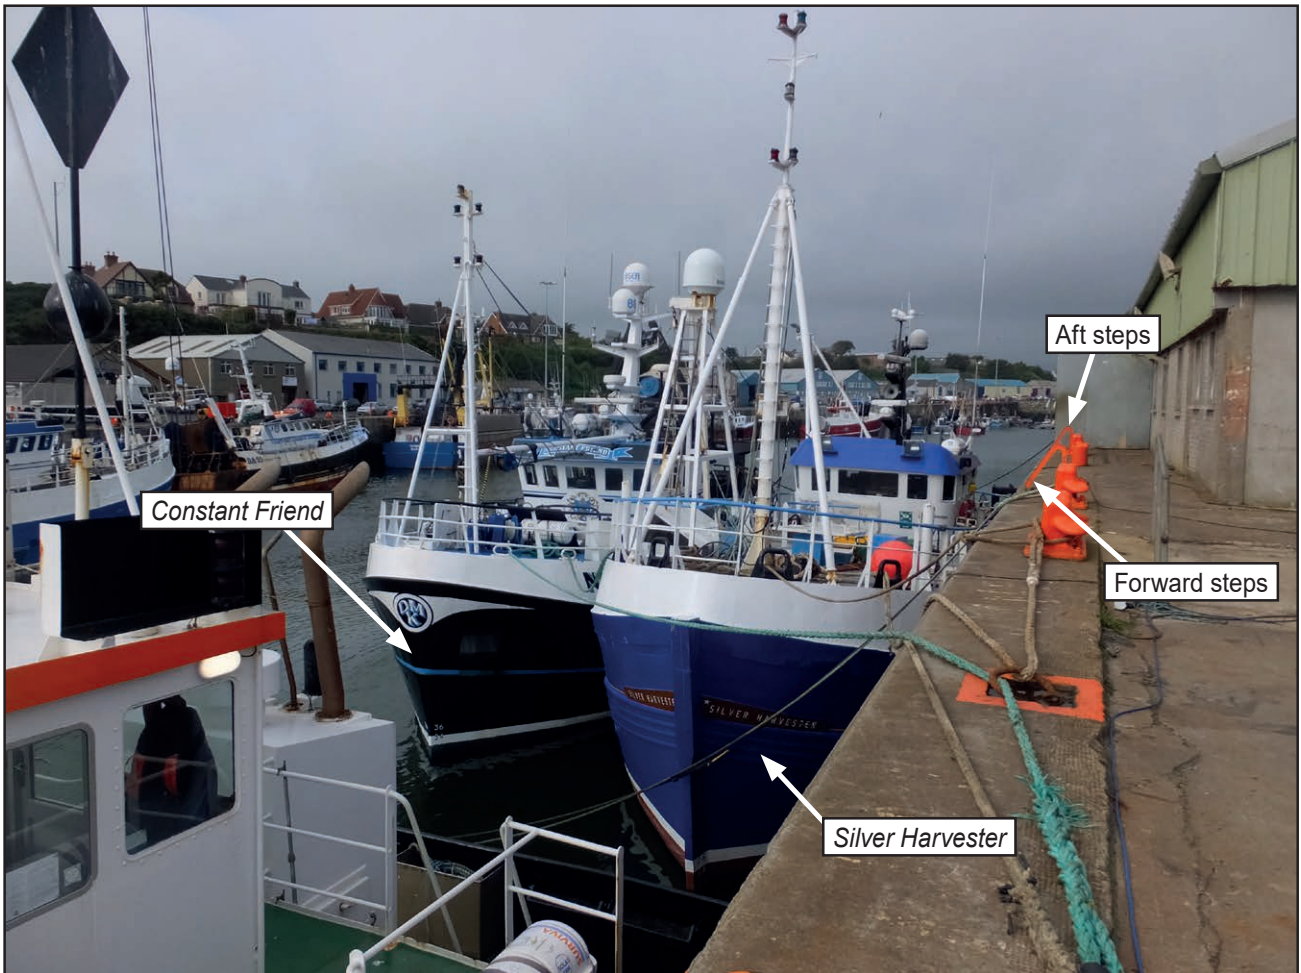
To access *Constant Friend*, the crew needed to board *Silver Harvester* from the quayside (**Figure 2**). There were vertical ladders set into the quay wall at the forward and aft ends of *Silver Harvester*. At the time of the accident, *Silver Harvester's* guardrails were approximately level with the quay, which meant that access could be achieved by climbing over the boat's guardrails directly from the quayside. To cross from *Silver Harvester* to *Constant Friend*, crew had to climb over the guardrails of one boat, step across the intervening gap, and then climb over the guardrails of the other boat (**Figure 3**).

Figure 2: Quayside to *Silver Harvester* access

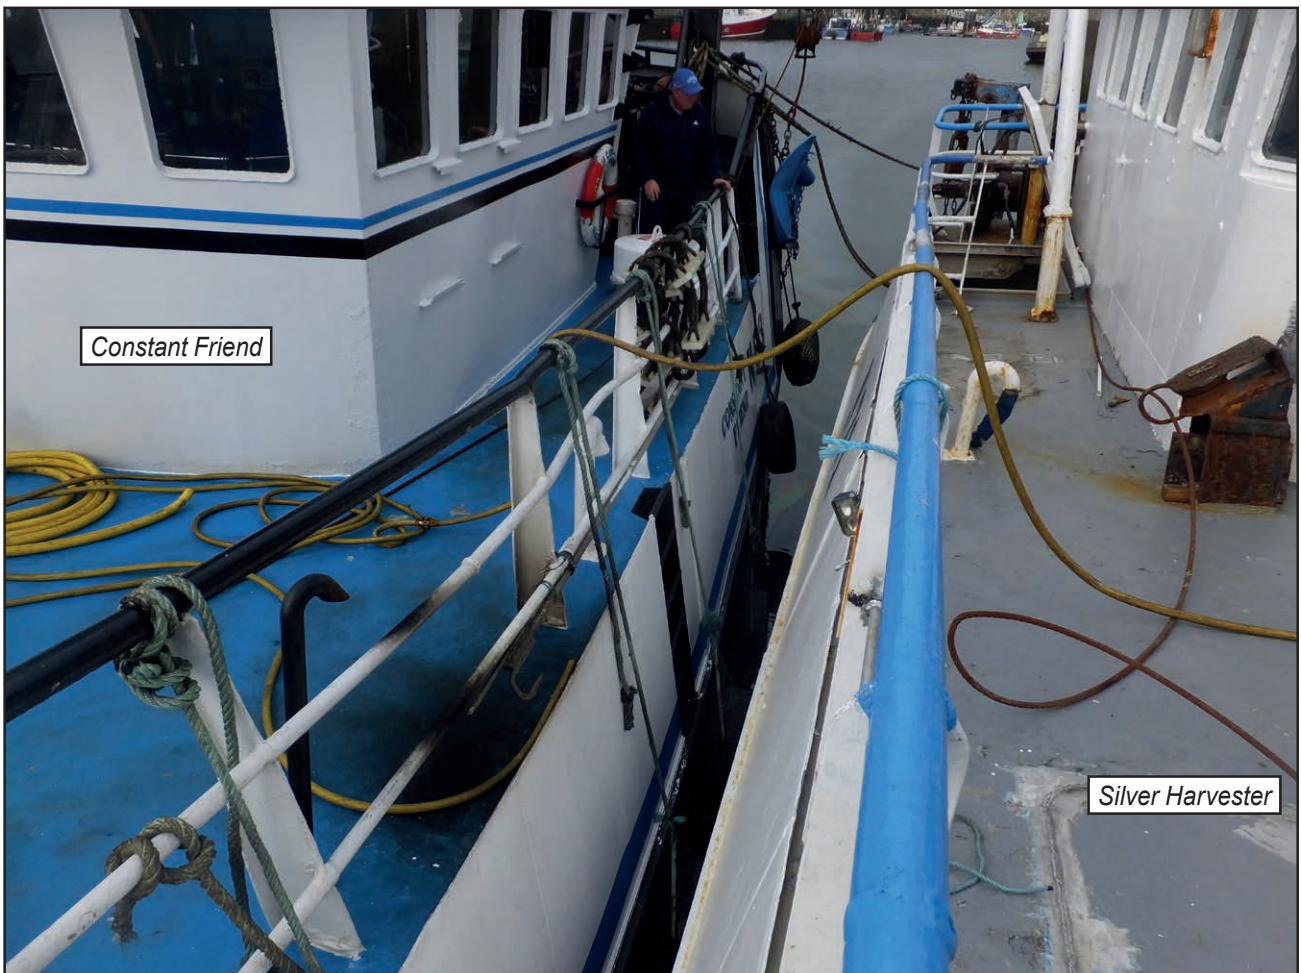
Figure 3: *Constant Friend* berthed alongside *Silver Harvester*

There were no boarding gates or removable sections of guardrail on either *Constant Friend* or *Silver Harvester*. This meant that although only a short step was required to pass between the boats, particularly around amidships where the decks of the two boats were level, access to *Constant Friend* still required climbing over the guardrails of both boats.

Balancing on a vessel's coaming or fish plate to climb over guardrails is inherently hazardous, and the risk of a slip or fall is increased at night, in wet and slippery conditions, and when the vessel is moving, whether or not the individual has consumed alcohol. Had *Silver Harvester* and *Constant Friend* both been equipped with a guardrail gate, or similar arrangement, around the midships area, such that the guardrail openings could be aligned during berthing, a much safer means of access for the crew could have been provided and this tragic accident prevented.

- 2018/111** Review *Constant Friend's* risk assessment relating to boarding and leaving the boat. The risk assessment should include the hazards associated with crew members proceeding to and from the shore for recreational activities, and take into account the increased risk of a crew member falling in as a result of adverse environmental conditions. Suggested control measures for consideration include the provision of guardrail gates and a formal arrangement for a nominated crewman to monitor and assist individuals boarding the boat.
- 2018/112** Develop a contact card and procedure to enable crew to directly and immediately alert the emergency services (when in port).

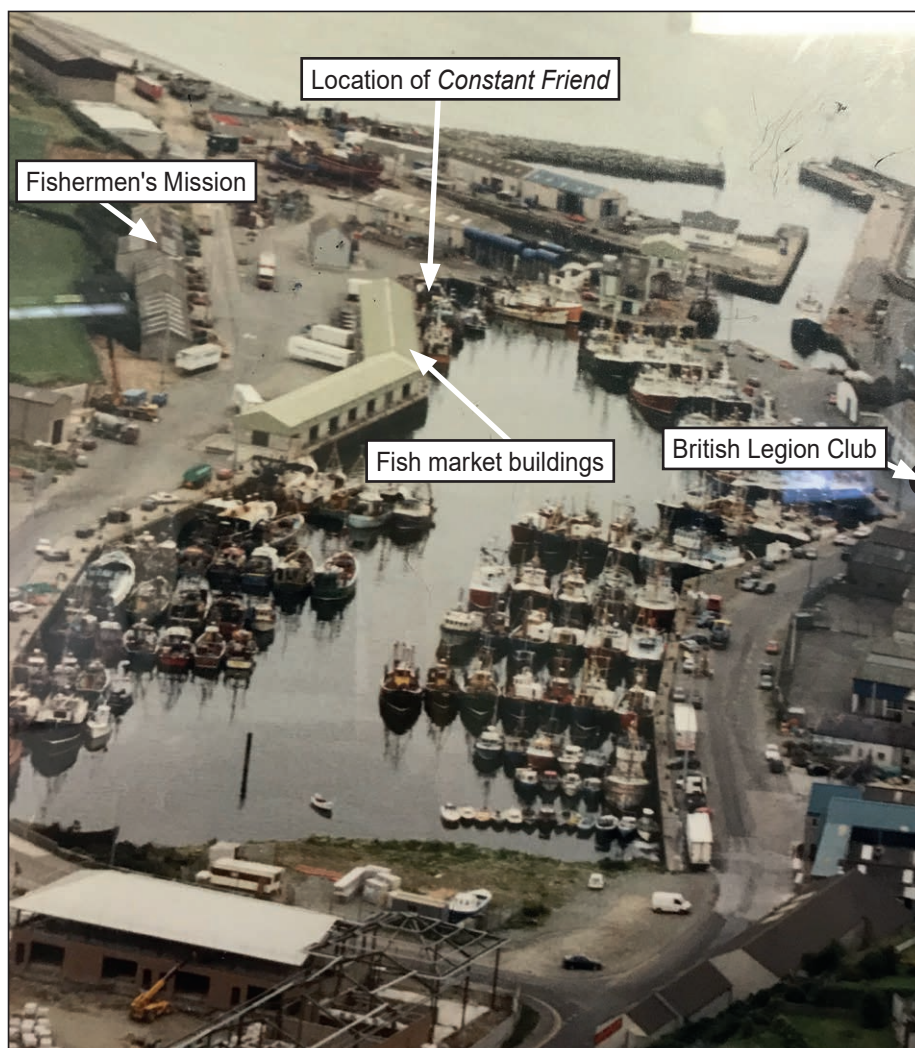
Up to four fishing boats were often berthed alongside each other parallel to the quay wall (**Figure 4**). Access to the boats required crews to climb over guardrails and to step across the gap between adjacent boats. The berths were well-illuminated at night by regularly spaced high pressure sodium lamps (**Figure 5**).

Figure 4: Kilkeel Harbour (historical photograph)

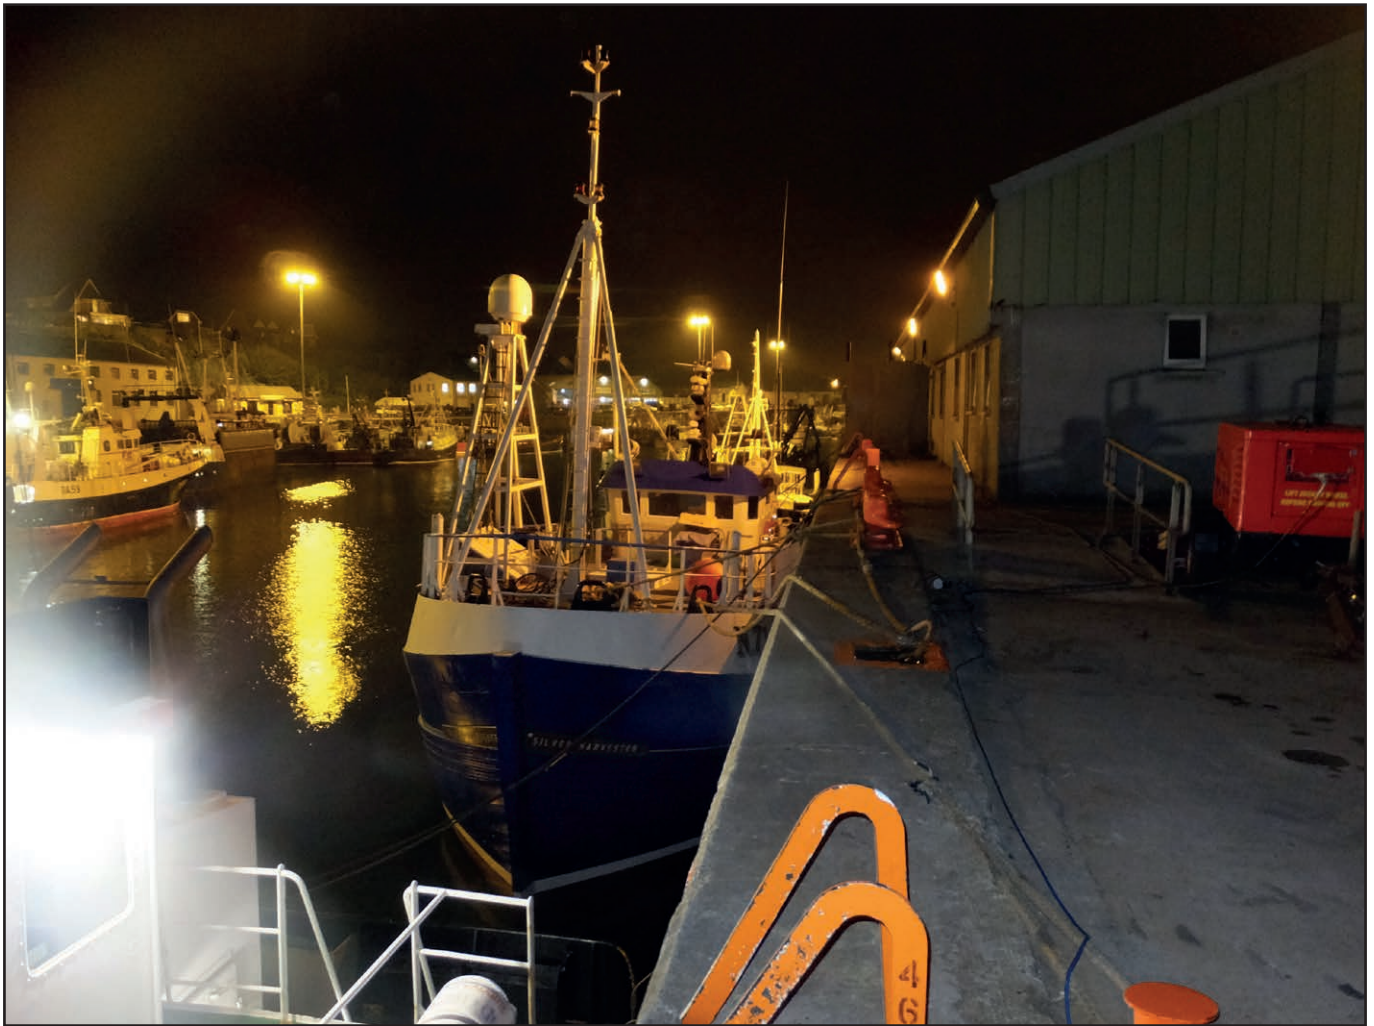
Figure 5: Quayside lighting

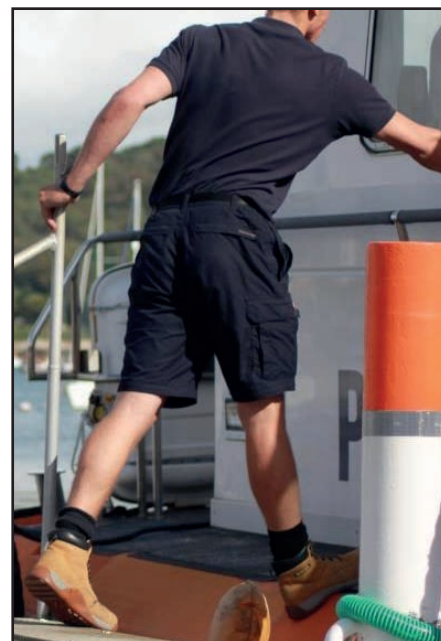
Figure 6: Level access

Further guidance is available in the Ports Skills and Safety publication SIP021 – Safe Access to Fishing Vessels and Small Craft in Ports, which contains 15 sections covering specific aspects of vessel access. Section 4 addresses co-operation and co-ordination between the port authority and its users, and recommends regular meetings to discuss access requirements and concerns. Section 6 reiterates the increased risk associated with consumption of alcohol. Section 9 allows for access by stepping directly from one vessel to another, provided such access is level and requires only a short step (Figure 6).

While MSN1872 (F) specifies the use of a gangway and net, it acknowledges that safe access may be achieved by other appropriate means. In this regard, the Port Skills and Safety publication SIP021 allows the practice of stepping directly from one vessel to another provided such access is level and requires only a short step (**Figure 6**).

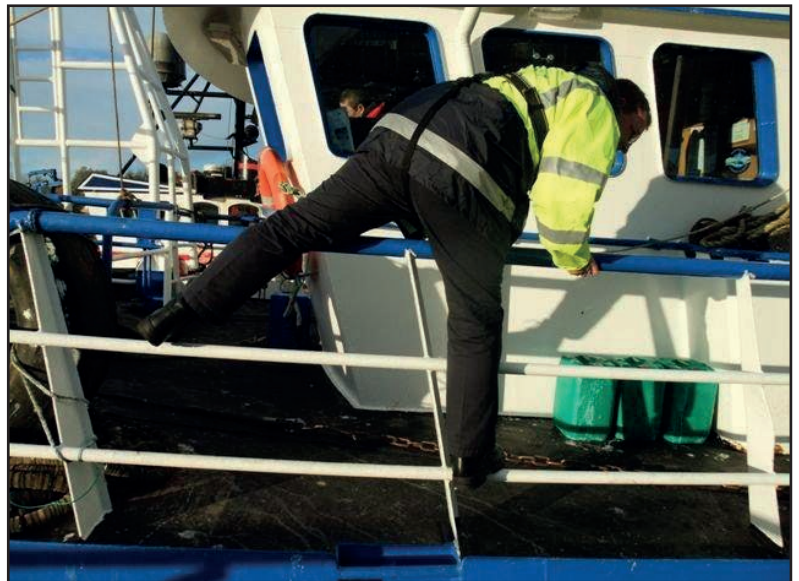
The skipper had his right foot on the lower horizontal guardrail, and was holding onto the top rail as he attempted to swing his left leg over *New Dawn*'s 1m high guardrails (**Figure 7**). As he did so, he appeared to lose his balance, lost his grip on the wet bulwark guardrail and fell into the water. As he fell, he struck his head on one of the pier's coping stones.

Figure 7: Climbing over *New Dawn*'s guardrail
