## The collision between the commercial fishing vessel *Vertrouwen* and recreational motor cruiser *James 2* resulting in the sinking of *James 2* and loss of three lives Shoreham-by-Sea 6 August 2017

### SUMMARY

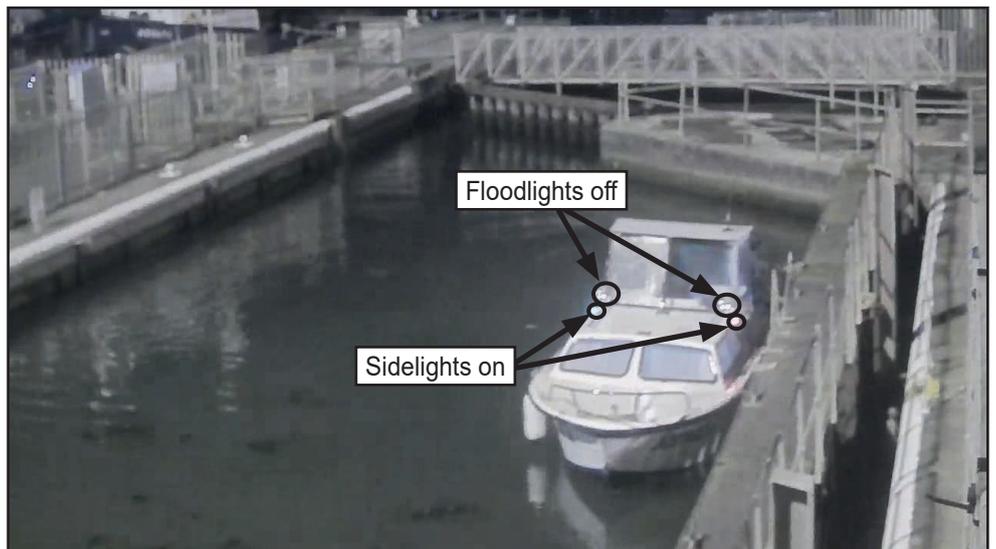
Figure 2: *James 2* in locks

*James 2* had port and starboard sidelights and these were on when the boat departed Shoreham (**Figure 2**). It did not have a masthead light, sternlight or all-round white light. Mircea used *James 2*'s forward-facing spotlights to assist his manoeuvre off the pontoon in the marina and out of Riverside Yard, but they were switched off before the vessel entered the lock and left the port. Mircea and Irinel wore LED head torches on the evening of the accident, and they also had hand torches available on board.

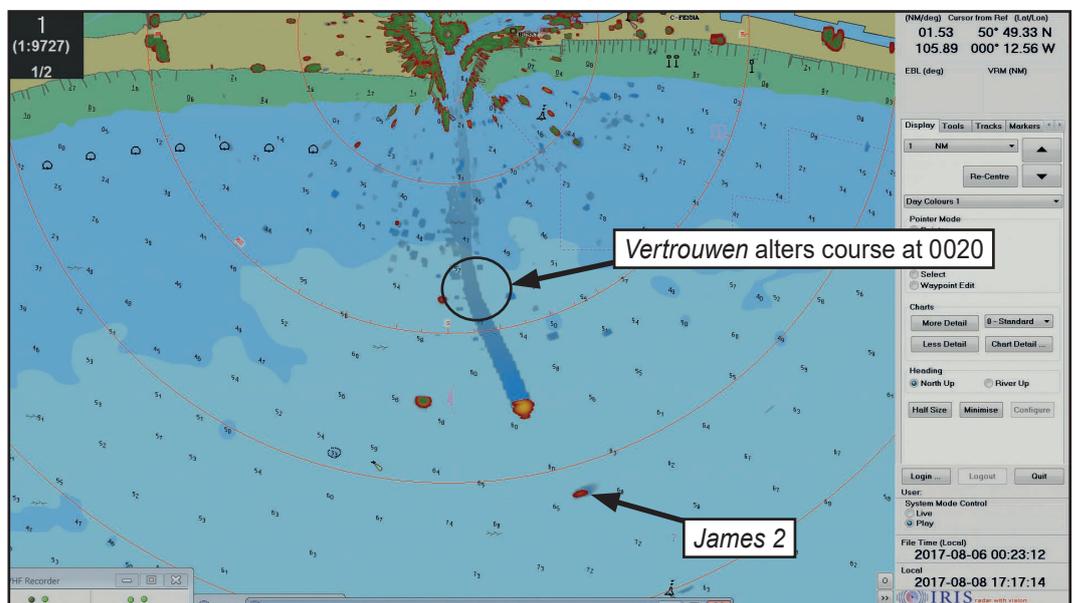
Figure 3b: *Vertrouwen* passage from Shoreham

At 2354, *Vertrouwen's* skipper manoeuvred his vessel out of the dry dock and into the harbour lock. About 15 minutes later, *Vertrouwen* left the lock and proceeded out of the port, passing the outer breakwaters at 0015 (6 August). As the skipper brought the vessel out of the port, his crew made their way from the deck to the wheelhouse. The skipper told the crew that he had no other work for them to do and that he would take the first watch. The crew left the wheelhouse and went to their bunks. Once clear of Shoreham, the skipper increased *Vertrouwen's* speed to about 7kts and set a southerly course on the autopilot. At 0020, he altered course slightly to port, putting the vessel on a south-south-easterly heading (Figure 3b).

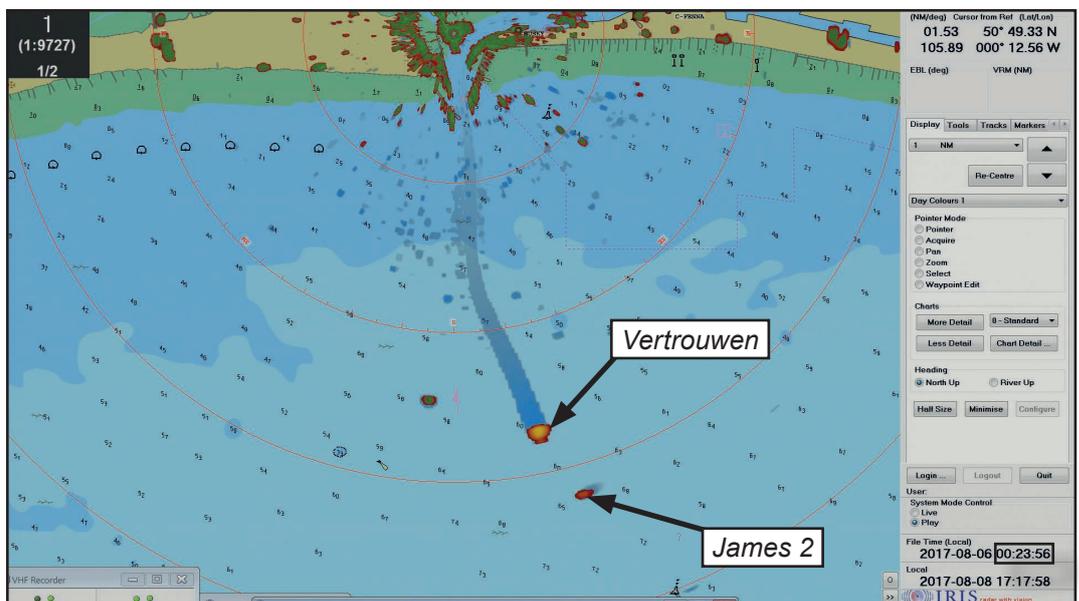
Figure 3c: *Vertrouwen* position as skipper uses his mobile phone

At 0024, *Vertrouwen's* skipper used his mobile phone to send a message on social media to a friend on board another fishing vessel; *Vertrouwen* was about a quarter of a mile from *James 2* and on a collision course with the boat (Figure 3c). The skipper then started to compile his electronic departure report.

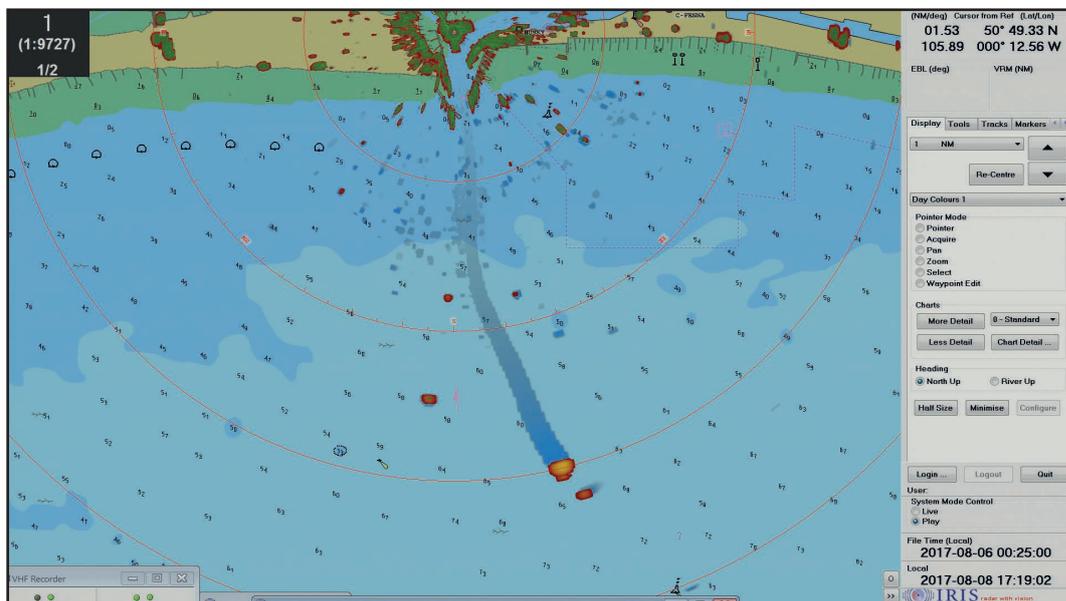
**Figure 3d:** *Vertrouwen* and *James 2* immediately before the collision

At 0026, *Vertrouwen* struck *James 2* on its starboard quarter with a glancing blow (**Figure 3d**) and its bow wave washed over the motor cruiser's stern. *James 2* started to sink by the

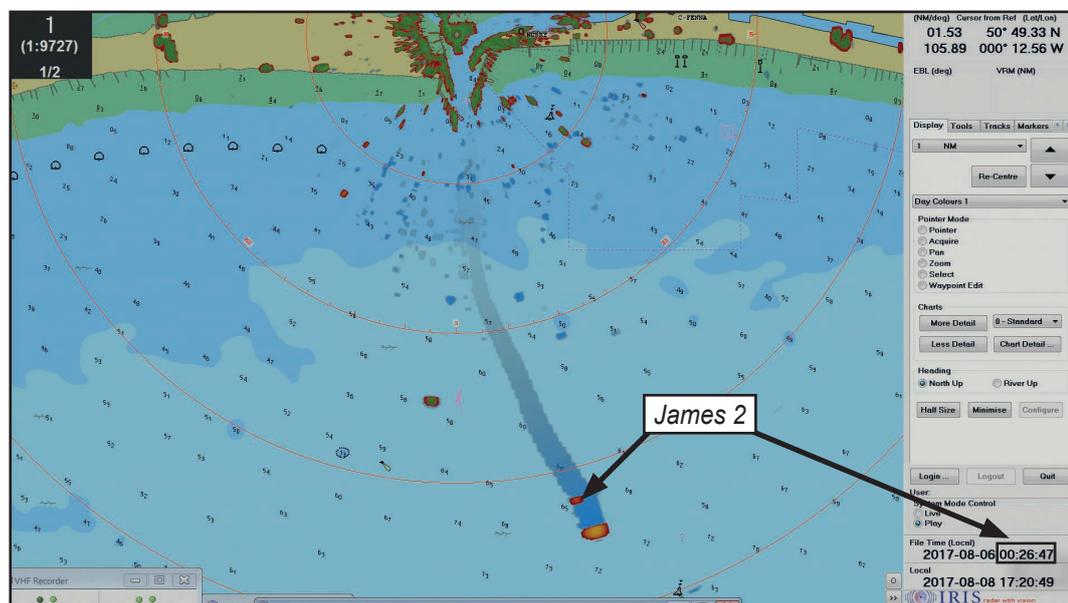
**Figure 3e:** *Vertrouwen* and *James 2* shortly after the collision

stern as water continued to flood over the low transom. The anglers tried frantically to bail the boat out and also gain the attention of the crew on board *Vertrouwen* by shouting and flashing their torches, but

*Vertrouwen* did not stop (**Figure 3e**).

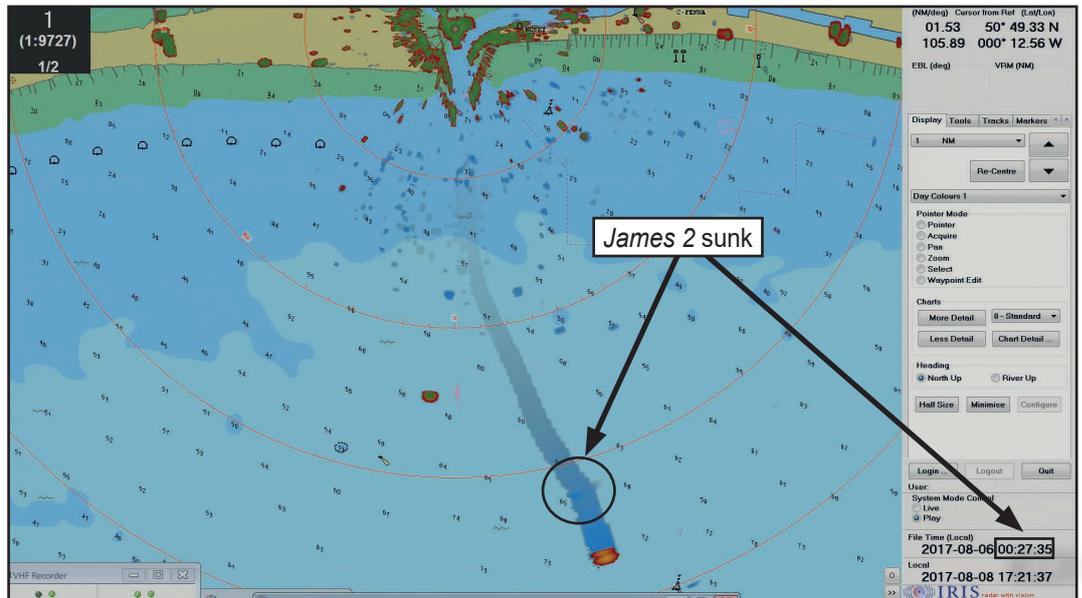
**Figure 3f:** *James 2* sunk position

passed his knife to the survivor, who managed to cut a second fender free as *James 2* sank less than 2 minutes after the collision (**Figure 3f**).

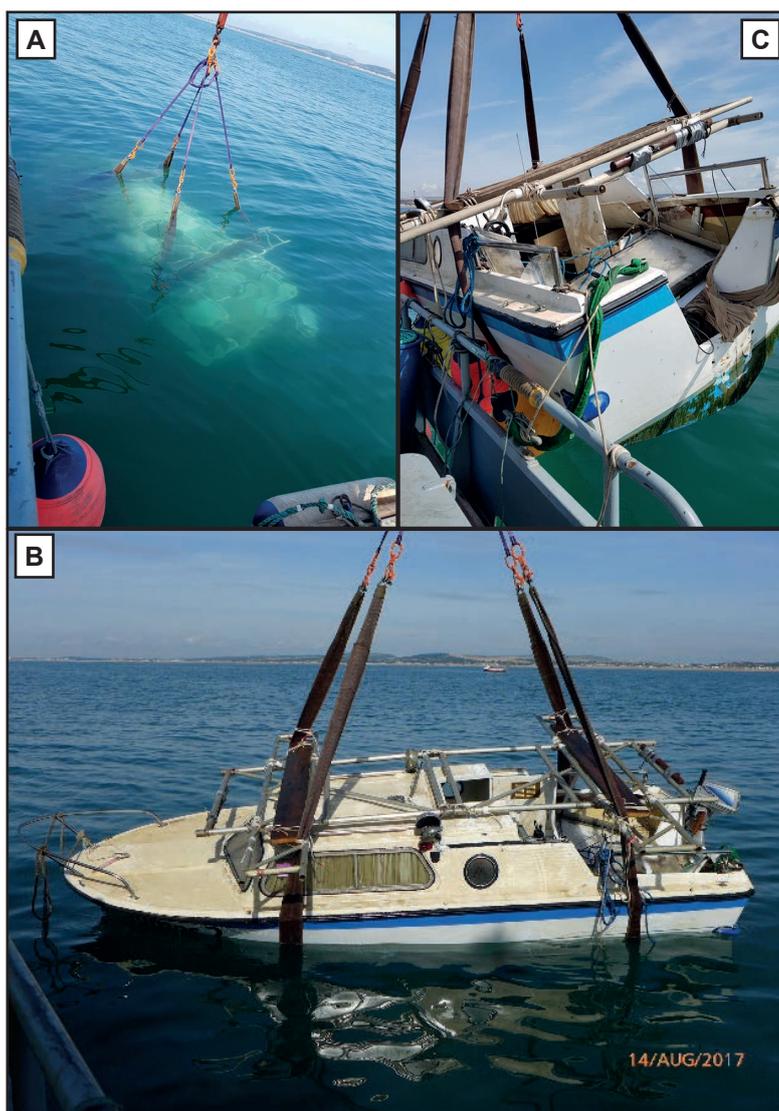
Figure 4a, b and c: *James 2* wreck recovery

The wreck of *James 2* was located using side-scan sonar 6 days after the accident. The wreck was initially surveyed on the seabed by divers and, on 14 August 2017, it was raised and landed ashore (**Figures 4a, b and c**).

Close examination of the wreck revealed that *James 2* had suffered no structural damage as a result of the collision. Some minor scuff marks were found on the starboard quarter of the hull, but these appeared to be old and similar to other scuff marks found around the hull. The inspection also identified that the engine throttle was in the neutral position and the cabin lights were switched off.

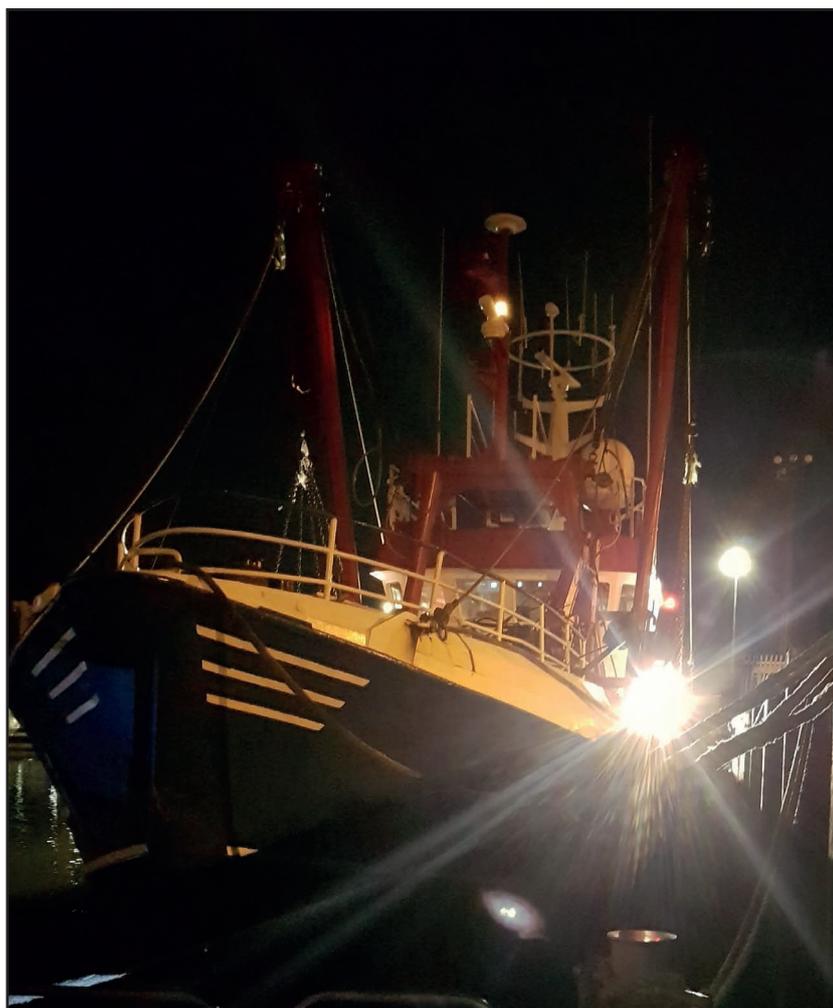
When *Vertrouwen* departed Shoreham harbour its navigation lights were showing. *Vertrouwen* had halogen and LED floodlights for illuminating its forward and aft working decks. It also had two forward-facing halogen floodlights to illuminate the port and starboard dredge bag landing areas (**Figure 6**). The skipper usually left these on at night, and they were on when *Vertrouwen* left the harbour.

**Figure 6:** *Vertrouwen*'s forward facing dredge deck floodlights visible from ahead

The brightness of *Vertrouwen*'s floodlights would almost certainly have created backscatter from its deck, superstructure, and equipment forward of the wheelhouse. This would have adversely affected the skipper's night vision and diminished his ability to visually identify small craft with low levels of illumination, such as *James 2*.

*Vertrouwen* was showing the navigation lights required by the COLREGS for a motor vessel of its size while underway. However, the brightness of its forward-facing floodlights would have made it harder to see the vessel's navigation lights from *James 2*'s deck and so determine its direction of travel.

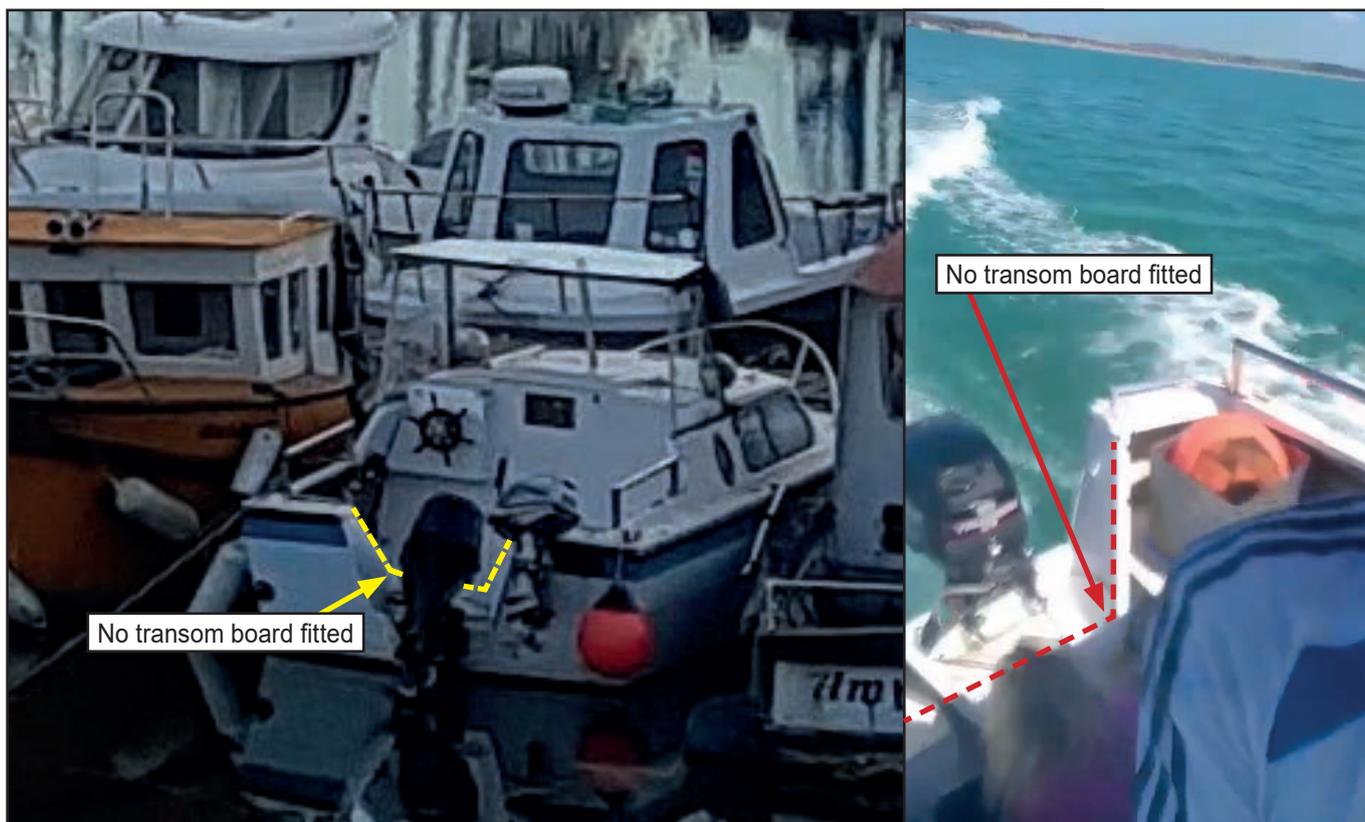
mounting the outboard motor. Inspection of the boat identified that previous owners had fitted transom boards on the inside of the cut-out to increase the boat's freeboard to about 740mm. Mircea never used transom boards (**Figures 7a and b**).

**Figure 7a:** *James 2* on its berth in Riverside Yard July 2017

**Figure 7b:** *James 2* at sea summer 2017

*James 2* was undamaged by the impact of the collision. It sank because it was swamped by *Vertrouwen*'s wash and had insufficient reserve buoyancy to remain afloat in the flooded condition. The cut-out in *James 2*'s transom had reduced the boat's freeboard, and therefore its downflooding height to less than 250mm. This was inadequate for a boat of its size and design when operating at sea. Had a watertight board been fitted on the inboard side of the transom cut-out, the boat's freeboard would have been almost three times greater and the risk of it becoming swamped would have been significantly reduced. If the boat had had the reserve buoyancy through built-in flotation required of similar sized boats, built to comply with the RCD, it would not have sunk. At worst, the boat would have floated awash, providing something for the sea anglers to cling to while in the water.

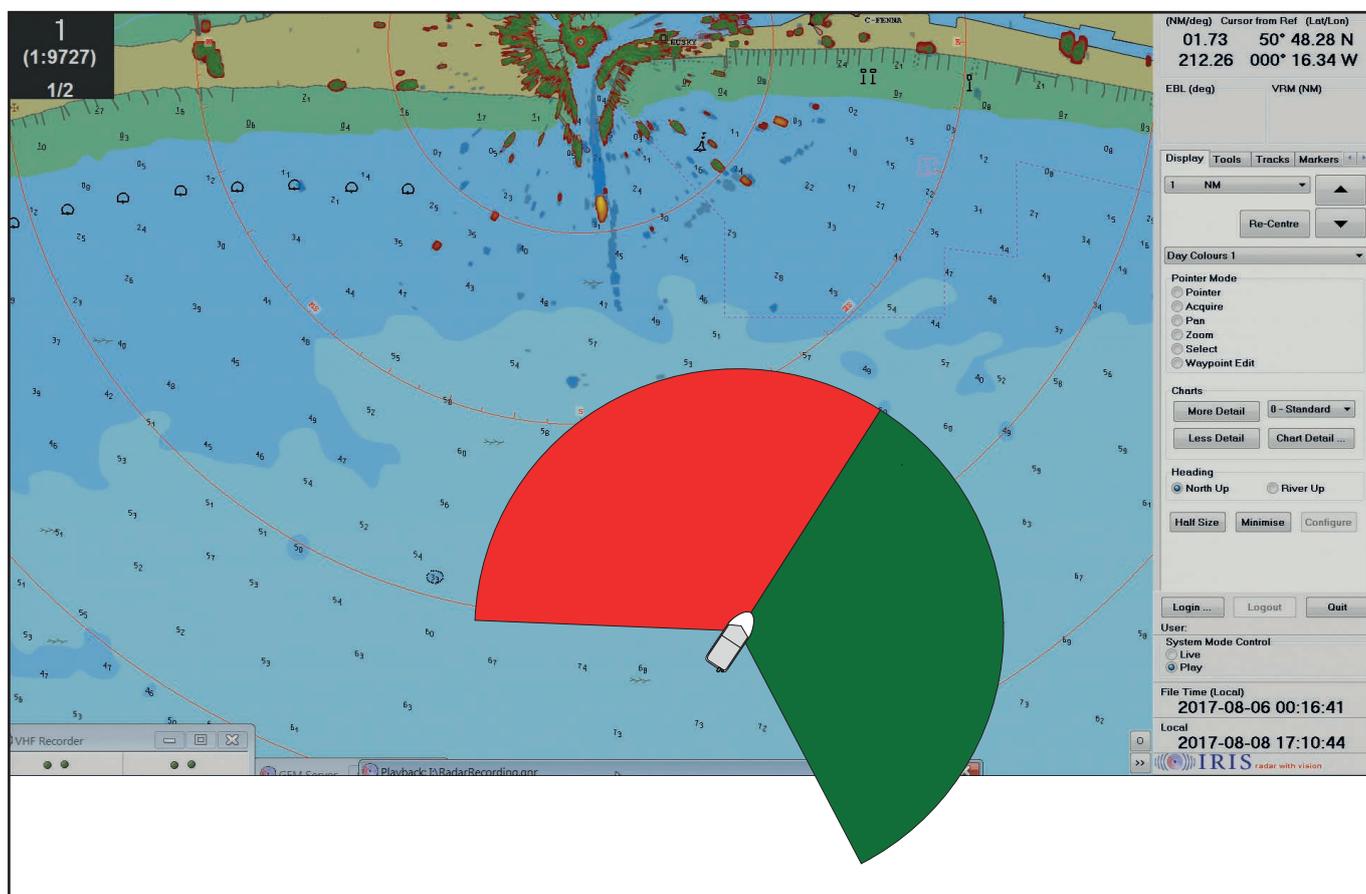
*James 2* was not showing all the navigation lights required for a boat of its size; it did not have either a masthead light and sternlight, or an all-round white light. If *James 2* was facing head or beam onto the approaching *Vertrouwen*, its sidelights should have been visible from *Vertrouwen*'s wheelhouse at a distance of at least 1 mile; or for at least 8 minutes prior to the collision (**Figure 8a**).

**Figure 8a:** Most likely orientation of the lights shown by *James 2* when it stopped to fish

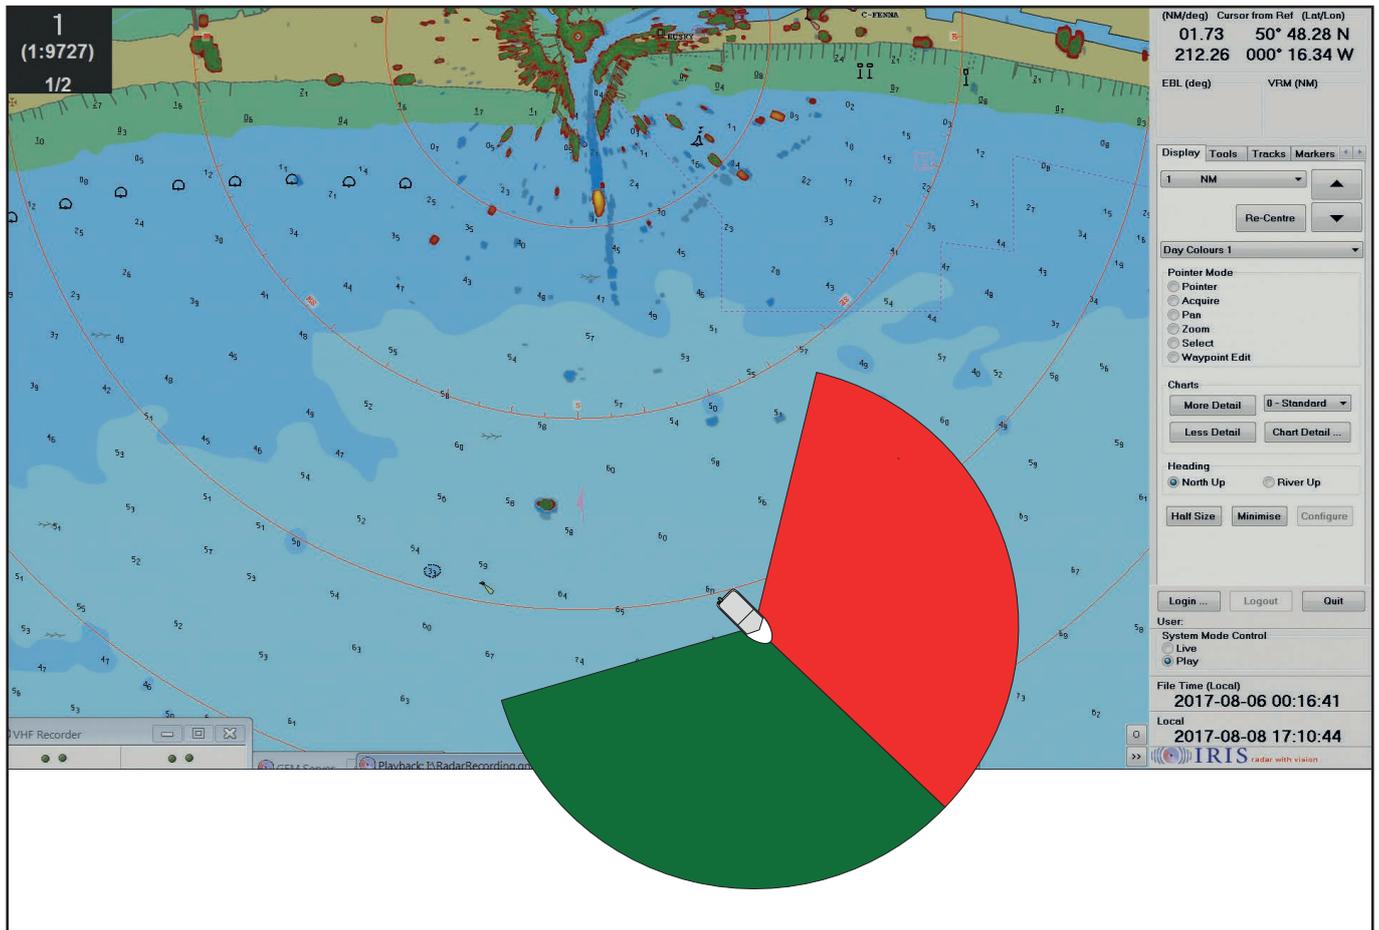
The night time visibility trials conducted by the MAIB confirmed that *James 2* would have been clearly visible from the harbour breakwater if it had been showing the white navigation lights mandated in the COLREGS. The trials also showed that *James 2* would not have been visible from *Vertrouwen*'s wheelhouse until it was in very close range if the motor cruiser was drifting with its stern, or port or starboard quarters facing toward the fishing boat (**Figure 8b**).

**Figure 8b:** Most likely orientation of the lights shown by *James 2* as *Vertrouwen* approached
