## SIMPLIFIED SAFETY INVESTIGATION REPORT

REPORT NO.: 05/2018

### **MV CHODZIEZ** **Main engine damage** **in position 42° 45.0' N 004° 47.0' E** **31 March 2017**

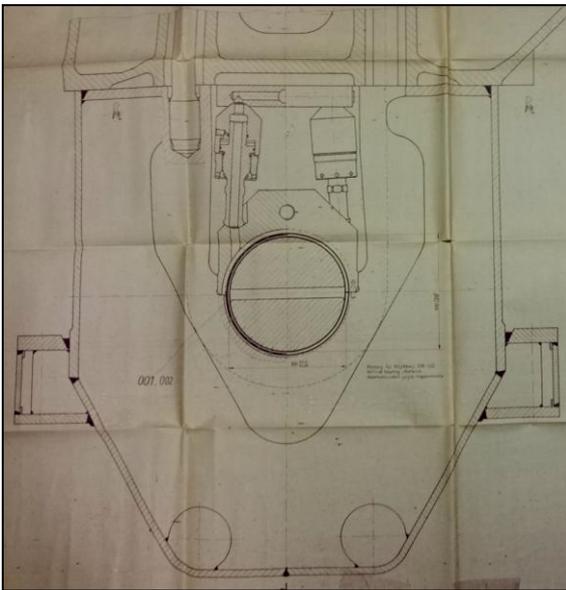
With the crankcase doors open, the three engineers were able to see inside of the crankcase. The extent of the damage was immediately evident. No. 2 main bearing (Figure 1) had seized. White metal particles were visible on the crankcase walls. Main bearing shells were noticeably damaged and it was also suspected that the crankshaft's main journal no. 3, big end bearing no. 2 and the corresponding connecting rod journal were damaged. Bearing shells were displaced and raised from their housing.

Figure 1: Main bearing assembly

Service engineers were contracted to assess the condition of the crankshaft and a decision was taken to grind the crankshaft in situ. During the grinding, cracks which could not be removed by machining remained visible. Deeper grinding exposed further cracks. In order to minimise the machining costs, the grinding was suspended and it was agreed that the crankshaft had to be replaced.

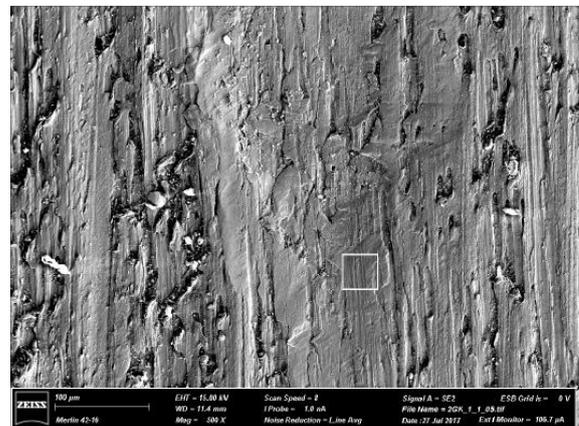
The damage on bearing no. 2 is typically known as 'hot short'<sup>6</sup>. The appearance of the bearing surface included wiping, severe galling and blackening from heat. The lining had been removed from several areas. The galling phenomena observed in bearing no. 2 was a severe form of adhesive wear that could have occurred with sliding between metals, resulting in high friction and thus elevated operating temperatures. In this case, extensive galling could be distinguished by localised macroscopic roughening and the creation of several protrusions above the original bearing surface. Areas which included both plastic flow and material transfer were also identified (Figure 2).

Figure 2: Areas with plastic flow and material transfer

The wavy surface topography may have also facilitated this effect. However, both surface topography and material selection are intended by design for good operation of these bearings; for instance, these features / characteristics are necessary for lubrication purposes. As a result, it is plausible (assuming that these bearings are well designed to serve their intended purpose and generally survive for a minimum lifetime of 12,000 hours) that the cause of failure is out-of-roundness and/or misalignment in the bearing assembly. It was therefore proposed that misalignment led to overloading and thus failure of shell bearing no. 2.

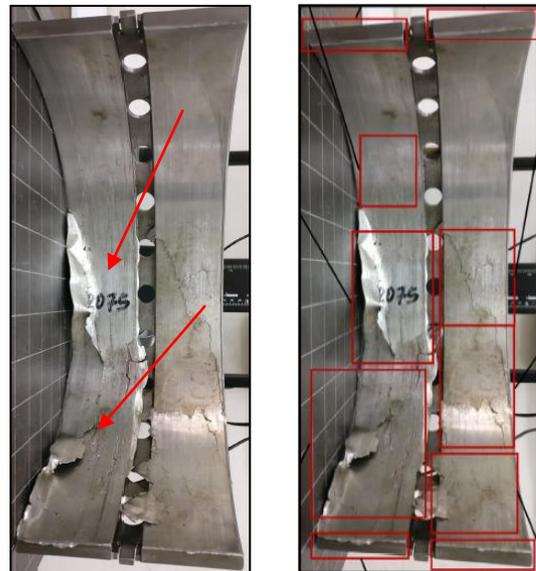
The babbitt material was observed under optical and electron microscopes. Yet again, no foreign material was found embedded in it; instead, a clean separation from the steel backing could be observed (Figures 3a, 3b).

Figures 3a and 3b: Clean separation on the bearing shells

Figures 3a and 3b show that large areas of the babbitt metal had spalled away from the backing and other areas could be readily lifted off with minimal force. Furthermore, the analysis also showed extrusion of the lining material out of the bearing edges.

In this case, the failure of the overlay was only partly attributable to fatigue. Fatigue damage overlay is usually visible in the form of a continuous network of cracks, followed by partial flaking of the coatings. In this case, the amount of cracks visible in the remaining lining material did not relate well to the large scale delamination observed for this bearing. However, in the case
