## SIMPLIFIED SAFETY INVESTIGATION REPORT

REPORT NO.: 07/2018

### **MV UMM SALAL** **Grounding in position 02° 51.00' N 101° 00.36' E,** **2.45 nautical miles South of One Fathom Bank,** **Selangor, Malaysia** **06 April 2017**

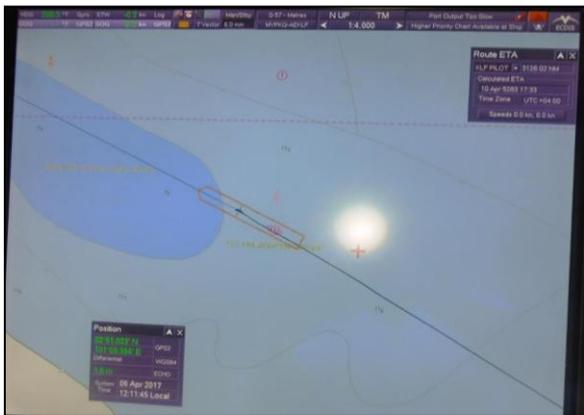
Soon after the chief engineer left the bridge, at about 1533, the OOW noticed the ship vibrating. Concerned about this, the OOW looked at the echo sounder's front panel which read a depth of 2.0 m. The ECDIS indicated that the vessel was heading towards a shallow patch of water<sup>2</sup> (Figure 1).

**Figure 1: Screenshot from the ECDIS showing vessel heading in shallow water**

The traffic situation evolving ahead of the ship prevented the OOW from shifting his attention to the navigational aids which were clearly indicating that the vessel was heading into shallow waters.

A post-accident inspection after the accident confirmed that although the alarms on the ECDIS were functional, these were intentionally turned off to avoid continuous activation. Therefore, it may be concluded that not only was the (timely) intervention missing because of the evolving situation, but the feature which could have triggered the intervention had been switched off.

*07/2017\_R1* ensure that navigational equipment on board is used properly, especially equipment fitted with audible and visual alarms.
