MARINE SAFETY INVESTIGATION REPORT

Safety investigation into the fatality inside the elevator shaft
on board the Maltese registered bulk carrier

ABYO AUDREY

MARINE SAFETY INVESTIGATION REPORT NO. 06/2018

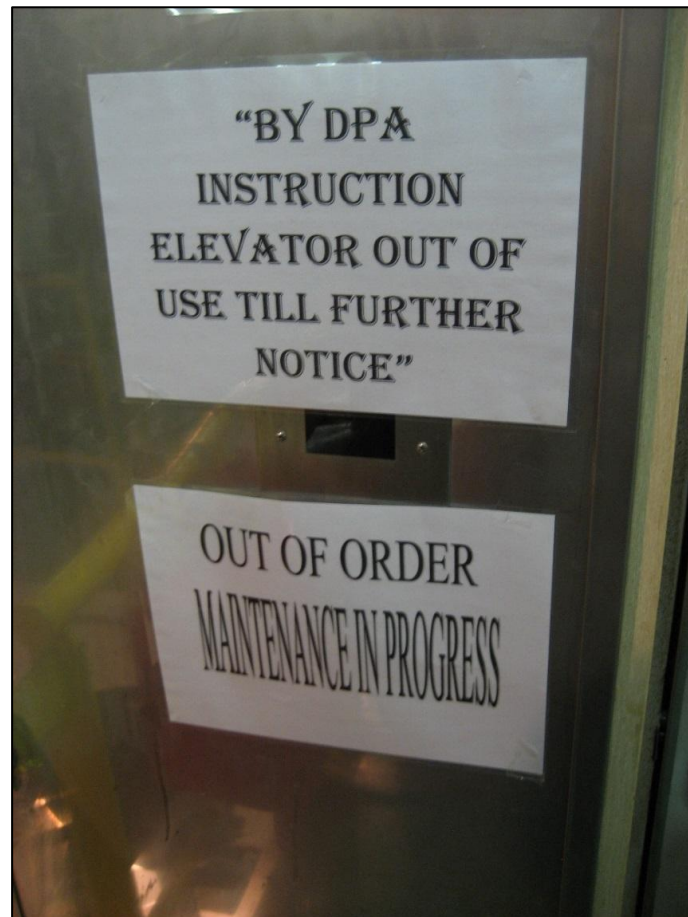
Figure 3: Out of Order Sign *(The DPA sign was put after the accident happened)*

In trying to check the governor and limit switches, the chief engineer wanted to try and rectify the problem with the elevator car not stopping exactly at the deck level. It was reported that prior to the commencement of this work, signs were posted on every floor and on the control panel indicating that the equipment was out of order due to maintenance (Figure 3). Similar signs were posted over the call buttons at individual decks.

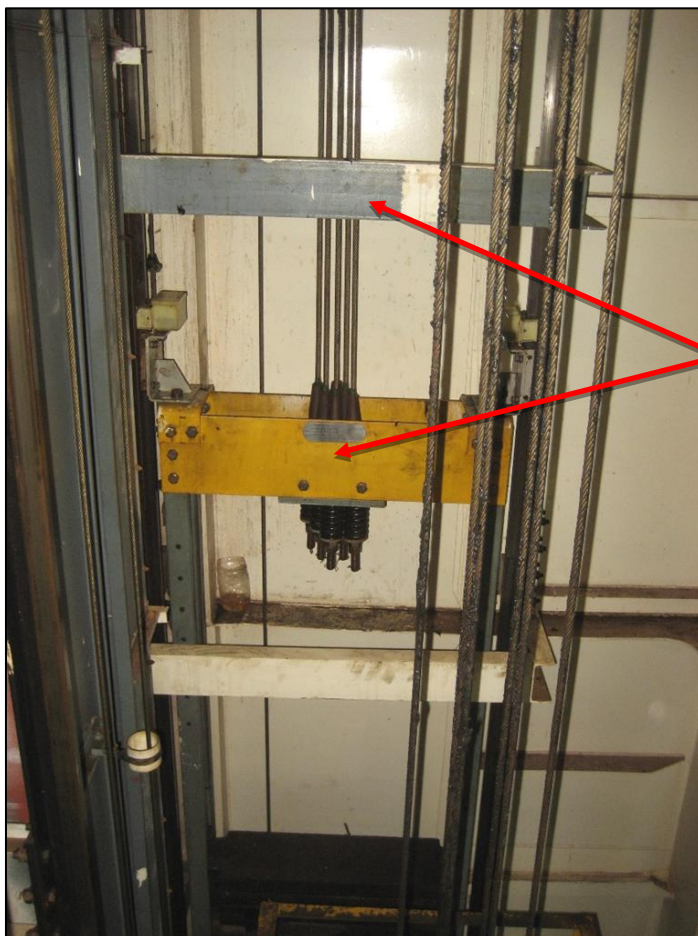
Figure 5: The area where the electrician was found inside the elevator shaft

It was noticed that the electrician was wearing a safety harness but was outside the safety of the cage on the top of the elevator car (Figure 5).

The electrician's torso trapped between the counterweight (yellow) and the beam (grey), with his right leg straddling the counterweight.

The position he was found in suggested he was engaged in an activity in the far left corner of the elevator shaft. This hypothesis was based on the position he was discovered where his feet were straddled between the horizontal frame on the far side of the elevator shaft and the counterweight protection beam with the counterweight between his legs.

- .1 The immediate cause of the death was the downward powered movement of the elevator car, causing the counterweight to move upwards and entrapping the electrician between the counterweight and one of the counterweight guard beams.

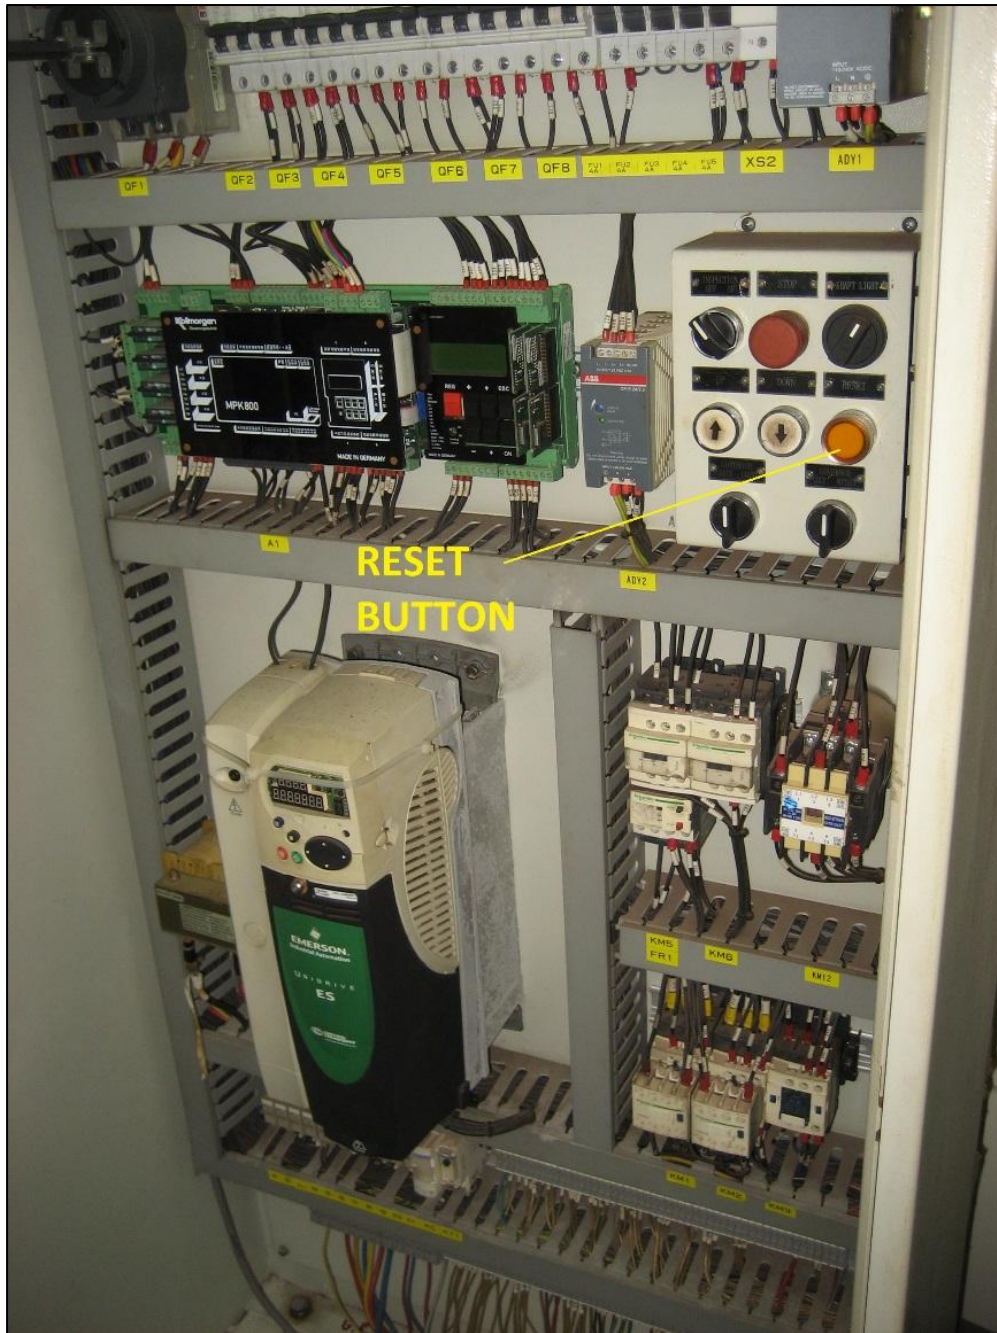
Figure 6: Reset button inside control cabinet

the machinery room inside the control cabinet on D deck (Figure 6). However, following the accident, the maintenance switch was found in the 'ON' position, which meant that the electrician could move the elevator car up or down from within the elevator shaft, as long as the shaft doors were closed and the emergency latch-out was not triggered.

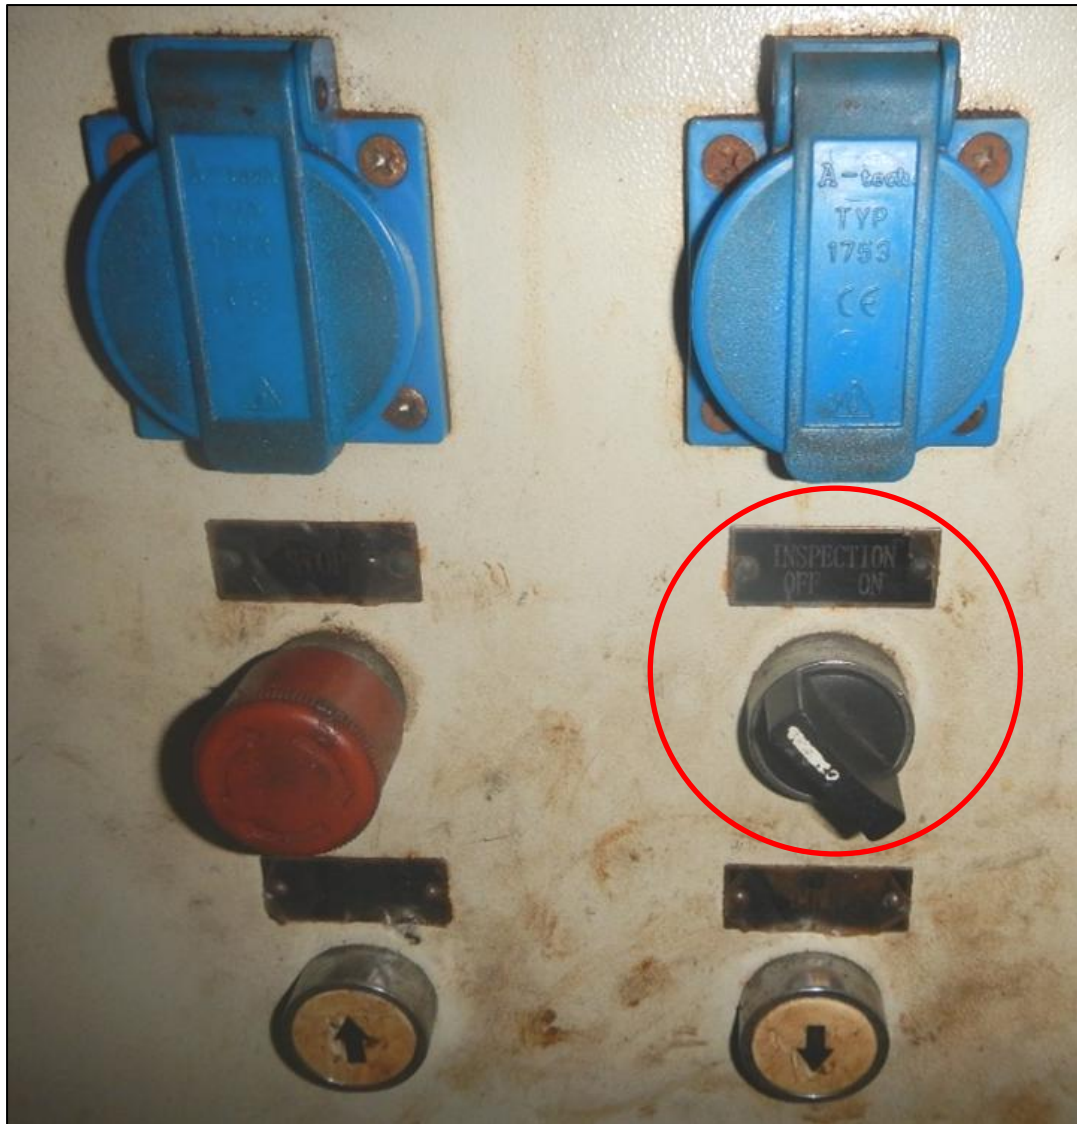
Figure 7: Inspection switch (in the OFF position)

This switch enables the engineer to move the elevator car by the use of up and down buttons whilst inside the elevator shaft. It would also ensure that no one outside the elevator car operates the elevator. The top of the car has a safety cage and is intended for the engineer to remain within it when operating the car from inside the elevator shaft (Figure 8).

As already explained, whilst working inside the elevator shaft, the maintenance switch on top of the car had to be switched to the 'ON' position (Figure 7). According to the interviewed crew members, this was the position in which the switch was found².

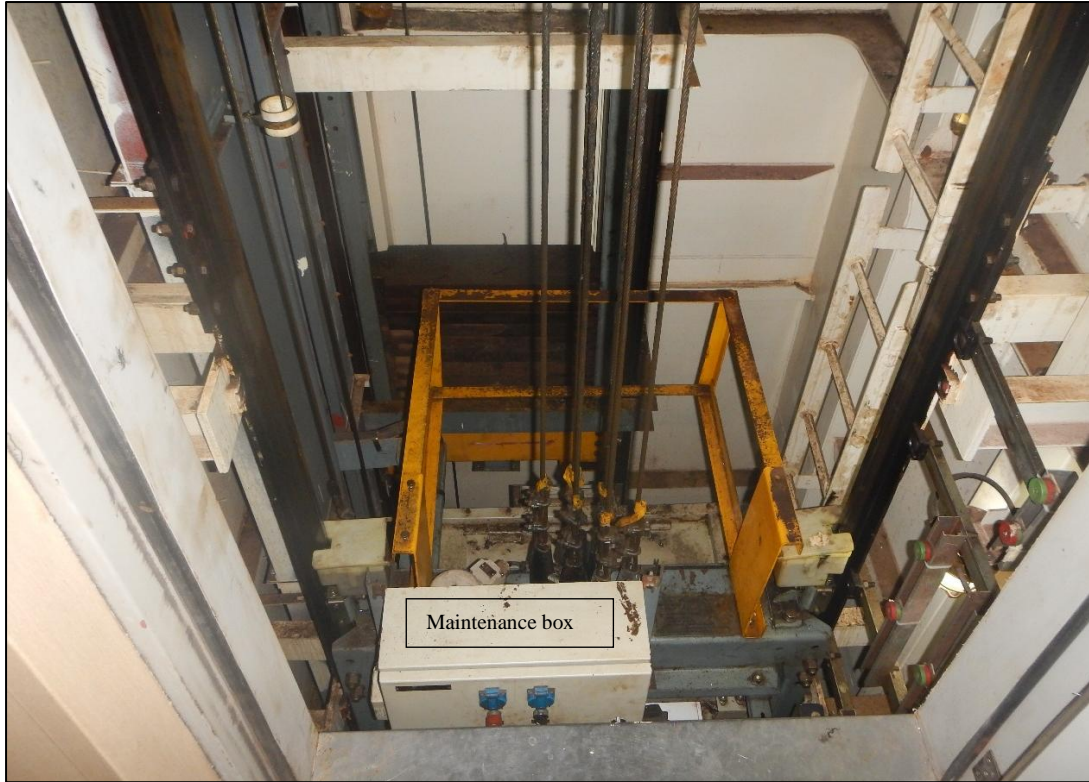
Figure 8 – Top of elevator car, showing maintenance box and safety cage

The electrician was found outside the boundary of the safety cage, while the elevator was powered on. The safety investigation could neither establish why the electrician stepped out of the safety cage, nor why the elevator car moved uncontrollably. These points, however, and a number of contributing factors to the accident are discussed in the sections below.

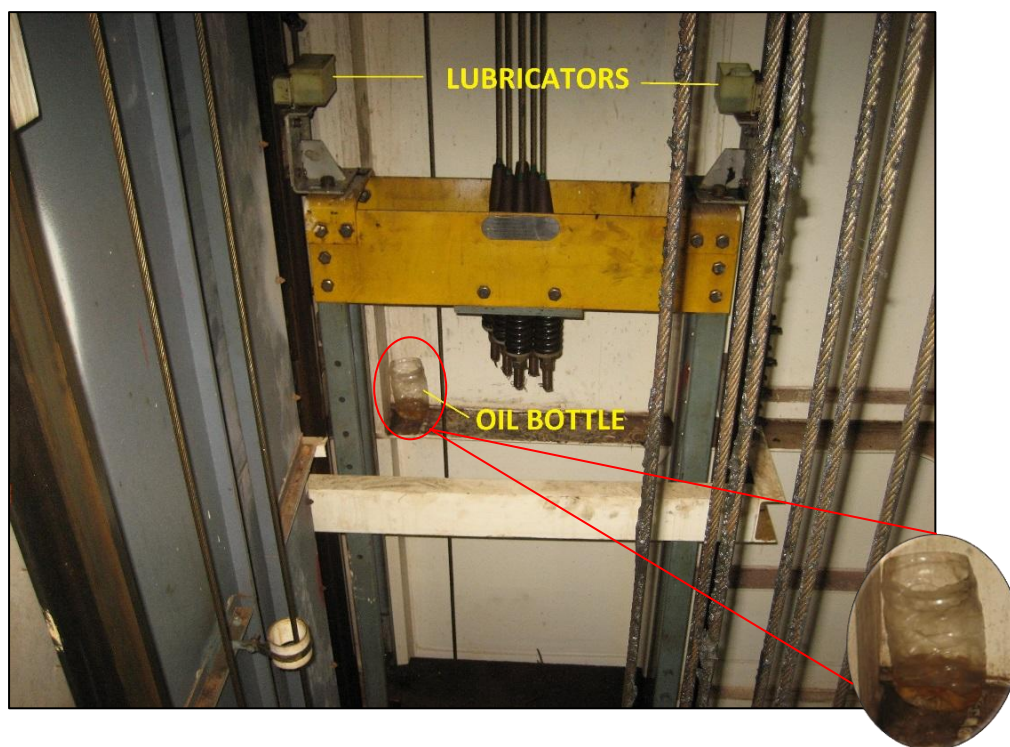
Figure 9: Position of lubricators and plastic oil bottle left in the elevator shaft

From the position in which the electrician was found, the only logical explanation appears to be that he returned to retrieve a plastic bottle of oil (Figure 9), either to prevent an oil spillage or to top it up and return it on the following day.

This bottle was used to top up the guide rail lubrication boxes and had been left behind on the horizontal frame at the back of the shaft. The only probable reason appears to be that while trying to retrieve the bottle, the elevator must have inexplicably moved downwards, trapping him between the counterweight and the counterweight guard beam.

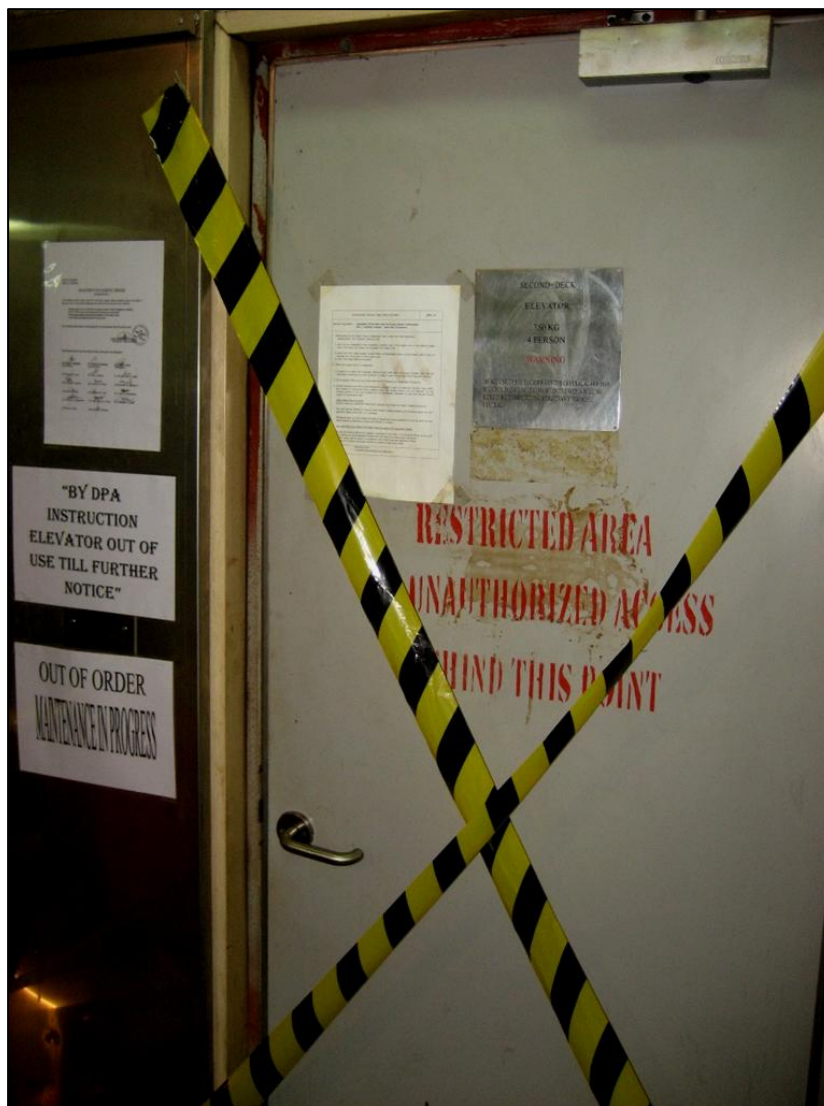
Figure 11: Signage on each deck during maintenance

- Tool Box meeting in the morning to discuss the work for the day, including who will carry out which task and who will assist;
- A risk assessment was in place for working on the elevator cage shown (**Annex J**);
- A risk review was carried out by the chief engineer and electrician prior to commencement of work and a permit to work aloft was issued before work commenced;
- "OUT OF ORDER MAINTENANCE IN PROGRESS" signs were posted over the call buttons on each individual deck (Figure 11);
