**REPORT OF THE  
INVESTIGATION INTO THE  
FATAL INCIDENT  
INVOLVING  
*'FV KERRI HEATHER'*  
EAST OF KILMICHAEL POINT,  
ARKLOW, CO. WICKLOW  
ON  
16th NOVEMBER 2016**

**REPORT NO. MCIB/268  
(No.1 OF 2018)**

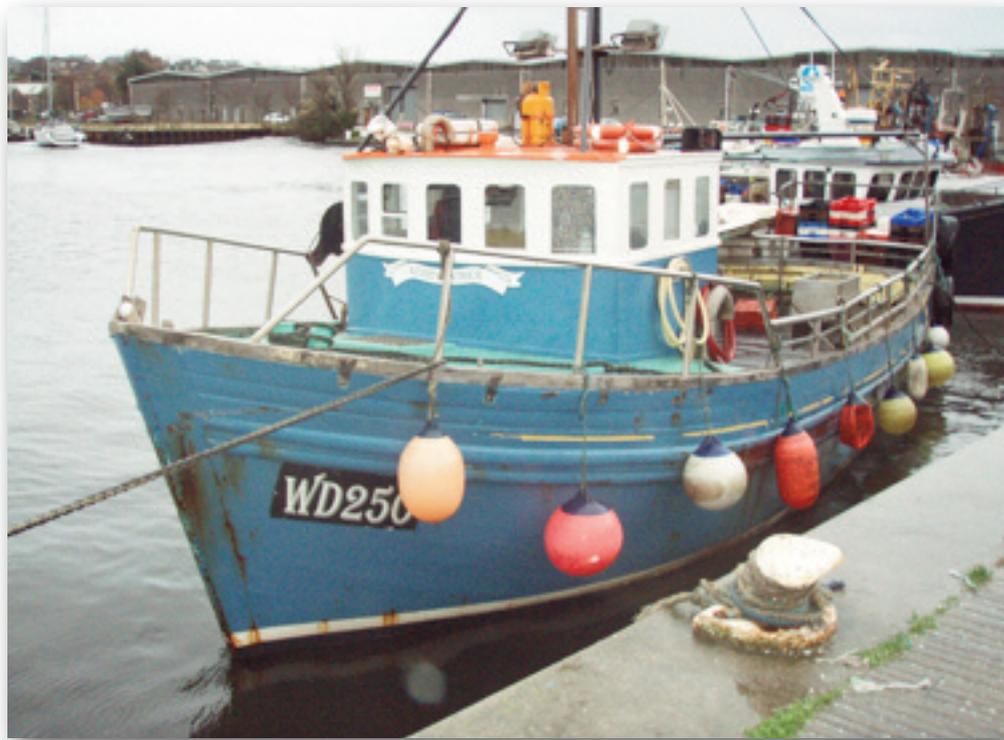
Photograph No. 1: The 'FV KERRI HEATHER'.

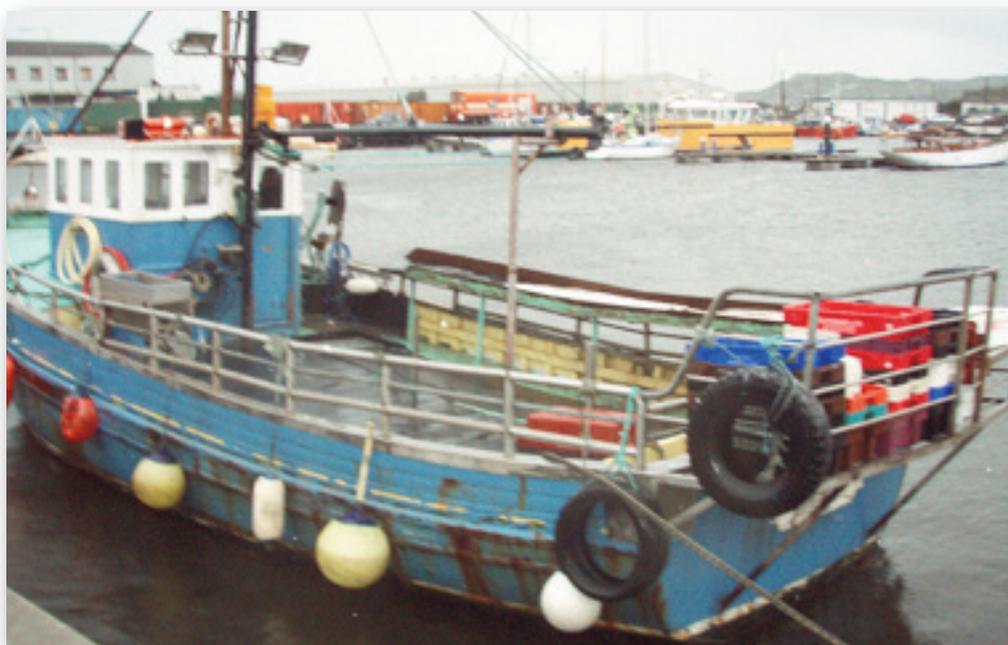
Photograph No. 2: The 'FV KERRI HEATHER' viewed from astern, note pot hauler and ramp on starboard side.

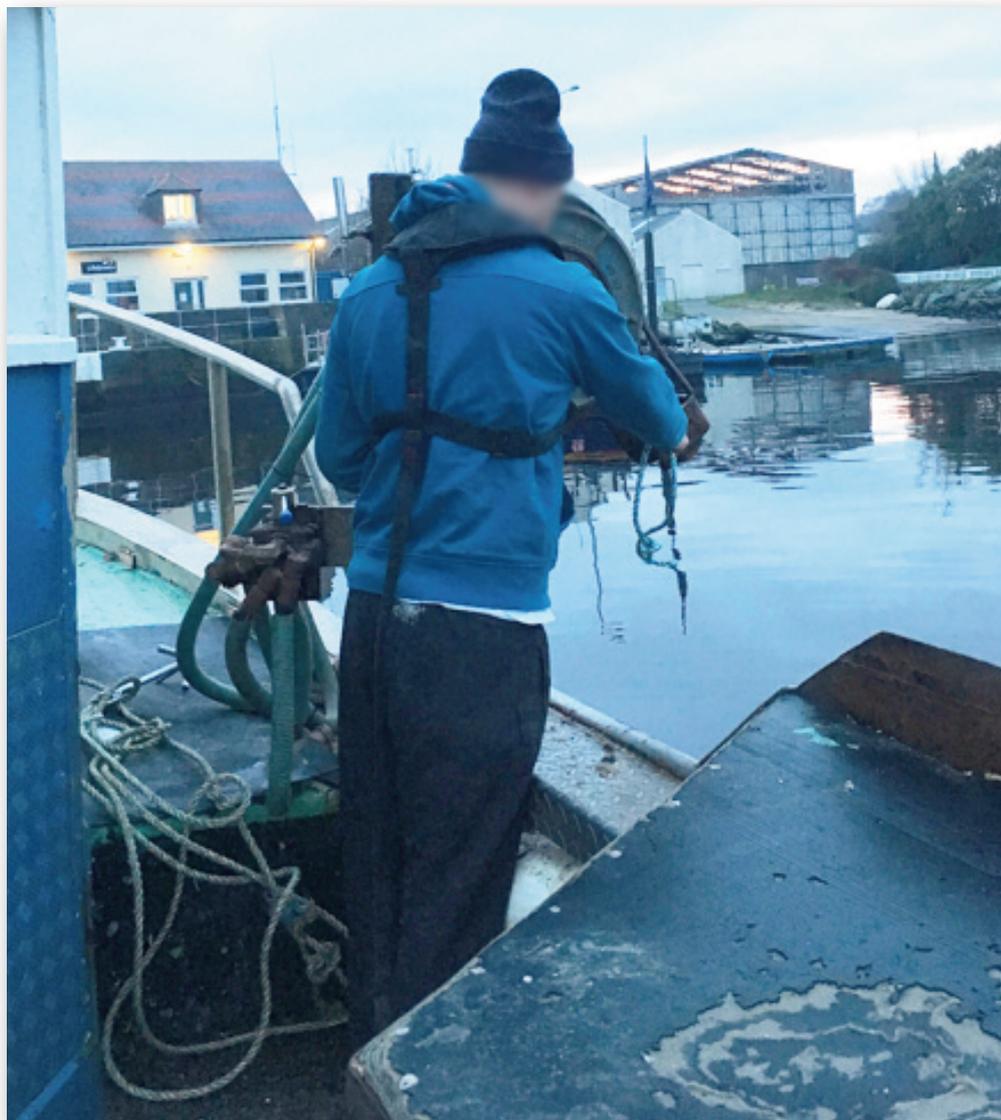
- 4.1 The regulation height of the bulwarks or guard rails is 1,000 mm above the deck, however, the height may be reduced “where there would be unreasonable interference with the efficient operation of the vessel”. The bulwark height at the pot hauler is 720 mm, which is approximately mid-way between a person’s knee and hip thus increasing the risk of falling overboard to the person operating the pot hauler. A sudden motion of the vessel could unbalance the operator and pitch him over the side.

- 4.2 The vessel was hauling pots in a 3-knot tide and the strong westerly wind, which would put an increased strain on the hauler. The anchor was placed on the ramp behind the operator and not secured. Loss of tension of the line on the pot hauler would cause the pot line to slip and pull the anchor back overboard, hitting the man on the hauler as it went. Loss of control could be due to one of the lines to a pot, with its knot passing over the pot hauler or due to the line slipping off the pothauler as the vessel sheered (i.e. swinging from side to side from the direct course), or a combination of both.

- 4.4 Crewmember No. 1 who fell overboard was unresponsive to shouts from the Skipper, nor did he attempt to swim or stay afloat. He did not reach for the lifejacket that was thrown, nor attempt to catch the line thrown to him. When the Skipper entered the water, he did not attempt to catch hold of the Skipper. This indicates that he was unconscious. He possibly hit his head on the pot hauler as he went overboard or the anchor hit him when he was in the water.

Photograph No. 3: Position of person at pot hauler when hauling pots. The anchor was reported to be on the ramp in foreground of the photograph. When falling forwards a person could hit their head on the hauler.
