Sinking of the US Cargo Vessel *El Faro*

Illustrated Digest

This digest of the National Transportation Safety Board's (NTSB's) Marine Accident Report **NTSB/MAR-17/01** contains a description of the accident and safety issues, and summarizes some of the safety recommendations intended to prevent such an accident from happening again. The full report and docket can be found at www.nts.gov.

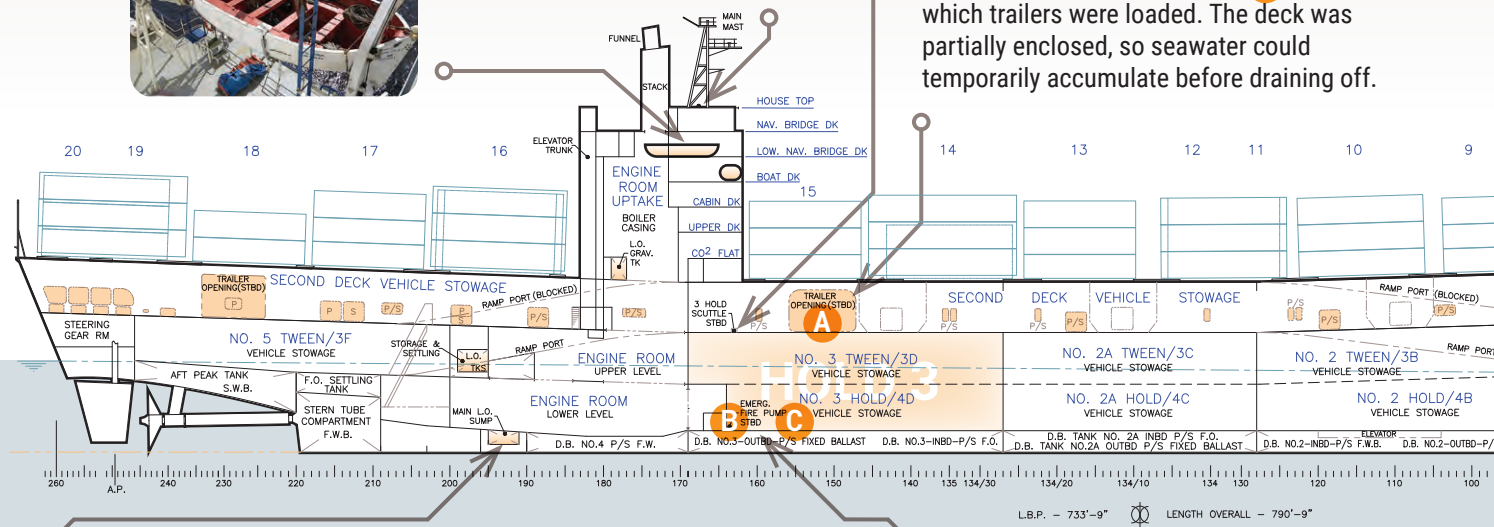
Scuttles are small hatches that allow crewmembers to transit between decks. However, the scuttles on the weather deck (second deck) had to be securely fastened to ensure the ship’s watertight integrity. *El Faro* did not have remote open/close indicators for its scuttles (see Recommendations, p. 13).

Seawater could flow onto *El Faro*'s second deck through openings, including large openings in the starboard side **A** through which trailers were loaded. The deck was partially enclosed, so seawater could temporarily accumulate before draining off.

According to logbook entries, the level of lube oil in the sump had been kept at 25 or 26 inches for most of the 2 years before the accident. In rough seas, this could lead to loss of propulsion (see Loss of lube oil suction, p. 7).

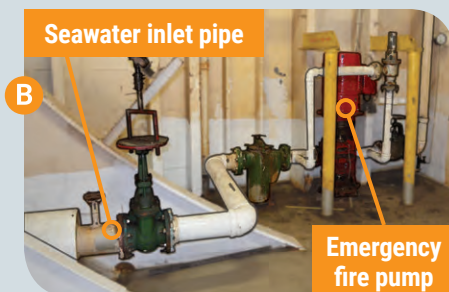
Cargo hold 3 housed the emergency fire pump, which was connected to a seawater inlet pipe **B** (photo at left is of *El Yunque*'s emergency fire pump and unprotected inlet piping). Similar components, although arranged differently, made up the corresponding system on board *El Faro*. Hold 3 was also used for vehicle storage. **C**

Once the deck became wet in hold 3, automobiles were more likely to break free of their lashings. An automobile likely struck the intake piping leading to the emergency fire pump. Seawater piping to the emergency fire pump in cargo hold 3 was inadequately protected from such impact.

With a severe breach of the intake piping, water would have flowed into hold 3 under seawater head pressure. Bilge pumps could not keep up with flooding through the fire main.

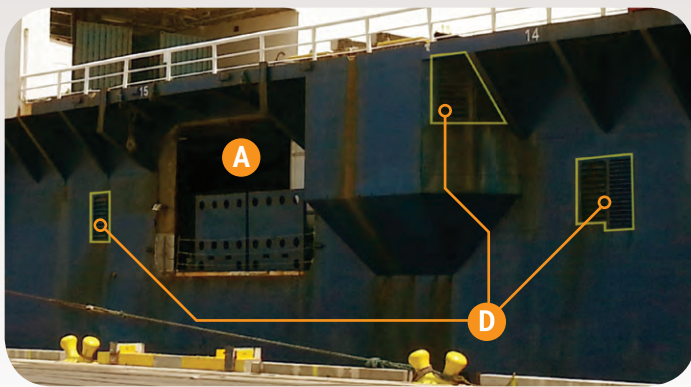
Louvered openings in the hull **D** allowed air to flow in and out of the cargo holds via ventilation ducts. These were required to be opened under way, but could have been shut in heavy weather. Pictured at left is the starboard side of *El Faro*, just above hold 3. Louvered vents are outlined in yellow and a large trailer opening **A** is also visible.

As the ship’s permanent angle to the sea (sustained list) increased past 15 degrees, the high seas would have allowed water to enter the hull through ventilation openings.

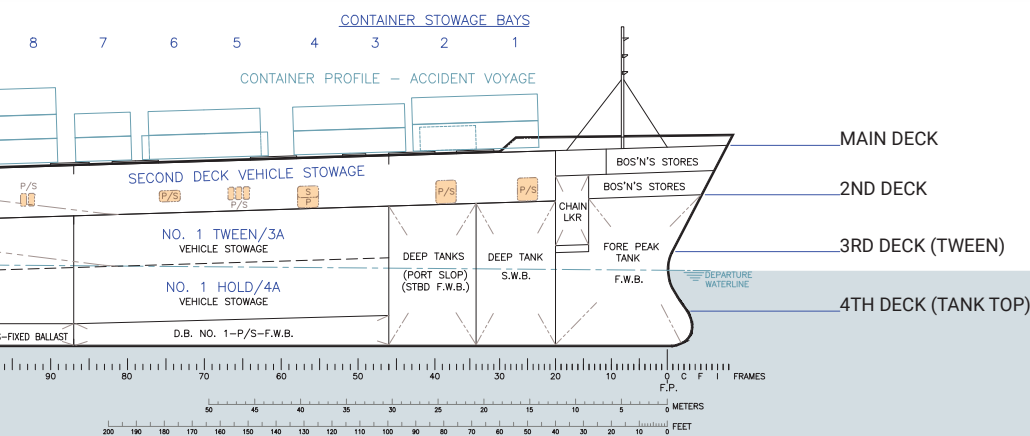
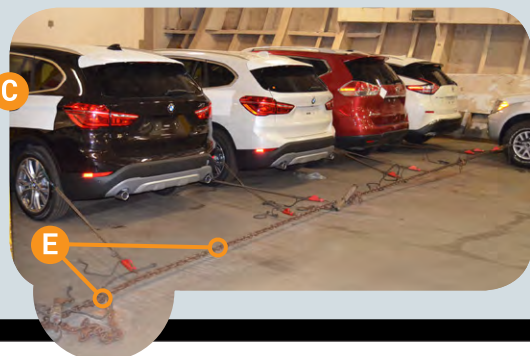
Instead of each automobile being secured to the deck at each corner, they were secured to a long chain across the width of the ship **E** (photo at left is from a similar lashing arrangement on board *El Yunque*). As the ship encountered heavy weather, vessel motion increased and lashings would have failed more easily as the deck became wet and the ship rolled (see How the water got in, p. 6).

At **0544**, the captain was heard on the VDR saying “We got cars loose,” likely referring to automobiles that had broken free from their lashings. The automobile-lashing arrangement did not meet the requirements of the vessel’s approved cargo-securing manual, making automobiles more likely to shift in heavy weather.

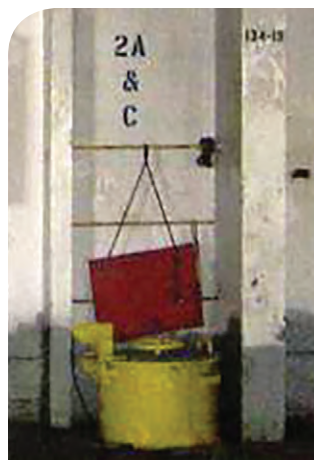
The crew found that a scuttle (small watertight hatch) on the second deck, starboard side, was open and seawater on deck was flowing over it and down into cargo hold 3. The ship’s list to starboard was causing seawater to pool near the scuttle located on the starboard side. The captain told an engineer to begin transferring ballast water from the starboard ramp tank to the port ramp tank.

Second deck scuttle to hold 2A, similar to hold 3 scuttle
Photo: Herbert Engineering

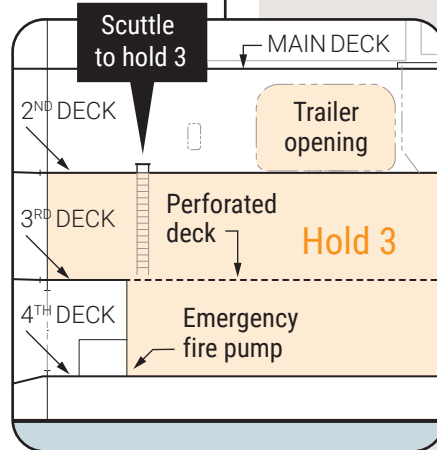
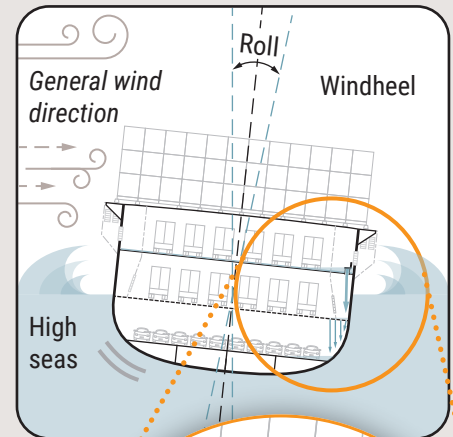
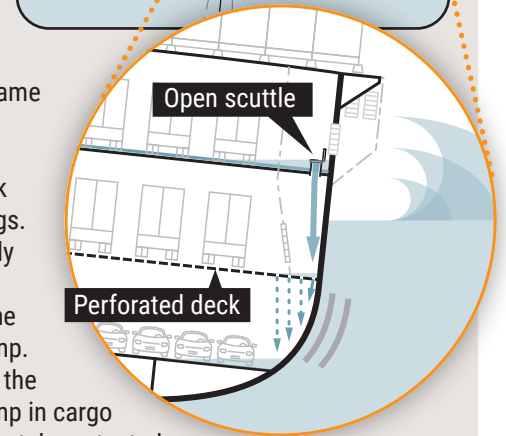
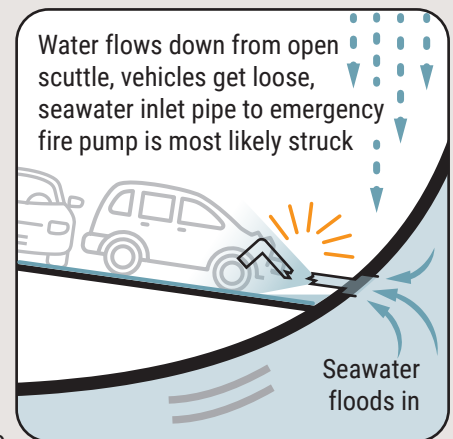
How the water got in

El Faro’s partially enclosed second deck had a number of scuttles that had to be closed and fastened (“dogged”). Flooding began through an open scuttle.

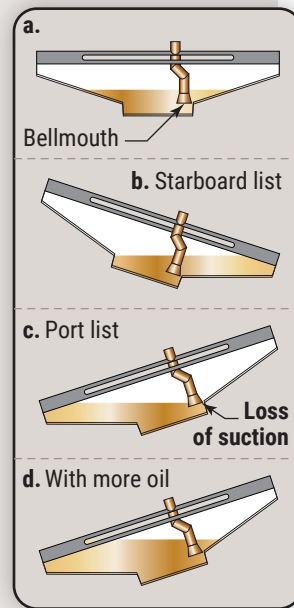
Loss of lube oil suction

Because the bellmouth (intake) for the main propulsion engine lube oil pump was located toward the starboard side, it mattered whether the ship was listing to port or starboard. (The trim of the ship also affected the oil suction; forward trim was worse). It also mattered how much lube oil was in the sump.

Log books indicated no more than 26 inches of oil in the sump in the months before the accident (a). With this oil level, the bellmouth would not take in air (lose suction) with an 18-degree list to starboard (b), but would lose suction with an equivalent list to port (c). With 32 inches of oil in the sump, the bellmouth would continue to take in oil with the same 18-degree list to port (d) allowing normal functioning.

The loss of lube oil pressure would have triggered a protective device, the low lube oil pressure switch, which would have shut off the flow of steam to the main engine. (However, steam continued to flow to turbogenerators for lights and other systems.) To reset the switch, lube oil pressure would have to be restored. Without propulsion, El Faro could not maneuver and was at the mercy of the storm.

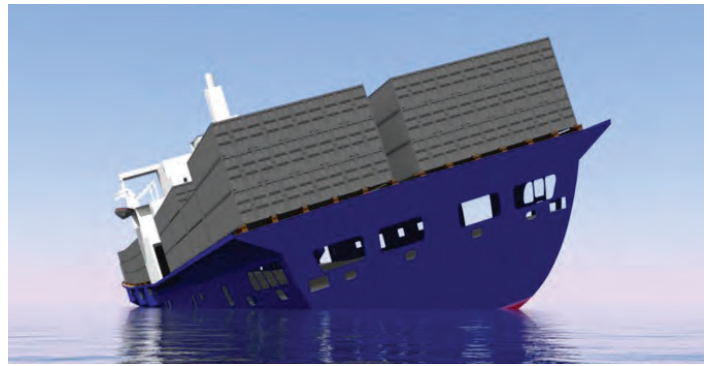
The increasingly large induced list to port from wind and increasing flood water levels in hold 3, combined with the vessel’s rolling in the storm seas, likely caused seawater to enter cargo hold ventilation openings in the hull. It was possible to close these openings, but they were left open during the event; they were not considered downflooding points in any available guidance documents. Seawater poured into hold 3 and then into hold 2A and 2. At **0714**, the chief mate told the captain that the chief engineer had said that, “something hit the fire main, got it ruptured, hard” (see How the water got in, p. 6).

***El Faro* computer rendering in static surface water showing list to port of 18° with departure trim 5.8 feet by the stern due to flooding of hold 3 estimated at 20% and windheel.**
