Report	
Report title Investigation report following the fatal accident on <i>Maersk Interceptor</i>	Activity number 400010004

Maersk Interceptor (source: AoC application)

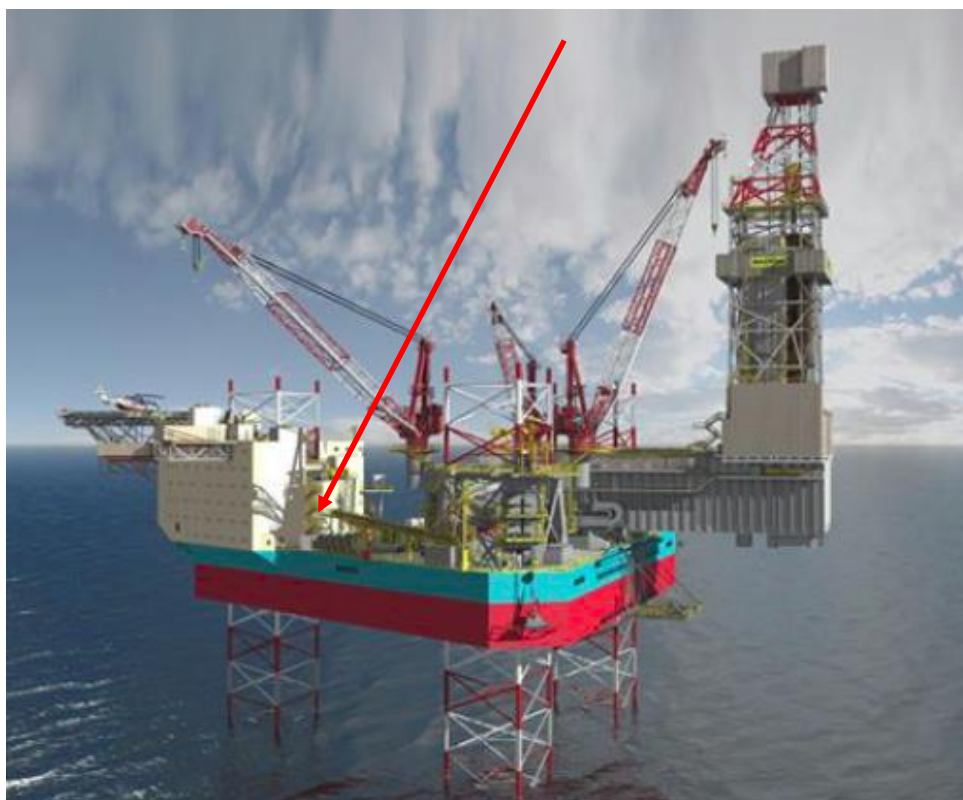
Illustration 4: The arrow points to where the raw water pump was to be installed.

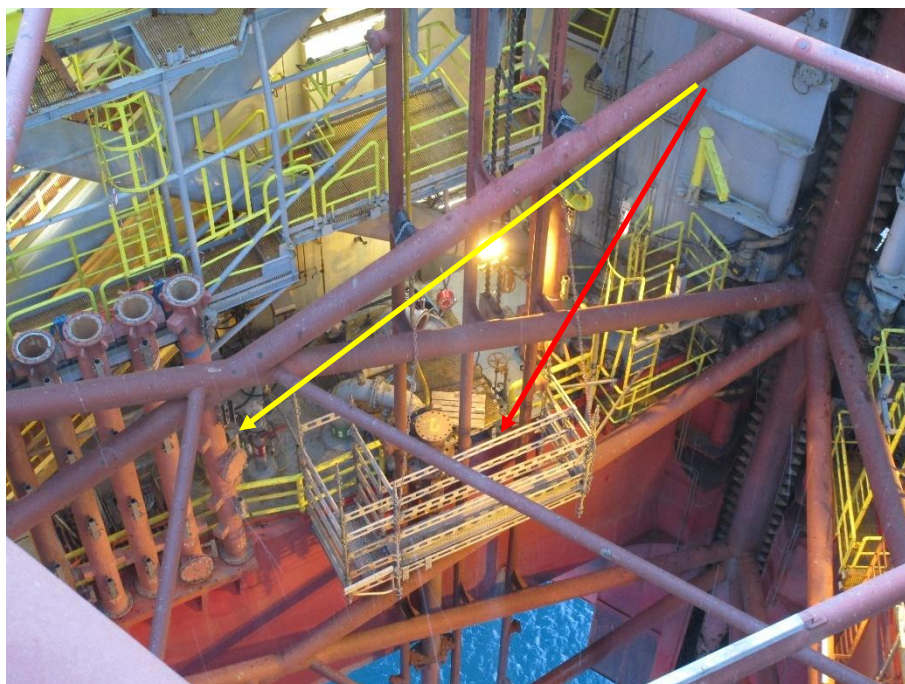
A suspended scaffolding was constructed at the rear edge of the site where the raw water pump would be installed (see illustration 5). This was to ensure access for the mechanic to assemble riser sections for the pump. It emerged from interviews that the job would have been regarded as work over the sea if no scaffolding had been provided. This was the first time MINC used scaffolding (see illustration 5) during installation of a raw water pump system, but the solution had been used on other Maersk facilities.

Illustration 5: The raw water pump was to be lowered between two guide pipes (red arrow) and readied for installing riser sections (yellow arrow).

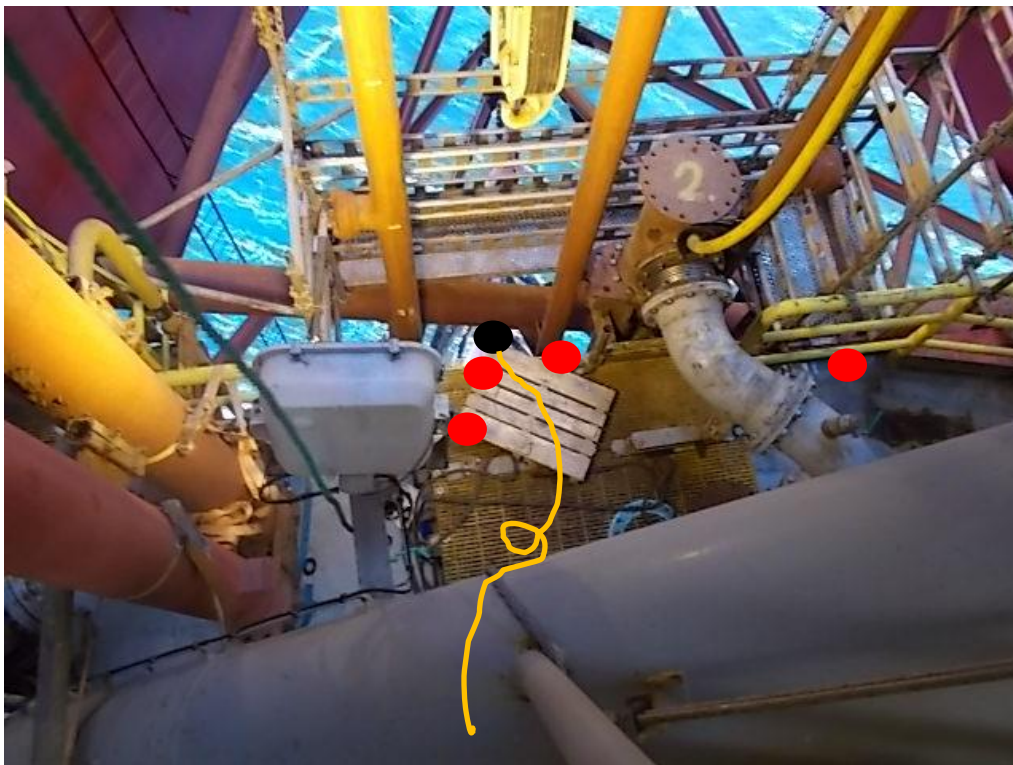
It is not clear why roustabout A went overboard. The most likely explanation is that he was hit by the cable. The supervisor *was* hit by the cable and ended up lying on the deck with his head over its edge. He says he could hear the cable running out and tried to reach a safe place.

Illustration 6: Where the team believes personnel involved in the operation were standing (red dots) when the sling broke and the raw water pump (black dot) with cable (yellow line) plunged into the sea.

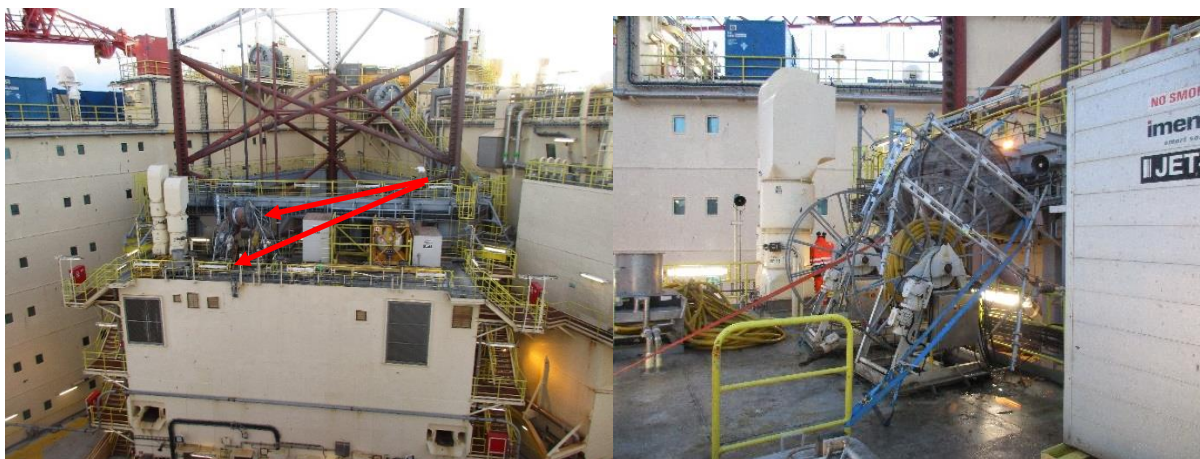
The temporary cable stand was not fastened, but stood atop the ventilation housing and was held in place by the weight of reel and cable. The stand fell over during the incident and was turned through 180 degrees. Scaffolding components fell to the main deck.

Illustration 7: The photograph on the left shows where the cable reel was positioned for reeling out while the raw water pump was being positioned. The photograph on the right shows the overturned scaffolding.

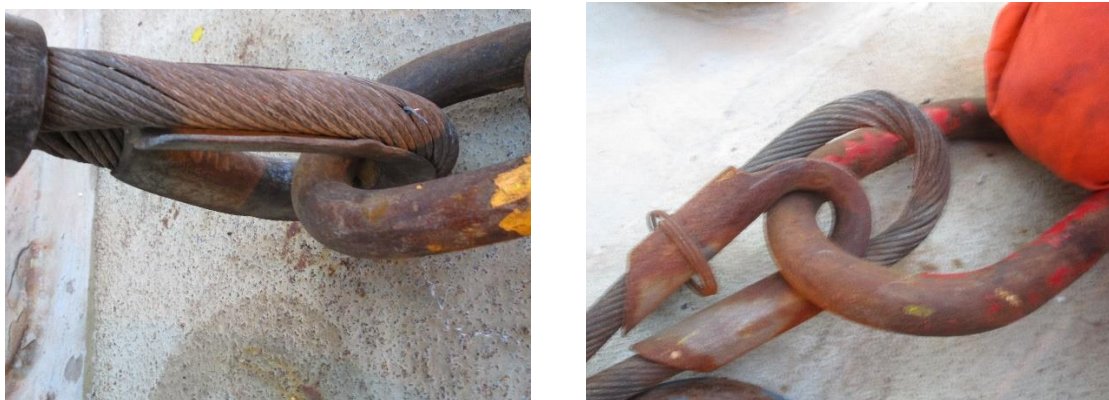
The offshore review identified faults and deficiencies in the crane pennant used when lifting the raw water pump and cable reel into place. Maersk was unable to provide user manuals for the pennant. These should include information on use, checking and maintenance as well as how the pennant should *not* be used.

Nor was the pennant checked as described in the specified part C14 of Norsok R-002. Damage to all three pennants used for lifting was incompatible with continued use.

Illustration 13: Damage to the crane pennant used when moving the pump and cable from the deck to the roof of the ventilation housing.

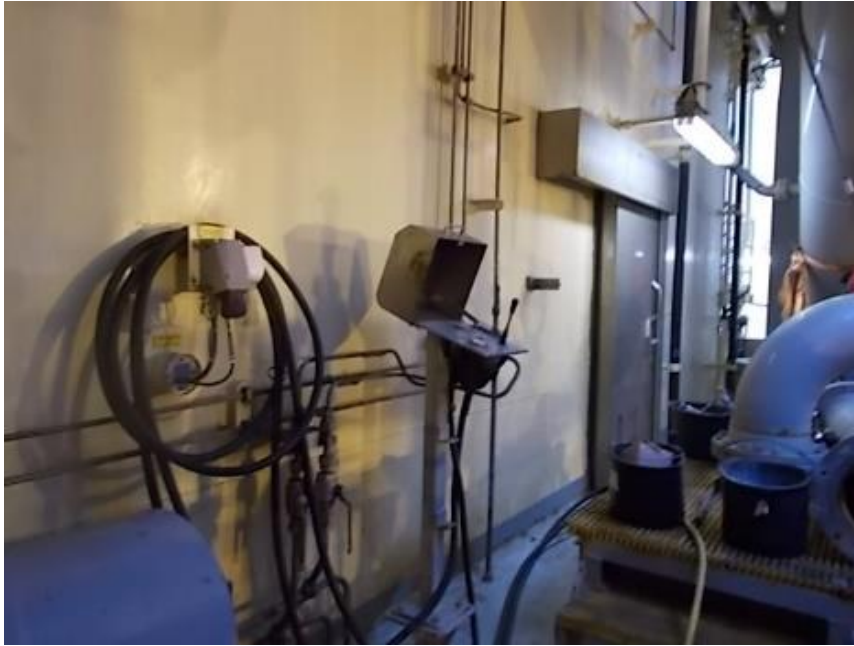
To assist installation/removal of riser components and the pump, two beams were installed which could be pushed out hydraulically to relieve the load from the pump and the individual riser. This system was combined with sideways movement of the overhead crane. Simultaneous operation of crane and beams was prevented through a hydraulic interlock system. A description and marking were missing on the control panels for the suspension beams. Nor were they included in the OJT description for this type of operation. Erroneous settings for these valves could have led to movement in the suspension beams.

Illustration 14: Operation panel and control valves to operate the relieving system for the raw water pump.
