SAFETY INVESTIGATION REPORT

REPORT NO.: 10/2018

May 2018

MV UNIVERSAL DURBAN **Grounding in position 02° 14.65' N 109° 05.17' E** **13 May 2017**

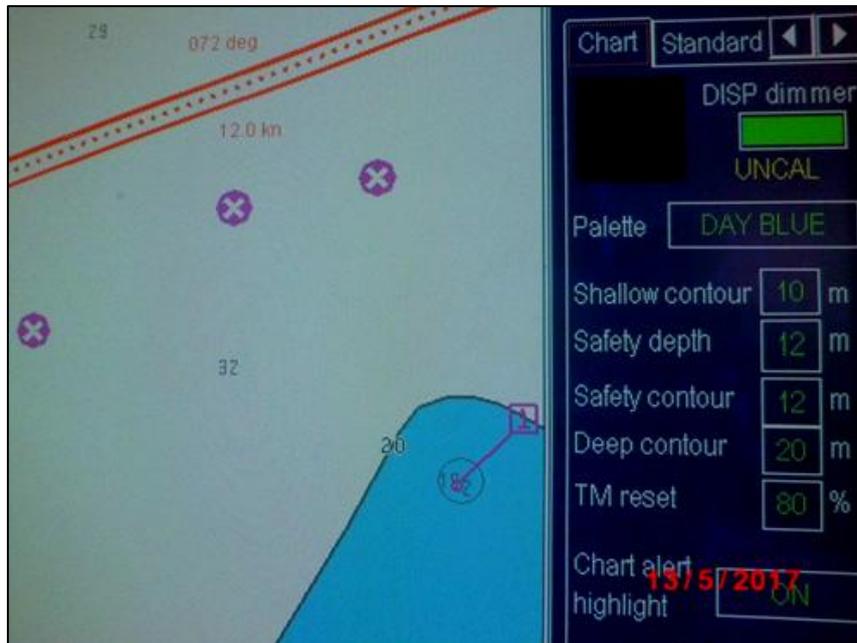
Figure 2: Image from ECDIS showing safety depth/contour settings in Alur Pelayaran Serasan

At 1000 on 13 May 2017, *Universal Durban* was in position 001° 54.80' N 108° 55.26' E. She was transiting Alur Pelayaran Serasan between the island of Pulau Serasan and Palau Merunding. The third mate was the officer of the watch (OOW) and the master was on the bridge. The vessel was on autopilot on a course of 028° and the speed was about 11.5 knots. The safety depth and deep-water contour were set as shown in Figure 2.

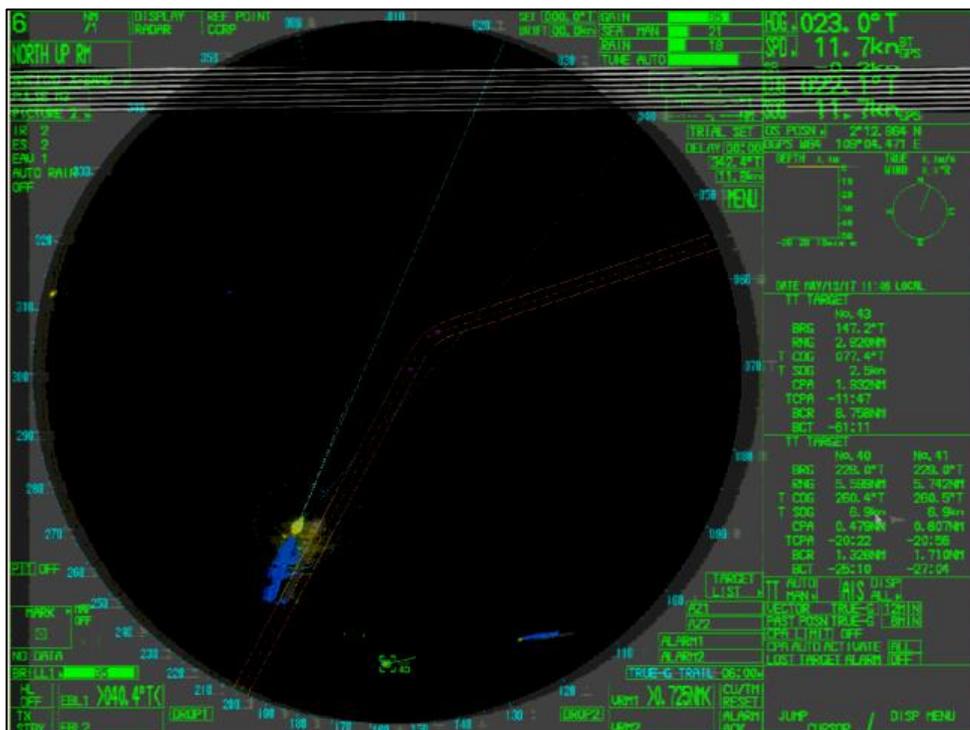
Figure 3: Radar image from VDR showing track outside of the port XTD limit.

At 1144, the course was again adjusted to 020°, sailing outside of the port XTD limit (Figure 3) and about two nautical miles, West of the

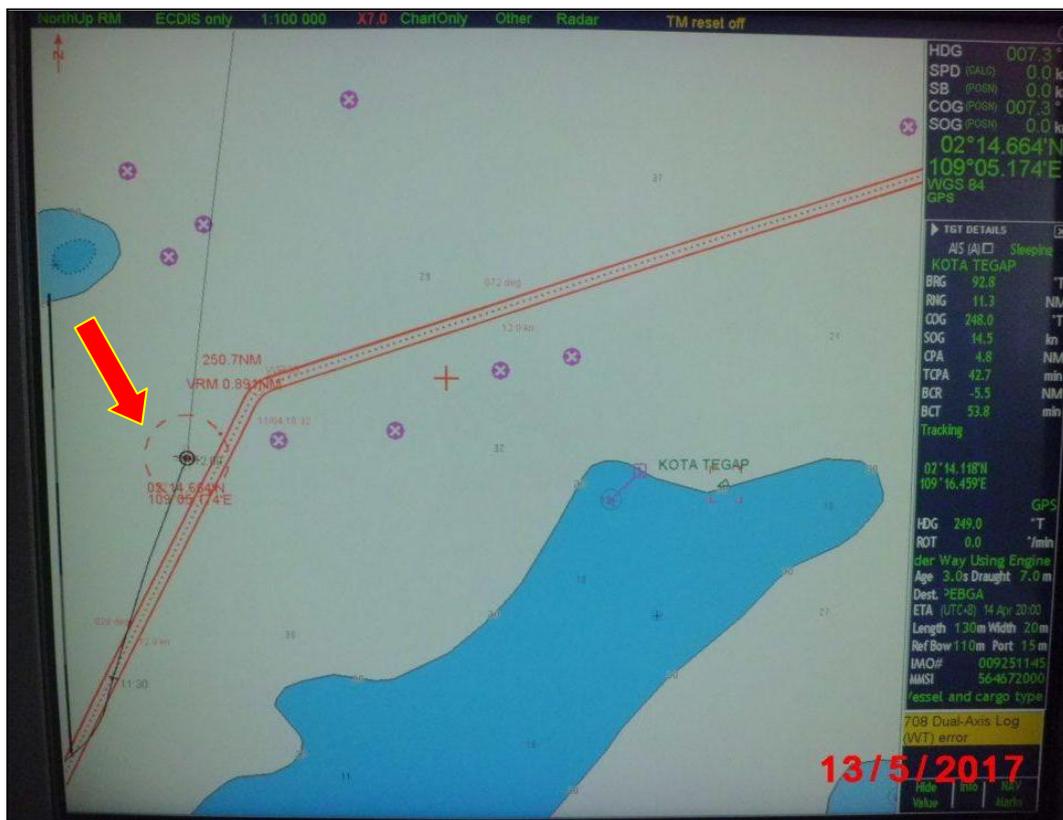
Figure 4: ECDIS image showing *Universal Durban* aground in position 02° 14.65' N 109° 05.17' E

At 1156 *Universal Durban* was reported stranded in position 02° 14.65' N 109° 05.17' E (Figure 4).

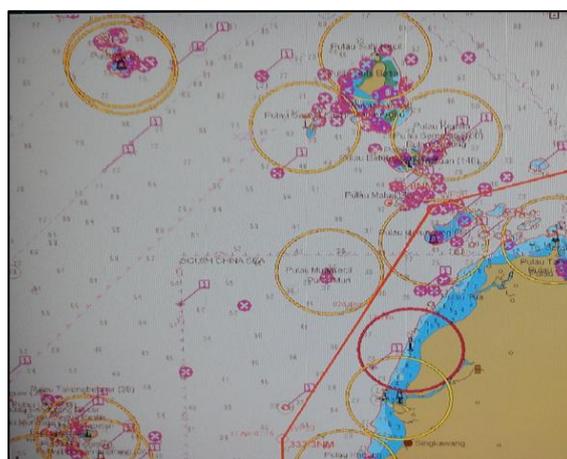
Figure 7: ECDIS image showing planned route, North of Pulau Merunding

A prima facie, evidence submitted to the MSIU suggested ineffectual appraisal of the voyage plan. There was no indication of sailing directions being referred to or chart permits sent by the chart supplier checked before uploading to ECDIS¹⁰. Moreover, the MSIU believes that since the ECDIS auto scan route check triggered no safety alarm, the visual route check by the second mate was only cursory and eventually, the route North of Pulau Merunding through Alur Pelayaran Serasan (Figure 7) was approved by the master.

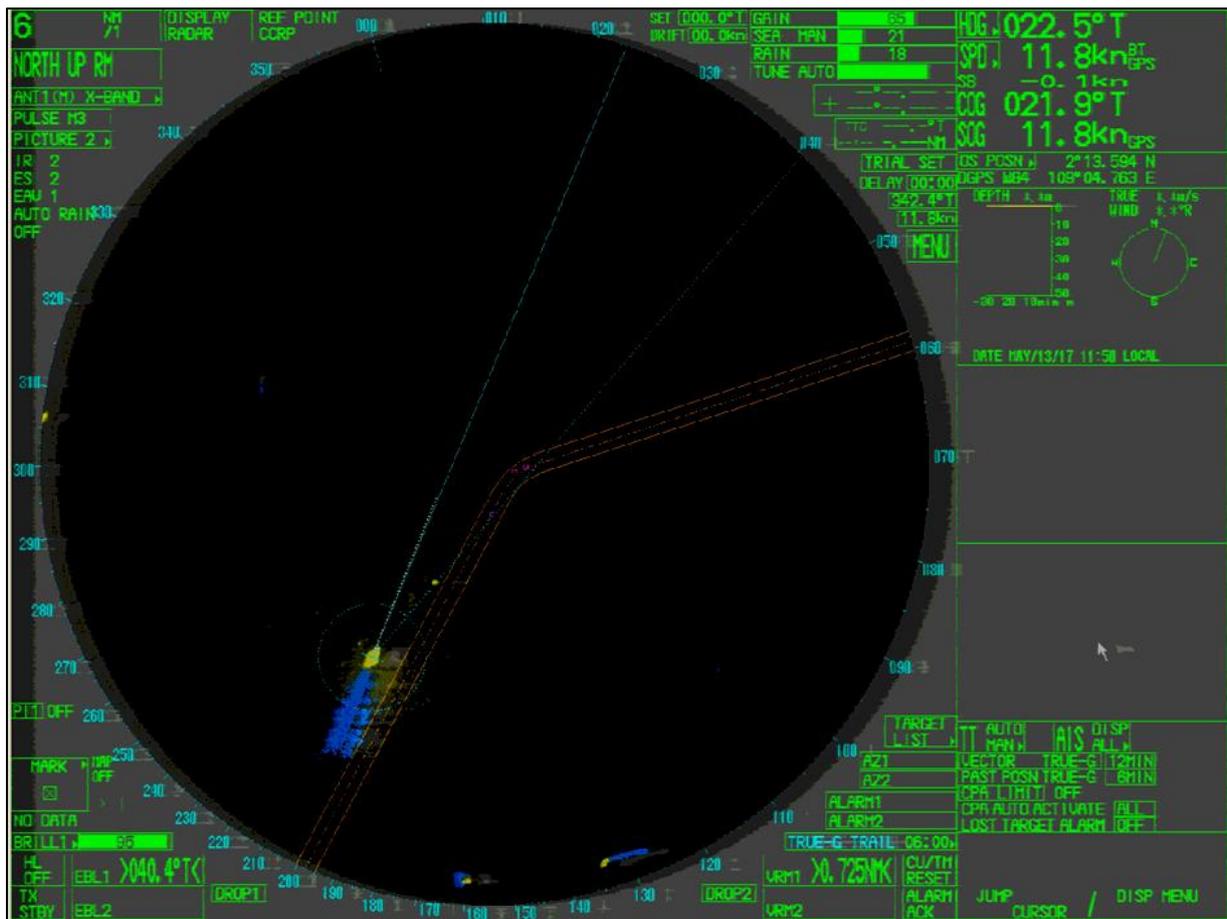
Figure 8: Shallow rocky head detected by X-band radar

officer, was unaware of the approaching hazard both visually and on the radar (Figure 8).

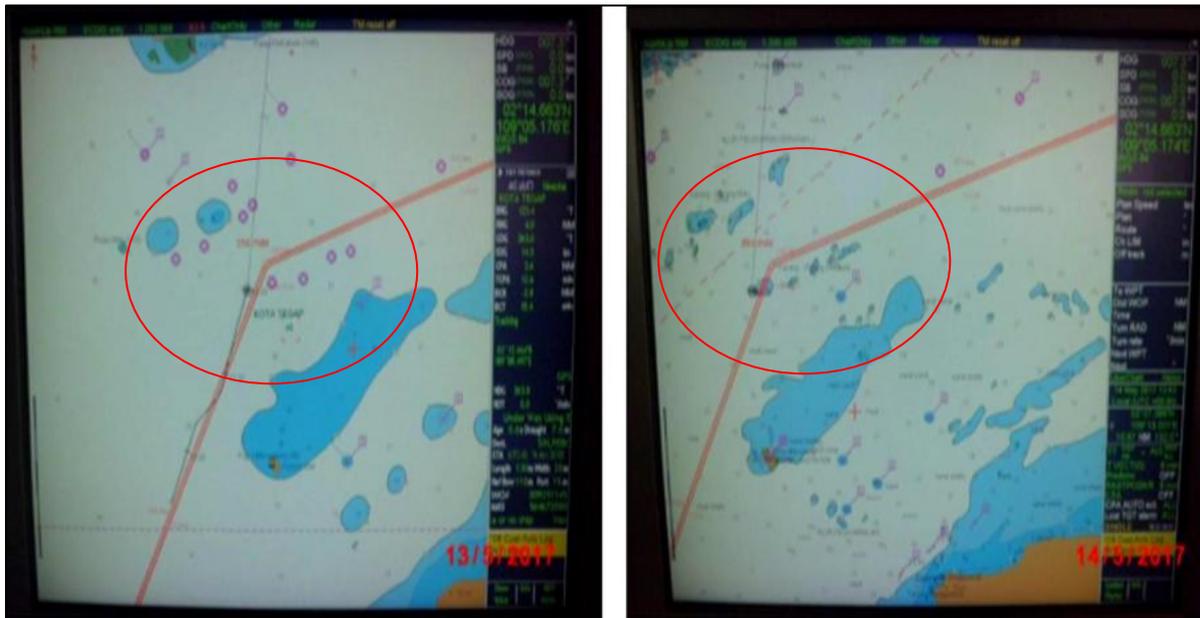
Figure 9: ECDIS image showing ENC EA200003 and ENC ID300428 at scale 1:200,000

Moreover, it was apparent that the original course drawn on ENC ID300428 was unsafe and the stranded position in Figure 9 (ENC ID300428) appeared very close to the West most extremity of Karang-Karang Sembumi. The safety investigation considered this as a compelling indication of a positional anomaly on ENC EA200003.

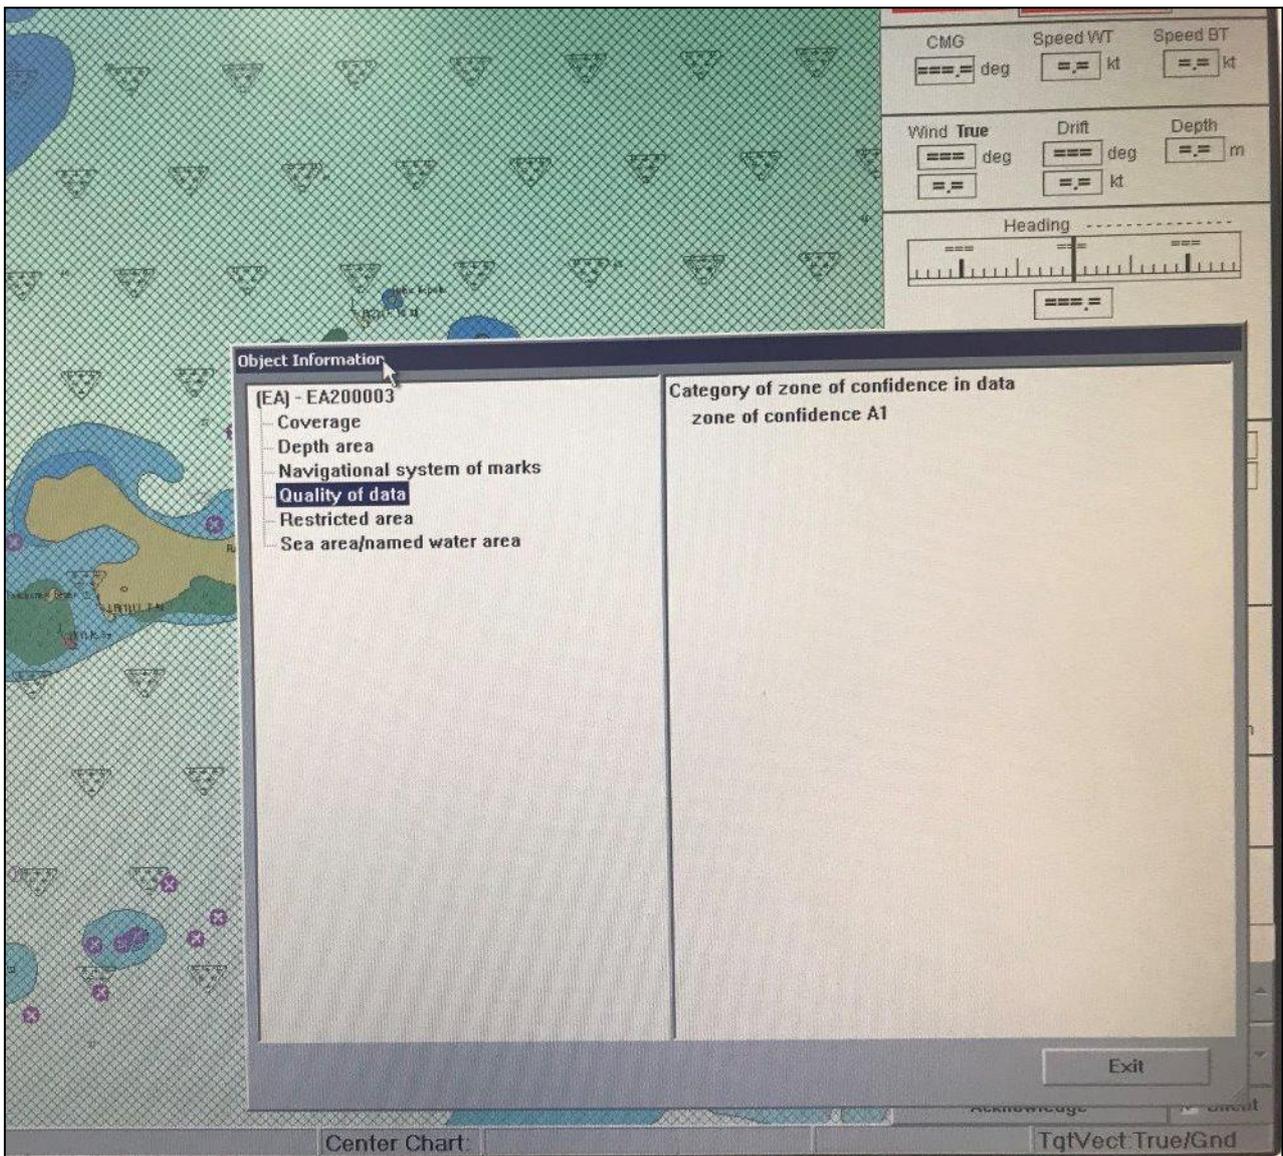
Figure 10: ECDIS image showing quality of data and COTZAC symbol on ENC EA200003

A distinctive symbol also appears on the chart. The number of asterisks in the symbol acknowledges quality of data (Figure 10). This key information gives mariners an estimate of the reliability of charted data when planning or conducting navigation.

It was evident that the quality of data encoded within the composite data quality did not correspond with the value shown on the chart. Indeed, data quality attribute CATZOC A1 gave a misleading impression of accuracy.

10/2018_R1 Review the ENC production process in order to ensure that CATZOCs are populated with meaningful values, commensurate with quality of data survey.

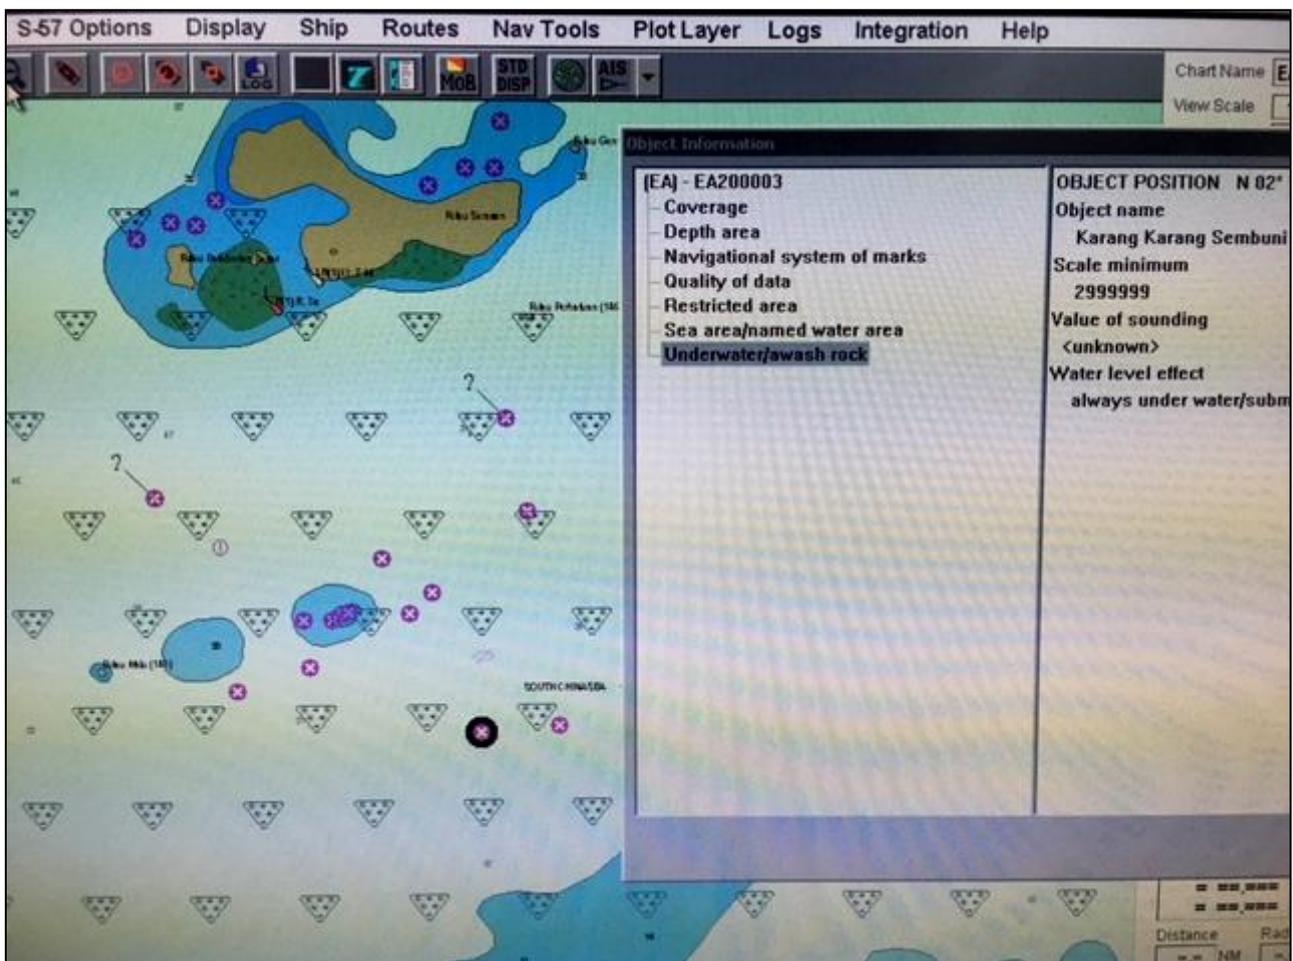
Figure 11: ECDIS image showing position and textual information of

(underwater/awash rock) in Figure 11 shows the position marked at 02° 15.053' N 109° 07.114' E. The fact that *Universal Durban* stranded in position 02° 14.65' N 109° 05.17' E, where water depths are indicated to be in the region of 30 m are given on ENC EA200003, suggested that the area North of Pulau Merunding was not comprehensively surveyed¹⁴ and that generic isolated danger exceed the tolerance defined by the CATZOC.
