Grounding of the general cargo ship *Islay Trader* Margate, UK 8 October 2017

SUMMARY

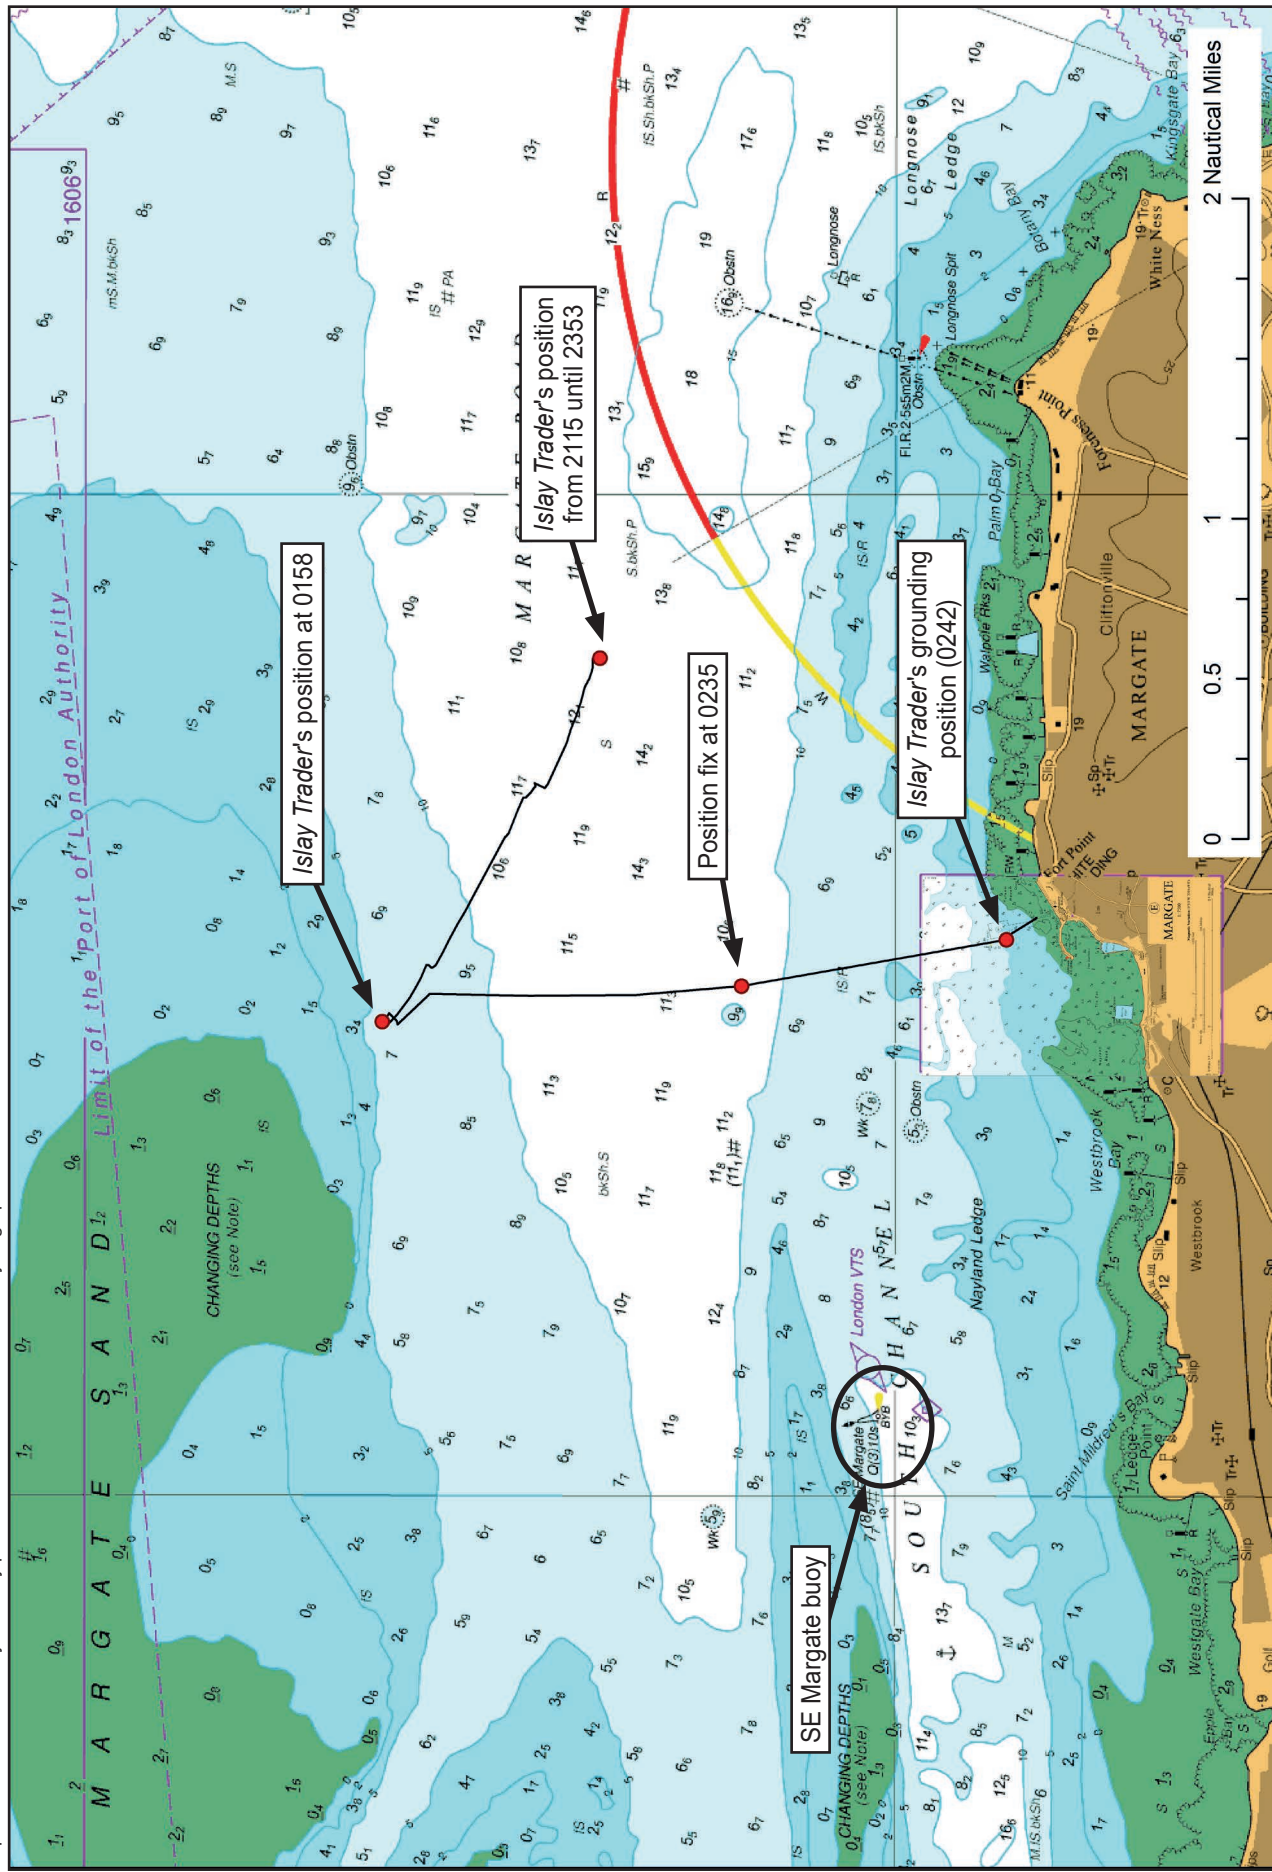
Figure 1: Extract of Admiralty chart 1828 showing Islay Trader's AIS positions

AIS transmissions from *Islay Trader* indicate that the vessel started to drag anchor and move from its initial anchor position towards the north-west at 2353 (**Figure 1**). From then, until being alerted by London VTS at 0158, the vessel's speed over the ground reached a maximum of 1.2kts (0043-0048) and its heading yawed between 023° and 066°. Between 0147 and 0214, *Islay Trader* was stationary on a heading between 052° and 063°.

Between 2353 on 7 October and 0147 the following morning, *Islay Trader* moved 1.3nm to the west-north-west of its original anchorage position. A significant factor contributing to the failure of the vessel's anchor to hold was that only 3 shackles of chain cable was used. For an anchor to achieve its maximum holding power, sufficient cable must lie along the seabed before rising to the hawse pipe. In this case, although the sandy seabed afforded reasonable holding ground, the change of the cable's scope caused by the flooding tidal stream and the rising tide was sufficient to raise the lead of the cable. Consequently, the anchor's holding power was reduced until the vessel entered the shallower water towards Margate Sand.

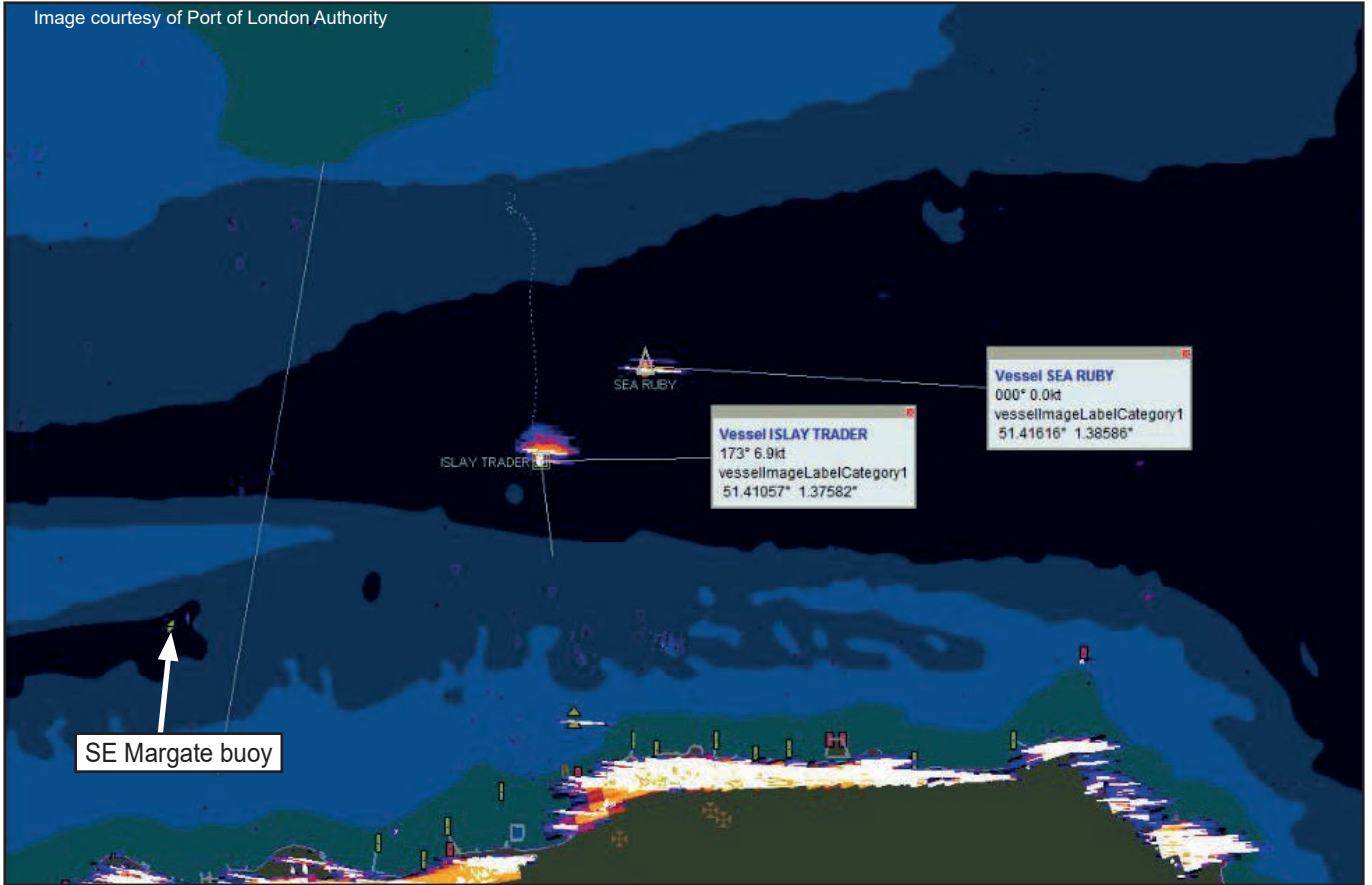
Figure 2: VTS radar extract showing *Islay Trader* at 0233

At 0233, the VTSO saw that *Islay Trader* was heading further to the south than he had expected (**Figure 2**) and again called the vessel via VHF radio (**Table 2**)

When the chief officer was advised by the VTSO at 0233 not to proceed any further to the south, *Islay Trader* was approaching the position the chief officer intended to turn to the west. That he responded by plotting a GPS position on the chart, rather than heed the advice of the VTS or turn to the west as planned, indicates that he was uncertain of the vessel's position. By then continuing to the south despite the repeated challenges of the VTSO, the chief engineer and the ABs on the forecastle, suggests that the chief officer also became overloaded and overwhelmed by the situation.

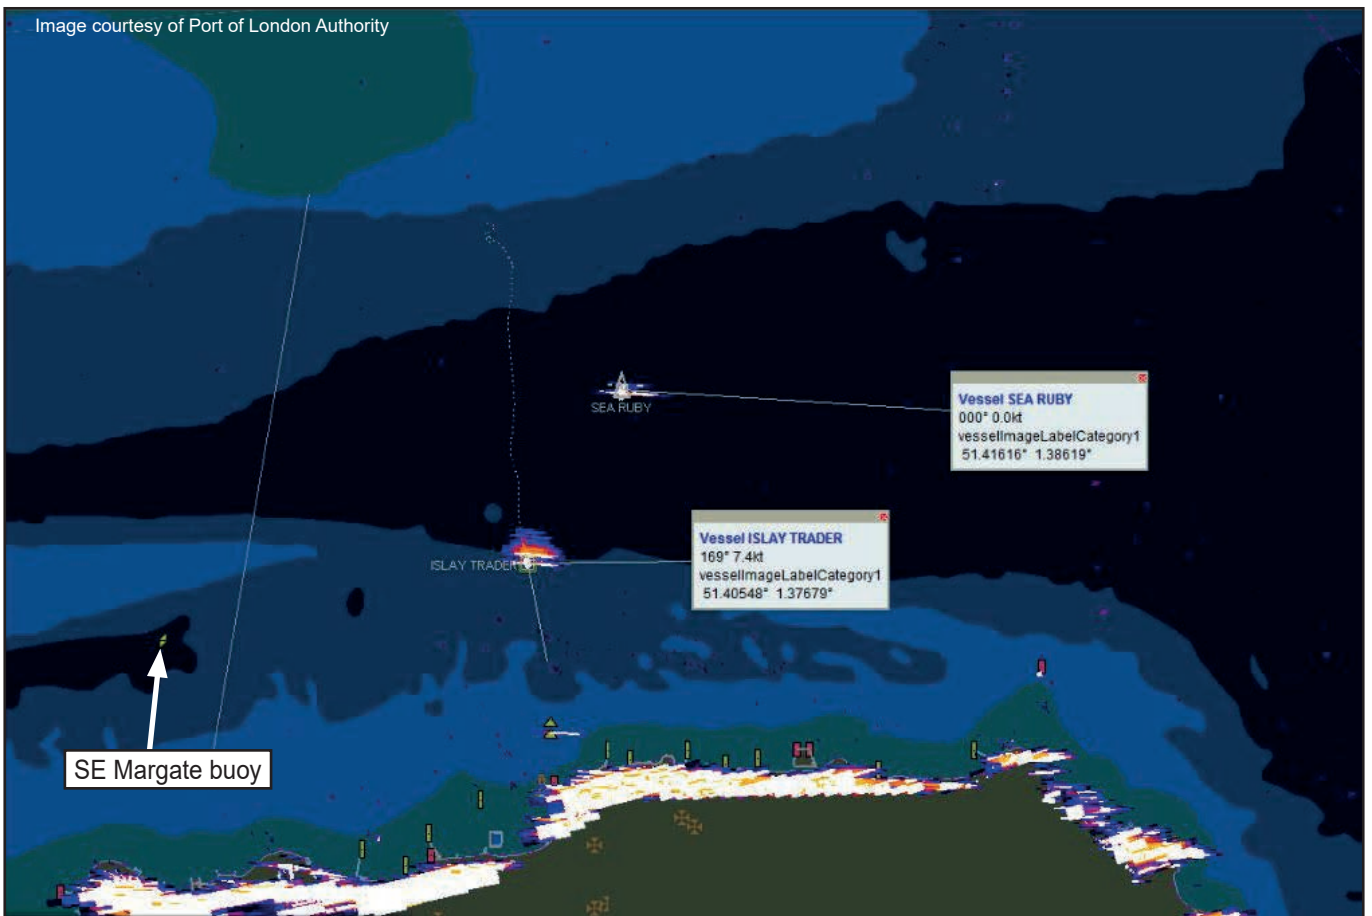
Figure 3: VTS radar extract showing *Islay Trader* at 0236

At 0235, *Islay Trader*'s chief officer plotted a GPS position on the paper chart. Meanwhile, the VTSO became increasingly concerned about the vessel's southerly track (**Figure 3**). At 0236, he again called the vessel (**Table 3**):

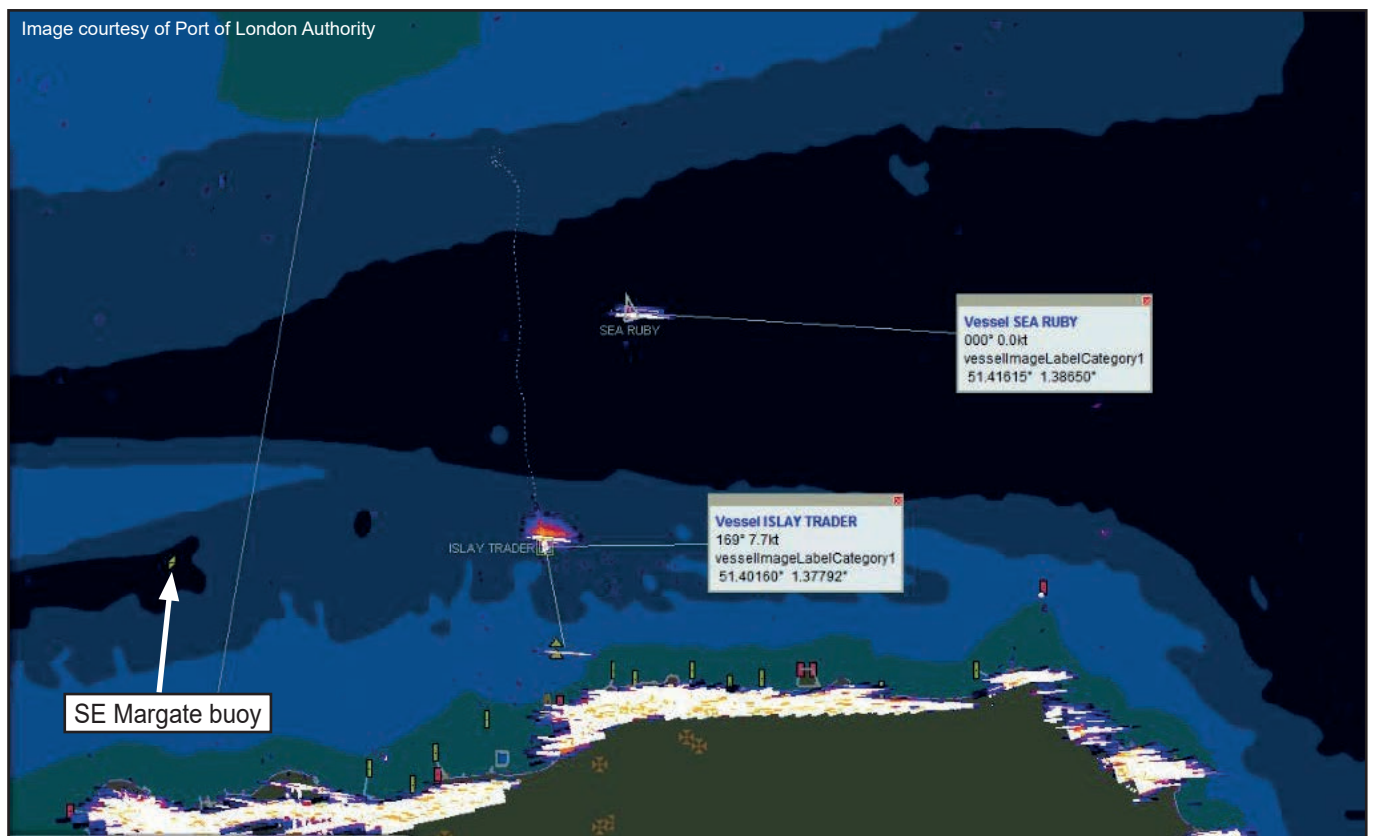
Figure 4: VTS radar extract showing *Islay Trader* at 0238

Although between 0236 and 0239 the chief officer advised the VTSO that he was turning *Islay Trader* to the north and putting the engines astern, the vessel's heading remained steady and its speed did not reduce. It is possible that when he moved the Schottel wheel controls (**Figure 5**) 180° to thrust astern, he inadvertently declutched the Schottel units. Also, with the wheel controls rotated to this extent, operation of the engine speed lever would have been less intuitive and, under stress, the chief officer might have moved the lever in the wrong direction. However, if this was the case, it could only have occurred in the moments before the vessel grounded, otherwise a speed reduction would have been evident.

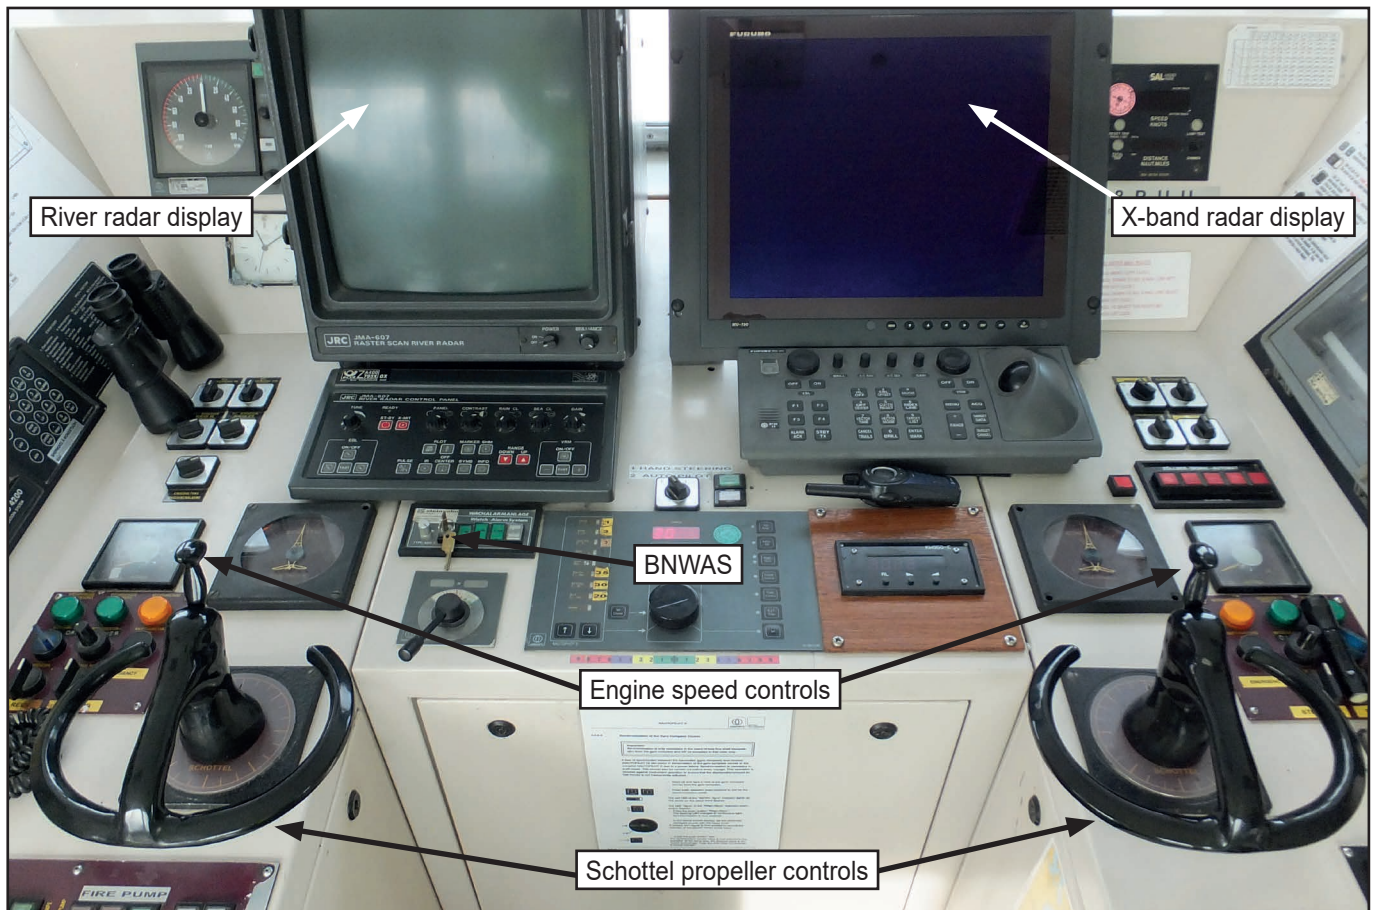
Figure 5: Front console of conning position

At some point, *Islay Trader*’s chief officer moved the controls of the vessel’s Schottel Rudderpropellers (**Figure 5**) to provide propulsion astern, but the vessel continued to head towards the south at about 7kts. He asked the chief engineer if there was a problem. In response, the chief engineer replied that the engines were working as normal. As *Islay Trader* passed a tide gauge, close off Margate’s sea front, the chief officer ordered the ABs on the fo’c’sle to let go the starboard anchor. The ABs did so, and allowed 1 shackle of cable to run free.

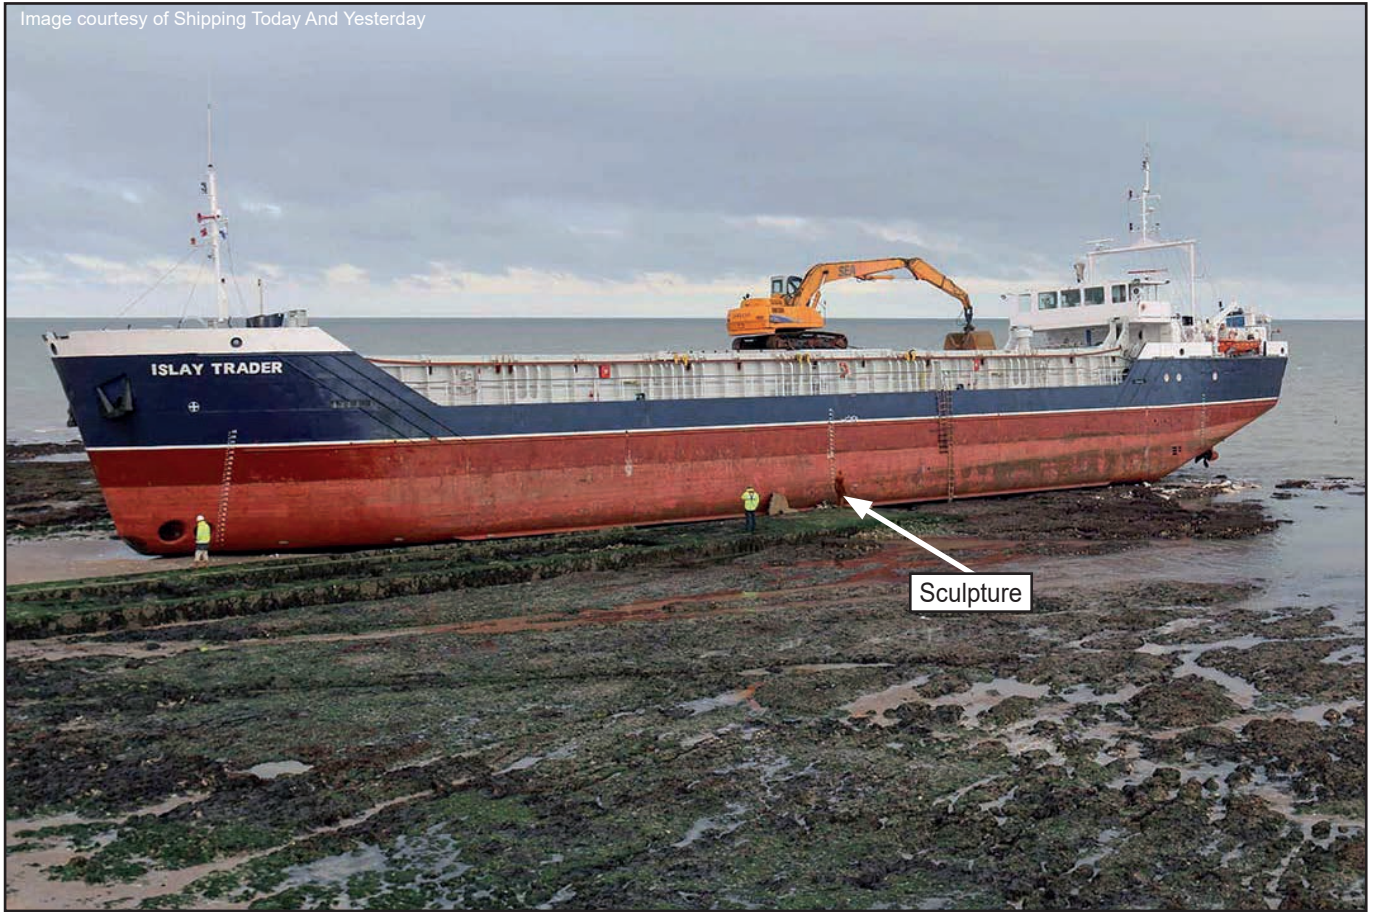
Figure 6: *Islay Trader* aground

At 0242, *Islay Trader* grounded as it crossed the 0m depth contour (**Figure 1**). The vessel’s master was woken up by changes in engine noise and vibration. A call from the chief engineer alerting him to the situation soon followed. When the master arrived on the bridge, he attempted to re-float the vessel by

using astern propulsion, but his attempts were unsuccessful. The vessel eventually settled bows south onto a slipway, very close to a life-size sculpture by the artist Sir Antony Gormley (**Figure 6**). The ballast tanks were sounded, but no evidence of water ingress or other damage was found. The master informed *Islay Trader*'s owners and Dover Coastguard of the situation.

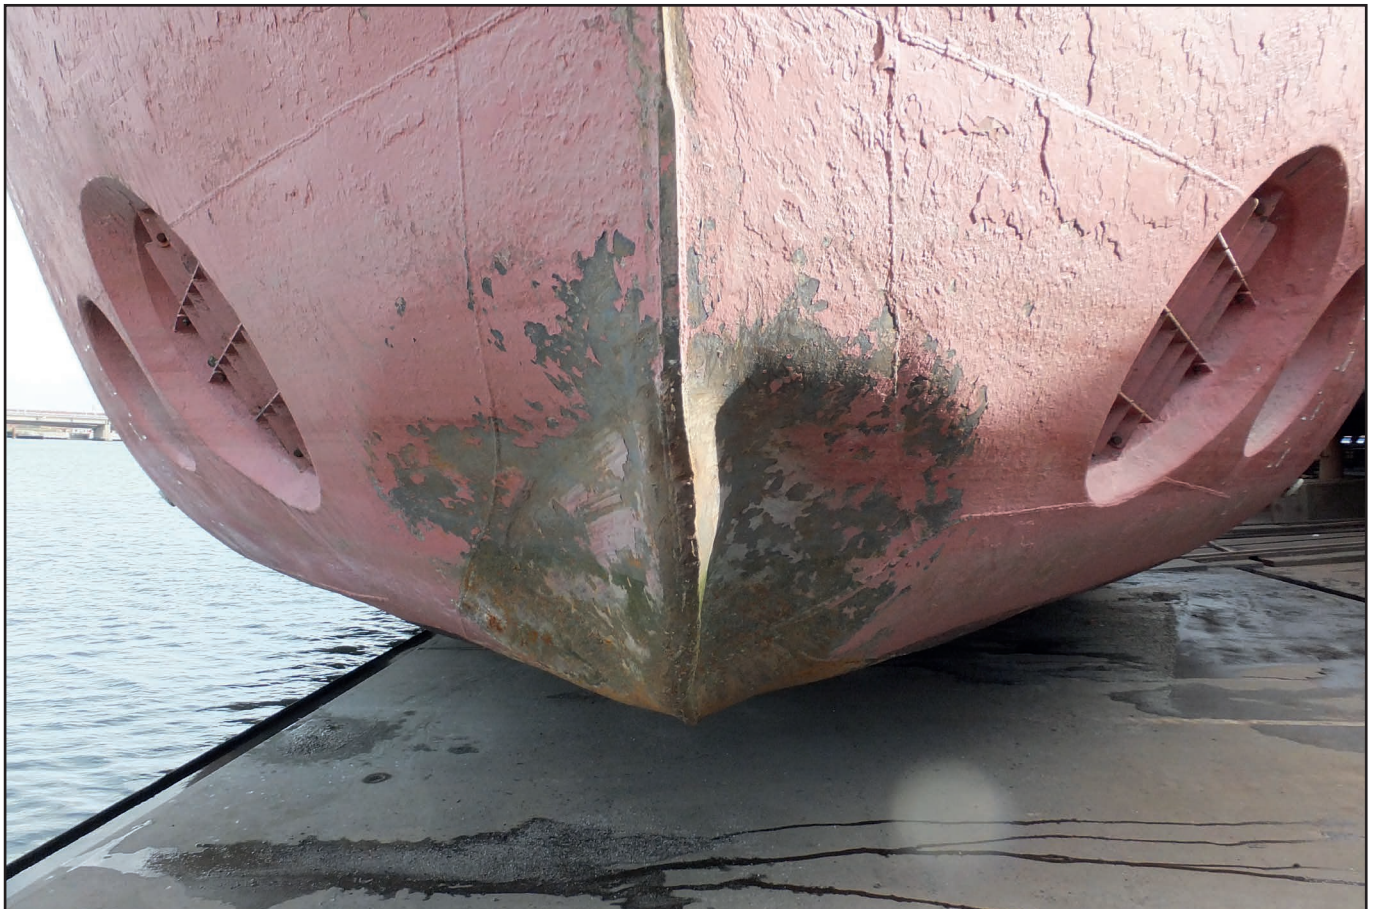
Figure 7: Bow damage

On 12 October, an out of water inspection in Dordrecht identified that *Islay Trader*'s hull was indented below the waterline either side of the bow (**Figure 7**). Five vertical stiffeners were also bent in way of a fresh water tank towards the stern.
