Report on the investigation of the
flooding and foundering
of the trawler

Ocean Way (LK207)

18 nautical miles north-east of Lerwick,

on 3 March 2017

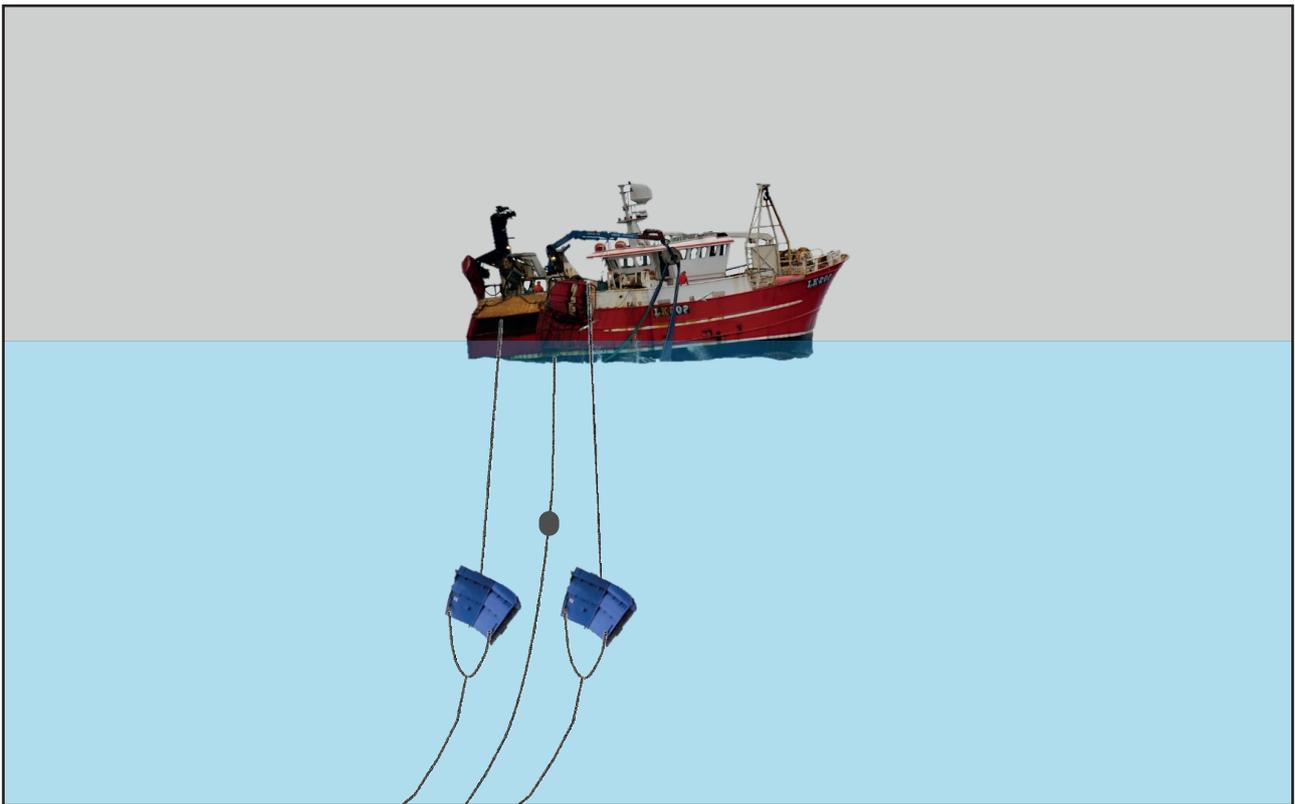
At about 0630, the starboard winch drum started paying out wire, indicating to the skipper that the starboard net had come fast on an obstruction. The skipper stopped the boat and started heaving in the fishing gear until the boat was directly over the obstruction. The skipper then repeatedly heaved in and released the starboard winch wire in an attempt to free the net. After several attempts, the starboard net came loose and the skipper decided to recover and inspect all the gear. *Ocean Way* was on a north-westerly heading making good between 1 and 2 knots (kts) through the water, both trawl doors and the clump weight were suspended about 25 metres (m) beneath the vessel in approximately 100m of water (**Figure 3**).

Figure 3: Schematic diagram of *Ocean Way's* fishing gear prior to the impact of the port door on the hull (not to scale)

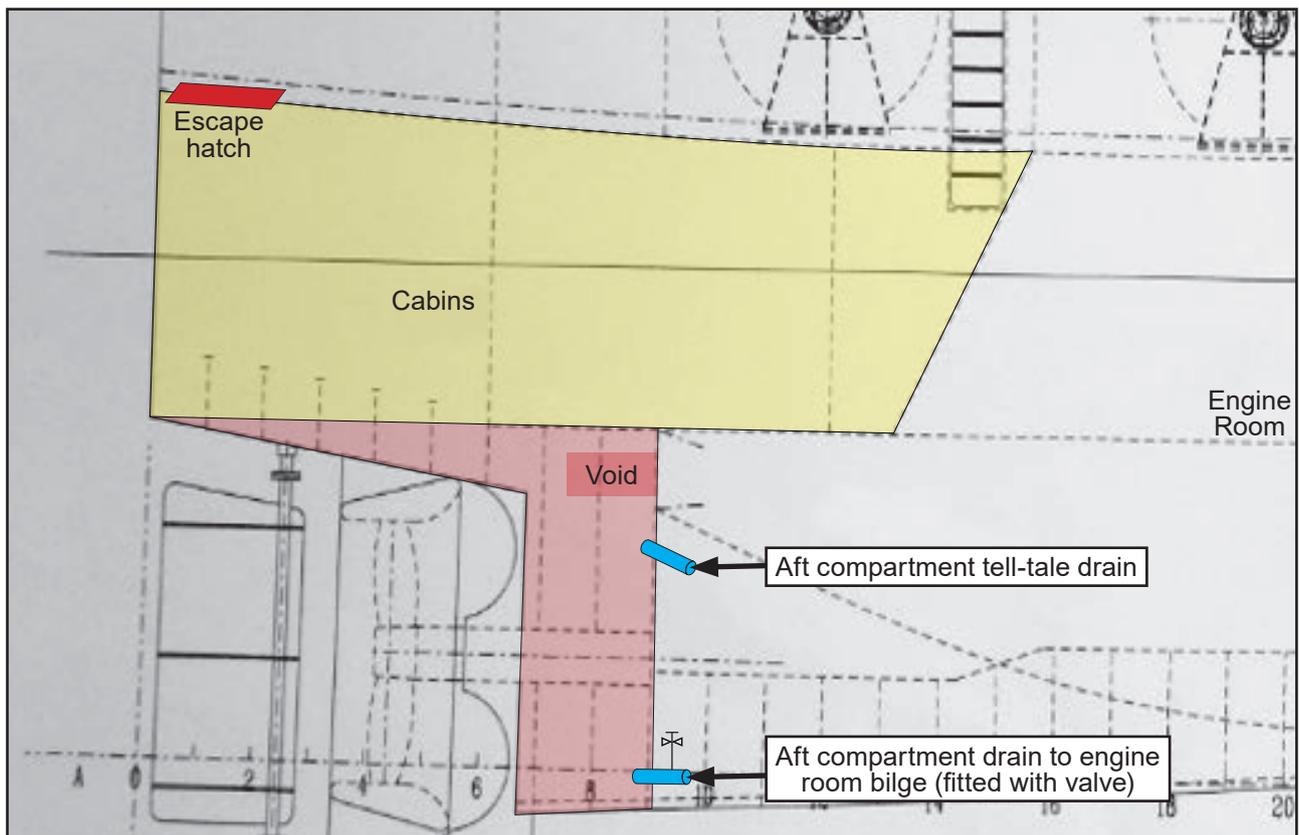
In the engine room, the engineer saw water flowing into the bilges through the drain valve¹ from the aft compartment² (**Figure 4**). He then went back to the wheelhouse to tell the skipper what had been found and to ask for help. The engineer returned to

Figure 4: Ocean Way – detail of the aft compartment

The bilge system had two suctions in the engine room, one forward and one aft, and one each in the fish hold and main ballast tank. There was no bilge suction in the aft compartment; instead, drainage from this compartment was via a 5.08cm pipe fitted with a hand-operated screw-down valve that was routinely left open. In this condition, it would also allow water to pass into the aft compartment in the event of engine room flooding.

The flooding occurred in the aft compartment, which was one of *Ocean Way's* four main internal spaces (**Figure 1**); it was separated from the engine room by a watertight bulkhead. Potential sources of seawater ingress directly into the aft compartment were: a breach of the steering system, a breach of the emergency fire pump sea water inlet or hull damage caused by the impact of the port trawl door.

The extent of the damage caused by the impact can only be estimated as the hull damage was never sighted by the crew during the emergency and the wreck was not examined. However, the conclusion that the hull was breached below the cabin floor level is underpinned by the fact that, had the breach been higher up, it is highly likely that the crew would have seen or heard water entering the compartment.

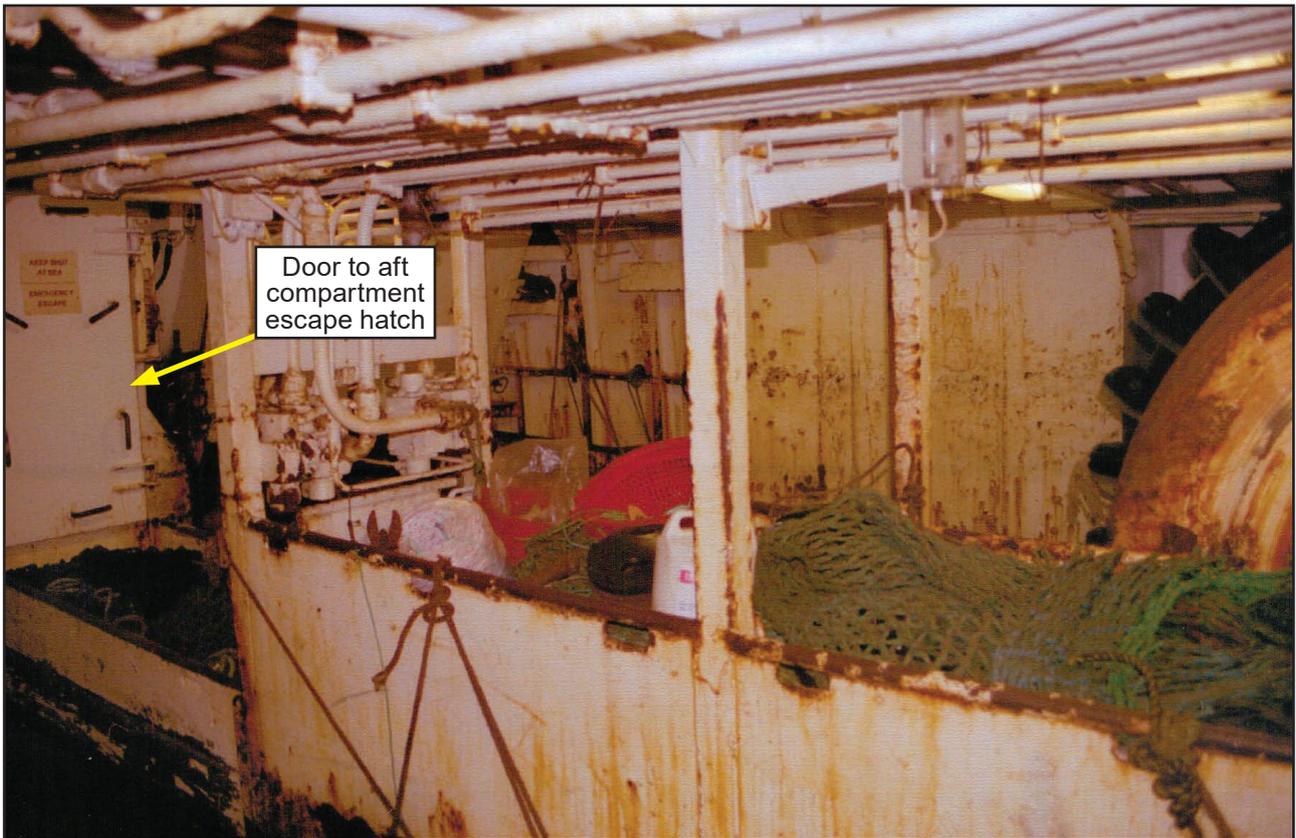
Figure 5: *Ocean Way* – main deck showing the watertight door to the aft compartment escape hatch

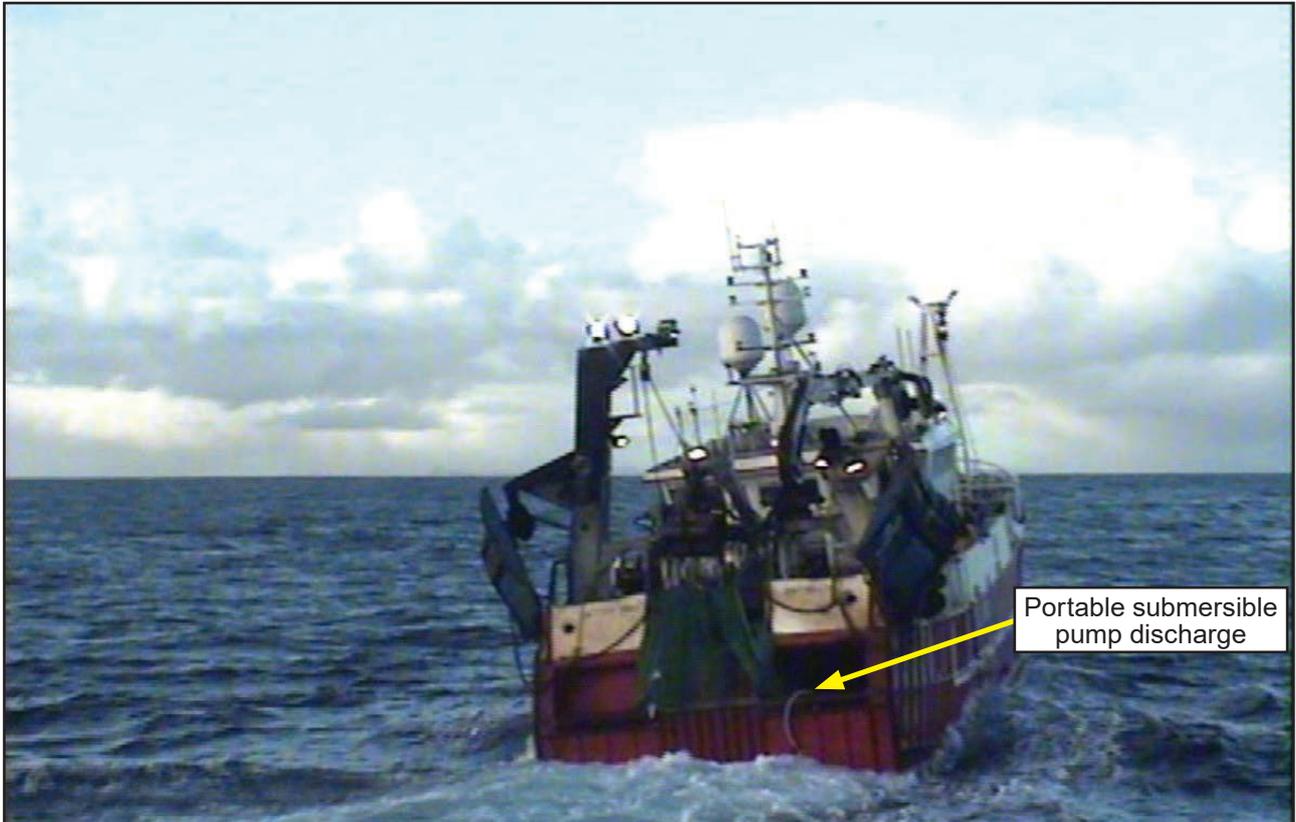
To assist the engineer, two deckhands arrived in the engine room with the vessel's 240 volt (v) portable submersible pump in case it was required to aid the pumping effort there. The engineer assessed that the portable submersible pump was not required in the engine room so it was taken to the aft compartment escape hatch, which was accessed by opening the watertight door on the main deck (**Figure 5**). Once this door was open, the portable submersible pump was lowered into the flooding space through the escape hatch and the pump's discharge line was placed over the stern on the starboard side (**Figure 6**).

Figure 6: *Ocean Way* during the flooding with the submersible portable pump discharge visible on the starboard side

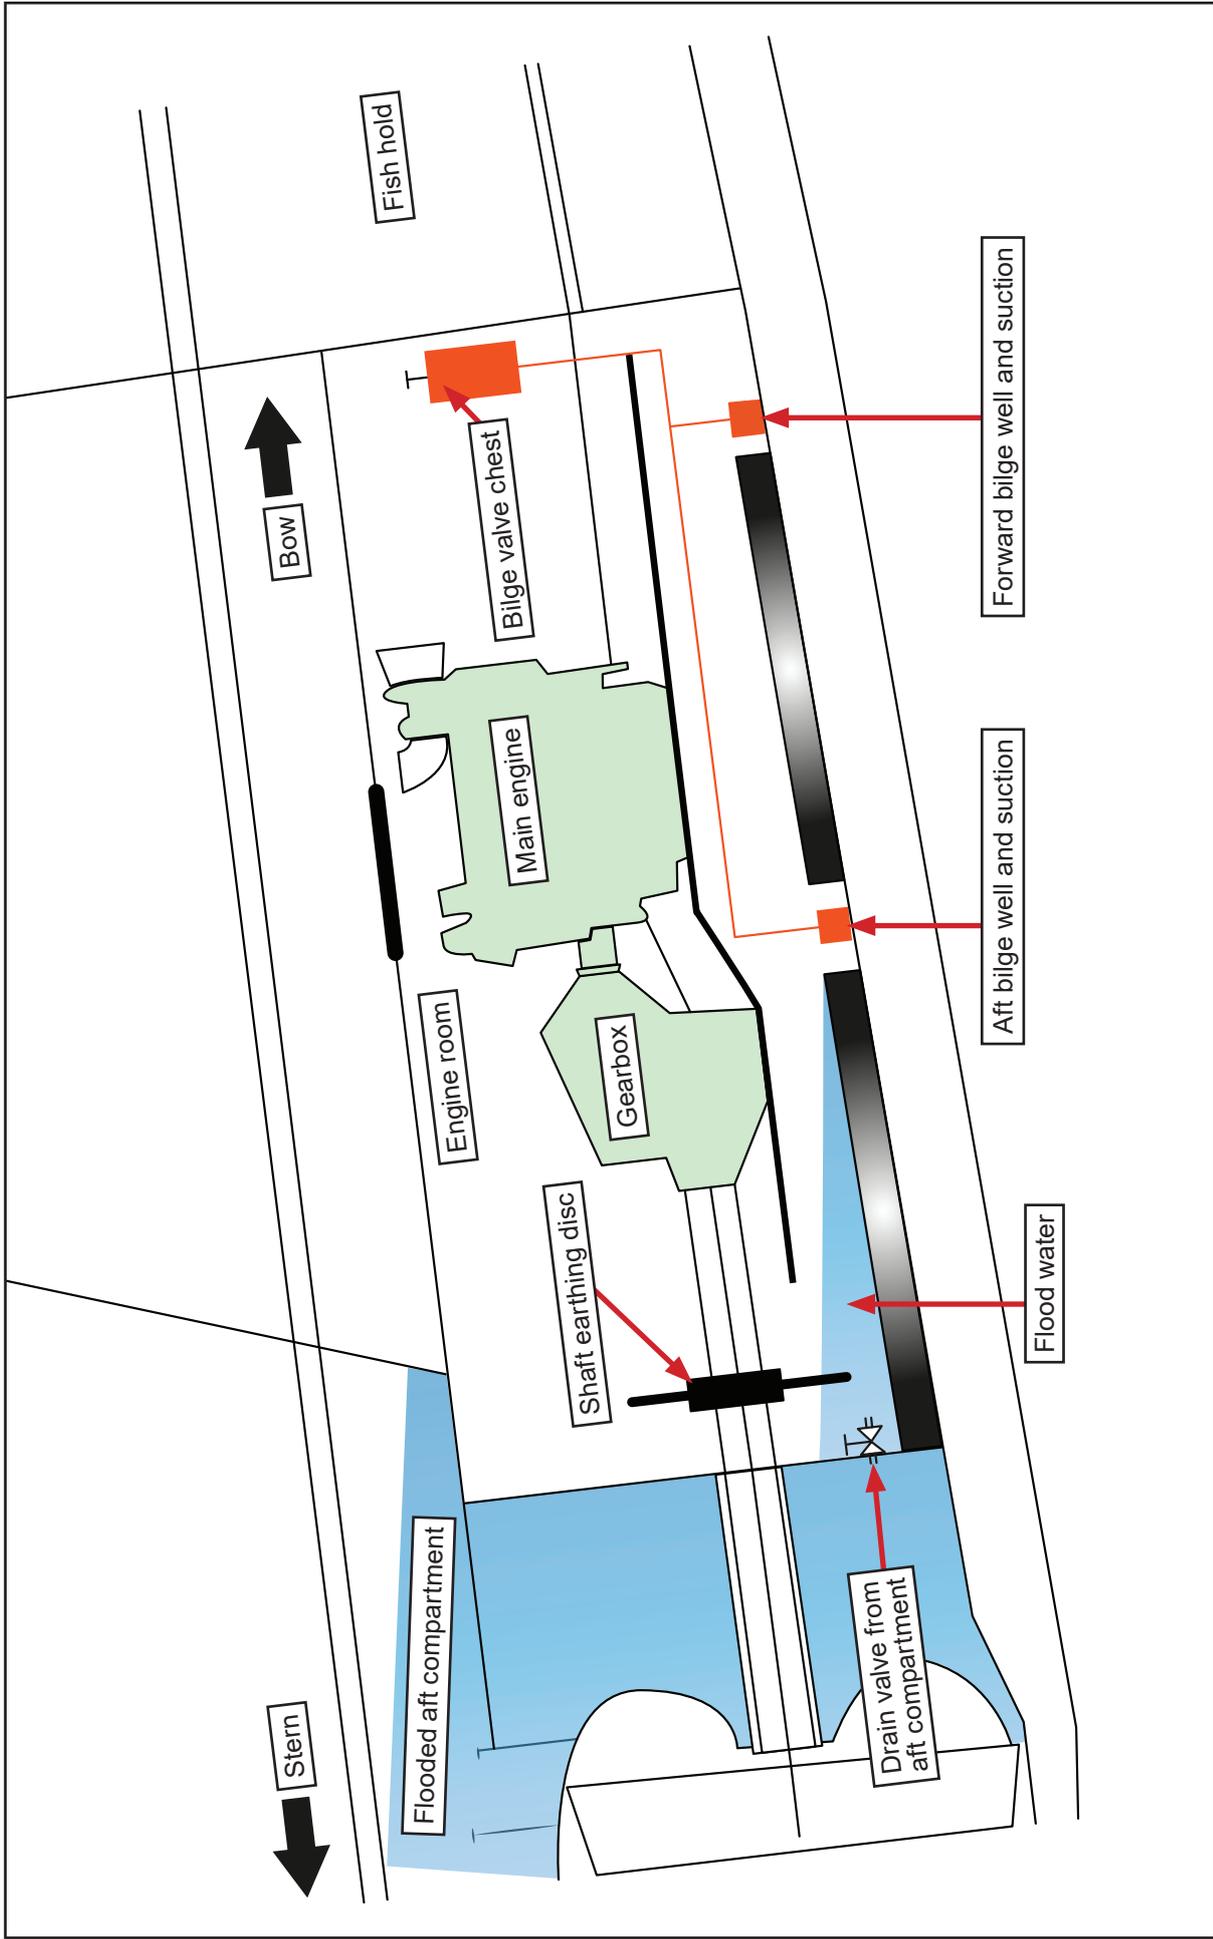
In the engine room, the engineer had continued to monitor the water level and the main bilge and deck wash pumps. The flooding of the aft compartment had caused a bow up trim which meant that the floodwater was at the aft end of the space and the forward bilge suction was no longer effective so the engineer shut it off (**Figure 8**). Floodwater had also been seen entering the engine room through a smaller and higher tell-tale pipe between the aft compartment and the engine room (**Figure 4**). This drain pipe did not have a shut-off valve, so the engineer blocked it using rags and a plastic bag held in place with cable ties.

As the bow up trim continued to increase, the aft bilge well in the engine room was also intermittently dry rendering bilge pumping from the engine room ineffective so the engineer shut the drain valve from the aft compartment and switched off the engine room pumps. The bow up trim had also caused the remaining floodwater to congregate at the aft end of the engine room and the propeller shaft earthing disc was partially submerged. This resulted in floodwater being sprayed around the engine room risking water damage to running machinery (**Figure 8**).

Figure 8: Illustration of the effect of a bow up trim on engine room bilge pumping (not to scale)

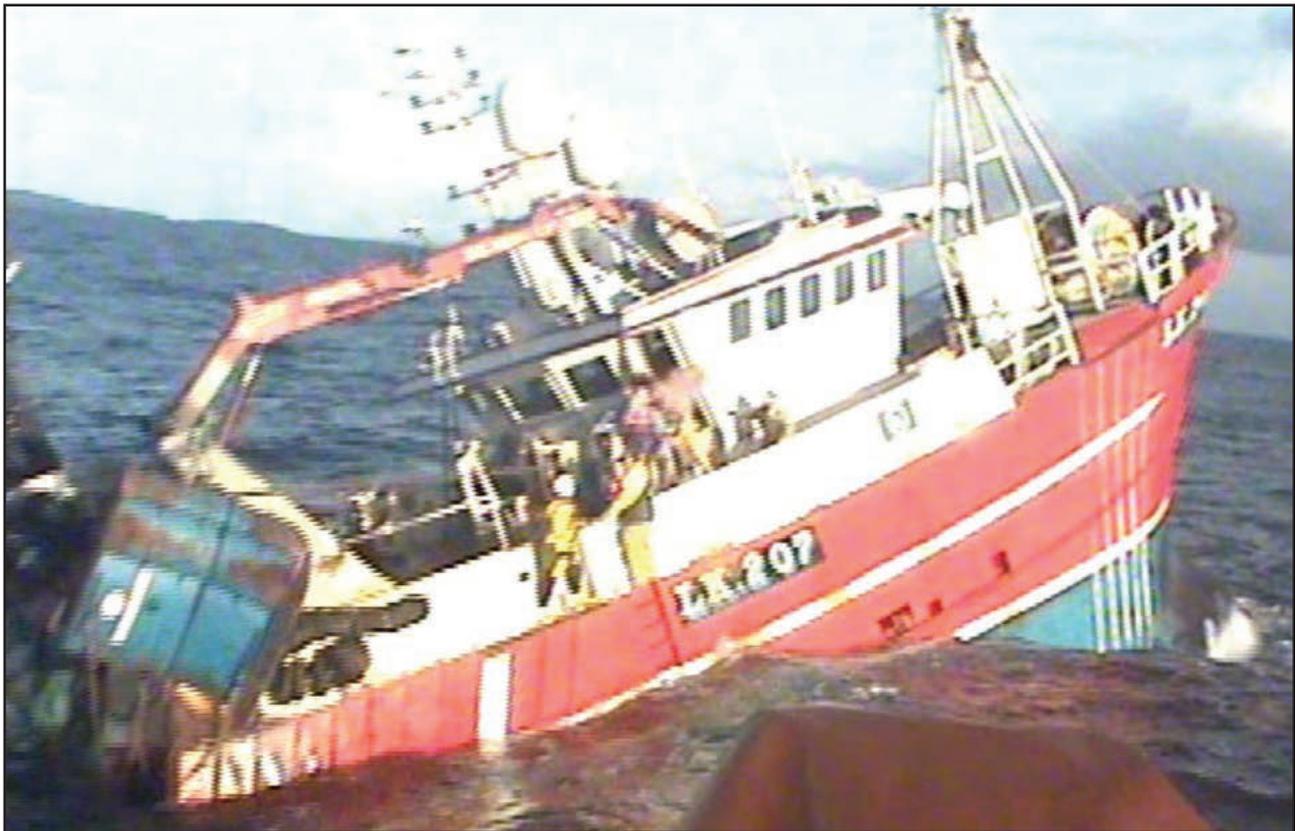
With no prospect of bringing the situation under control, everyone on board *Ocean Way* gathered on the starboard side by the wheelhouse in preparation for abandonment (**Figure 10**). All three deckhands had donned lifejackets and the skipper and engineer were wearing Fladen⁸ buoyancy jackets.

Figure 10: *Ocean Way* listing to port and trimmed by the stern just prior to foundering

A diminishing righting lever means an increasing risk of capsize, which can be exacerbated by sea conditions or a free surface effect if water can move in a partially flooded compartment. *Ocean Way* did list to port in the latter stages of the foundering but did not capsize, probably due to the relatively calm sea conditions. Nevertheless, had a capsize occurred, it would have been rapid in nature and placed the lives of the crew and the lifeboat men in immediate danger.

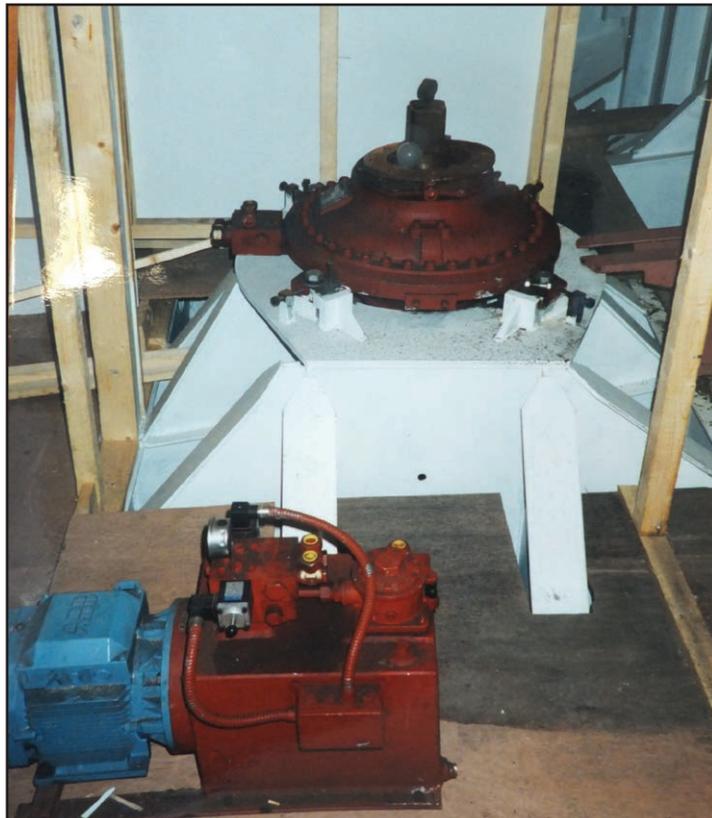
Figure 13: Head of steering system above the aft compartment deck (picture taken during vessel build)

The autohelm failure probably resulted from water damage to electrical components aft as *Ocean Way's* steering continued to respond normally to manual helm orders. The head of the rudder stock was situated above the level of cabin floor (**Figure 13**) and no water ingress was sighted in this area. A failure of the emergency fire pump sea suction inlet would have been evident to the crew when they entered the aft compartment, because a breach of this pipework would have been visible. Damage or failure of the steering or emergency fire pump systems in the aft compartment were not, therefore, sources of water ingress. Thus, it is almost certain that the flood was a result of damage caused when the port trawl door struck *Ocean Way's* hull.

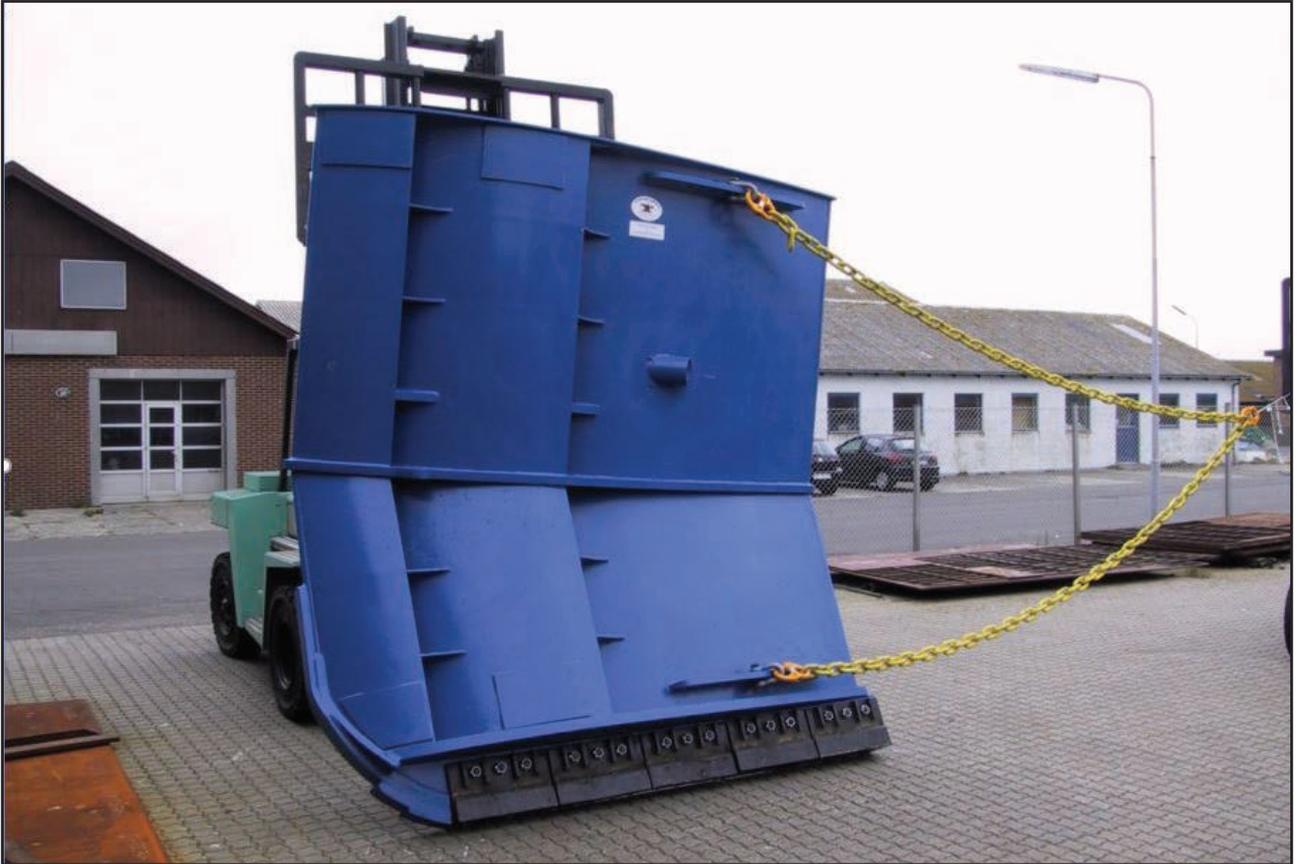
Ocean Way's original trawl doors (**Figure 14**) were oval in shape, and these had been replaced with Thyborøn Type 12D doors (**Figure 15**). The Thyborøn trawl doors were constructed of a high tensile steel, and three of the four corners were sharp edged.

Figure 15: Thyborøn Type 12D trawl door
