Collision between *Jag Arnav* and *Total Response*

26 NM north-west of Bunbury, Western Australia | 23 June 2015

ATSB Transport Safety Report
Marine Occurrence Investigation
MO-2015-003
Final – 8 June 2018

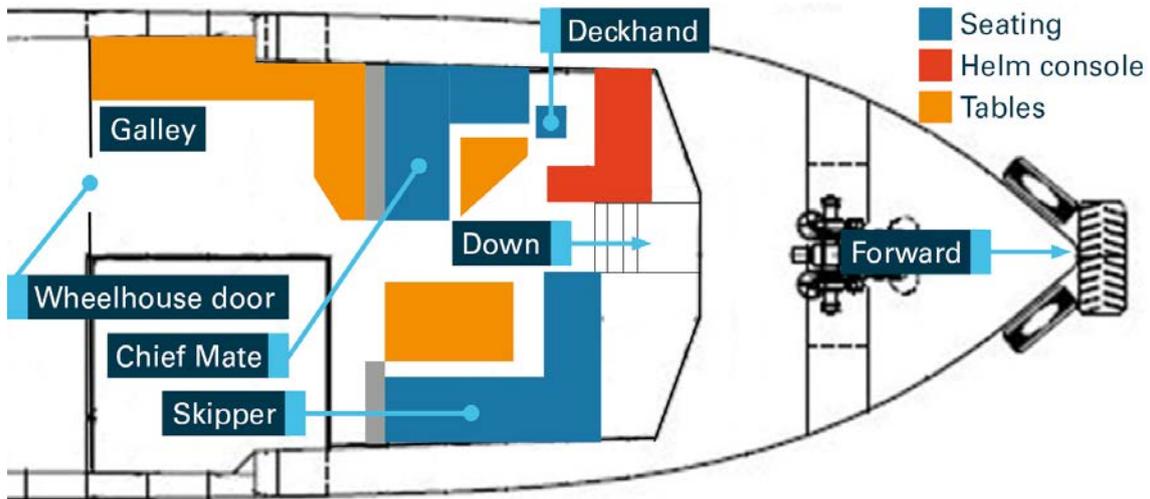
Figure 2: Locations of personnel in *Total Response's* wheelhouse

Meanwhile, in *Total Response's* wheelhouse, the skipper told the deckhand to keep the vessel on the track displayed on the chart plotter⁹ located near the helm console. The skipper also told the deckhand 'not to touch anything, to keep a lookout and call him if he had any problems'. He then retired to his seat to rest. The chief mate had finished using his computer and remained at the table behind the deckhand. Shortly after taking over the watch from the chief mate at 1000, the deckhand observed the automatic identification system¹⁰ (AIS) icon of a vessel near the coast on the chart plotter display. The deckhand did not report this to the chief mate or the skipper as he assumed the chief mate was already aware of it.

At 1119, *Total Response* was about 2 NM away on the same steady bearing. The vessel had maintained its course and speed with the deckhand seated at the helm console. The chief mate was still situated behind the deckhand while the skipper rested on the seat on the other side of the wheelhouse.

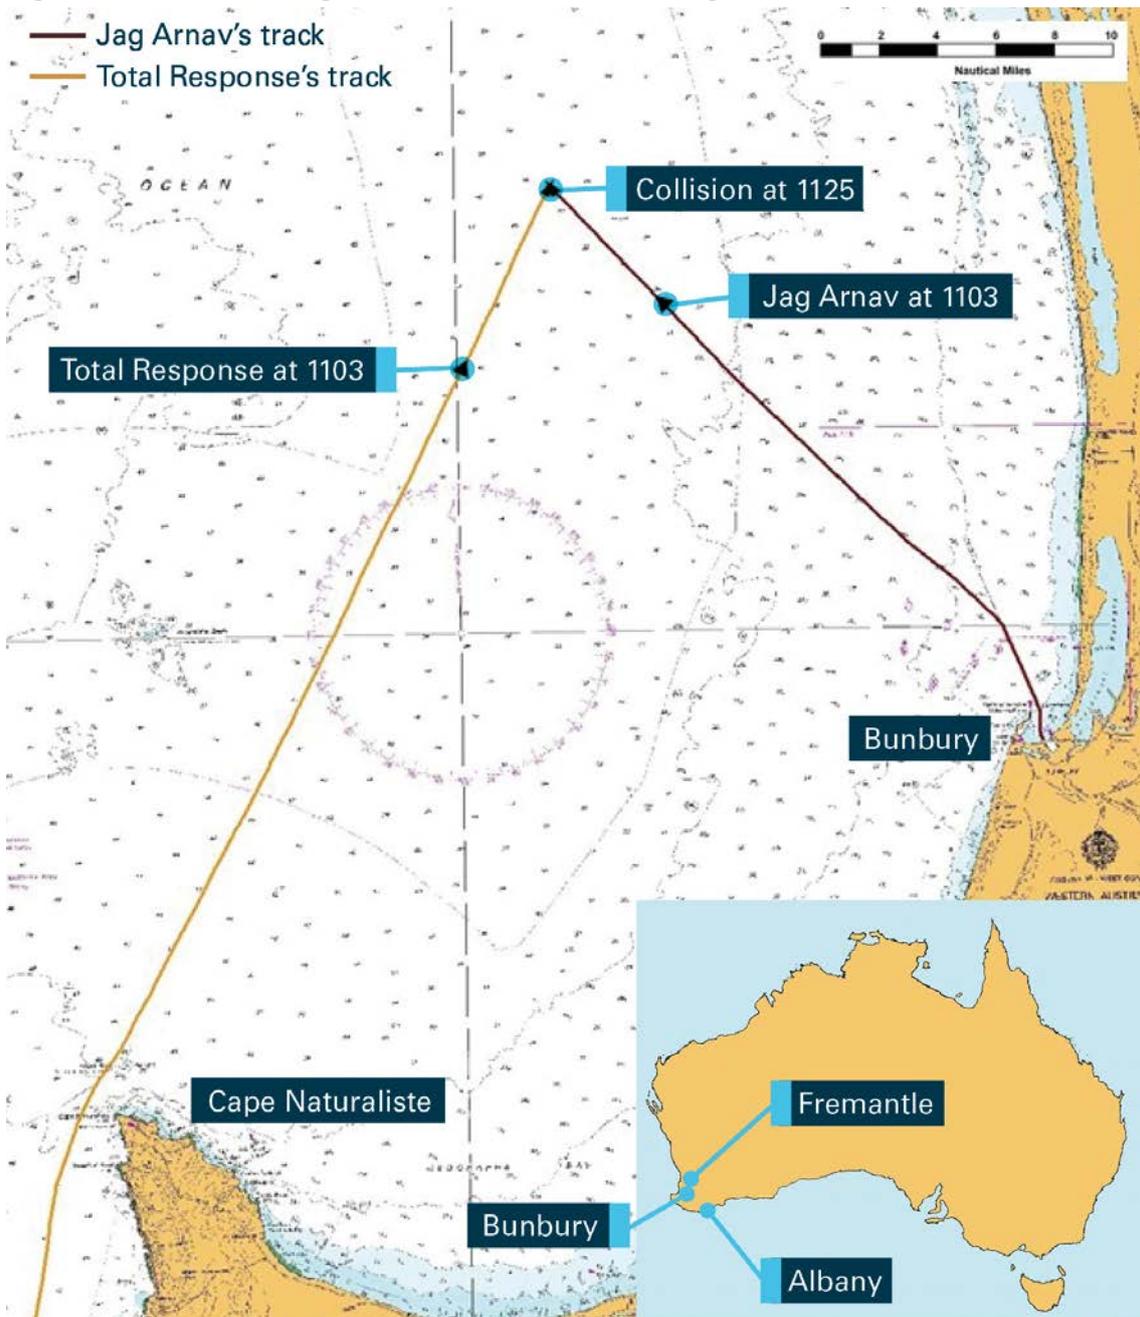
Figure 3: Section of navigational chart Aus 334 showing the tracks of both vessels

Meanwhile, *Jag Arnav* was near the coast to the east of *Total Response*. The 229 m long bulk carrier had just sailed from Bunbury (Figure 3) for the United Arab Emirates. The master, third officer and a duty seaman were on the ship's navigation bridge (bridge).

At about 1125, as the third officer acknowledged the cadet's radio call, *Total Response* collided with *Jag Arnav* near its number two cargo hold on the port side. The master had also heard the radio call and had gone to the port bridge wing where he saw *Total Response* close astern. Realising there had been a collision, he took over from the third officer and began manoeuvring the ship to assist the vessel if required.

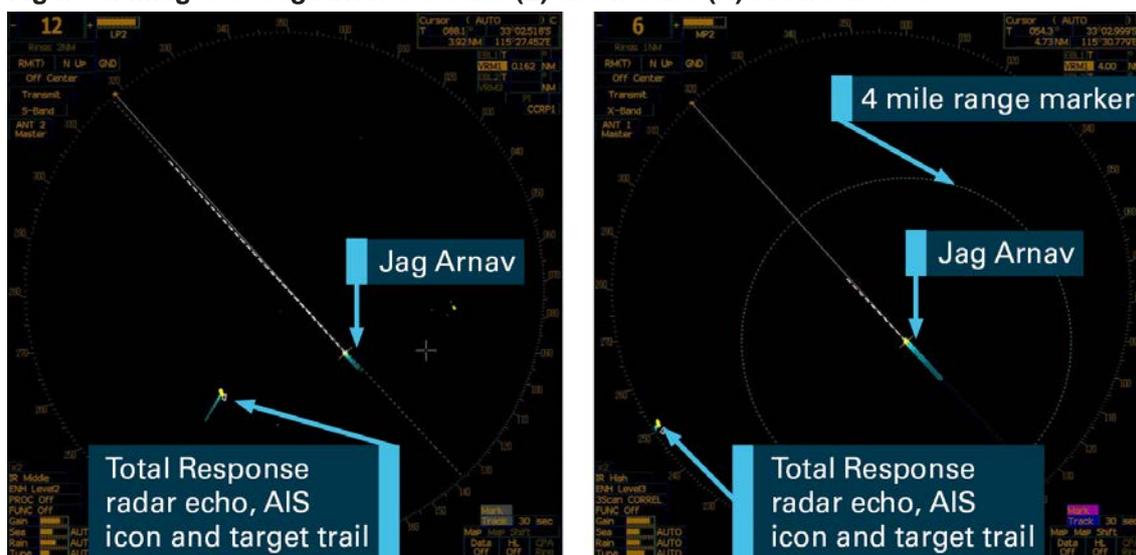
Figure 4: Images of *Jag Arnav*'s s-band (L) and x-band (R) radars at 1103

Shortly after, at about 1103, *Total Response's* radar echo and AIS icon also appeared on the x-band radar display (Figure 4).

At about 1112, *Total Response* was 4 NM away from *Jag Arnav* and still on a bearing of 251°. The vessel's radar echo, trail and AIS icon were conspicuous on both of the ship's radar displays. Neither radar's automatic radar plotting aid¹² function was used to track *Total Response*.
