Collision between the container ship *Glasgow Express* and the fishing vessel *Mako*

15 NM south of Cape Woolamai, Victoria | 12 August 2017

ATSB Transport Safety Report
Marine Occurrence Investigation
333-MO-2017-007
Final – 13 June 2018

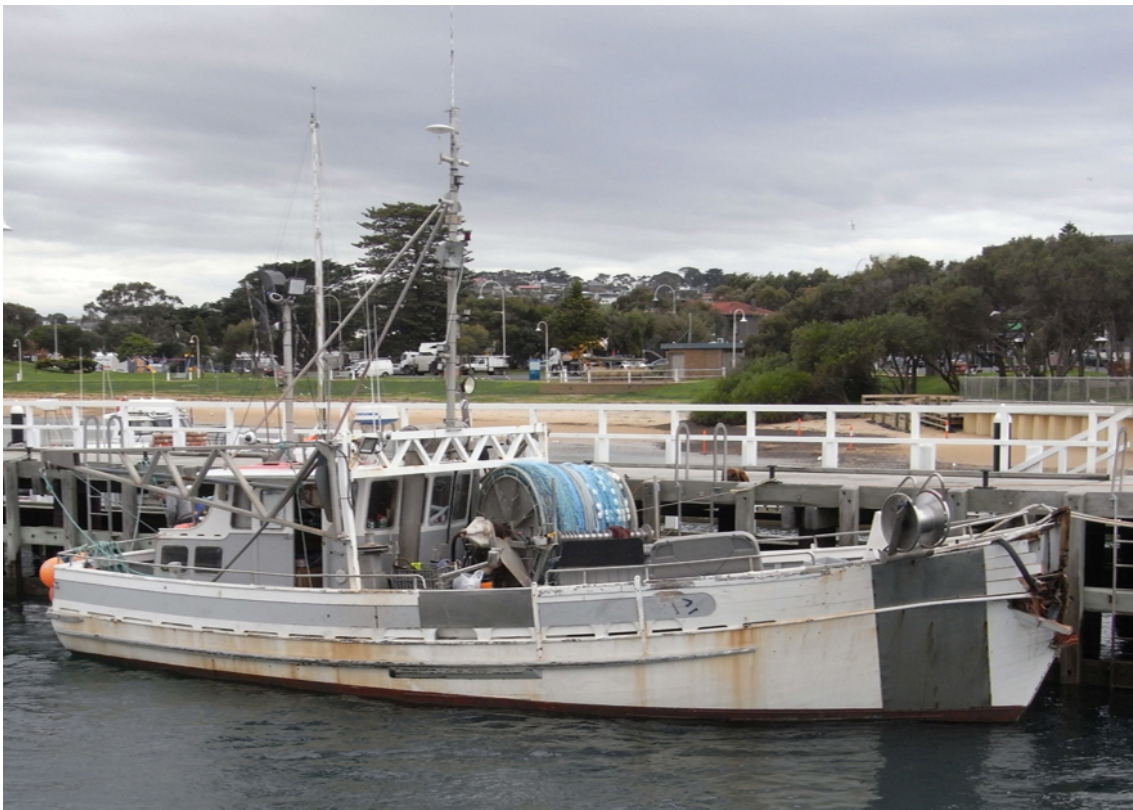
Figure 1: *Mako* alongside in San Remo after the collision

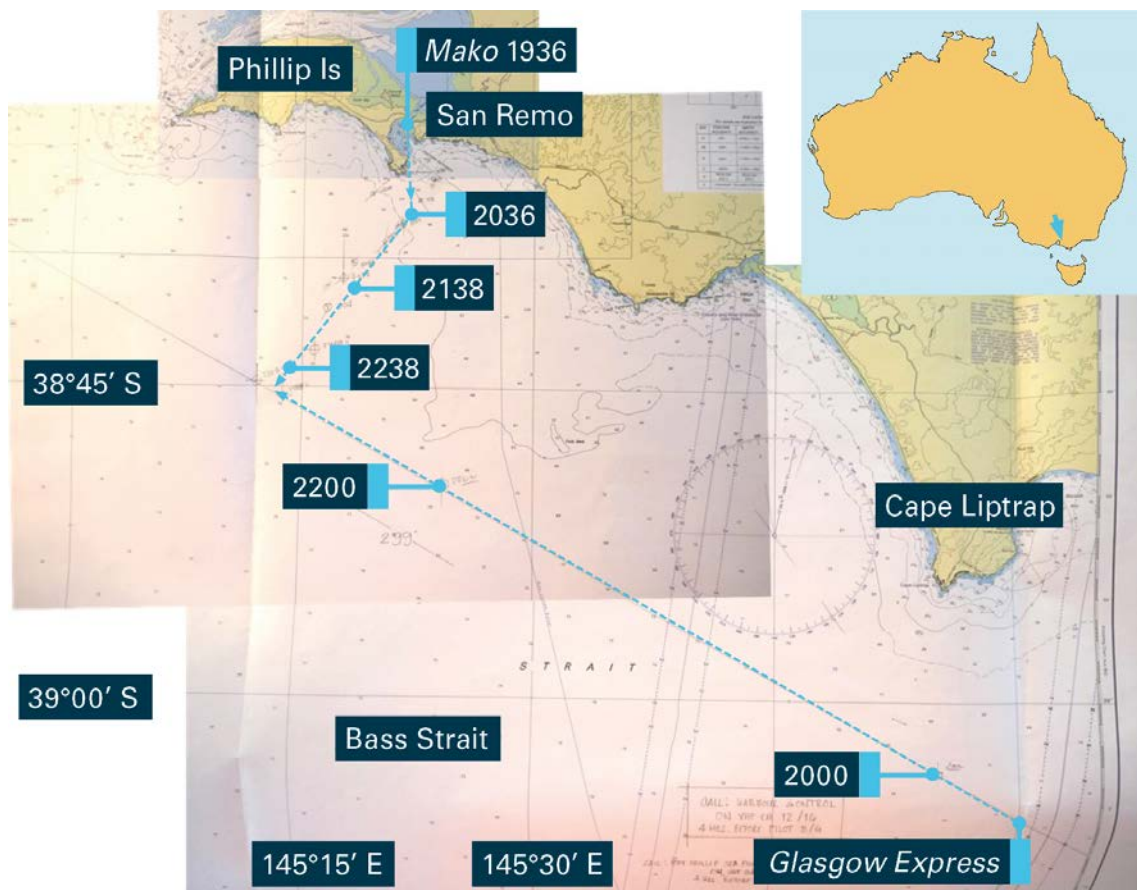
The fishing boat and the ship continued on their respective courses without change until, at 2246, in position 38° 45.5' S 145° 13.6' E, they collided (Figure 3).

Figure 3: Composite excerpt of *Glasgow Express's* navigational chart (Aus 801) showing vessel tracks to collision

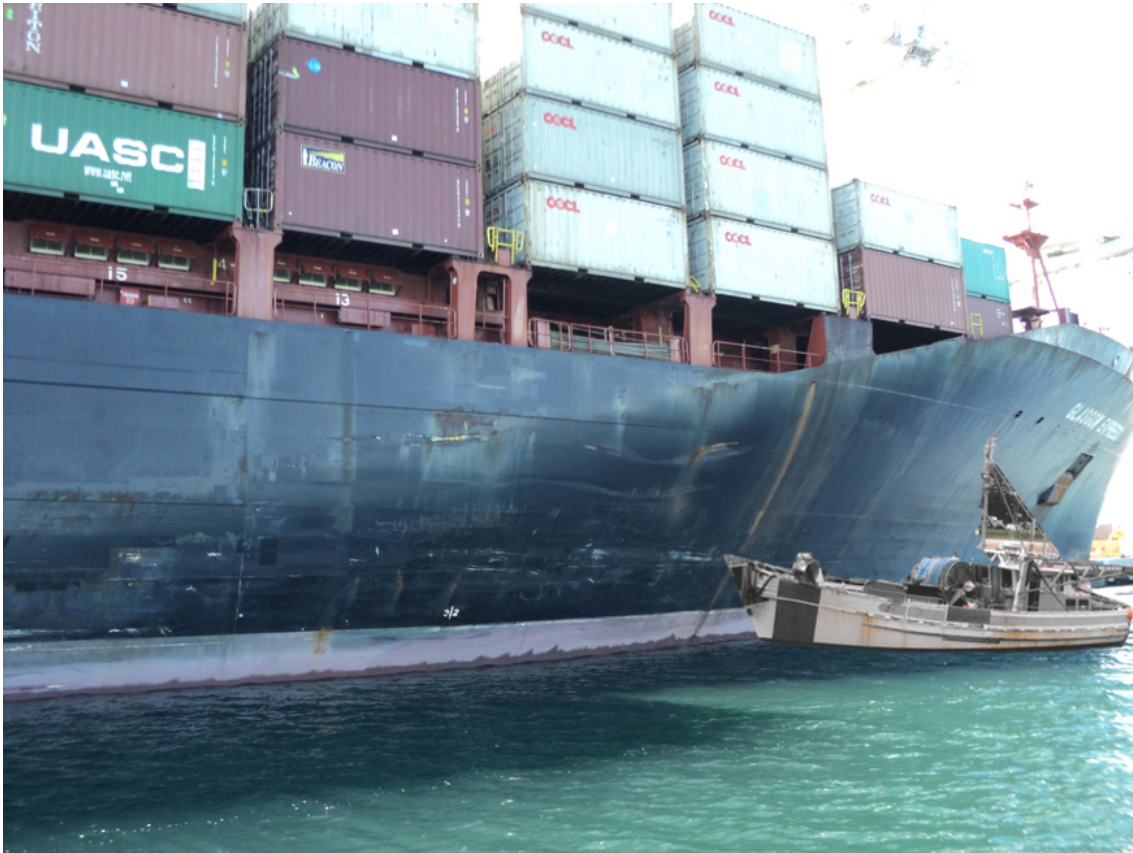
Figure 4: Composite representative image showing the scale and approximate point of collision

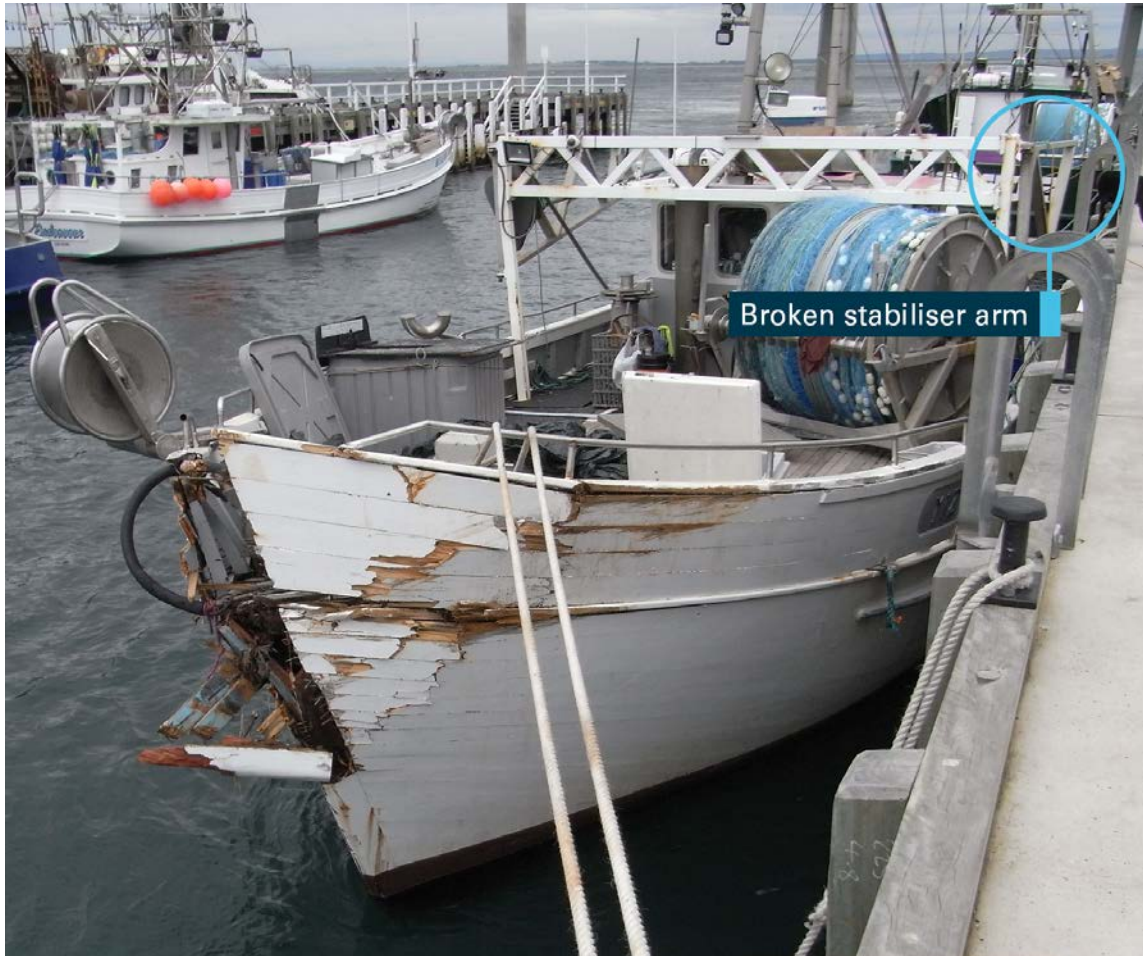
Mako suffered significant damage from the collision. The stem post was broken and the forecastle space was opened to the outside (Figure 5). However, the boat had remained otherwise watertight and did not take on any water. In addition, about 1 m of the bow was stoved in, the sheer strake⁶ was marked and scratched for several metres along the port side, and the port stabiliser arm had broken away and the stabiliser arm mounting structure, including the boat's main mast, had been pushed to starboard.

Figure 5: Damage to *Mako*.

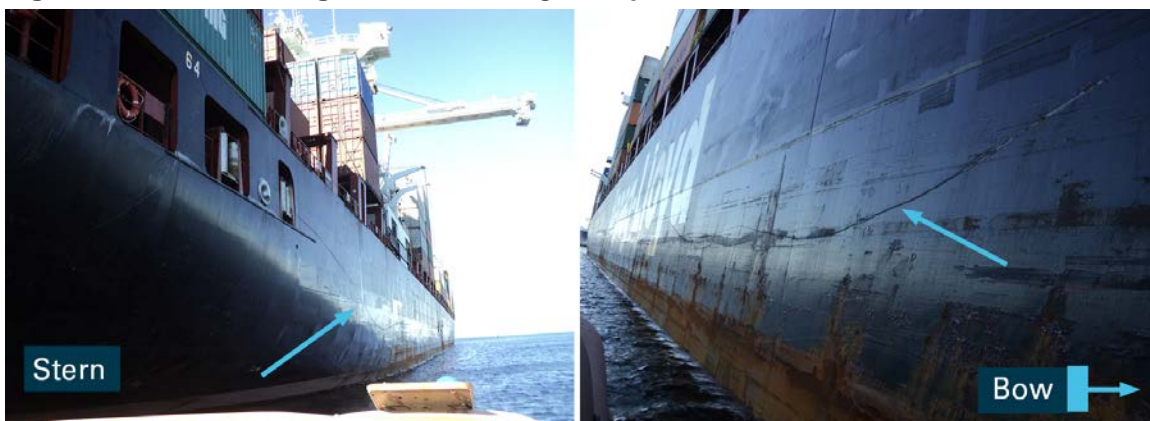
Glasgow Express was inspected while alongside in Melbourne. Scratch marks from *Mako*'s stabiliser arm were visible from the impact point, about 50 m aft of the bow on the starboard side, to the stern (Figure 6). No other damage was found.

Figure 6: Scratches along the side of *Glasgow Express*

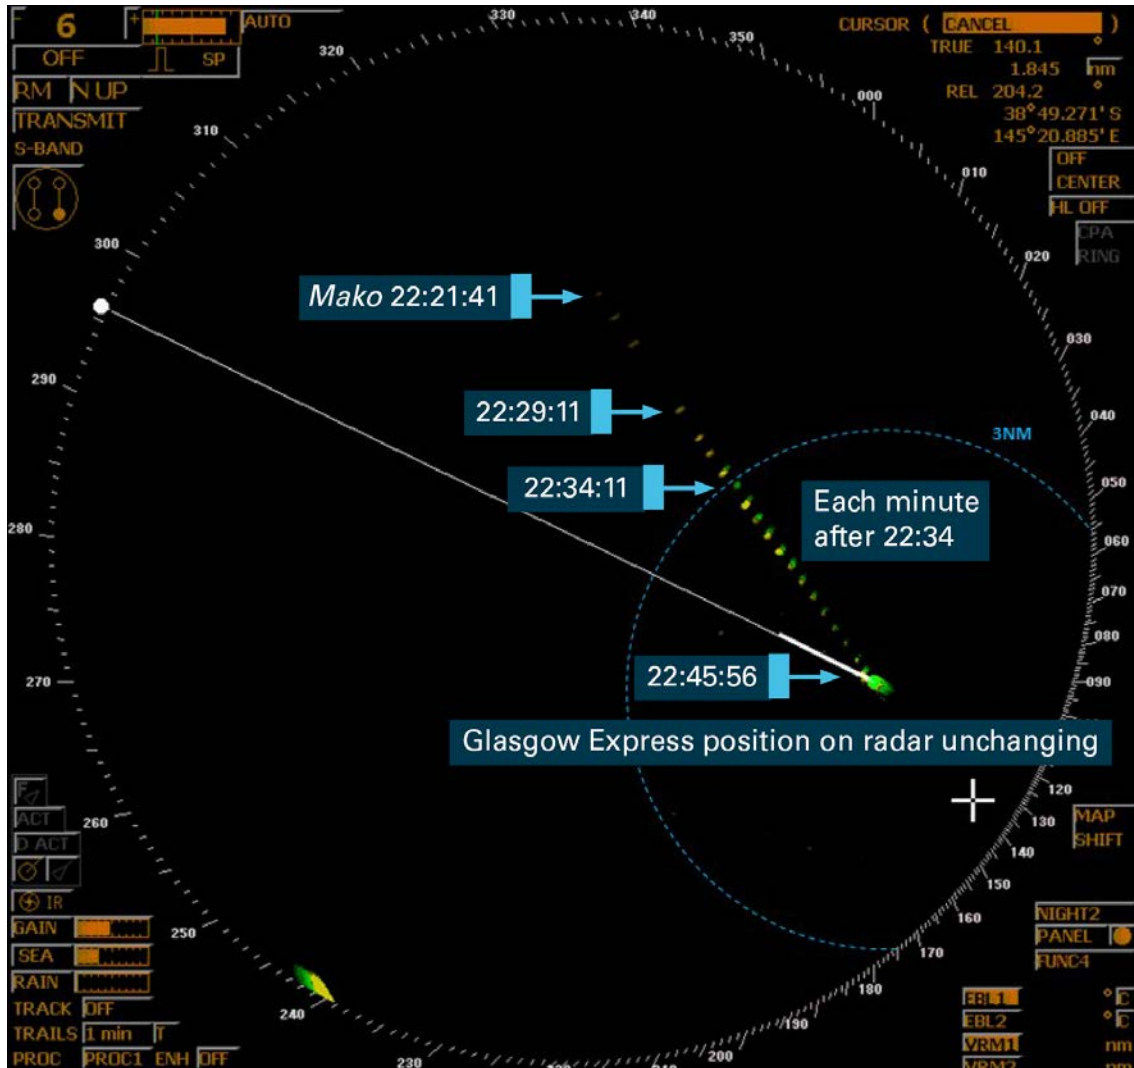
Glasgow Express's officer of the watch (OOV) first sighted *Mako* at about 2200. Together, the OOV and the lookout mistakenly interpreted the visual information and agreed that they were overtaking the fishing vessel. No action was taken to use any other bridge equipment to confirm the actual situation, despite *Mako* being visible on the S-band radar intermittently from 2222, and continuously from 2232 (Figure 7).

Figure 7: *Glasgow Express's* S-band radar image at 22:21:41 with the progress of *Mako* overlaid to the time of the collision

Furthermore, Figure 7 shows that for at least 25 minutes before the collision, *Mako* maintained an unchanging bearing in relation to *Glasgow Express*. As stated in the COLREGs, this is indicative of a collision situation. *Glasgow Express*'s OOW reported that he recalled first seeing the lights of *Mako* at about 2200. *Mako*'s bearing would have remained unchanged from this point. Therefore, there were more than 45 minutes in which the situation could have been clarified.

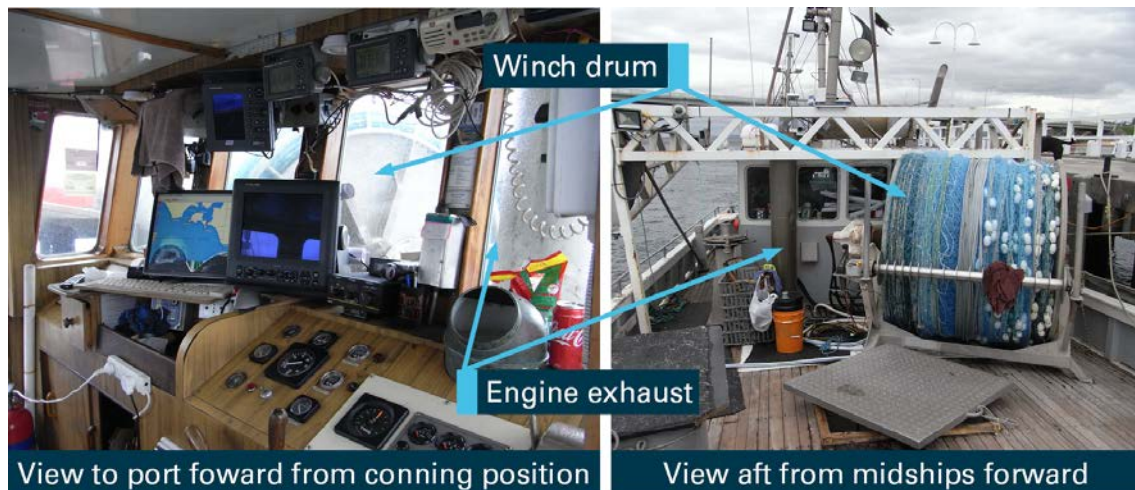
In addition, many fishing vessels are constructed with the working deck located forward of the wheelhouse. Some, such as *Mako*, are also fitted with fishing net winch drums on the working deck. These winch drums can be of substantial size and, as a result, create blind sectors and obscure the view forward from the wheelhouse (Figure 8). Current regulations¹³ (available at www.amsa.gov.au) limit the extent of such obstructions. However, these regulations have not been applied retrospectively and consequently, older vessels, such as *Mako*, continue to have equipment mounted on the foredeck obscuring the field of vision from within the wheelhouse.

Large equipment mounted on the foredeck presents as a significant risk to maintaining a proper lookout by watchkeepers. However, in this case, given the relative bearing of the *Glasgow Express*, it is unlikely that the winch drum significantly affected the ability of *Mako*’s watchkeeper to detect the other vessel. Nevertheless, it is important that this limitation in vessel design is recognised and understood by fishing boat crews in order to account for blind sectors and prevent future collisions.

Figure 8: View from the conning position in *Mako*’s wheelhouse
