# National Transportation Safety Board

## Marine Accident Brief

### Grounding and Sinking of Fishing Vessel *Southern Bell*

<b>Accident no.</b>	DCA18FM001
<b>Vessel name</b>	<i>Southern Bell</i>
<b>Accident type</b>	Grounding and Sinking
<b>Location</b>	Gulf of Mexico, east of Sabine Pass Jetty Channel, Texas 29°39.23' N, 93°49.42' W
<b>Date</b>	October 13, 2017
<b>Time</b>	0705 central daylight time (coordinated universal time – 5 hours)
<b>Injuries</b>	None
<b>Damage</b>	\$519,000 est.
<b>Environmental damage</b>	Approximately 3,800 gallons of diesel and oil
<b>Weather</b>	Visibility 9 miles, clear skies, winds east-northeast at 4 mph, waves east 1–2 feet, air temperature 72°F
<b>Waterway information</b>	The Sabine Pass Channel connects Sabine and Neches Rivers with the Gulf of Mexico. The channel has a depth of 40 feet and is located between Jefferson County, Texas, and Cameron Parish, Louisiana.

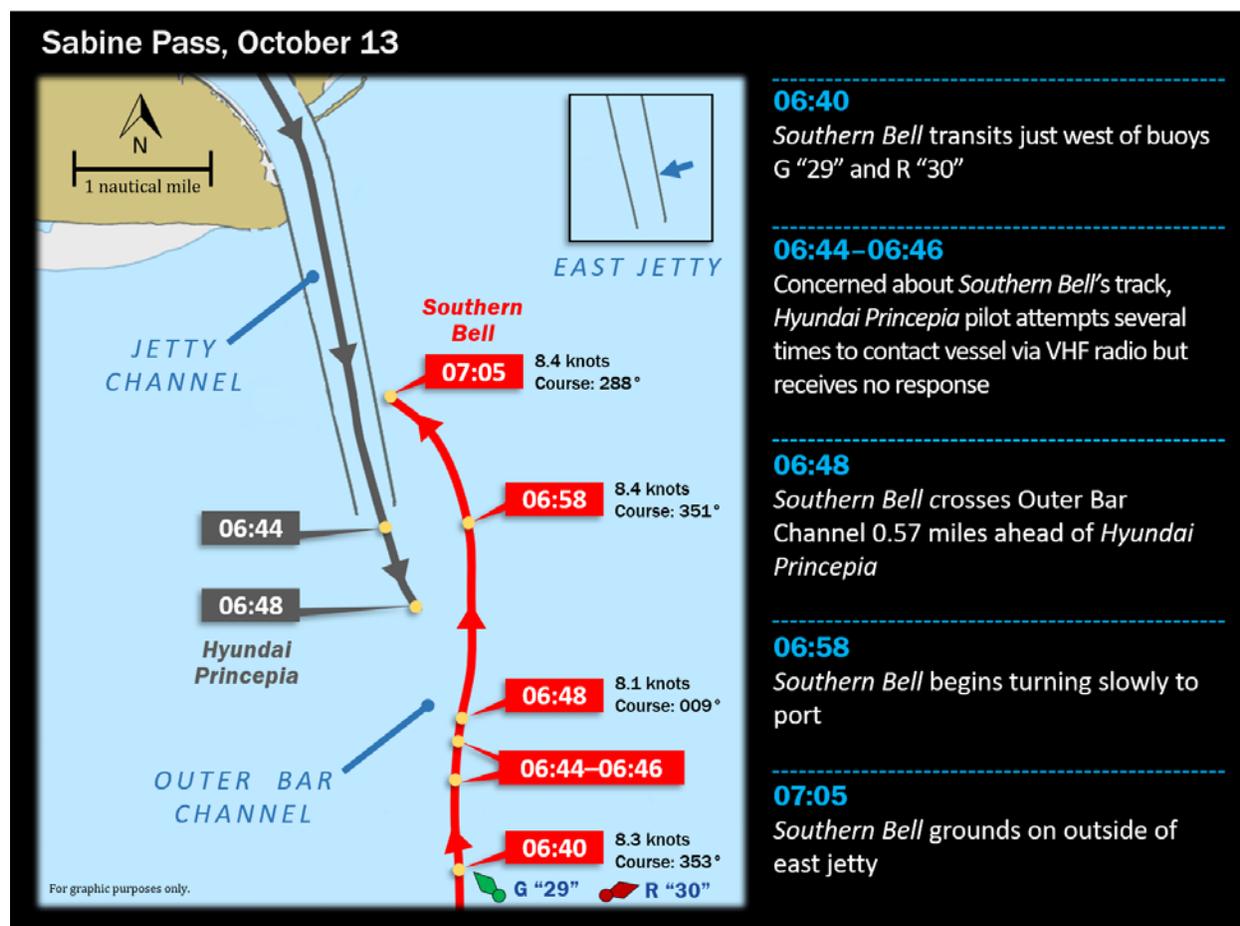
Traveling at a speed of 8.1 knots with a course of 009 degrees, the *Southern Bell* crossed the Outer Bar Channel at 0648 ahead of the *Hyundai Princepia* with an estimated closest point of approach of 0.57 miles off the bow of the *Hyundai Princepia*. Over the next several minutes, the *Southern Bell* maintained a course in a northerly direction ranging from 359 to 010 degrees at a speed of 8.2 knots. At 0658, the vessel began slowly turning to port, with its speeds remaining relatively constant (at 8.4 knots with a course of 351 degrees). However, its course swung from 003 to 288 degrees, until at 0705 the vessel grounded on the rocks outside the Sabine Pass east jetty near buoy R “20”.

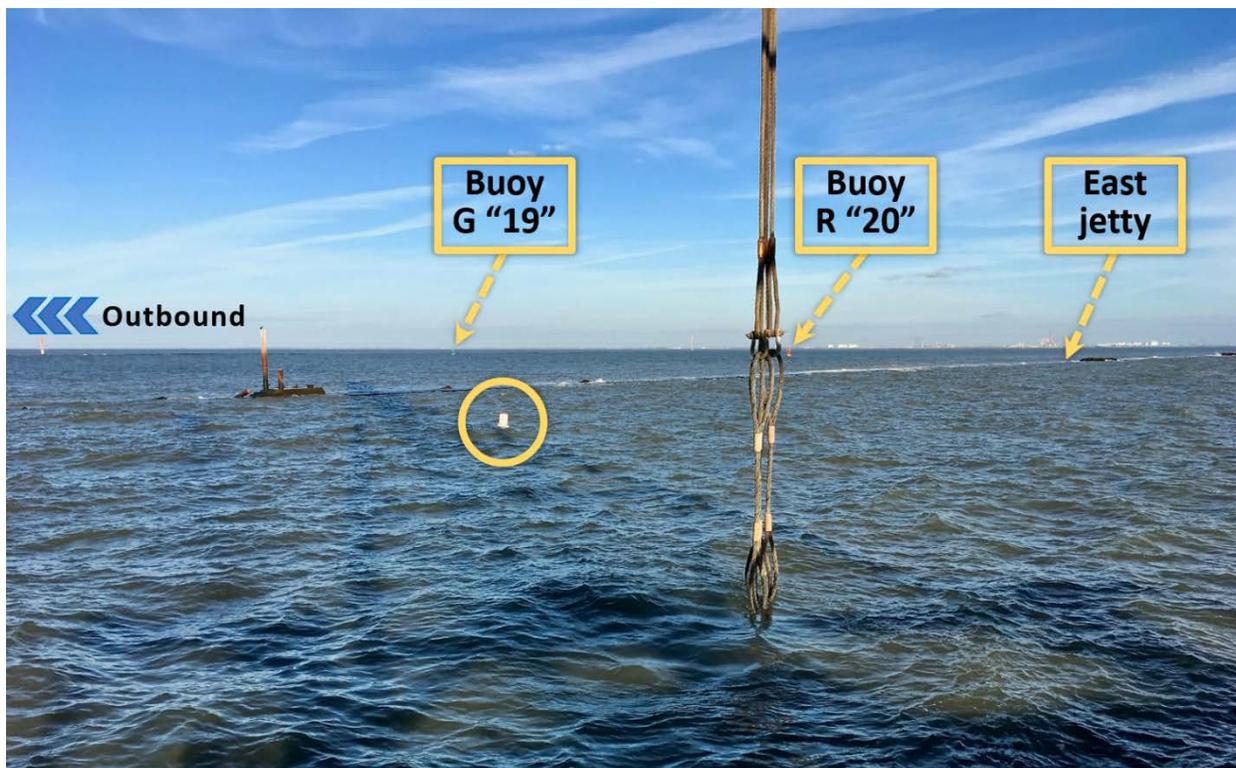
The white buoy (circled) was placed by the Coast Guard to locate the wreck of the *Southern Bell*. Navigation buoys G “19” and R “20” mark the Sabine Pass Jetty Channel beyond the east jetty. In the foreground are the lifting wires from a salvage barge; in the background, the structure to the left is the remnant of a channel marker no longer maintained.
