National Transportation Safety Board Marine Accident Brief

Towing by Coast Guard Response Boat *CG 29113* of Vanguard Sailboat, Resulting in Loss of Propulsion and Allision with Highway 11 Bridge, Lake Pontchartrain, Louisiana, May 3, 2017

Accident no. DCA17PM012

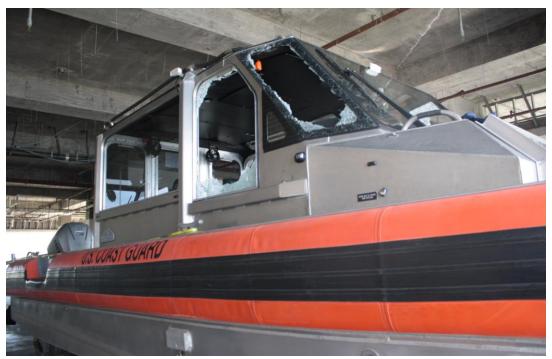
The CG 29113 sustained damage to the port and starboard cabin windows, window frames, cabin-top handrail system, engine-well gunnels, and taffrail. The main cabin window frames and roof supports were forced inward by the impact against the bridge pilings, causing three of the mechanical windows and spotter fixed-glass panels to shatter. The handrails along the cabin-top were severely deformed between frames 3 and 7. The collar (fender system) sheath upper track was damaged, and the port bow and the starboard-side edge were inset.

Starboard-side damage to CG 29113.

The sailboat's mast collapsed over the starboard quarter of the CG 29113, pushing the taffrail downward and splitting the material at the welds. All four taffrail anchor points became deformed with one of them separating from the gunnel and creating a breach above the waterline. Below the waterline, the hull was scraped on both sides by the boat coming in contact with the pilings and the wire-rope rigging from the sailboat's mast. No breach below the waterline was observed. The port engine's lower unit stabilizing fin was broken, and both propellers were damaged. A visual inspection of the outboard engines and lower units was conducted, revealing no mechanical damage.
