Marine Accident Investigation Branch  
First Floor, Spring Place, 105 Commercial Road  
Southampton, United Kingdom  
SO15 1GH

June 2018

# MAIB ANNUAL REPORT 2017

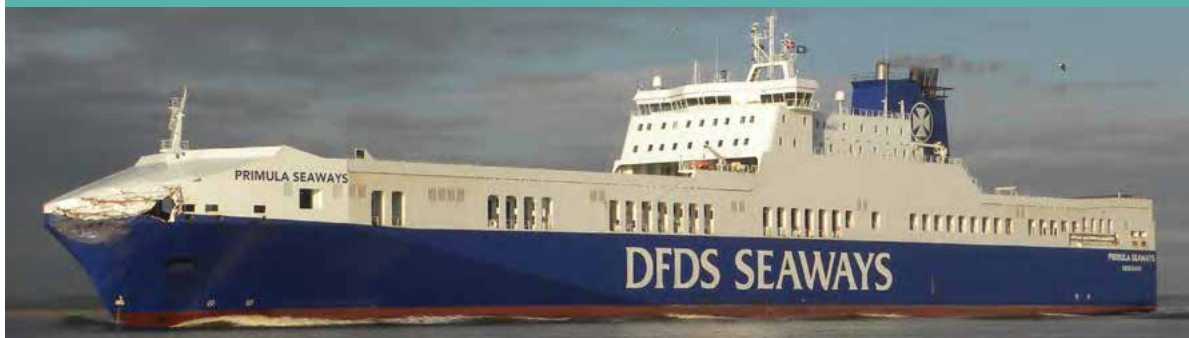
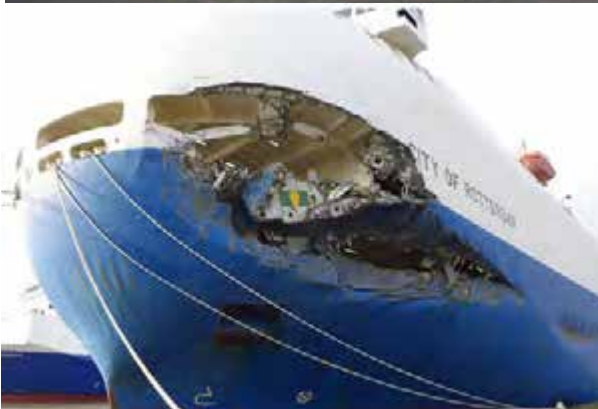
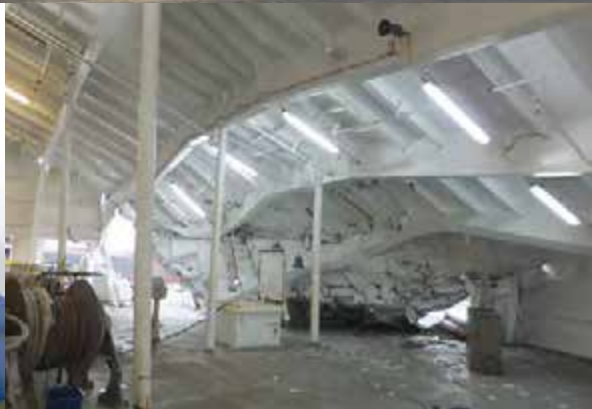
**Collision on the River Humber**

- ▶ Unforeseen consequence of novel bridge design was relative motion illusion
- ▶ Problem known to ship’s team but not addressed
- ▶ Had bridge team management been effective, accident could have been prevented

| No | Recommendation(s) to: | Bureau Veritas |
|---|--|---|
| 104 | Propose to the International Association of Classification Societies that Recommendation 95 “Recommendation for the Application of SOLAS Regulation V/15 Bridge Design, Equipment Arrangement and Procedures (BDEAP)” is revised to: | <ul style="list-style-type: none"> <li>• Improve the definition of conning position(s), taking into account the equipment that is required to be at, viewable from, and convenient to the position.</li> <li>• Raise the awareness of the dangers of navigating from off-axis windows and the effect of relative motion illusion.</li> </ul> <p style="text-align: right;">Appropriate action implemented ✓</p> |
| 105 | Propose to the International Association of Classification Societies that the status of Recommendation 95 is raised to a Unified Interpretation. | <p style="text-align: right;">Appropriate action implemented ✓</p> |

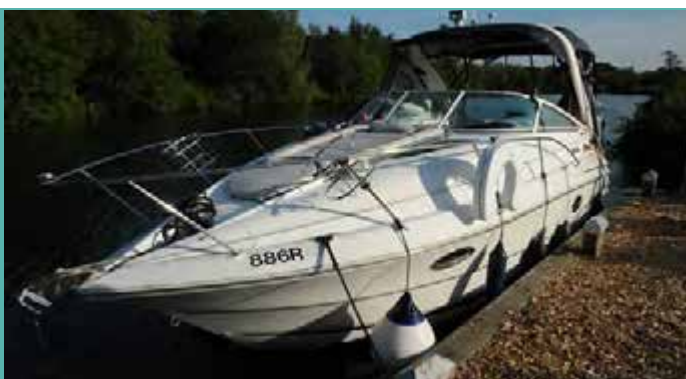
## Carbon monoxide poisoning on Wroxham Broad resulting in two fatalities

- ▶ Petrol engine used to charge batteries while alongside and exhaust fumes entered boat
- ▶ Vessel's cockpit and accommodation spaces were inadequately ventilated
- ▶ No CO alarm fitted

- Raising awareness of the likely sources of carbon monoxide, including from other boats.
- The dangers of using inappropriate or poorly installed fossil-fuel burning equipment.
- Recognising the early symptoms of carbon monoxide poisoning.
- The importance of ventilation in habitable areas.

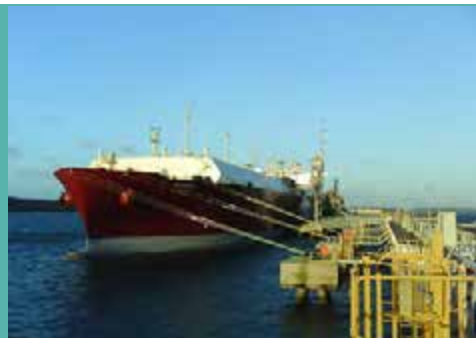
### Failure of a mooring line while alongside the South Hook Liquefied Natural Gas terminal, Milford Haven resulting in serious injury to an officer

- ▶ Elastic pennant on HMPE mooring introduced snap-back hazard
- ▶ Jacketed rope construction prevented inspection of load bearing yarns
- ▶ Conflict between rope manufacturers' guidance on factors of safety and the ship industry operating guidance

- Deck fitting and rope D:d ratios.
- Applying appropriate safety factors for given applications.
- Understanding the causes of kinking and the potential impact of axial compression fatigue on the working life of HMSF rope.
- Rope fibre examination and testing as part of the assessment of fibre fatigue degradation and discard.

120 Develop robust mooring line procurement criteria to ensure rope manufacturers' recommendations on safety factors and D:d ratios are carefully considered.

122 Investigate methods for monitoring the through-life condition of HMSF rope mooring lines with the aim of ensuring ropes are retired and replaced before their residual strength drops below their expected working load limit.

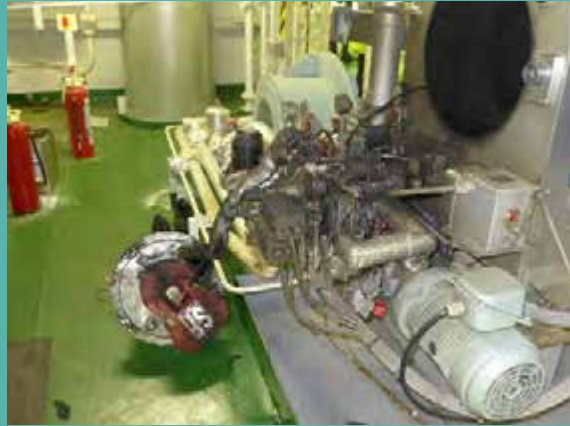
## Manhattan Bridge

- ▶ Maintenance management; faulty igniter and leaking solenoid valve found during evidence collection
- ▶ Inappropriate fuel resulted in waxing under cold conditions
- ▶ Limited knowledge of boiler fuel/control system resulted in repetitive use of reset function
- ▶ Failure of burner locking arrangement

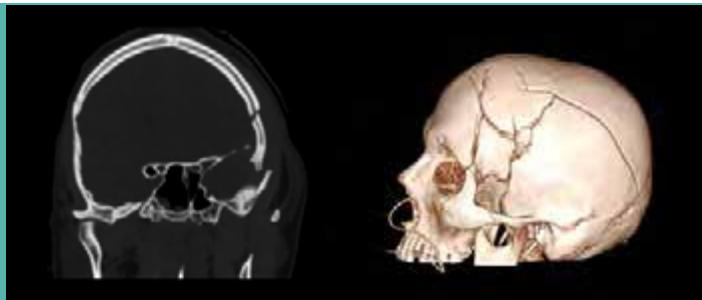
- ▶ Guiding-on pole for trawl net failed under transverse load
- ▶ Crewman was standing in hazardous area

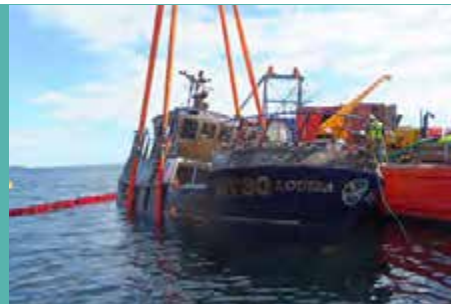
### Foundering while at anchor off the Isle of Mingulay in the Outer Hebrides resulting in three fatalities

- ▶ Crew fatigued from working excessive hours
- ▶ Out-of-date lifesaving appliances
- ▶ Deficient liferaft maintenance
- ▶ Abandon ship lifejackets failed to keep the unconscious crews' faces clear of the water

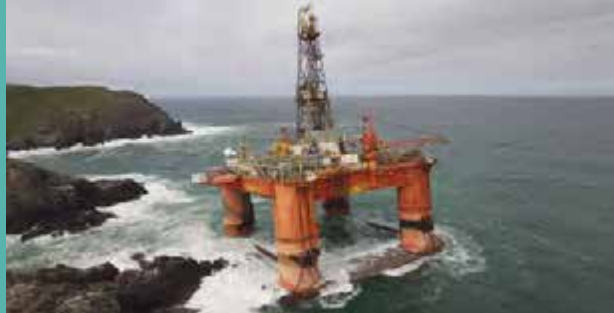
## Grounding of *Transocean Winner* following the loss of tow from *ALP Forward* on the Isle of Lewis

- ▶ Inadequate allowance for weather during planning stages
- ▶ Effects of wind on rig not assessed during planning stages
- ▶ Length, load and catenary of tow line inadequately managed

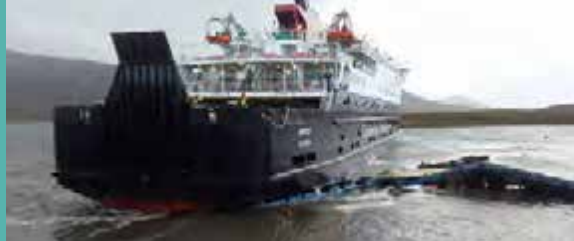
## Loss of control and grounding of ro-ro passenger ferry at Lochmaddy, North Uist

- ▶ Machine service instructions not available to staff and not followed during routine maintenance
