## Grounding of the general cargo vessel *Ruyter* Rathlin Island, UK 10 October 2017

### SUMMARY

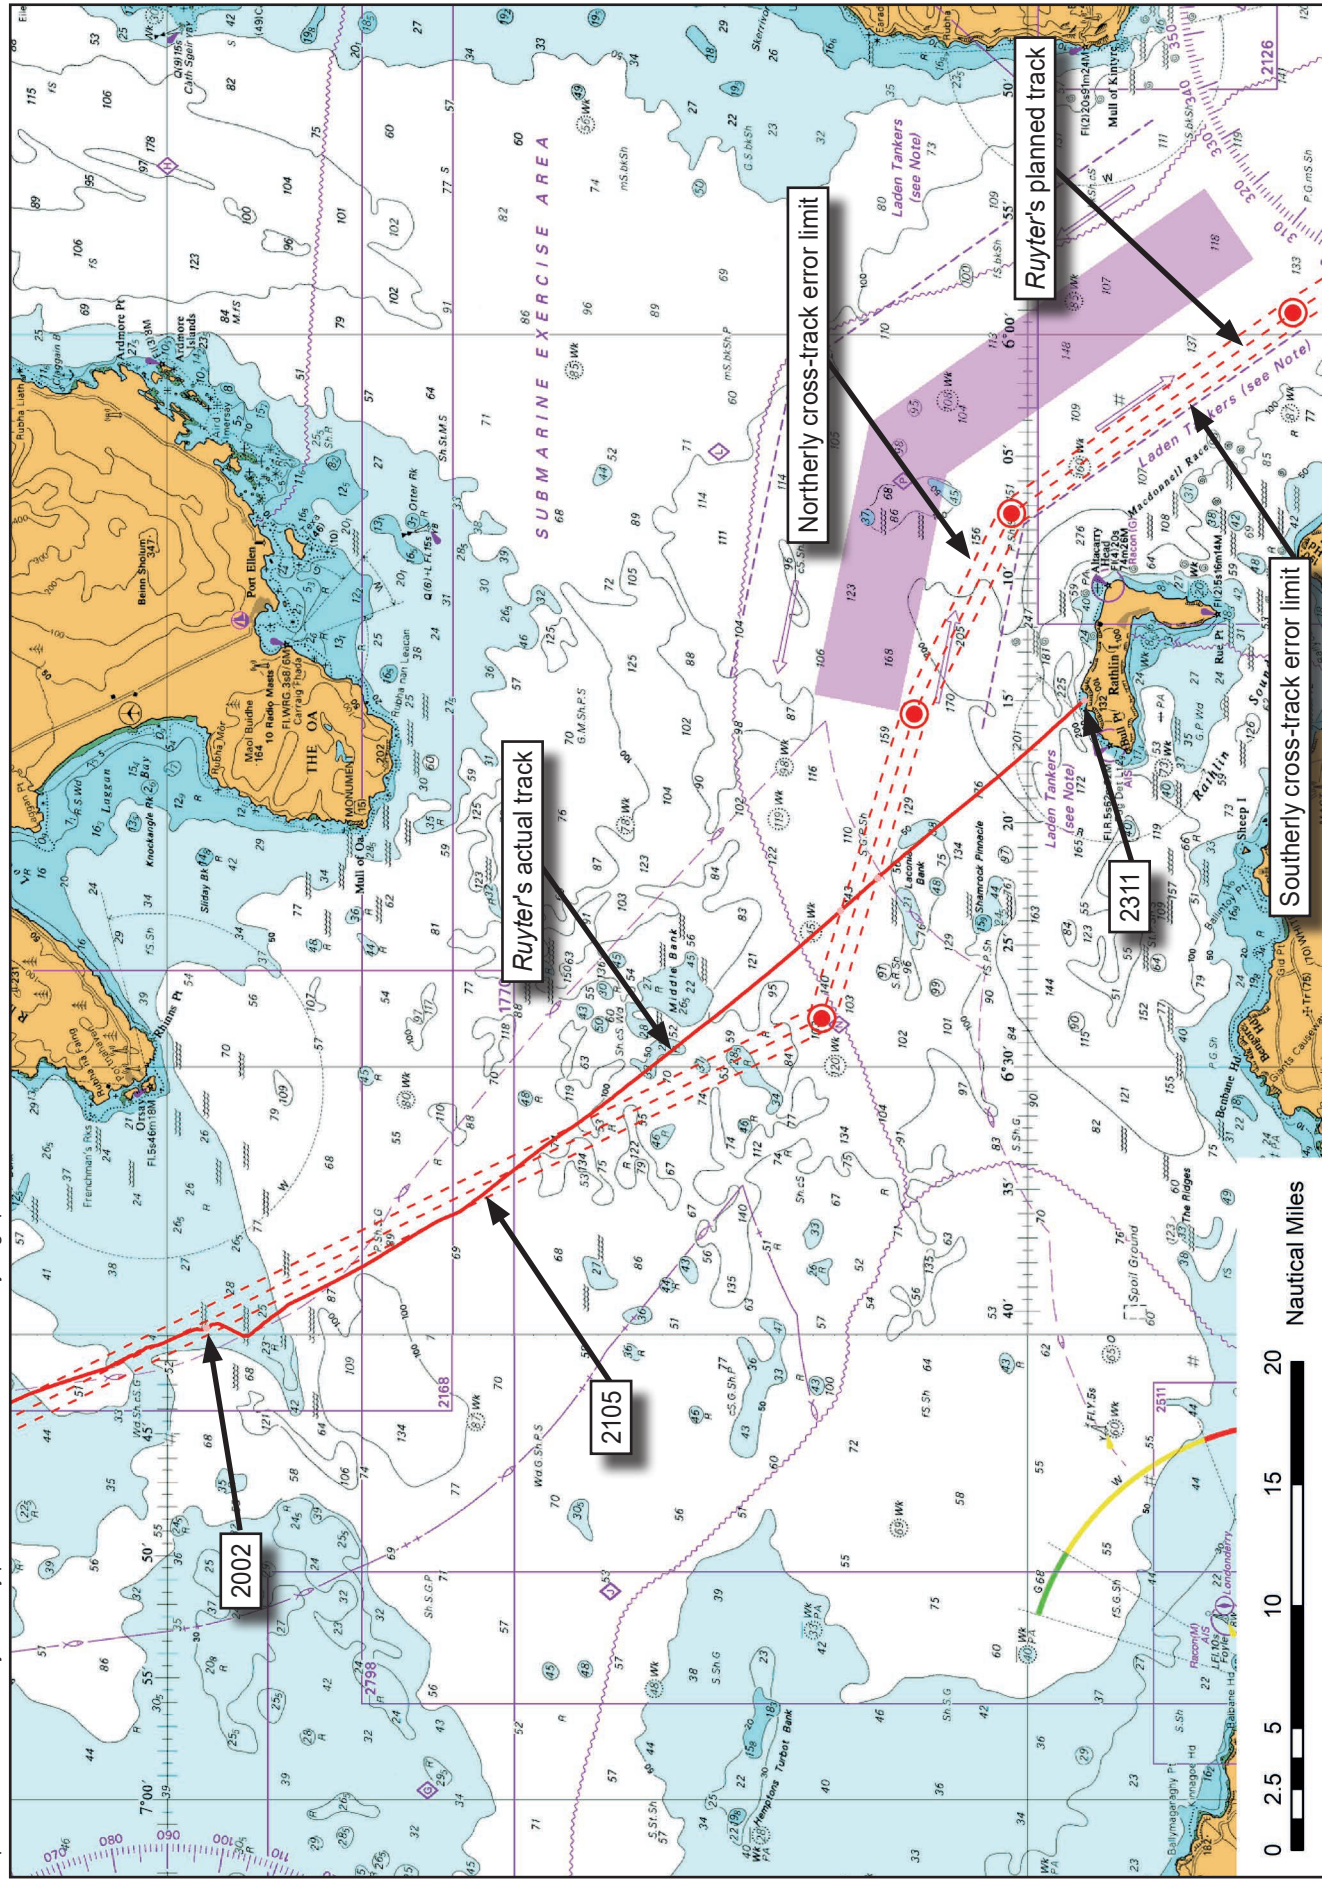
Figure 1: Ruyter's planned and actual tracks

The investigation found that *Ruyter* grounded because no action had been taken to correct a deviation from the ship's planned track. The master, who was the sole watchkeeper, had left the bridge, and the bridge navigational watch alarm system, which could have alerted the chief officer to the fact that the bridge was unmanned, had been switched off.

Shortly before 2000, *Ruyter* was 5.5nm to the west of Orsay, Isle of Islay, and making a course over the ground (COG) of 162° at a SOG of 4.9 knots (**Figure 1**). The master returned to the bridge for his designated 2000 to 2400 watch. Again, the chief officer smelled alcohol on the master's breath but remained satisfied that the master was fit for watchkeeping duties. After briefing the master on the local traffic situation and handing over the watch to him, the chief officer went below, leaving the master alone on the bridge.

At 2105, *Ruyter*'s master set the autopilot to steer 145°. The ship then maintained this heading until about 2311, when it ran aground on the north shore of Rathlin Island.
