MARINE SAFETY INVESTIGATION REPORT

Safety investigation into the grounding of the
Maltese registered container ship

Kea Trader

MARINE SAFETY INVESTIGATION REPORT NO. 14/2018

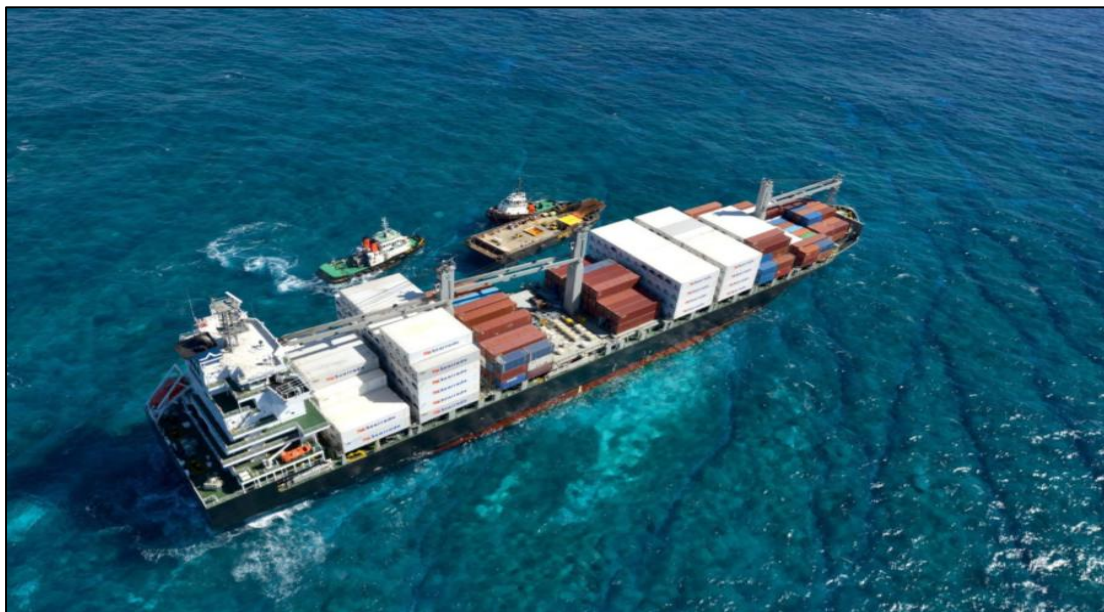
The RPM reading was 101 but the vessel was almost stationary. He set the engine telegraph to stop and re-set the echo sounder, which read between 1.5 m and 2.0 m. The deck lights were switched on and a search light was directed into the water. The visual sightings of the rock under the ship's hull affirmed grounding on *Recif Durand*⁷, in position 22° 02.28' S 168° 38.25' E (Figures 4 and 5).

Figure 4: *Kea Trader* hard aground on *Recif Durand*

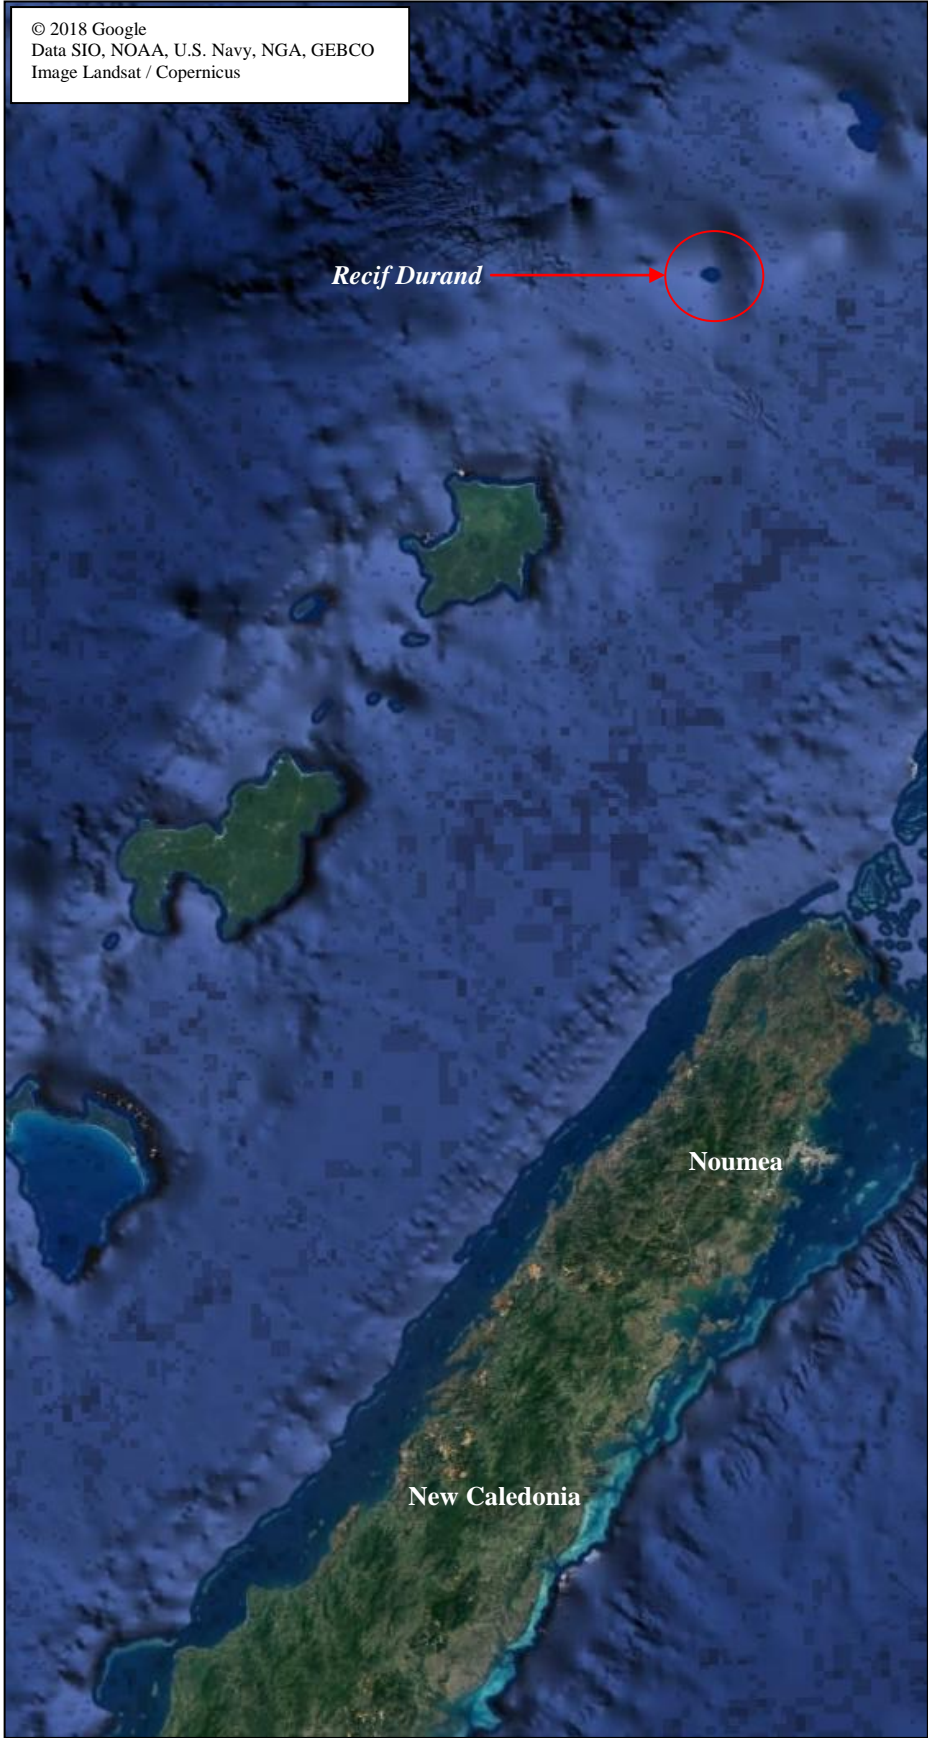
⁷ Admiralty Sailing Directions (NP 61) Pacific Islands Pilot Vol. II describes *Recif Durand* as a dangerous rock, six cables in diameter midway between Ile Walpole and Ile Marie, in position 22° 02' S 168° 57' E.

Figure 5: Location of *Recif Durand*.

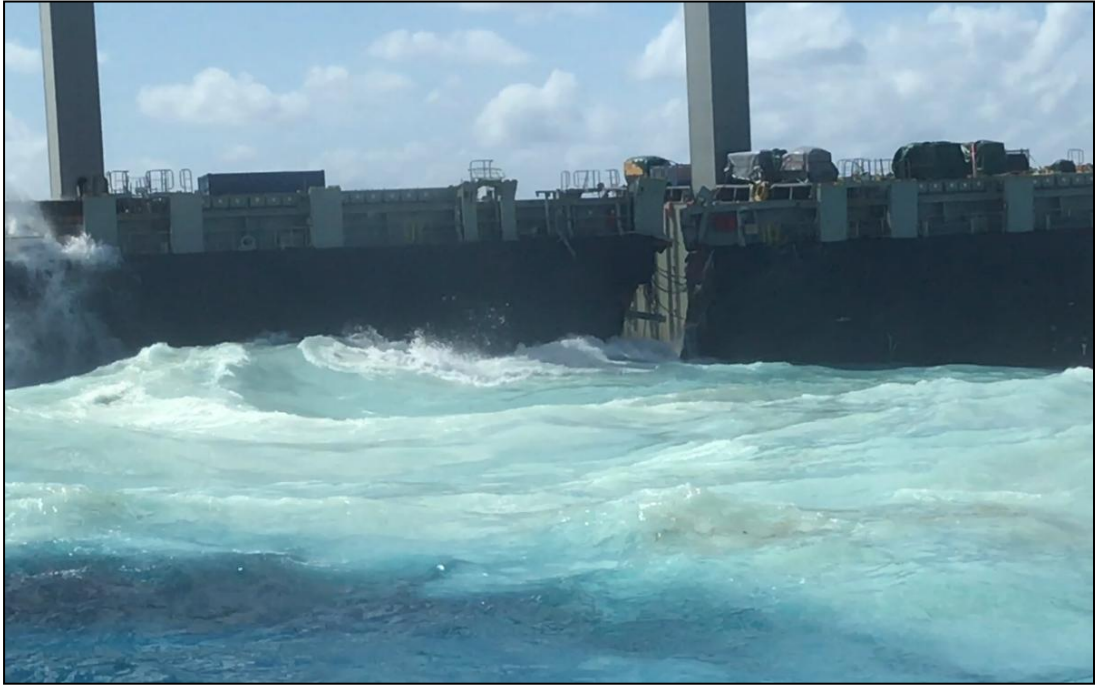
In the afternoon, the starboard shell plating in way of frame 92 fractured, leaving an opening of about 2.5 m and exposing the hull to further breach. On 04 December 2017, *Kea Trader* broke in two, in approximately in way of the same frame (Figure 6). By this time, 674 containers had been air lifted and landed ashore (one container was lost overboard), recovered 207 m³ of slops and 596 m³ of fuel oil.

Figure 6: *Kea Trader*'s structural failure, in way of frame 92

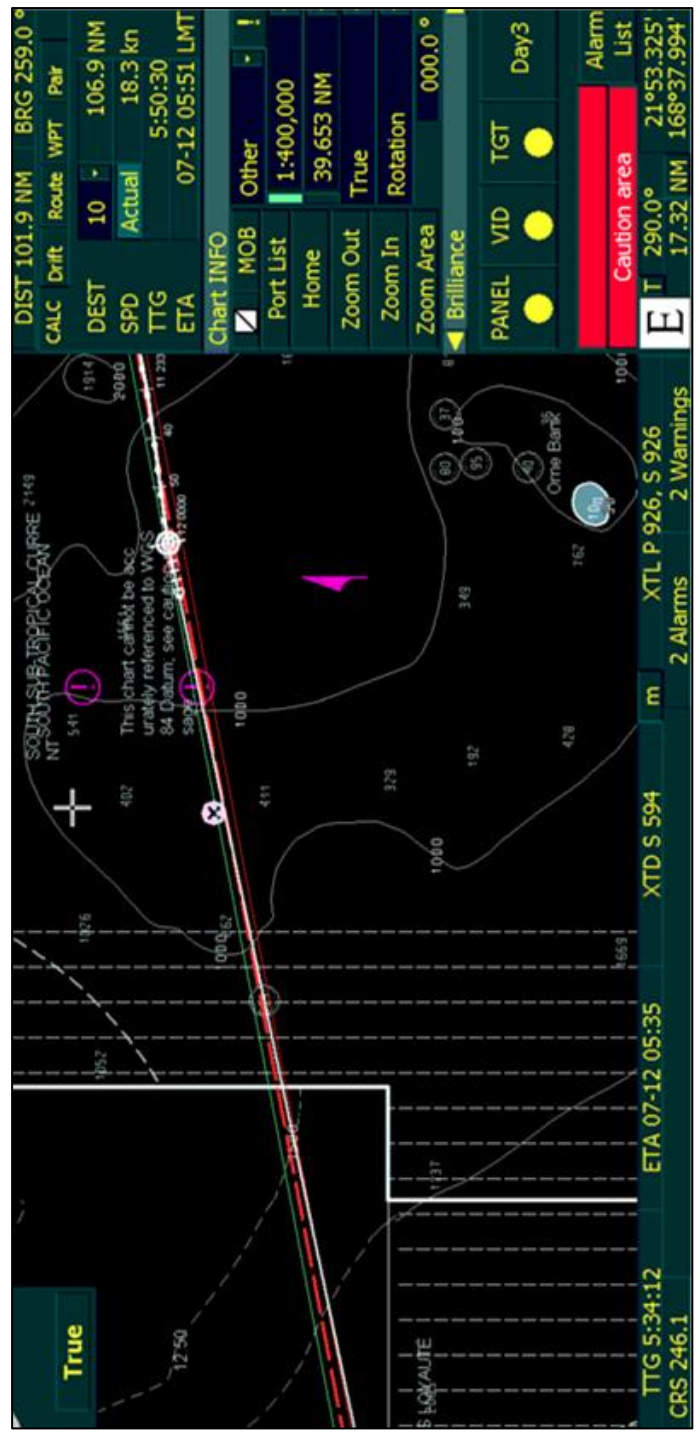
The revised track to Havannah Pilot Station involved an alteration of course from 255° to 259°. The second mate noted an isolated danger symbol and zoomed-in on the relevant section of the chart. He stated that the track passed about 0.6 nm South of the isolated danger symbol and outside of the XTL limit. After finishing the pilotage segment of the passage, he visually checked the track and judged it safe for navigation. He amended the Passage Plan Form BOF-2.1b (**Annex 3**) and left it on the chart table for the master and OOW to take note of the revised passage to Noumea.

Figure 7: Reconstruction of ECDIS image (scale 1:400,000) showing the revised track, starboard XTL and isolated danger symbol

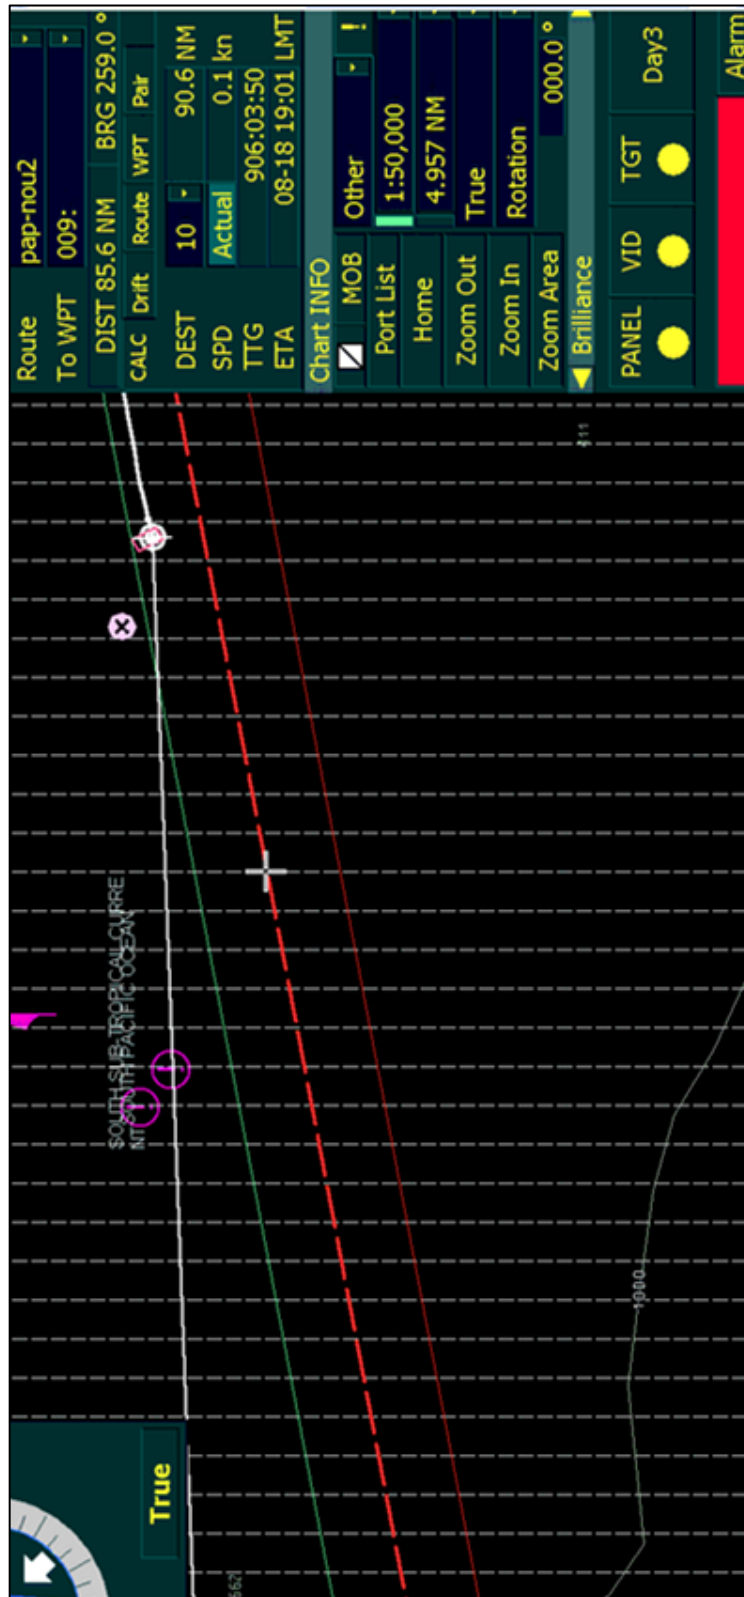
The second mate's observation of the isolated danger symbol appearing outside the starboard XTL due to zooming-in and possibly over-scaling the ECDIS display, led to the incorrect assumption of safe water within the XTL corridor (Figure 8).

Figure 8: Reconstruction of ECDIS image - scale 1:50,000 after the grounding, showing the isolated danger symbol outside starboard XTL

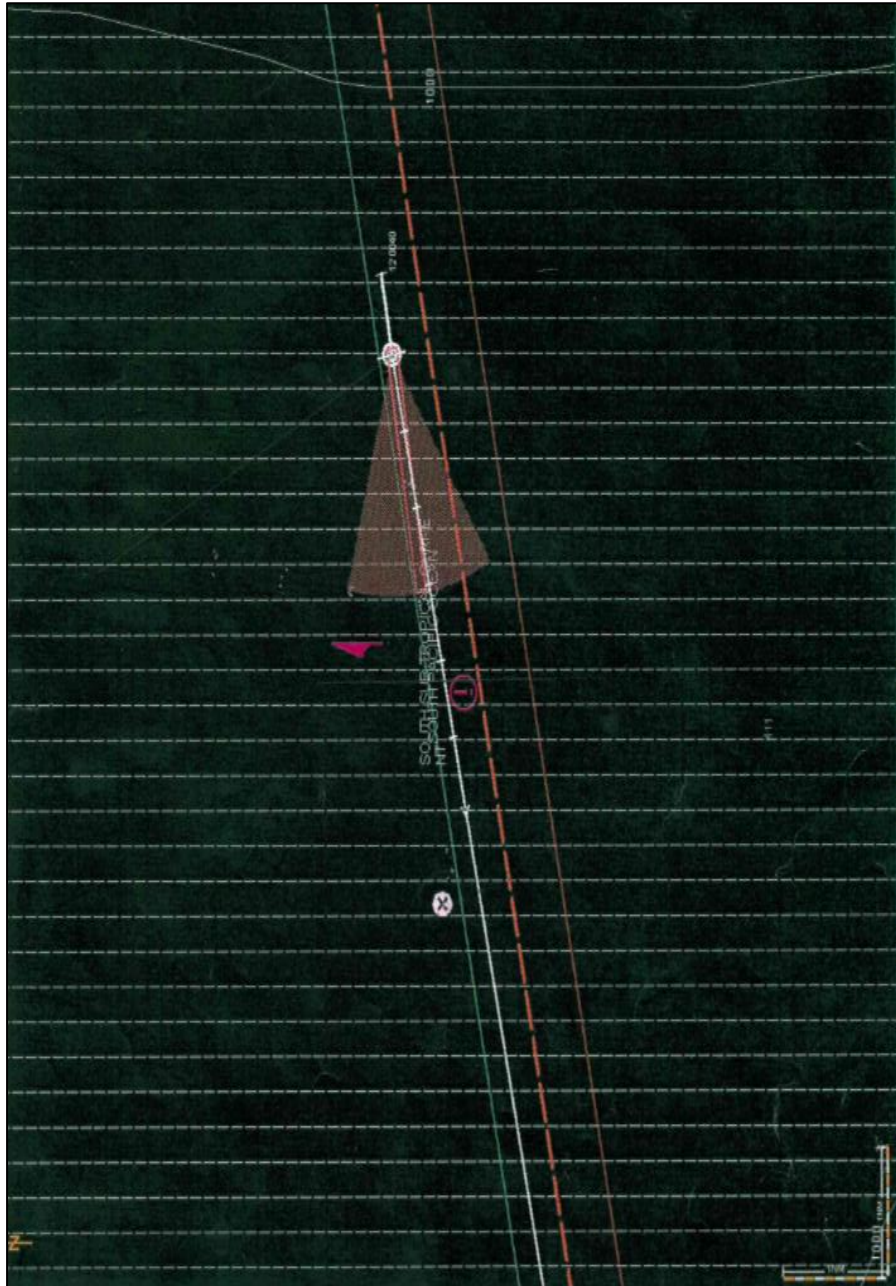
A review of ECDIS data submitted to the MSIU, showed that the detection vector had a width of 0.1 nm and 1.9 nm ahead and the detection sector was set at 45° over the same distance (Figure 9), effectively giving the OOW just about six minutes to

respond to the safety alarm. These readings were measured using the scale in Figure 9. It is evident that the look-ahead settings are not in accordance with the parameters noted in the safety card.

Figure 9: Reconstruction ECDIS image showing safety frame detection vector and detection sector

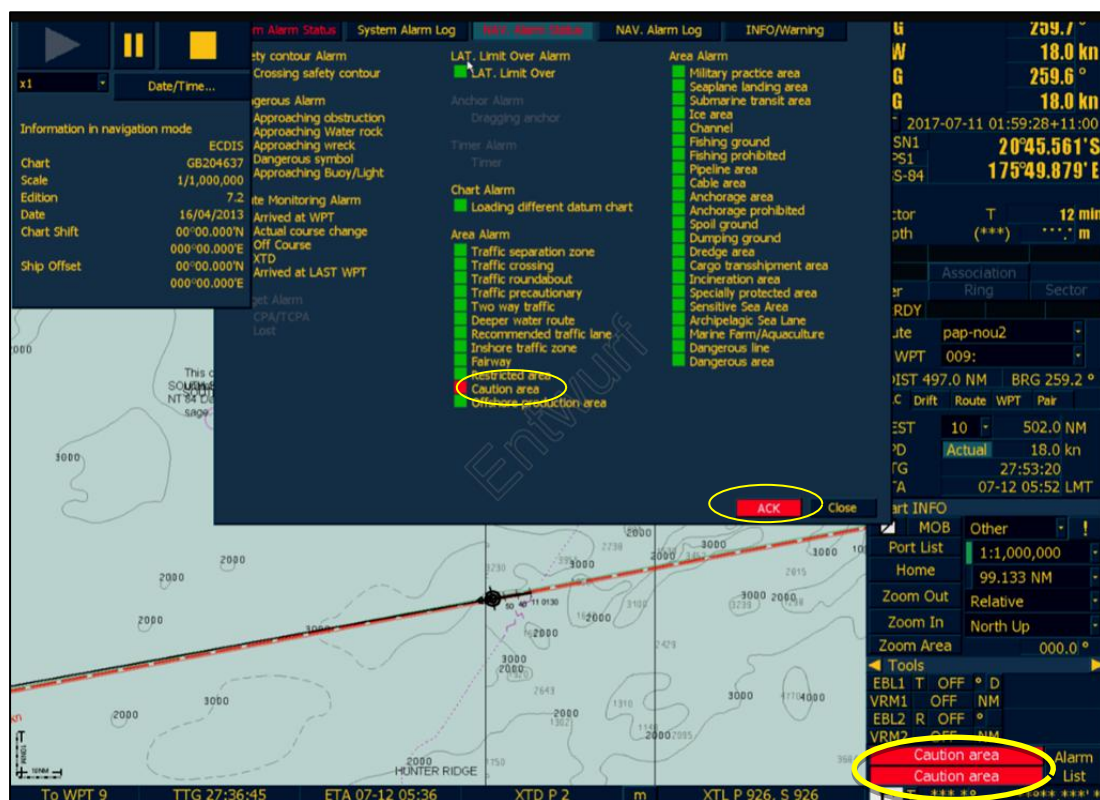
At 0159 on 11 July 2017, roughly 23 hours before the grounding, an alarm displaying 'caution area' was activated (Figure 10). At that time, *Kea Trader* entered the chart display area of ENC GB204637. The object category of zone of confidence of the ENC was two stars and the alarm was a forewarning to the bridge team to exercise caution using or navigating on this chart.

Figure 10: Reconstruction of ECDIS image showing caution area alarm

However, no evidence was found of the associated symbol being either interrogated or the navigational significance of the caution area alarm understood. The ‘caution area’ message repeatedly displayed in the subsequent navigational watches was largely overlooked by the bridge team.

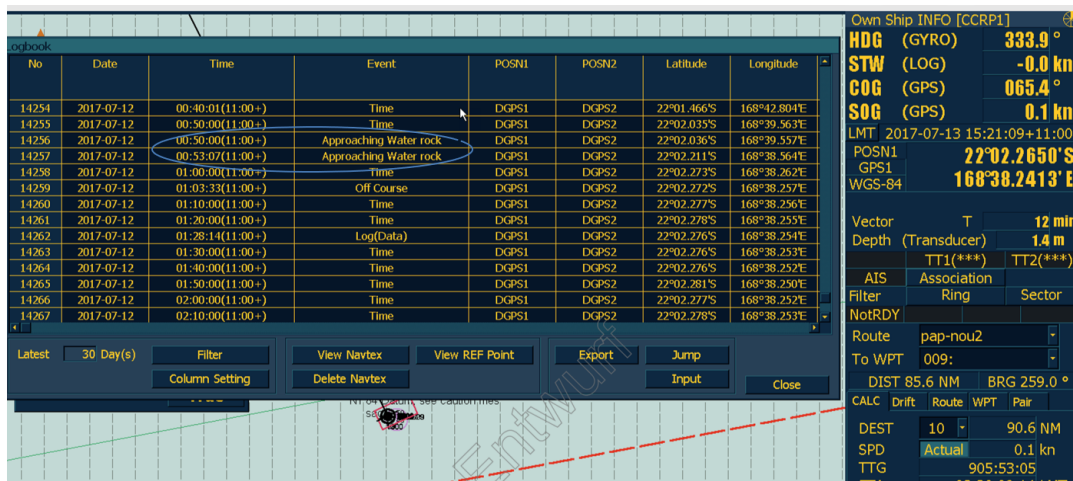
During the course of analysing ECDIS replay, the safety investigation noted the ECDIS system had logged ‘approaching rock’ at 0050 and again at 0053 (Figure 11). However, no evidence of the safety alarm - crossing safety contour, approaching underwater rock / obstruction / wreck or dangerous symbol – was found displayed on the ECDIS to either alert or indicate to the OOW / lookout of imminent danger of grounding.

Figure 11: ECDIS log file showing ‘Approaching Water Rock’ at 0050 and 0053/07 s
