## Catastrophic engine failure, resulting in a fire and serious injuries to the engineer on board *Wight Sky*, off Yarmouth 12 September 2017

### SUMMARY

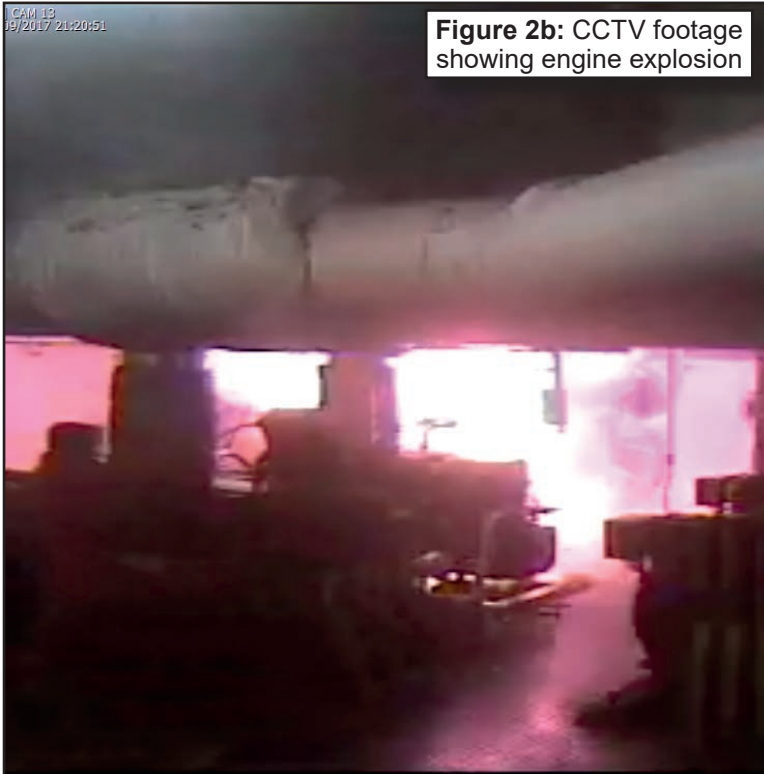
**Figure 2b:** CCTV footage showing engine explosion

At around 2130, the engineer went down to the forward engine room from the machinery monitoring room (MMR), located on the main vehicle deck immediately above, to note the machinery running parameters for the logbook. He saw that the high temperature cooling water header tank for ME2 required topping up and, while he was filling the tank with coolant, he heard an unusually loud sound from the engine. The mechanic was attending to main propulsion engine 1 (ME1) located in the same space (**Figure 2a**). At 2133:51, as the engineer rushed towards ME2’s emergency shutdown button, there was a loud explosion from its crankcase (**Figure 2b**).

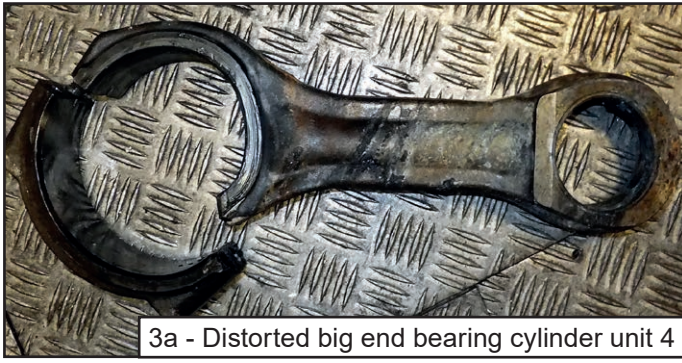
3a - Distorted big end bearing cylinder unit 4

Most of the visible damage was observed in and around cylinder unit 4 of ME2. The big end bearing was distorted radially (**Figure 3a**), white metal had melted onto the bearing pin on the crankshaft (**Figure 3b**) and two of the four big end bearing bolts had sheared at the joining face between the top and bottom halves of the bearing keep. The outboard side of the crankcase was punctured (**Figure 3c**), creating a large opening through which several components, including the gudgeon pin, connecting rod and fragments of the piston and cylinder liner had been ejected. There was fire damage on and around the engine (**Figure 3d**).

The investigation report by Volvo Penta concluded that, when the shells for main bearing 5 turned, they blocked the lubricating oil channel on the main journal leading from the journal to cylinder unit 4's crank pin. This caused the big end bearing to seize on the crank pin, leading to the failure of the bearing bolts. The rotating crankshaft then hit the unrestrained connecting rod, which impacted against the side of the crankcase, puncturing it and breaking the piston cooling oil gallery.

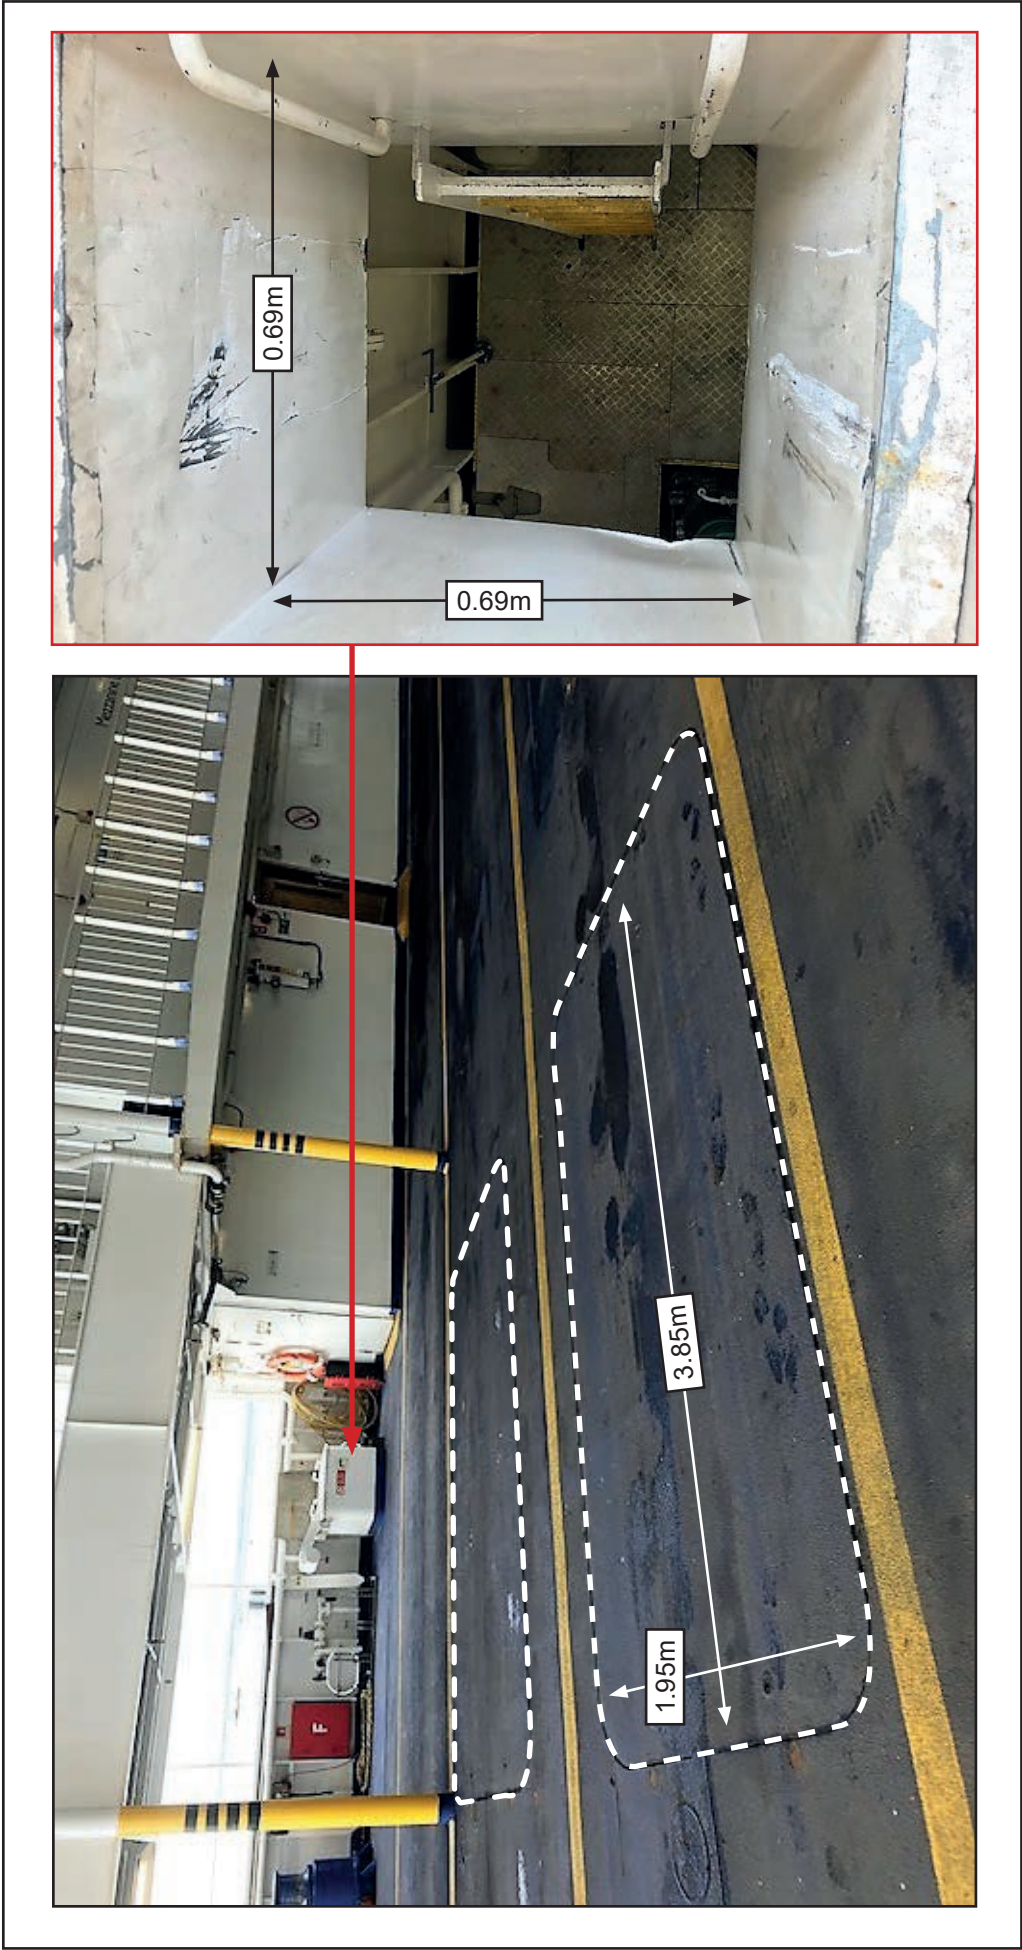
Figure 5: Soft patch and escape hatch

All of *Wight Sky*'s four main propulsion engines had a 'soft patch' in the deckhead directly above them that could be removed to permit the removal and replacement of complete engines (**Figure 5**). Each opening was 3.85m by 1.95m and was closed with a steel plate bolted down and sealed flush with the vehicle deck. At the deckhead level in the engine room, the soft patch was insulated and covered over with cladding plates held in place by pop rivets. Opening the soft patch involved the removal of several items associated with the engine, including a large section of exhaust pipe, crankcase breather, engine lifting beam and several brackets supporting the pipes.

The soft patches were not used to move the engines in or out of the engine rooms due to the disruption their removal would cause. Therefore, RKM planned its work around the use of the emergency hatch. This required the engines to be partially disassembled and rebuilt in the engine room, transporting the majority of the components in the short block.

The source of any debris that might have entered the oil channels cannot be known for certain. However, ME2's short block had been exposed to the elements for 3 days with only a loose plastic sheet for protection, and debris could have entered the oil channels during this time.

Rebuilding the entire engine under a clean and controlled environment and transferring it directly into the engine room through the soft patch would have significantly reduced the likelihood of debris ingress during transit and while awaiting fitting.

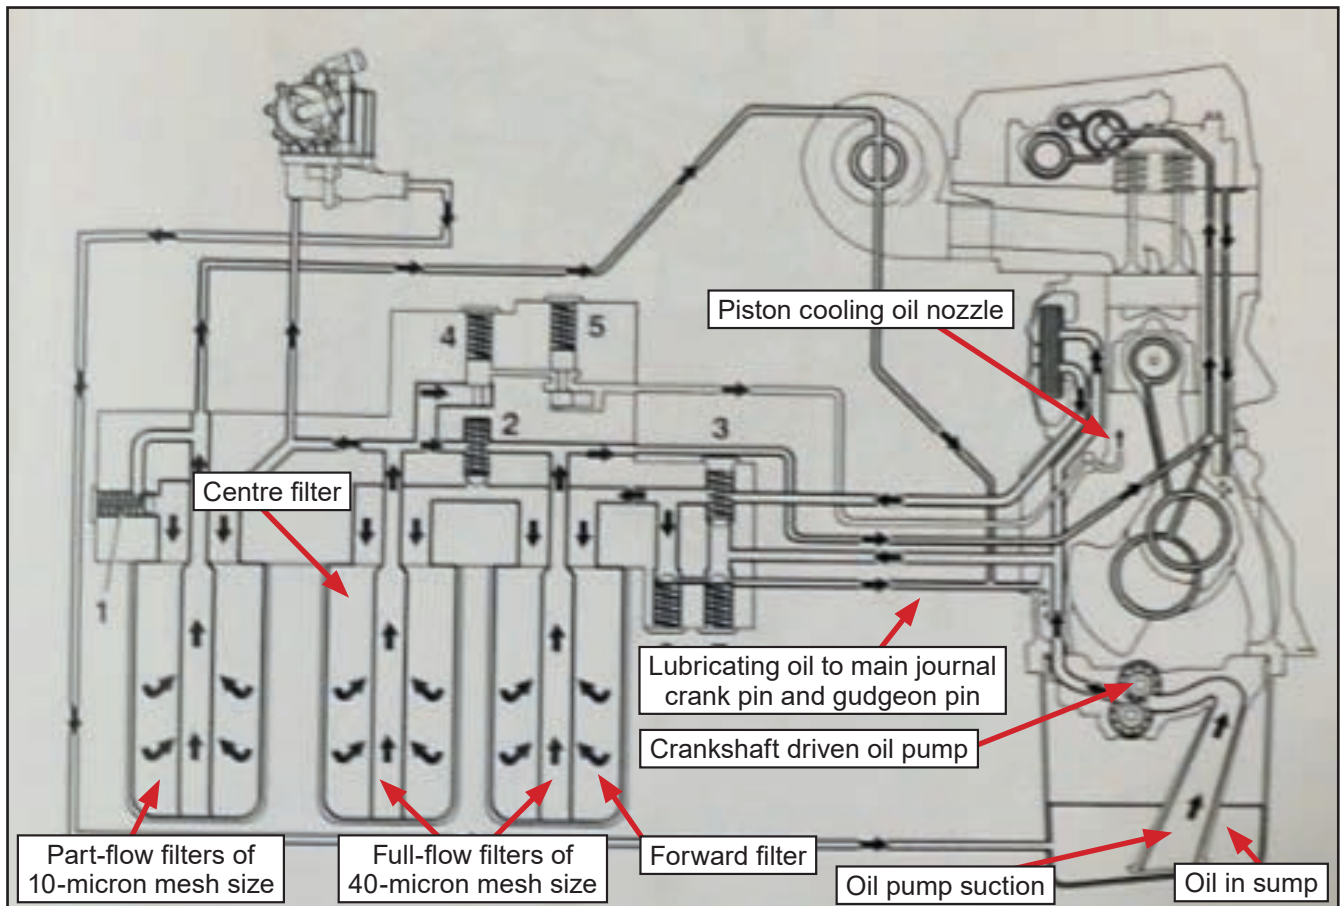
**Figure 6:** Engine lubricating oil system

The lubrication system (**Figure 6**) consisted of a crankshaft-driven oil pump, which delivered the sump oil through two full flow filters of 40-micron mesh size and a third, part-flow filter of 10-micron mesh size. The total quantity of lubricating oil was 55 litres. An oil channel along the inboard side of the engine block conveyed the lubricating oil to the main bearings. From the main bearing the oil was fed to the big end bearing immediately forward of it through a drilled channel. Piston cooling and lubrication oil was carried through a separate channel on the outboard side of the block.

The forward and centre filter (**Figure 6**), along with oil samples from forward filter housing and the engine sump were analysed independently for their physical and chemical characteristics and accumulated wear particles.

The presence of a high number of particles larger than 10 microns as indicated by a high PQ index (**Table 1**), combined with a low count of small iron particles in the oil sample from the forward filter, suggests a sudden and rapidly progressing wear-down. The unusually large wear particles in the filters, some of which were larger than 1mm, also implies that accelerated wear had started before developing into a catastrophic failure. This wear-down probably started before the main bearing shells turned, since the total starvation of oil supply would have resulted in nearly instant seizing of the big end bearing, giving insufficient time for the wear particles to find their way to the filter. Therefore, the wear particles exhibiting heat damage were most likely to have been from main bearing 5, generated before the bearing shells turned.

It is evident from the alarm logs that the lubricating pressure shutdown was activated a few seconds before the explosion. By that time, the damage had already been done. As the engine was not fitted with a particle detector or other means of detecting rapidly progressing wear, there was no possibility of receiving an early warning before the engine failed. The previous accident on *Windcat 8* and other failures on sister vessels of *Wight Sky* could also have potentially been prevented had a particle detector system been fitted.

**2018/120** Consider offering wear particle detection technology for Volvo Penta marine engines that cannot be easily serviced on board.

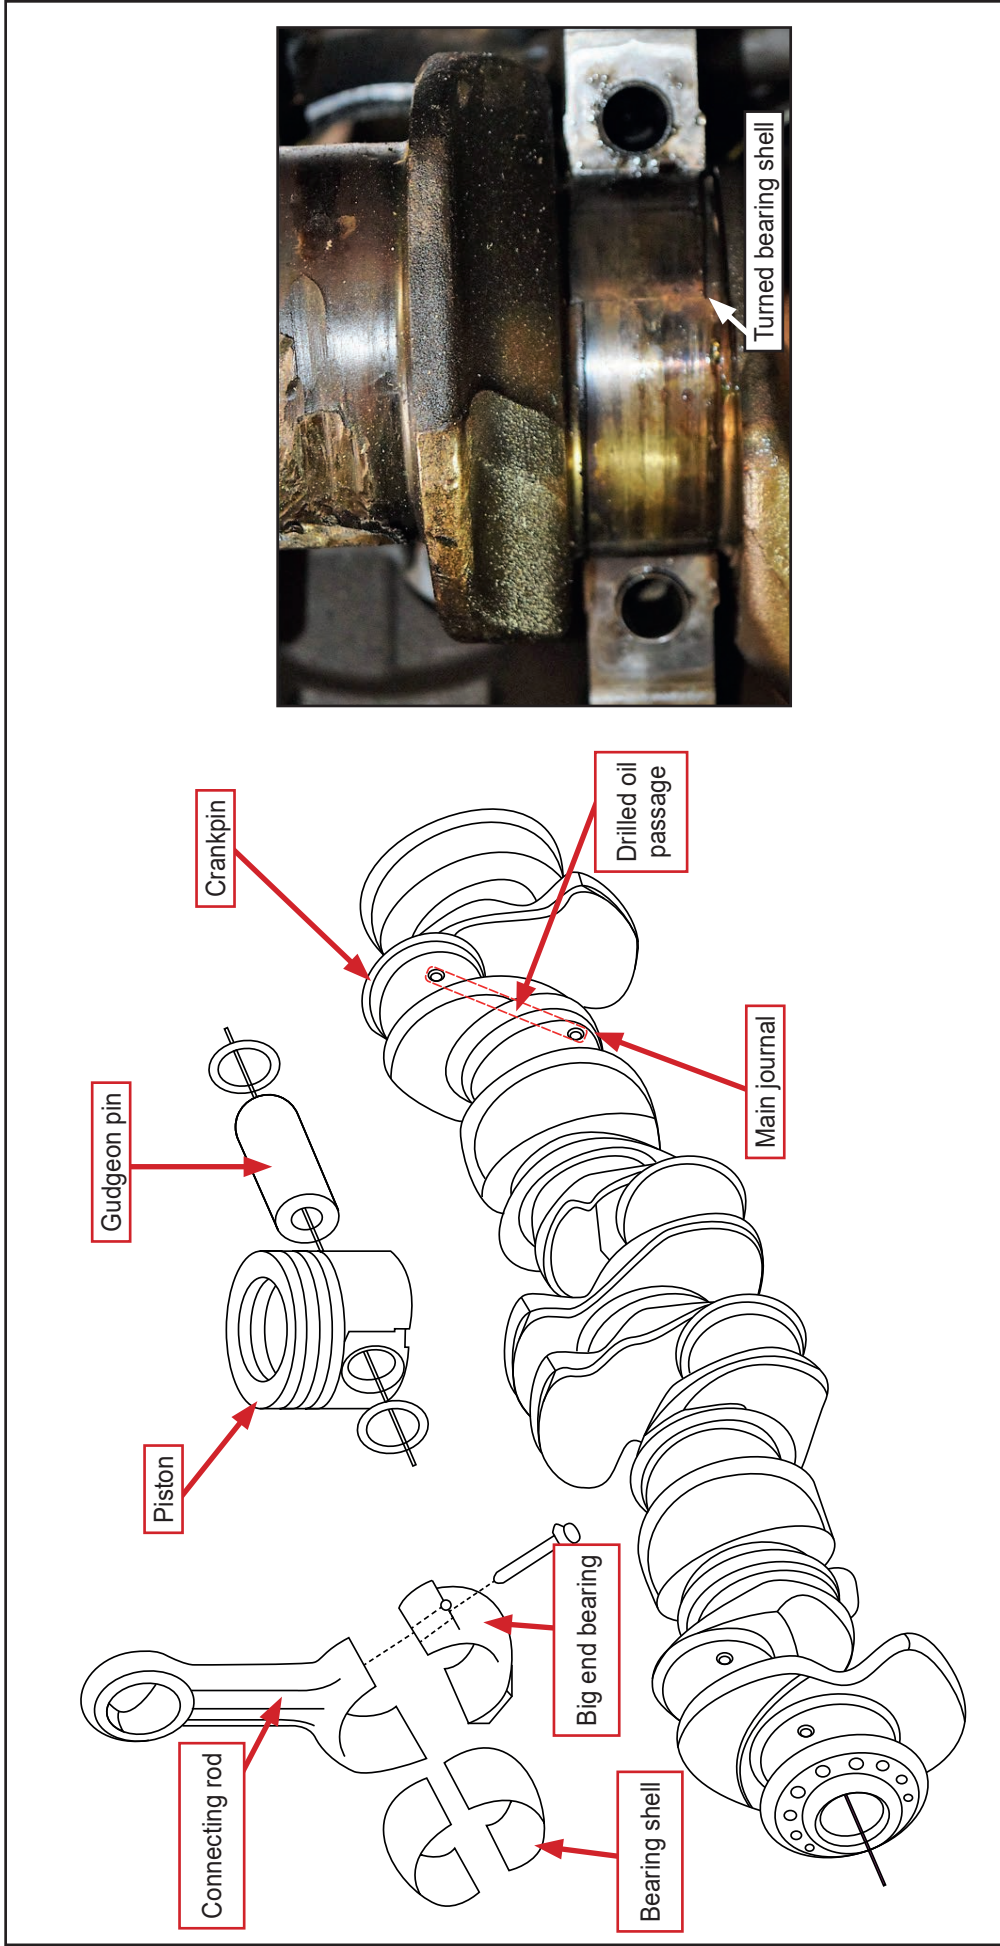
Figure 7: Schematic of crankshaft assembly

Volvo Penta's finding, that debris in the oil channels was the likely cause of the bearing shells turning, was not supported by direct evidence, such as embedded debris in the shells. However, debris of significant hardness and size, if lodged between the main bearing and crankshaft journal, has the potential to disrupt the hydrodynamic lubrication, resulting in metal to metal contact. This would be rapidly followed by the bearing shells turning, blocking the oil supply to the big end bearing, which then resulted in its failure.
