Grounding of the landing craft *Lauren Hansen*

Cape Keith, Melville Island, Northern Territory, 11 April 2018

ATSB Transport Safety Report
Marine Occurrence Investigation
342-MO-2018-005
Final – 5 October 2018

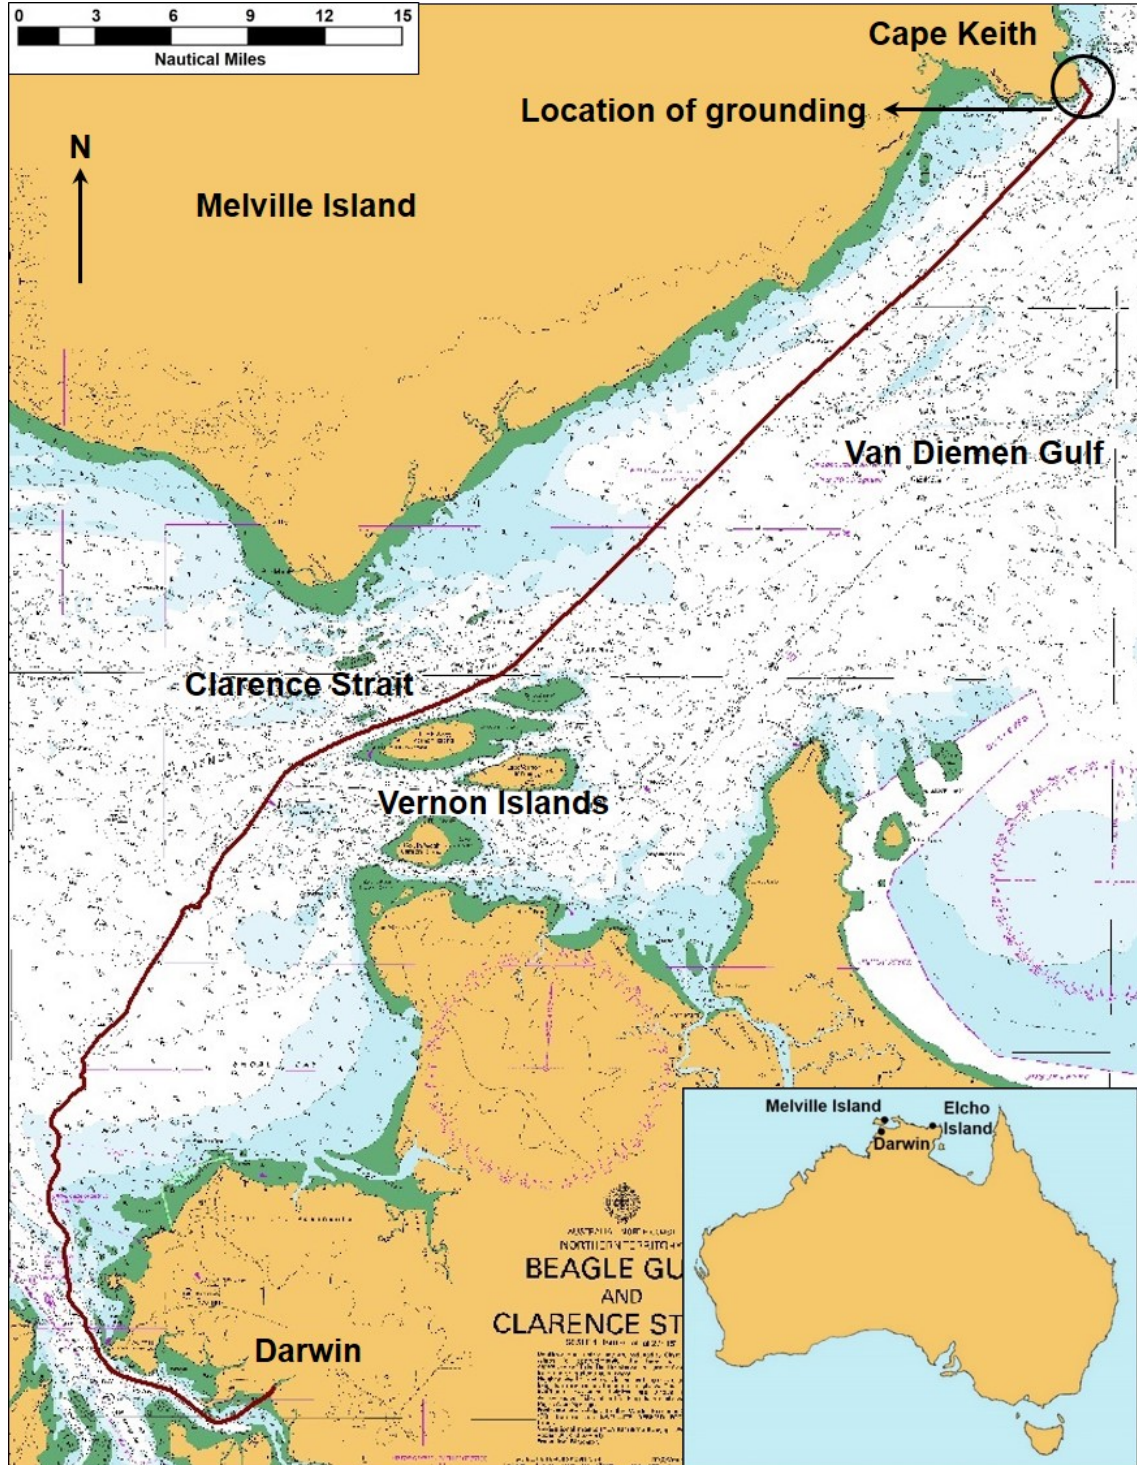
Figure 1: Lauren Hansen's track and location of grounding

At some time between 0213 and 0218, the ship commenced an unexpected turn to port, towards land, without any alarms or indications. Shortly after, the chief mate, who was monitoring the chart plotter³ and radar, noticed that the ship had started to turn to port. He reduced power on both main engines and attempted to call the master using the bridge telephone. Failing to receive a response using the telephone, the chief mate then left the bridge and went down to the master's cabin, one deck below. He alerted the master to the situation and both then returned to the bridge. As the master and chief mate entered the bridge, they noticed that the ship no longer appeared to be turning but had steadied on a north-westerly heading. At about the same time, *Lauren Hansen* grounded on a shoal about 170 m off the shoreline on Cape Keith, Melville Island (Figure 1). The grounding was logged in the ship's bridge logbook as having occurred at 0230.

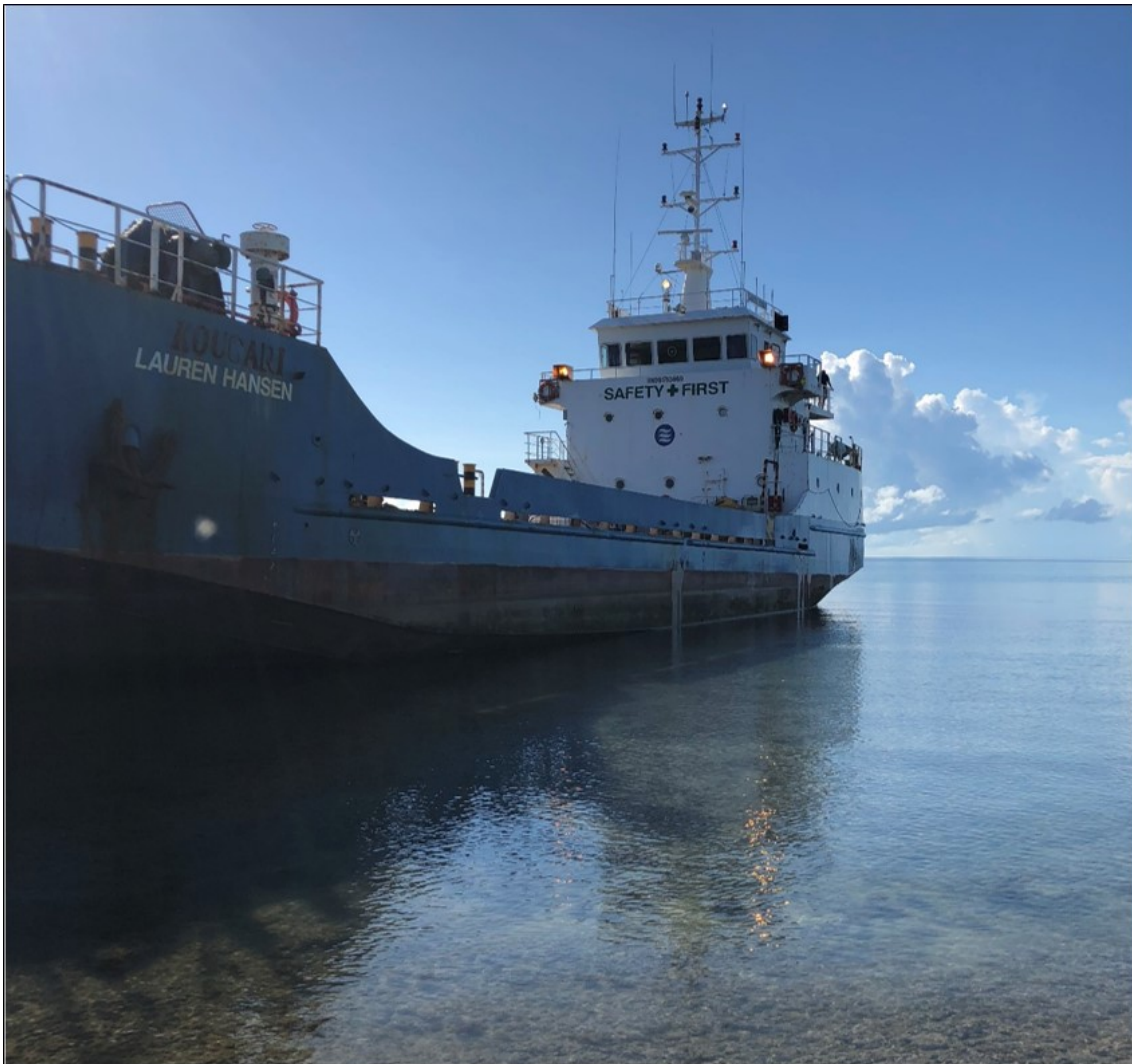
Figure 2: *Lauren Hansen* aground off Cape Keith

As the tide ebbed, the ship remained aground in an upright position with the propellers and rudders relatively unaffected in deeper water at the ship's stern (Figure 2). The crew continued to sound the ship's tanks and bilges on a 2-hour basis throughout the duration of the grounding.

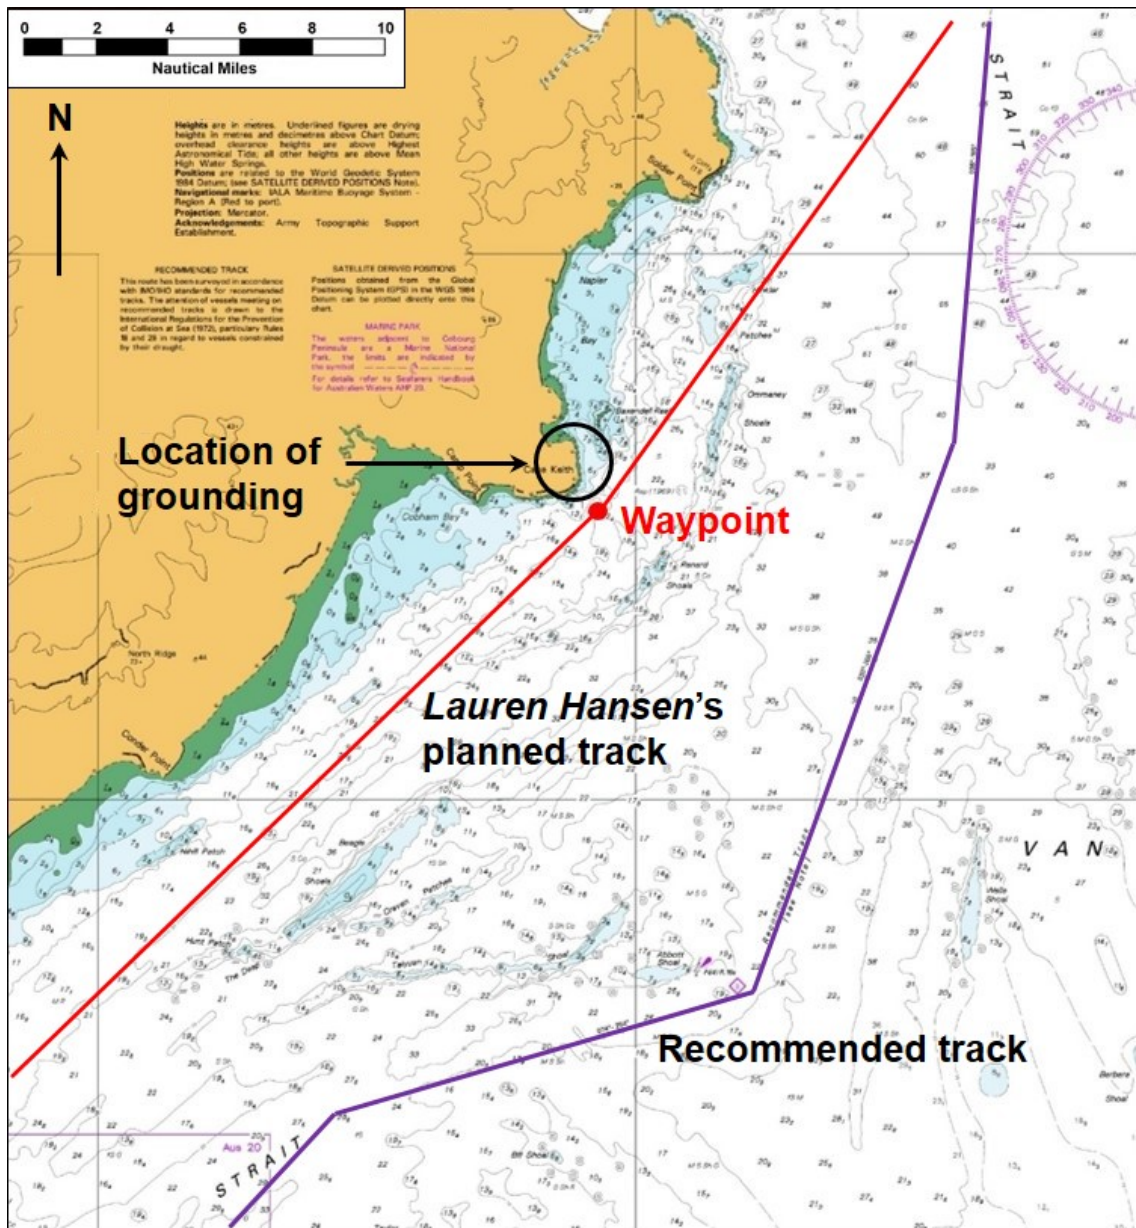
Figure 3: Section of navigational chart Aus 720 showing *Lauren Hansen's* planned track (in red) and the recommended track (in purple)

Lauren Hansen's passage plan for the voyage comprised a route that passed north of the Vernon Islands through the Clarence Strait and thence north-easterly through the Van Diemen Gulf. The planned route took the ship close to the coast of Melville Island with a waypoint laid about 0.9 NM off land in the vicinity of Cape Keith (Figure 3). Navigational charts for the area included a recommended track further to the east in more open waters but it was not used. The ship's master indicated that, generally, passages through the Van Diemen Gulf were laid close inshore off the coast of Melville Island and that this route had proved to be safe and reliable in the past. He also stated that the chart's recommended track was not used as experience had shown that the southern section, passing south of the Vernon Islands (see Figure 1), was subject to strong and at times, unpredictable, tidal influences.

- The decision to execute the planned route, which passed close to land, rather than a route in more open waters similar to the chart's recommended track through the Van Diemen Gulf, increased the risk of a grounding particularly when the unreliability of the autopilot was a known factor.
- *Lauren Hansen* experienced an unexpected turn to port while on passage in autopilot steering mode. The ship's manual or emergency steering modes were not engaged or utilised and the ship subsequently grounded.
- The unexpected turn to port was most likely the result of an intermittent fault in the ship's autopilot unit or in the compass top sensor unit that fed heading information to the autopilot unit.
- There was no compass deviation book maintained on board *Lauren Hansen* as required by Australian Maritime Safety Authority regulations.

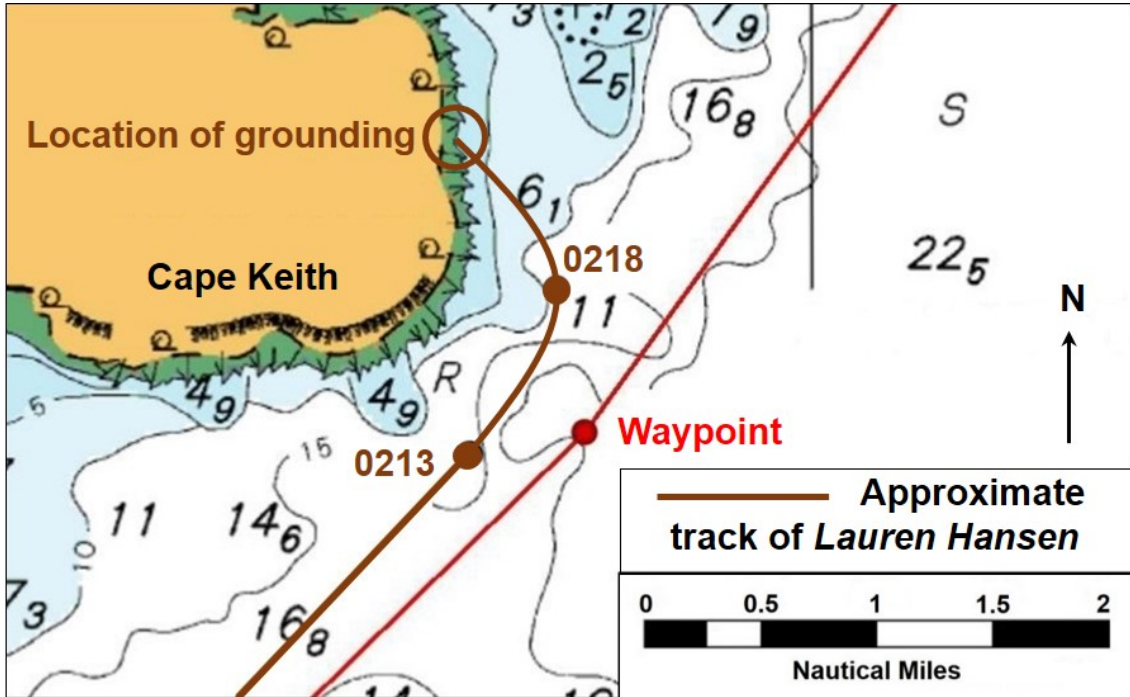
Figure 4: Section of navigational chart Aus 720 showing *Lauren Hansen's* approximate track with AIS derived positions (in brown)

Furthermore, AIS data indicated that *Lauren Hansen* was probably about 0.3 NM to port of the planned route and therefore, about 0.6 NM off land at about 0213, when the course alteration was performed (Figure 4).

As *Lauren Hansen* approached the waypoint off Cape Keith, the AIS data indicated that the ship was likely about 0.3 NM to port of the planned route. The chief mate, who was on watch, then successfully executed a course alteration to port using the autopilot and continued to monitor the ship's progress on the chart plotter and radar. Shortly after the course alteration, with the ship less than 1 NM off land, the chief mate reported observing the ship turn unexpectedly to port towards shallow water and land. The chief mate then reduced power on the ship's engines to slow the ship's progress towards land and attempted to alert the master for assistance. A changeover to either manual or emergency steering at this time would have enabled the chief mate to reassert control over the ship's steering system and direct the ship away from land. Leaving the autopilot

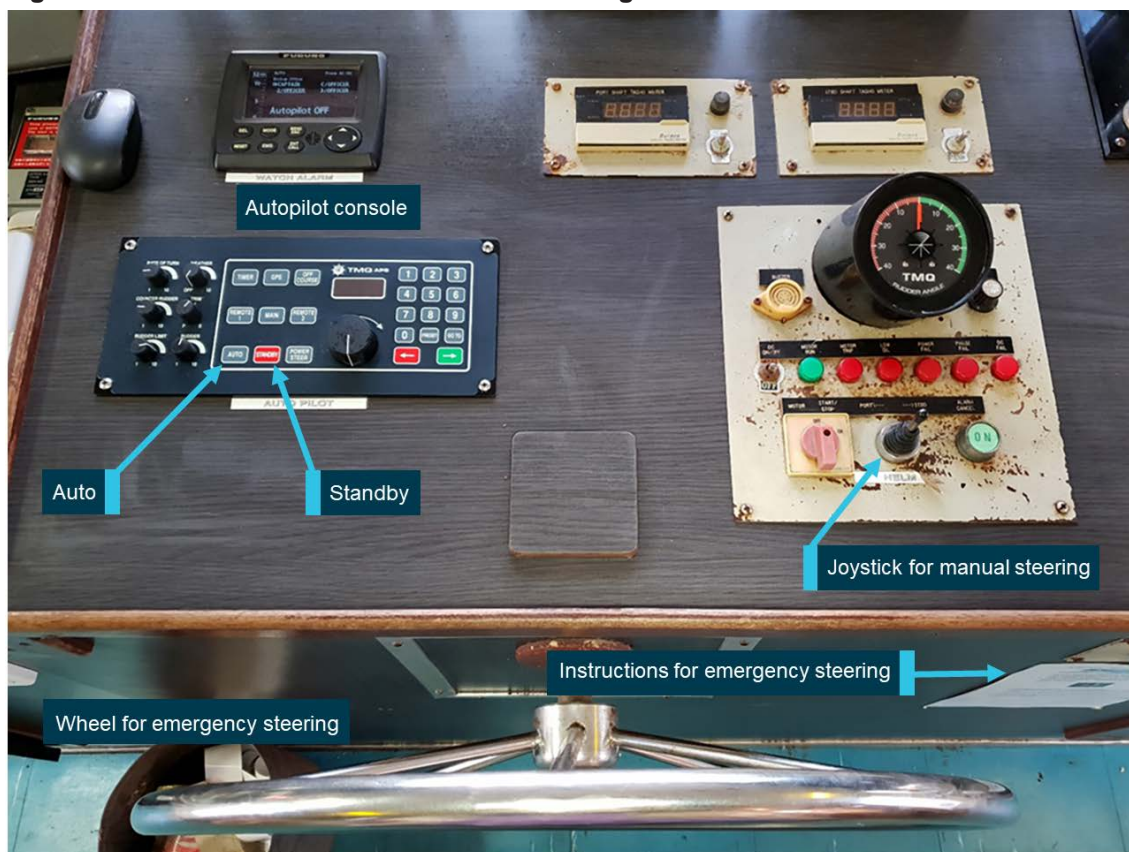
Figure 5: Helm console on *Lauren Hansen's* bridge

On *Lauren Hansen's* bridge, there were three primary modes of steering—autopilot, manual steering and emergency steering (Figure 5).

When turned on during the post-incident technical inspection, the autopilot unit's heading display showed a heading discrepancy between the supplied heading information and the magnetic compass heading at the time. The observed heading discrepancy appeared to be consistent with the previously observed steering deviations. The post-incident technical inspection concluded that the autopilot malfunction was possibly the result of an intermittent fault in either the CTS unit or the autopilot unit itself.

The autopilot unit and compass top sensor were both replaced with new units, with the autopilot now reported to be functioning normally. The ship has since been dry-docked and repairs and replacement of the damaged hull areas have been carried out as recommended by class.
