MARINE SAFETY INVESTIGATION REPORT

Safety investigation into the grounding of the
Maltese registered bulk carrier

MARBELLA

MARINE SAFETY INVESTIGATION REPORT NO. 18/2018

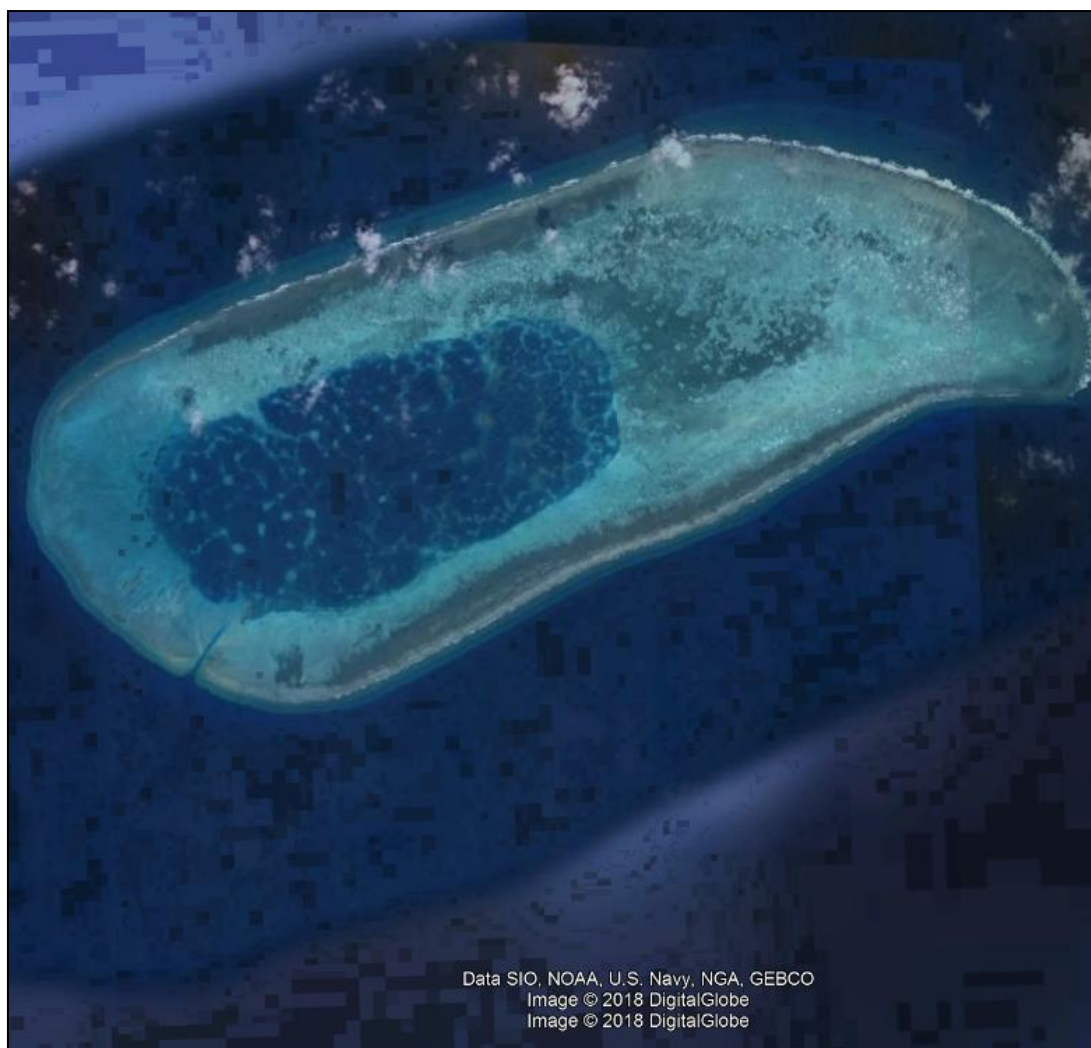
Figure 3: Satellite image of North Reef

North Reef (Figure 3), which is located in position 17° 06' N 111° 30' E in the South China Sea, is approximately 35 miles North and 43 miles West Northwest respectively from the Crescent Group and Amphitrite Group of Paracel Islands. The natural features of the reef are largely submerged and the rocks around the reef are unevenly craggy and barely rise above the water.

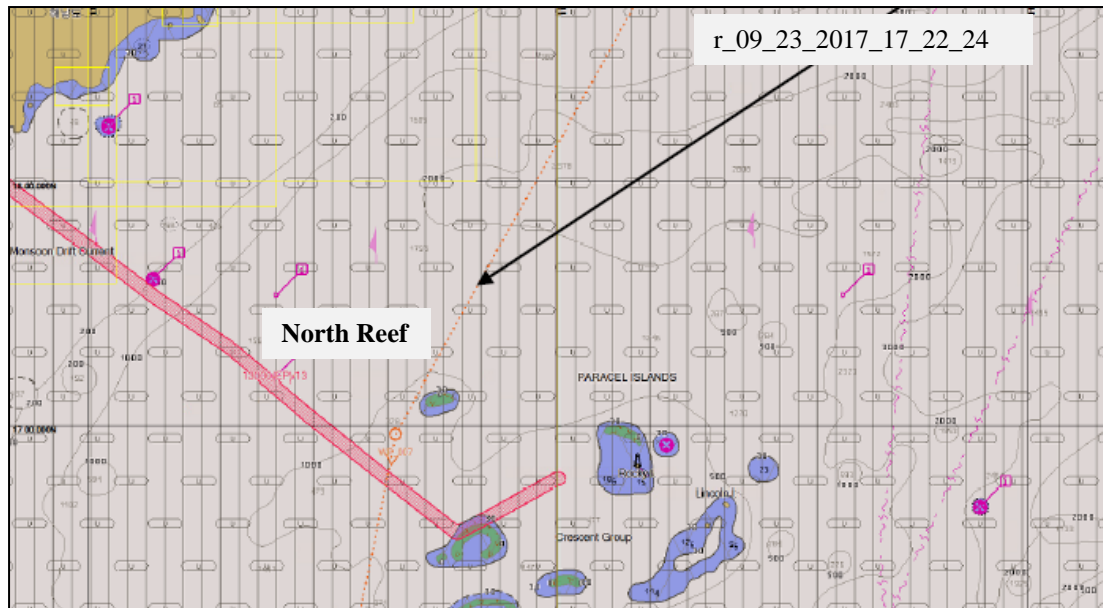
Figure 4: Route between waypoints 6 and 7

At 2350 on 26 September 2017, *Marbella* departed Hong Kong for Tarahan Coal Terminal in Indonesia. She was in ballast and her sailing draft was 4.40 m forward and 7.83 m aft. A route with file name ‘r_09_23_2017_17_22_24’, and which was saved in the active route folder, was uploaded on the ECDIS. A print-out of the route was attached to the voyage plan WF/MRS/534 (**Annex 1**) and approved by the master. According to the plan, North Reef lay to the East of the course, between waypoints 6 and 7 (Figure 4).

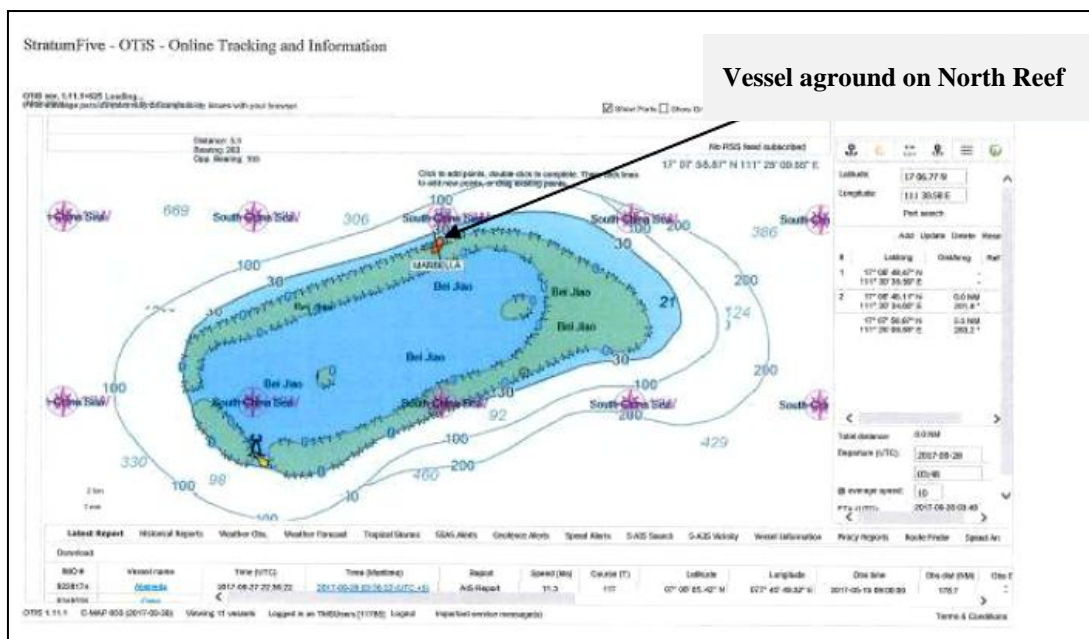
Figure 5: *Marbella* aground on North Reef

At 0327, *Marbella* shuddered to a complete stop as she grounded on North Reef in position 17° 06.80' N 111° 30.62' E. No injuries and pollution were reported but the vessel sustained structural damages in way of her double bottom tanks and bottom shell plating.

At 0327, *Marbella* shuddered to a complete stop as she grounded on North Reef in position 17° 06.80' N 111° 30.62' E (Figure 5).

- Indentation of bottom plates between frame 234 and frame 256 in way of the fore peak tank and water ballast tanks nos. 1 port and starboard including internal structural members;
- Bottom shell plates between frame 217 and frame 234 in way of no. 1 water ballast tank port deformed and between frame 241 and 243 cracked;
- Bottom shell plates longitudinally torn from frame 220 to frame 225; and
- Bottom shell plates from frame 127 to aft section in way of fuel oil tanks nos. 1 and 2 port and starboard were found scratched and slightly indented.

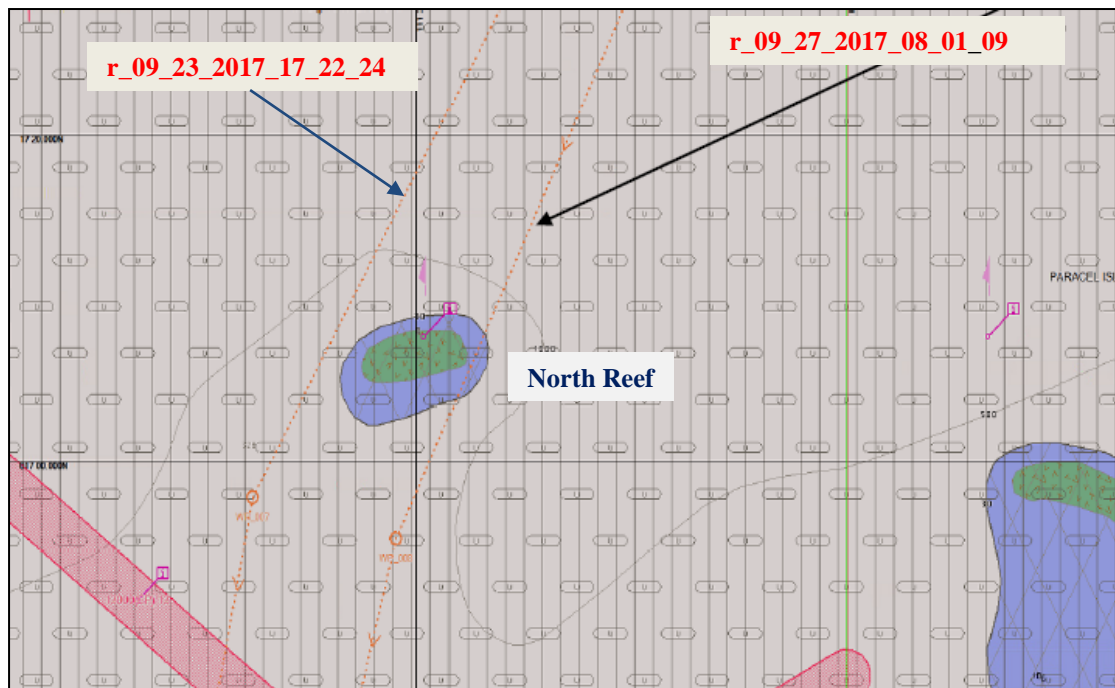
Figure 6: Reconstructed ECDIS image showing route r_09_27_2017_08_01_09 (test route) and original route r_09_23_2017_17_22_24

Documentary evidence submitted to the MSIU showed that route r_09_23_2017_17_22_24 (Figure 6) was activated upon departure Hong Kong and the ECDIS settings checklist was completed by the master and navigational officer. According to the checklist, the safety depth/contour was 12 m, cross-track distance was five cables and the guard zone (anti-grounding alarm) was set for 22° and 12 minutes. Even though the voyage plan was approved and co-signed by the watchkeepers, 'no-go' area/limiting danger lines were drawn around the reef or its position disclosed in the written voyage plan.

Route r_09_27_2017_08_01_09 (Figure 6) had been created earlier and saved in the active route folder as a test route to Indonesia. It appears likely that on the changeover of the route at sea, the test route was inadvertently clicked and uploaded on the ECDIS. It remains unclear, however, to the safety investigation as to why the route was deactivated and activated during the chief mate and third mate's navigational watch.

As noted in Figure 6, (test route) r_09_27_2017_08_01_09 appears outside the Eastern limit of the reef and across the 30 m depth contour, which may account for no navigational dangers highlighted on the ECDIS by the system's automatic route scan. Consequently, ENC's were not checked for visual verification and the potential danger of sailing in the close proximity of the reef was not recognised. Furthermore, the

18/2018_R1 Review and include in the SMS a detailed and comprehensive procedure on implementing changes to the approved passage plan at sea and activating on the ECDIS;

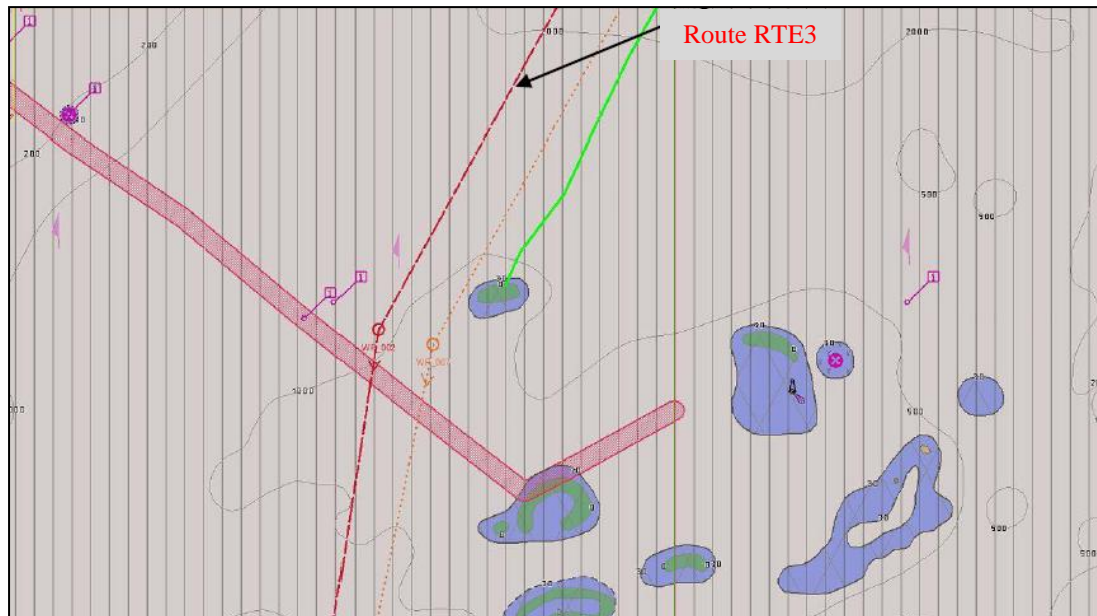
Figure 7: Reconstructed ECDIS image showing charterers' route plan RTE3 and track covered by *Marbella* (green).

master, who had indeed authorised changes in the original plan, was not involved in its activation on the ECDIS. Moreover, he did not envisage incorrect route activation and must have assumed that the route monitored by the watchkeepers was the charterers' defined route RTE3 (Figure 7). It is plausible that directional similarity of the route with the original and charterers route on this leg of the passage may not have been easily discernible and the erroneous route displayed on the ECDIS was not detected by the bridge team.

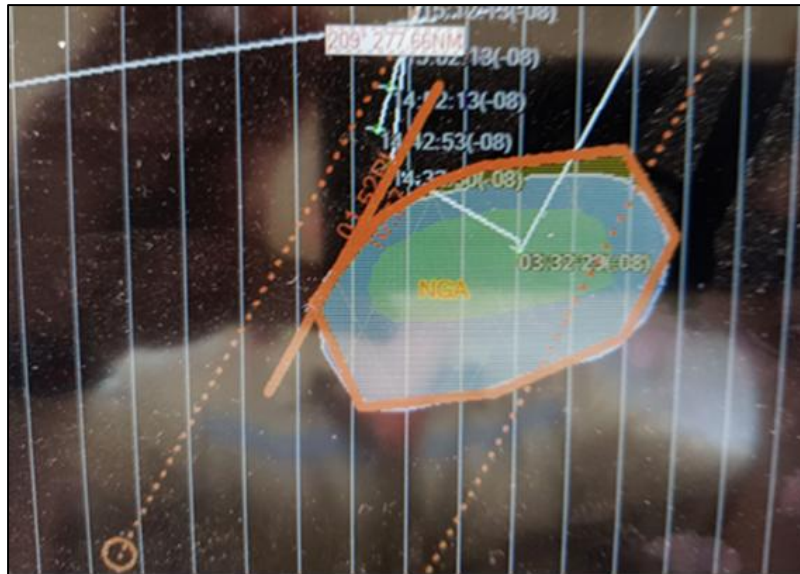
Figure 8: Reconstructed ECDIS image showing North Reef in dusk mode setting

The visibility was good and the traffic was light to moderate. There was no lookout⁵ and the OOW was navigating mainly by sight and by ship's radar. North Reef, which lay close to the route and identifiable in dusk mode setting (Figure 8), was not seen by the second mate. It is possible that the scale was not optimised and the reef was not

viewable on the ECDIS displaying the ENC. It would appear that although the ECDIS was the primary means of navigation, its innumerable functions were not used to their full potential. Throughout the period leading up to the grounding, the navigational OOW was unaware of the reef close ahead.

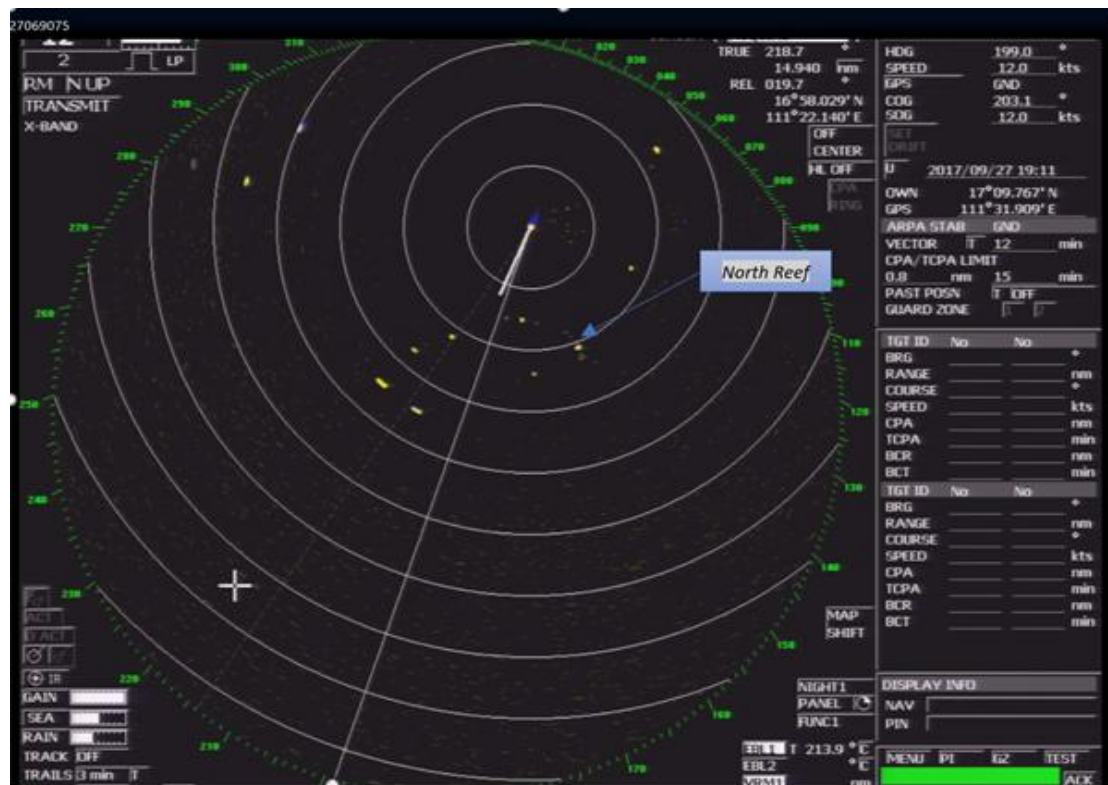
Figure 9: Image showing North Reef at three-mile range on X-band radar (scale 12 nautical mile).

Examination of radar images captured by the VDR displayed a weak outline of North Reef at three nautical miles range (Figure 9). Since a landfall was not anticipated, it was unlikely that the OOW regarded the randomly reflected radar signals as coming from the reef and at no time considered the situation a risk to safe navigation.

Moreover, an analysis of the ECDIS log and VDR submitted to the MSIU, underlined the fact that in the approaches to the reef, no record were entered of ECDIS guard zone alarm, which was intended to alert the OOW of impending grounding, captured on the VDR or logged in the ECDIS logbook⁶. With no advance warning from the ECDIS and no look-out on the bridge, the OOW's situational awareness was compromised as the vessel drew closer to the reef.

18/2018_R2 Ensure that all crewmembers are thoroughly familiar with safe navigational procedures including posting of a look-outs at sea.
