Working in refrigerated salt water tanks

Fatal enclosed space accident on board the fishing vessel

Sunbeam (FR487)

MAIB SAFETY BULLETIN 4/2018

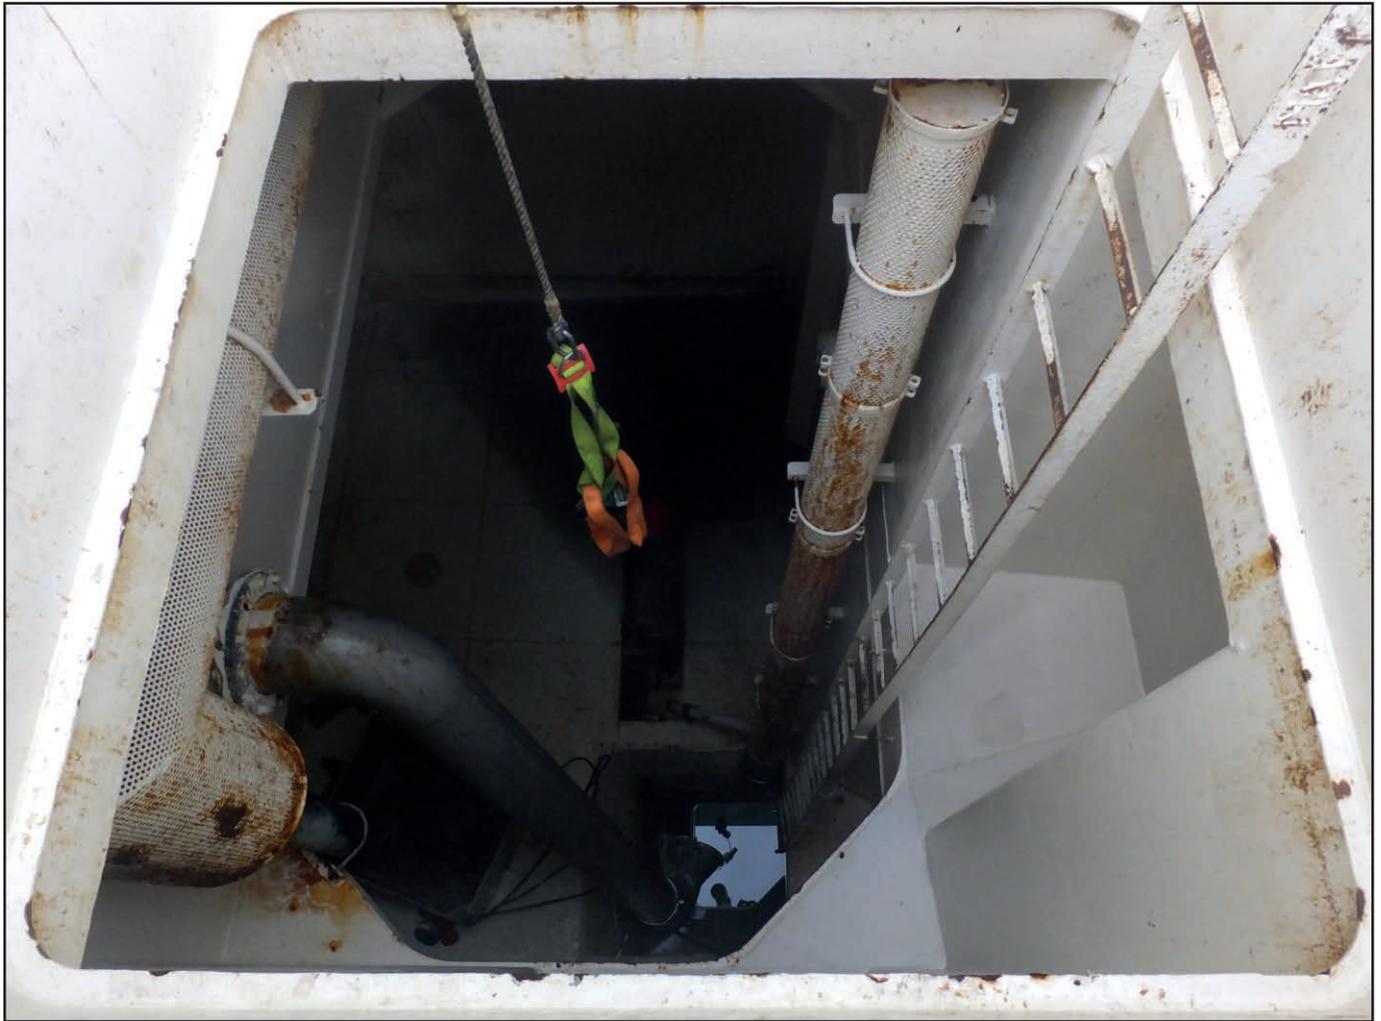
Figure 2: Aft centre RSW tank

At about 0900 on 14 August, *Sunbeam*'s crew arrived at the vessel's berth ready to begin work. The vessel's refrigeration plant had been shut down after landing the final catch at Lerwick, and its RSW tanks had been pumped out and tank lids opened in preparation for deep cleaning. At some time between 1200 and 1350, *Sunbeam*'s second engineer entered the aft centre RSW tank (**Figure 2**) and collapsed.

At about 1350, the second engineer was seen lying unconscious at the aft end of the tank by a crewmate, who immediately raised the alarm. Three of the vessel's crew entered the tank and tried to resuscitate the second engineer but they soon became dizzy, confused and short of breath. One of the crew managed to climb out of the tank unaided, the other two crewmen and the second engineer were recovered onto the open deck by two crewmen wearing breathing apparatus. The two crewmen made a full recovery, but the second engineer could not be resuscitated and died.

It is unclear when and why the second engineer entered the tank. However, evidence indicated that his intention was to sweep the residual seawater that had settled at the aft end of the tank forward in to the tank's bilge well. No safety procedures for entering or working in RSW tanks had been completed before he entered the tank.

Tests of the atmosphere in the tank following the accident showed that the level of oxygen at the bottom was less than 6% (normal level should be 20.9%). Further tests of both the tank atmosphere and residual water samples showed the presence of Freon R22, the refrigerant gas used in the RSW tank's refrigeration plant.

S2018/129 Conduct risk assessments specifically for entering and working in RSW tanks and provide safe operating procedures for its crew to follow and appropriate levels of safety equipment to use.

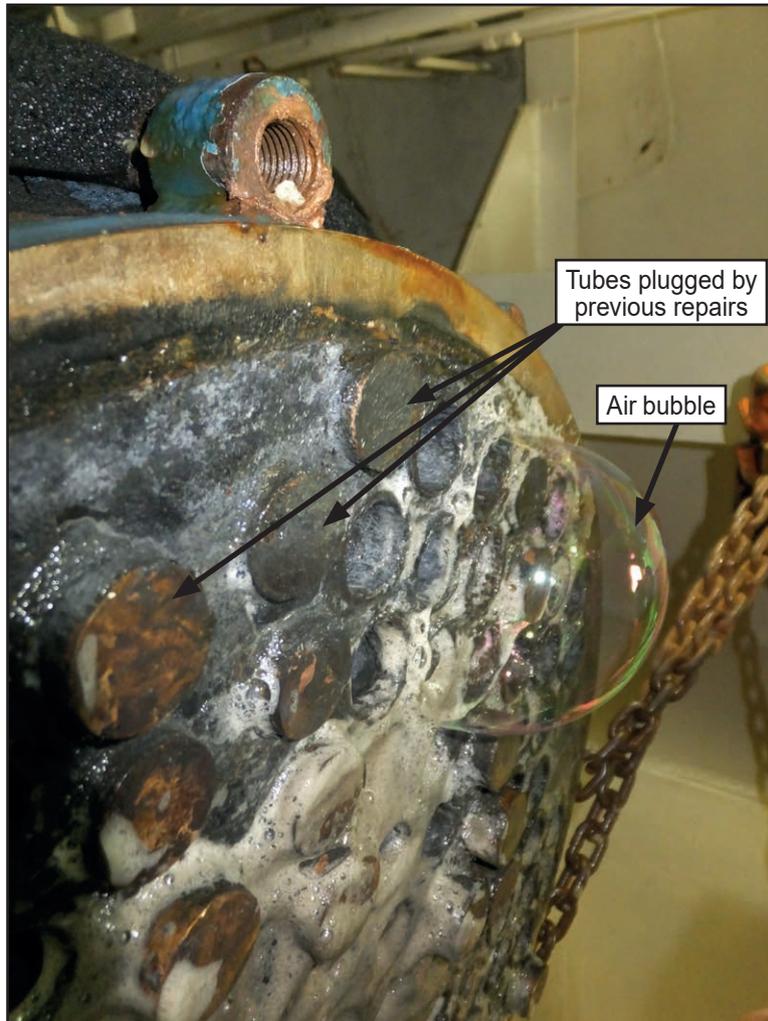
The MAIB's initial investigation identified that the refrigeration plant sea water evaporators had suffered several tube failures resulting in a number of repairs (**Figure 3**). It is likely that the refrigerant leaked through one or more failed tubes into the seawater system, and was released into the RSW tank. Freon R22 is four times heavier than air so it will displace oxygen at the bottom of an enclosed space, such as an RSW tank. It is a toxic, tasteless and mostly odourless gas. If it is deeply inhaled, it can cut off vital oxygen to blood cells and lungs.

Figure 3: Starboard evaporator tube leak
