**REPORT OF THE
INVESTIGATION INTO
A FATAL INCIDENT ON BOARD
'MV EUROPEAN ENDEAVOUR'
AT DUBLIN PORT
22nd JUNE 2017**

**REPORT NO. MCIB/273
(No.5 OF 2018)**

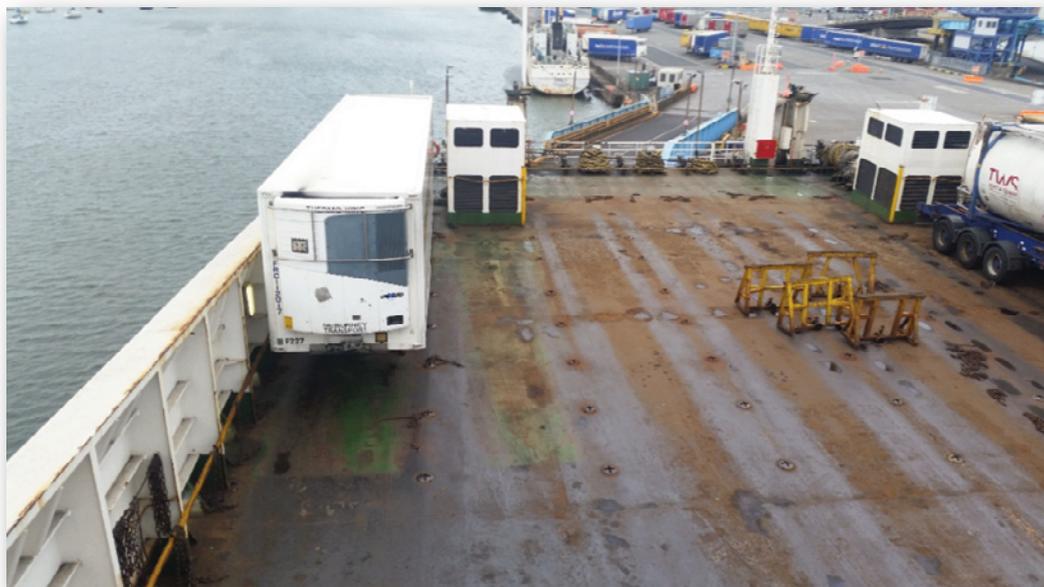
The location of the incident was Lane two, aft end, starboard side, Deck five. Immediately at the end of Lane two there was a ventilator shaft for cargo ventilation purposes.

Photograph No. 1: View of scene from above.

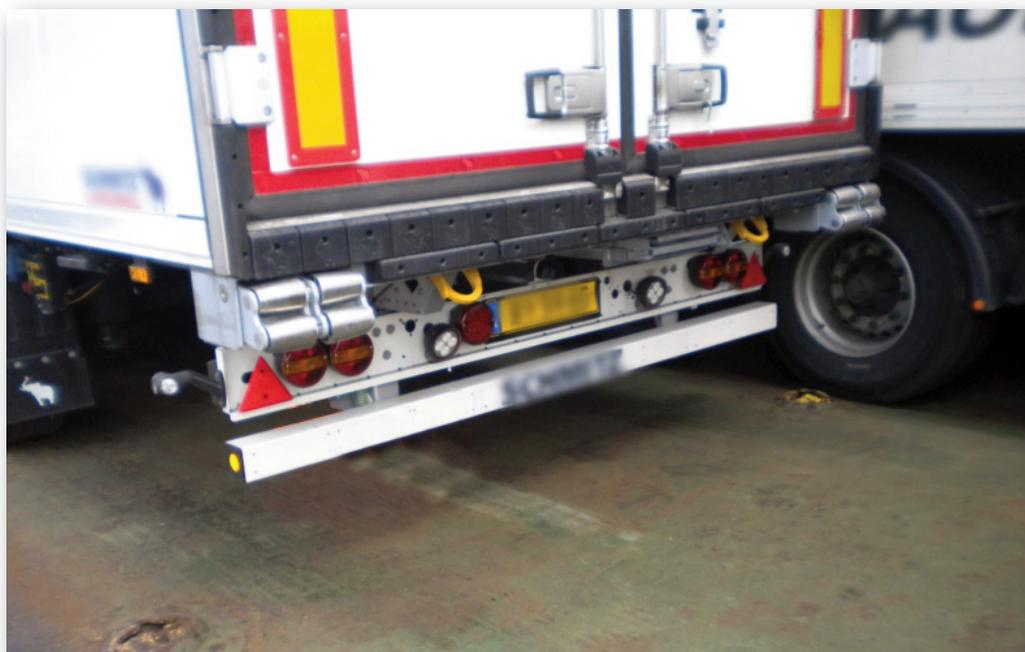
Photograph No. 2: Rear end of trailer.

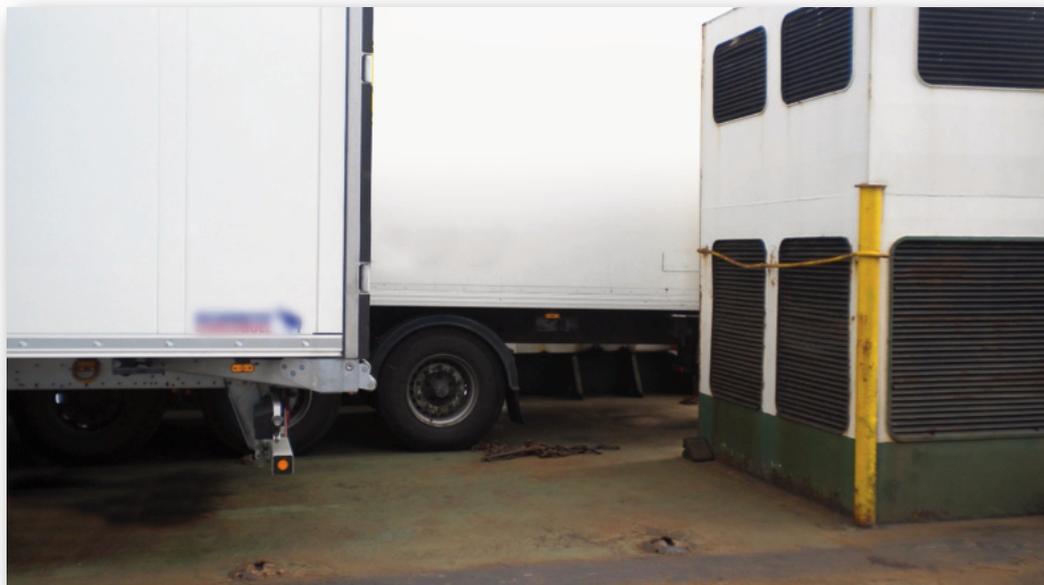
- 3.5 The trailer involved in the incident was the fifth unit to be loaded on Deck five. The location of the incident was Lane two, aft end, starboard side, Deck five (see Appendix 7.1 Photograph No. 2). Immediately at the end of Lane two there was a ventilator shaft for cargo ventilation purposes (see Appendix 7.1 Photograph No. 3).

- 3.11 The lower louvre at the front of the ventilator shaft was noted to be set in. This was examined and it was determined that the damage was old. The space between paint cracks was filled with dirt which was indicative of long term presence rather than fresh or recent damage.

Photograph No. 3: Ventilator shaft.

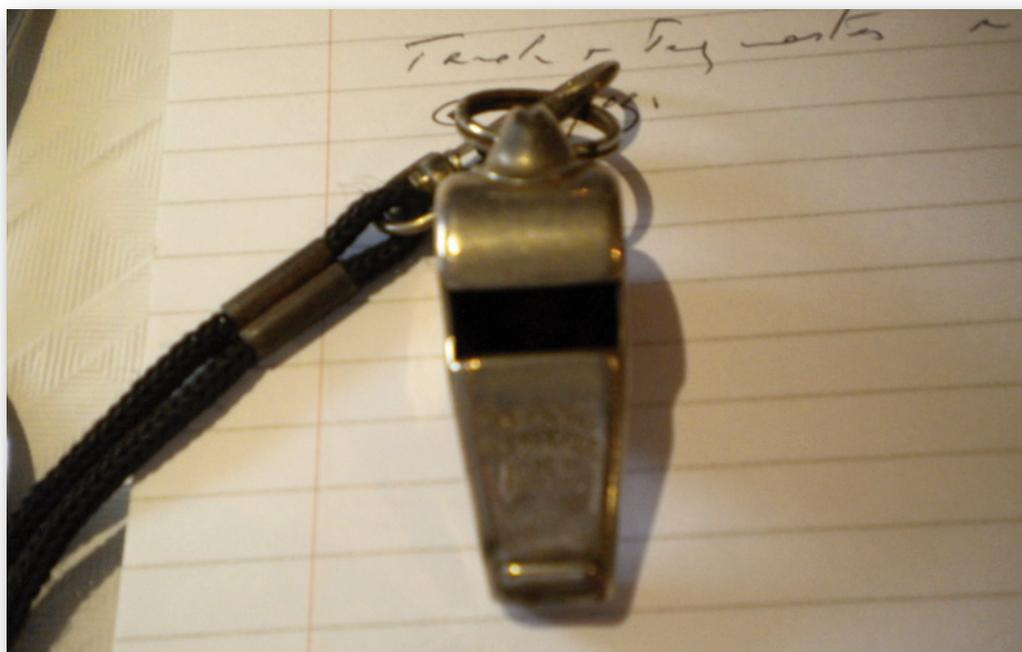
- 5.3 Under the system of loading unaccompanied trailer units, the driver of the tug cannot see the AB guiding him into position and the crew rely on whistles by the guide to alert drivers to any issue. During this incident the driver did not have sight of the guide and the whistle system was not effective, either because no whistle was heard or the guide was not in a position to blow the whistle.

Photograph No. 4: Whistle issued to crew.

- review the system of work in relation to cargo operations for unaccompanied trailers.
- review the application and enforcement of its drug and alcohol policy to ensure that it is fit for purpose.
