MARINE SAFETY INVESTIGATION REPORT

Safety investigation into the fatal occupational accident on board the
Maltese registered bulk carrier

ELENI M

MARINE SAFETY INVESTIGATION REPORT NO. 20/2018

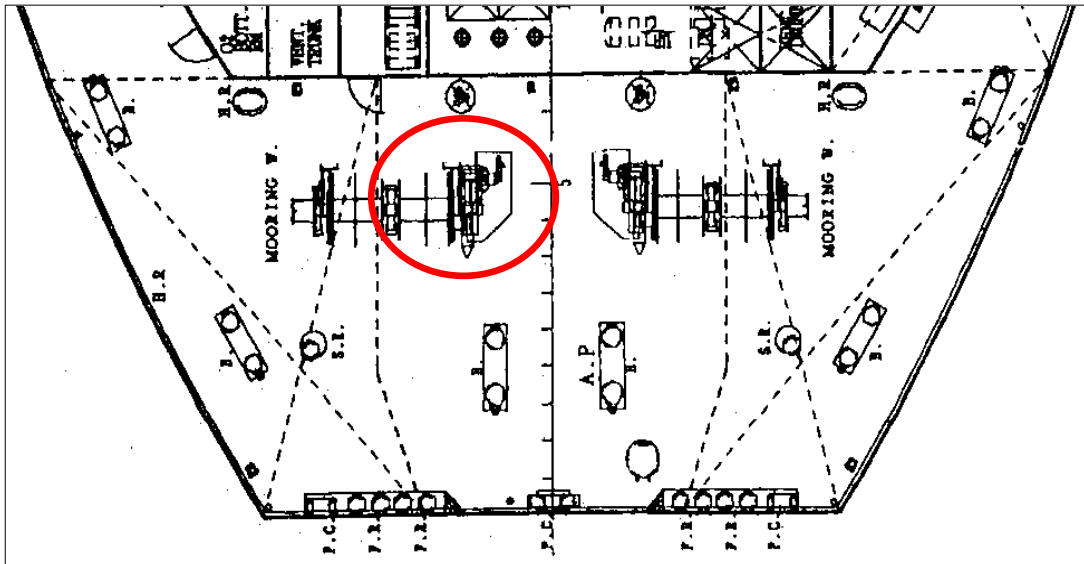
The aft deck on *Eleni M* was open, with two mooring winches installed as well as several mooring bits and fairleads (Figures 4 and 5). Although the accident happened at night time, the crew members found the mooring deck to be sufficiently illuminated.

Figure 4: Aft deck layout on *Eleni M*, showing the winch where the accident happened

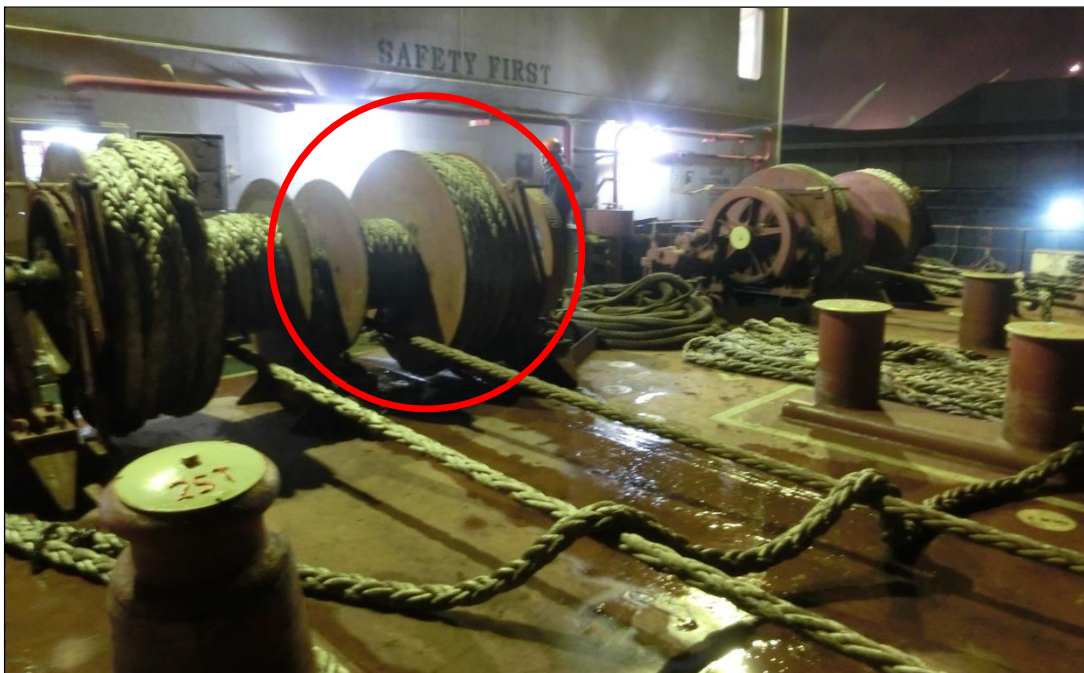
Figure 5: Aft deck layout on *Eleni M* at night, where the accident happened

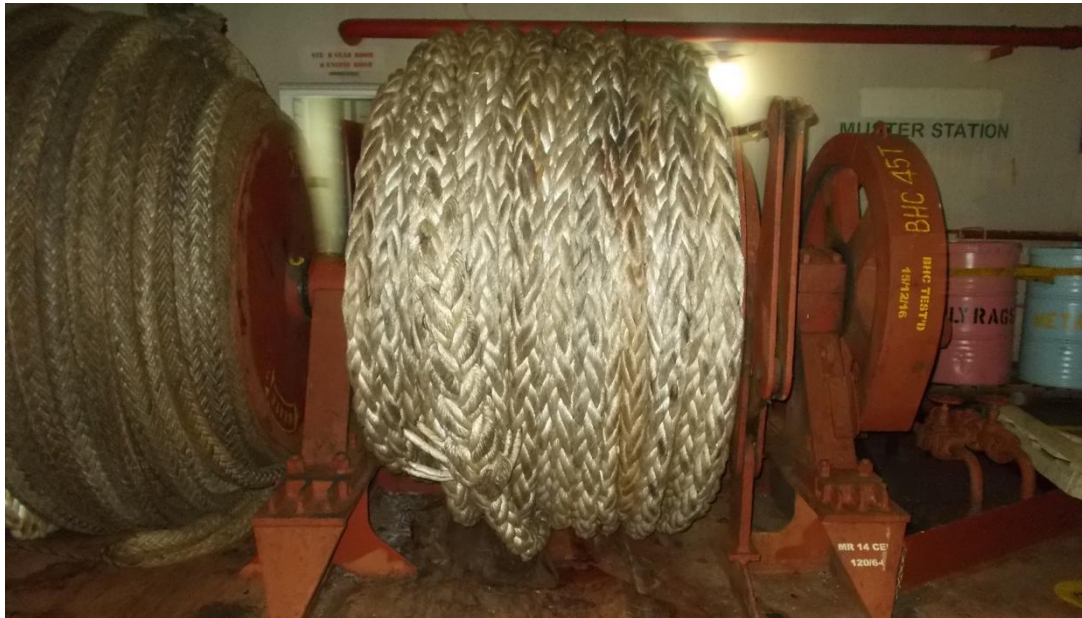
Each of the mooring winches had two working / storage drums and a warping drum at the one end. Each drum had a storage capacity to hold 200 m of mooring rope with a diameter of 70 mm (**Annex 1**). The mooring rope in use on the winch drum during the course of the accident had, according to its certificate, a length of 220 m and a diameter of 72 mm (**Figure 6 / Annex 2**).

Figure 6: Mooring winch drum with mooring rope fully reeled in

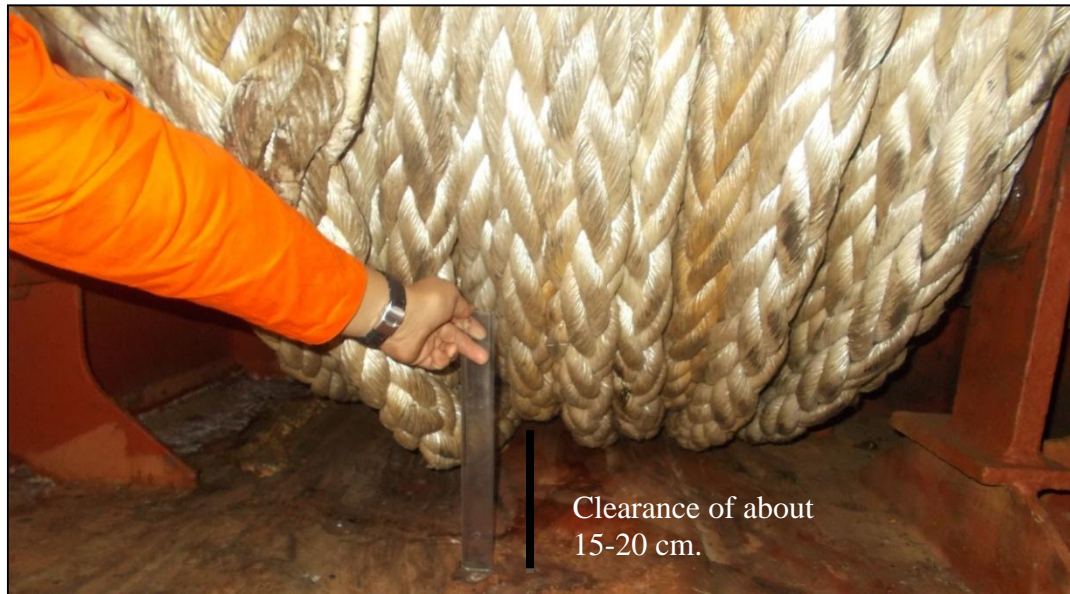
The discrepancy between the nominal holding capacity of the winch drum and the actual dimensions of the mooring rope in use, reduced the clearance underneath the drum when the mooring rope was fully reeled in on the drum. Furthermore, it was normal practice to reel two mooring ropes onto one winch drum, which effectively reduced the clearance even further and necessitated even more careful stowage to ensure that the rope fitted on the drum. The clearance between the mooring ropes and the deck underneath on the day of the accident was between 150 mm and 200 mm (**Figure 7**).

Figure 7: Clearance underneath the winch drum

- .3 There was an insufficient number of winch drums available to hold every mooring rope individually.
- .4 The clearance underneath the drum with the excessive mass of mooring rope stowed was severely limited, which made it possible to get caught between the remaining rope.

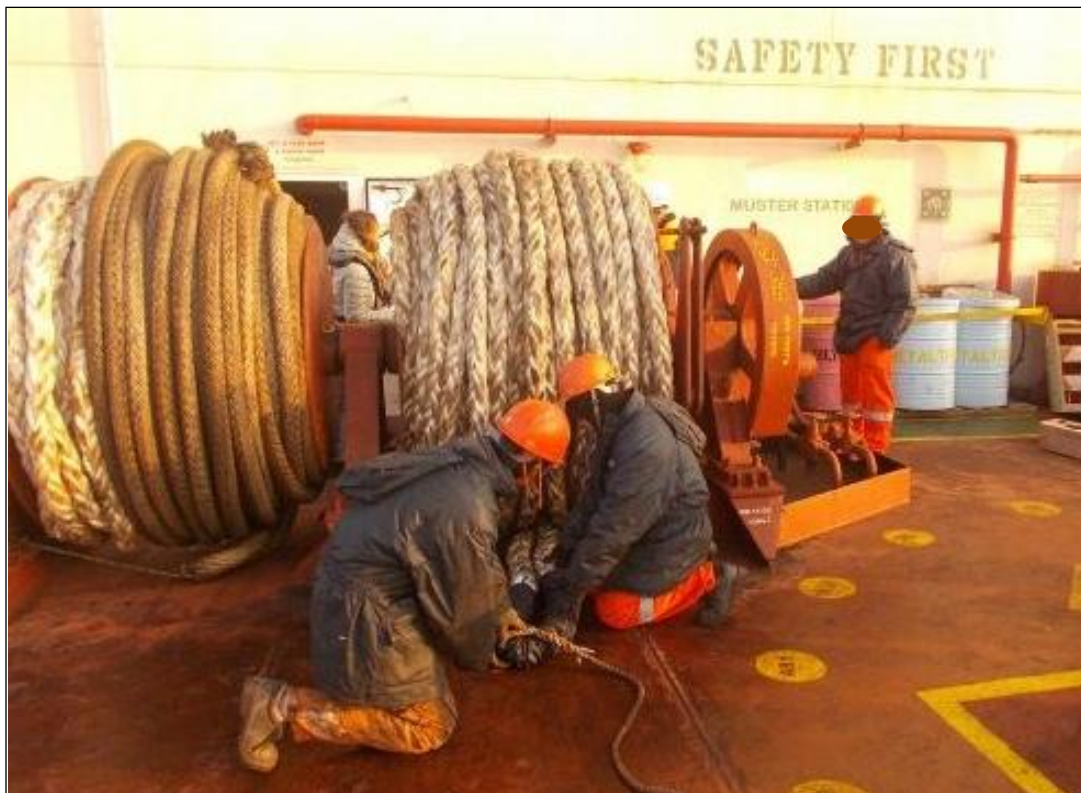
Communication was normally done by hand signals to the winch operator, either by the AB, or a supervisor working by the winch drum; verbal communication was hampered due to the high noise levels on the aft deck. During the course of the accident, the normal procedure was followed and a deck cadet assisted with the operation from a position behind the AB, as shown in Figure 8.

Figure 8: Securing the mooring line on the winch drum (*reconstruction*)

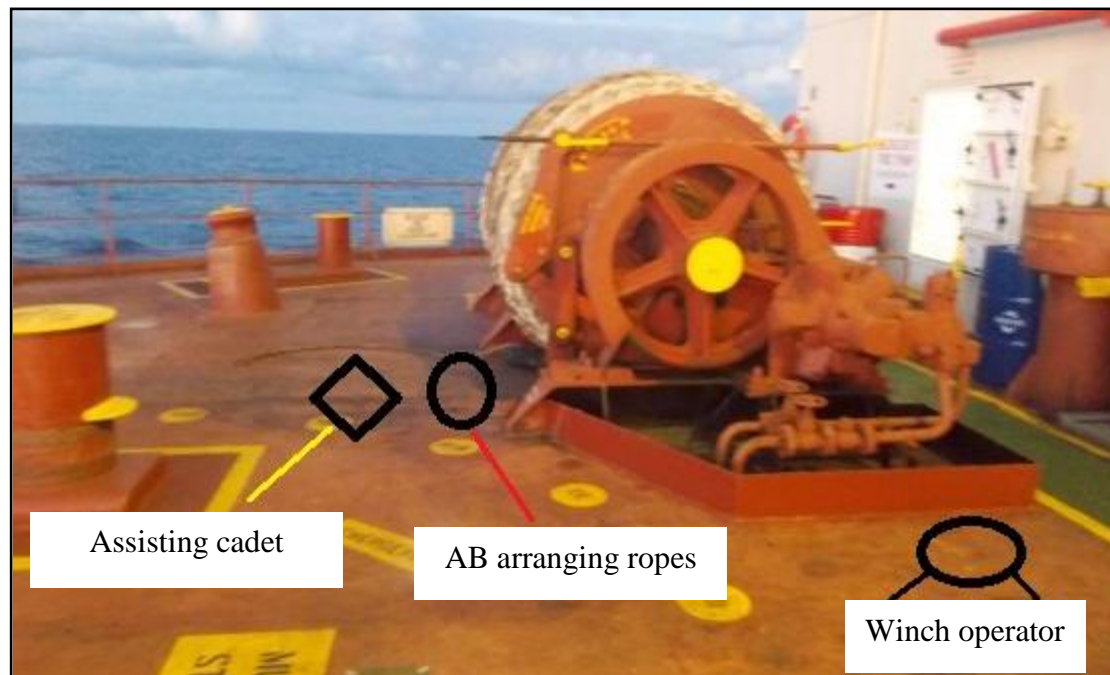
winch operator, acted as a communication link between the two ABs. Figure 2 shows positions of the crew members prior to the accident occurrence.

Figure 2: Positions of crew members prior to the accident (source: ELENI M)

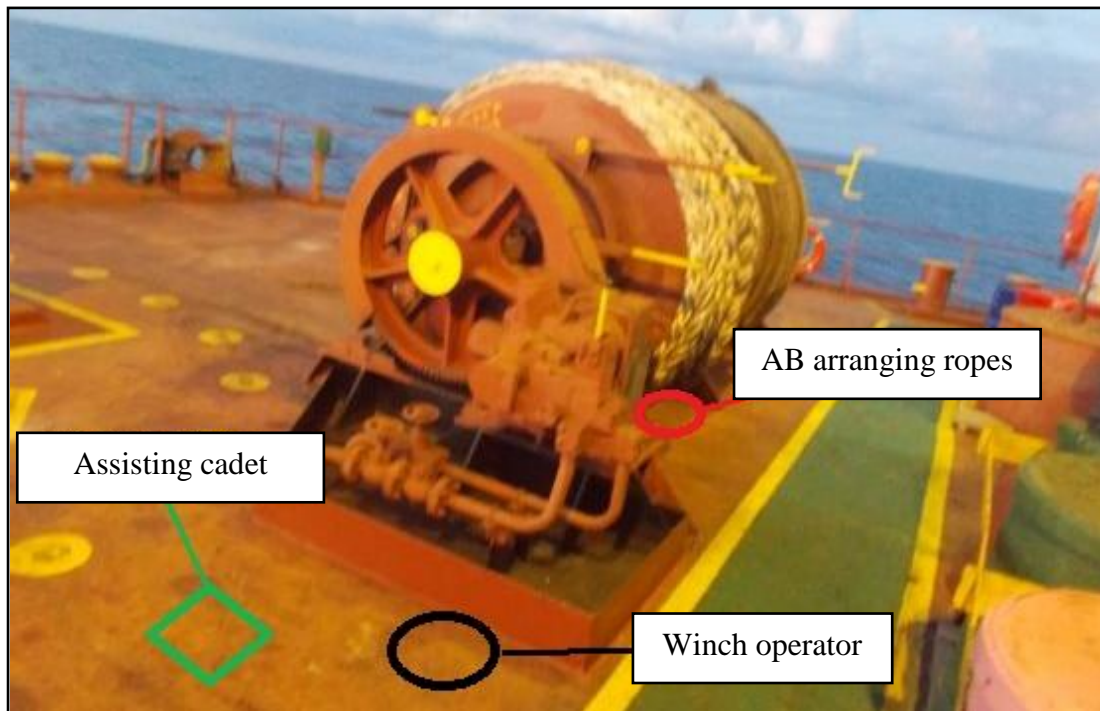
The cadet got up from his position and walked for approximately three metres to the winch operator's position and told the winch operator to stop the winch, which he immediately did. It was only about two to three seconds later, when the cadet turned around towards the aft part of the winch drum and noticed that the AB was no longer behind the winch. He also noticed that almost all of his body was now underneath the winch drum, despite the limited clearance between the stowed rope lines and the deck, with only his legs visible. The cadet shouted to the AB operating the winch, who immediately realised that a serious accident had just occurred. Figure 3 shows the locations of the crew members after the accident.

Figure 3: Positions of crew members after the accident
