SAFETY INVESTIGATION REPORT

REPORT NO.: 23/2018

November 2018

MV EUGENIA B **Fatal fall of a stevedore inside cargo hold no. 2** **in the port of Iskenderun** **30 November 2017**

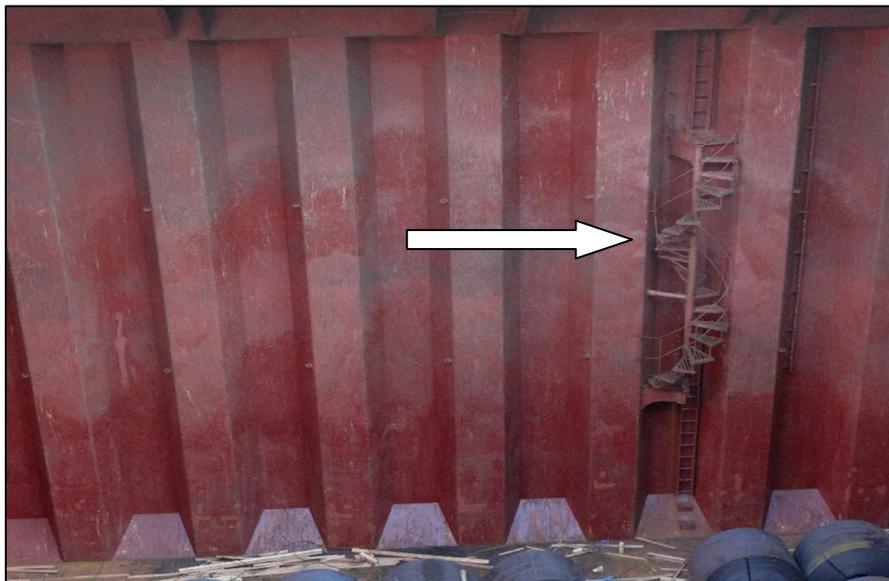
Figure 1: Access to cargo hold no. 2

The accident happened in cargo hold no. 2, which is fitted between frames 143 and 179. Access to the cargo hold is down a combination of vertical and spiral ladders fitted against the forward corrugated, transverse bulkhead³. The total height from the main deck down to the tanktop was 16.0 m. The ladder (Figure 1) was constructed in sections:

- A vertical ladder of two meters in length (access from the main deck booby-hatch), leading to the upper landing;
- A step to the side on the upper landing, leading to the second vertical ladder, through a hatchway (65 cm by 65 cm), of three meters in length and leading down to the middle landing; and
- A spiral ladder, six metres in length followed by a lower vertical ladder, which was four meters long and which led down to the cargo hold's tanktop.

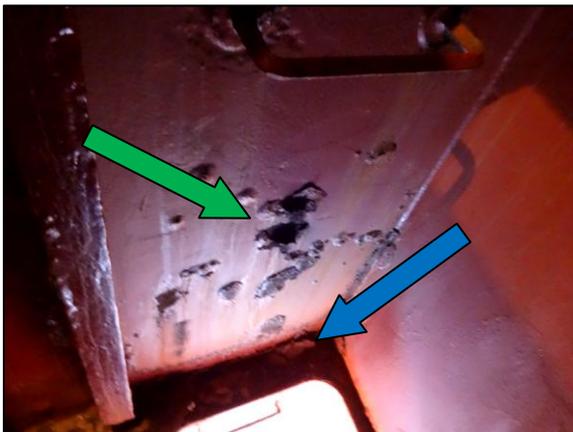
An inspection of the cargo hold access cover indicated it was also designed to help a person climb the vertical ladder. A stopper pin was fitted to keep the cargo hold access cover secured and in a vertical and open position. The MSIU found that the cargo hold access cover's stopper pin had been totally dislodged and the hinges had failed (Figure 2), in all probability while the stevedore was climbing out of cargo hold no. 2⁵.

Figure 2: Broken stopper (green arrow) and broken hinges (blue arrow)

It was clear to the safety investigation that the hinges and stopper failed while the stevedore was climbing his way up from the cargo hold. Moreover, the most logical sequence of events was for the stopper pin to fracture first, followed by the hinges (unless the hinges had already corroded away prior to the accident).

23/2018_R1 review its planned maintenance regime within the safety management system of the Company, to ensure that critical fittings inside the cargo holds are also thoroughly inspected and maintained, as necessary;

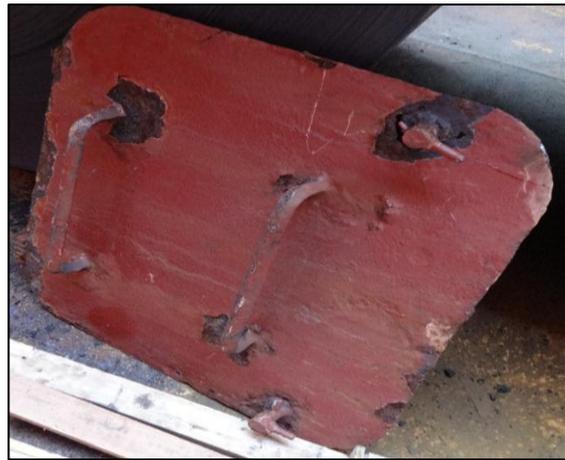
The cargo hold access cover had signs of general corrosion. Material wastage was evident, suggesting that it had not been maintained over the months prior to the accident (Figure 3).

Figure 3: Cargo hold access cover as found at the bottom of the cargo hold.

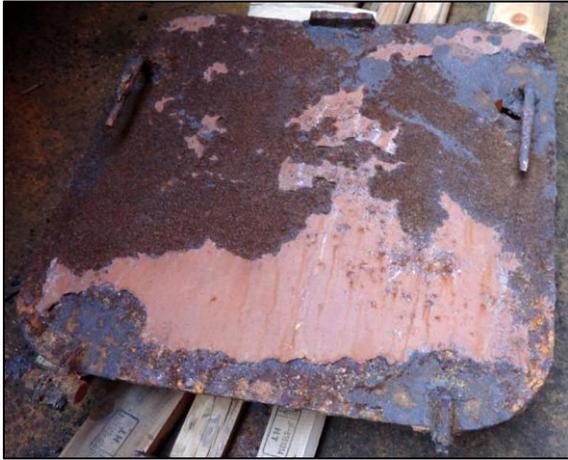
The safety investigation estimated that the back side of the cargo hold access cover had a 70% uniform loss of the metallic surface (Figure 4).

Figure 4: Material wastage signs and failed of hinges

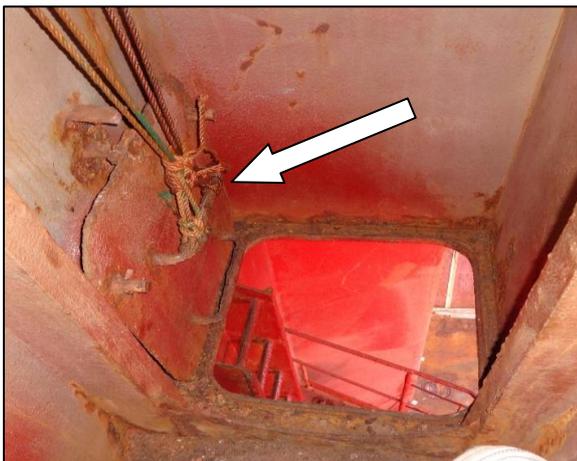
An additional cargo hold access cover was inspected during the course of evidence collection on board. The cargo hold access cover fitted in cargo hold no. 4 was found in a similar (poor) condition to that in cargo hold no. 2 (Figure 5).

Figure 5: Cargo hold access cover in way of cargo hold no. 4

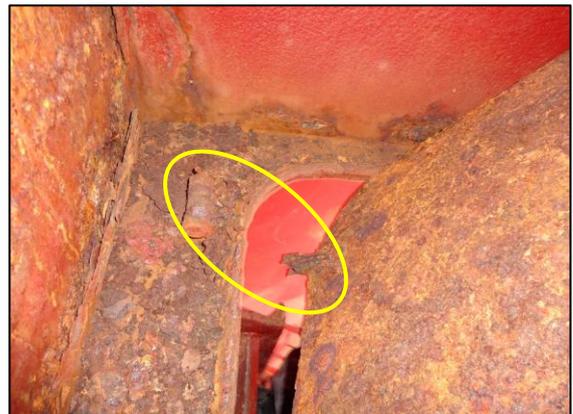
A closer, visual inspection revealed that the stopper and the hinges were rusty and broken (Figures 6 and 7).

Figure 6: Broken hinge

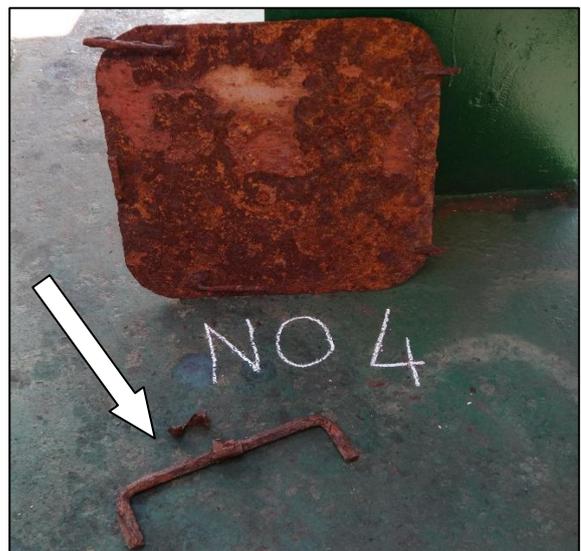
Figure 7: Broken stopper
