Report on the investigation into
the capsize and foundering of the fishing vessel
Solstice (PH199)
resulting in one fatality
approximately 7 miles south of Plymouth, England
26 September 2017

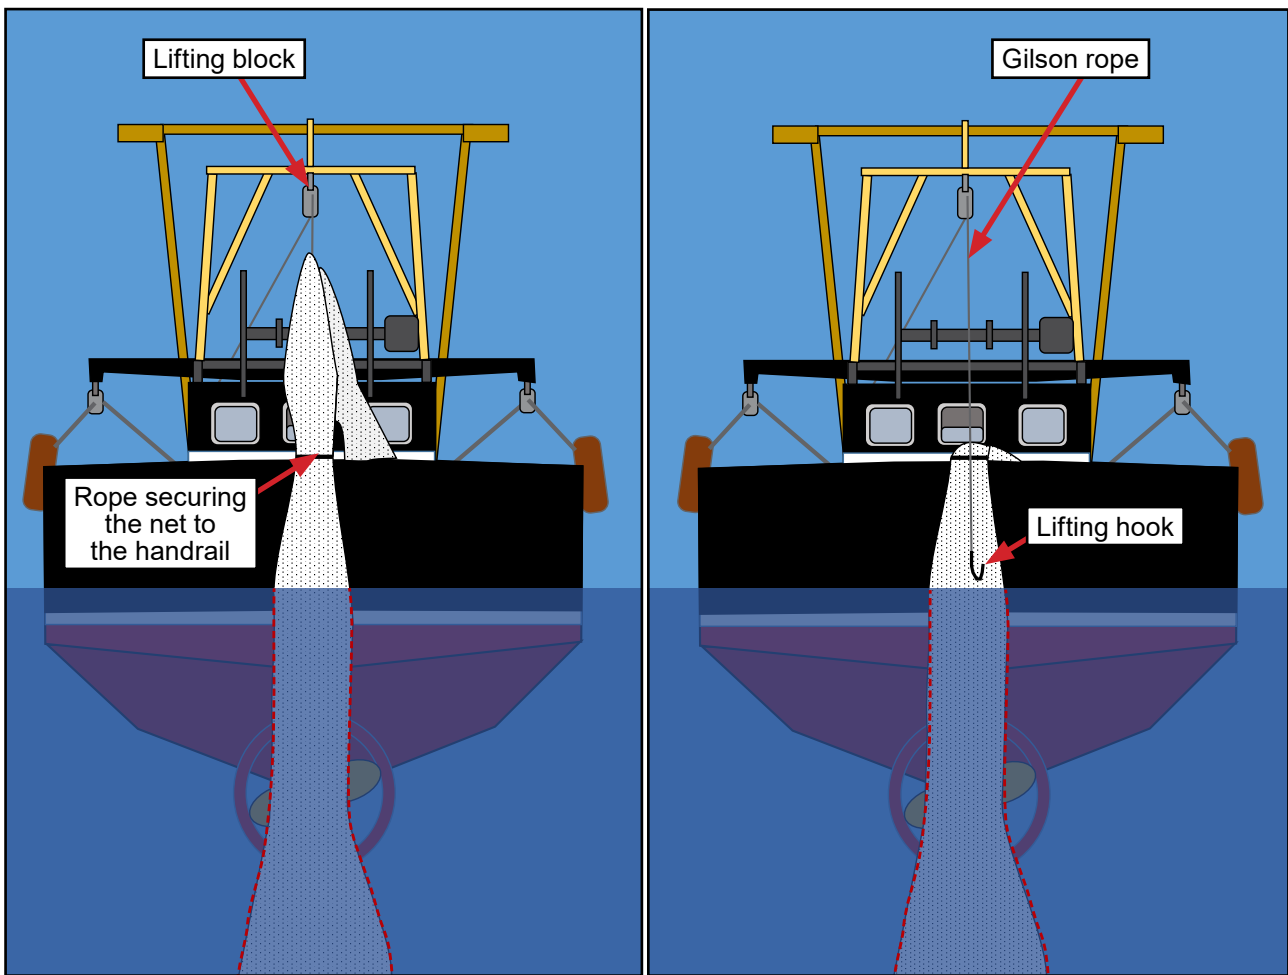
Figure 5: Recovery of net following net drum failure – view from astern

Tony and the skipper visually inspected the net drum and concluded that its hydraulic motor or gearbox had probably failed. Realising that they could not repair the net drum, Tony decided to attach a hook to the gilson rope and use the main deck winch to haul in the net and land the catch.

If not already apparent, the crew should have realised the weight they were trying to lift was excessive when the net drum failed. A further indicator was the parting of the rope used to hold the weight of the net during the subsequent attempts to recover the catch.

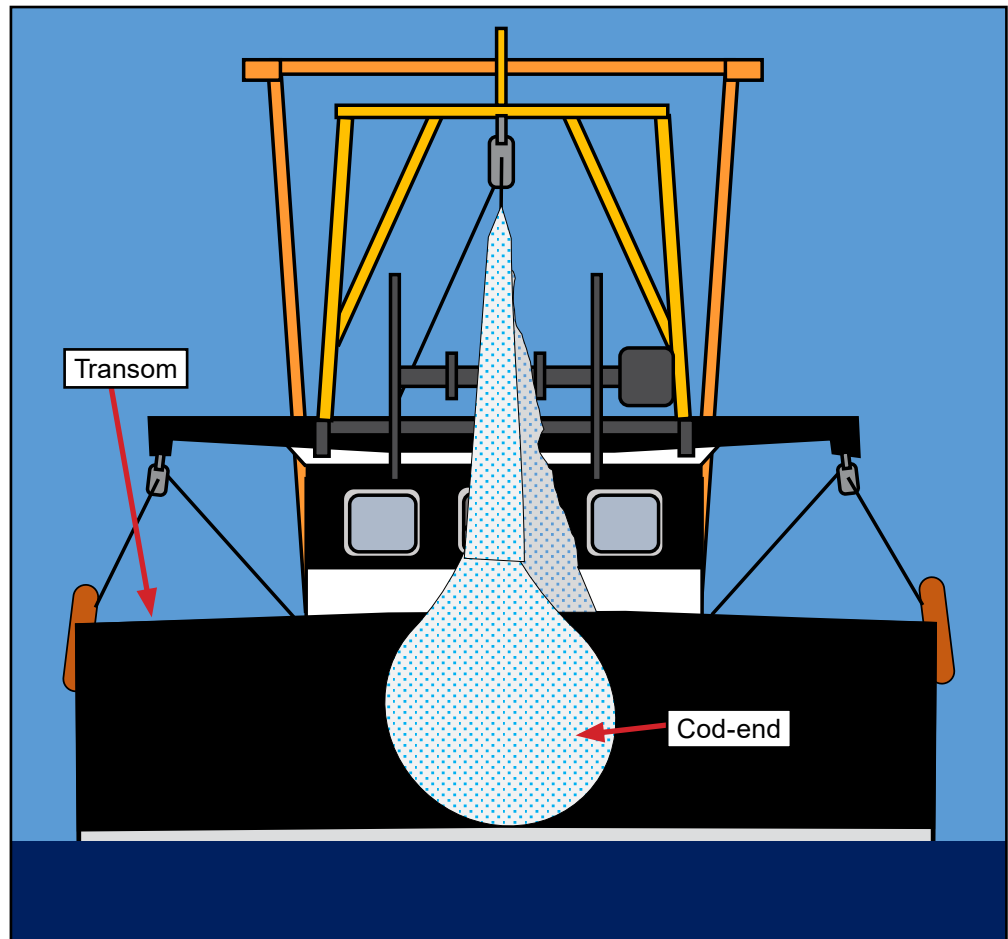
Figure 6: Cod-end out of the water, resting on the transom – view from astern

At about 1930, the cod-end was lifted clear of the water (**Figure 6**); it was full of fish, sand and moss. With the weight of the catch suspended from the gantry block, *Solstice* started to roll more heavily and the cod-end began to roll along the top of the transom. As the vessel rolled to port, the gilson rope and net slipped over the net drum cheek⁸ plate. As the cod-end swung further from the centreline it caused *Solstice* to list heavily to port (**Figure 7**).

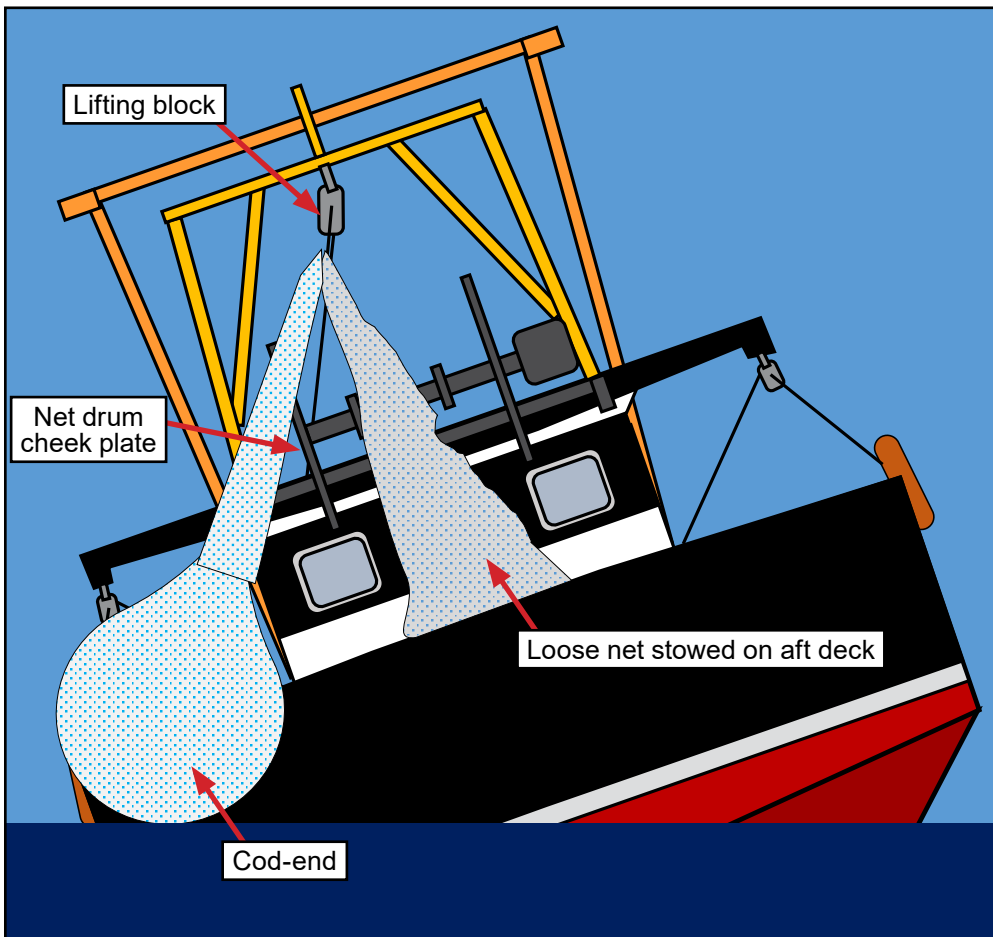
Figure 7: Cod-end on port quarter, heavy list to port as cod-end rolled across the transom – view from astern

When a suspended load swings outward in the direction of any heel, it pulls the vessel further over to that side, increasing the heel and the risk of capsize. If the righting moment is insufficient, the vessel cannot correct the heel and it will capsize. This is what happened when the cod-end started to roll across *Solstice's* transom.

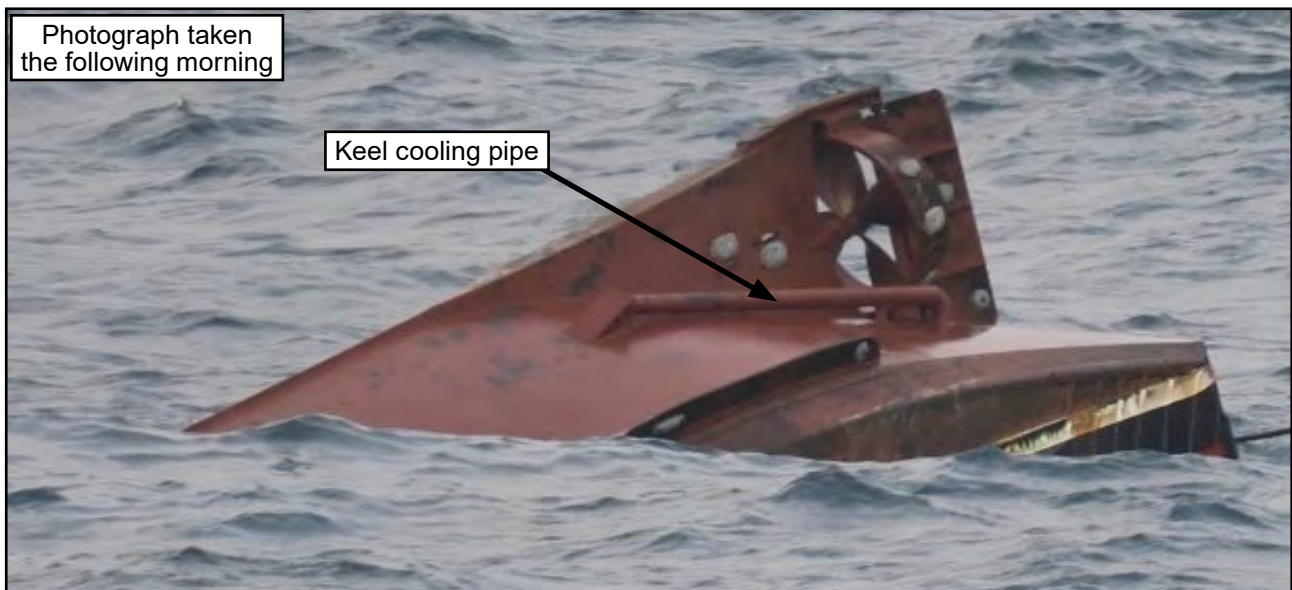
Figure 8: Upturned hull floating on surface

Solstice remained afloat with its upturned hull protruding out of the water (**Figure 8**). The crewman helped the skipper swim to *Solstice*'s hull and using the exposed scupper drains and engine cooling pipes, he climbed out of the water onto the upturned hull. He then took off his waterproof leggings and used them to help pull the skipper out of the water. Without any means of raising an alarm, the two men lay against the engine's keel cooling pipe for warmth.

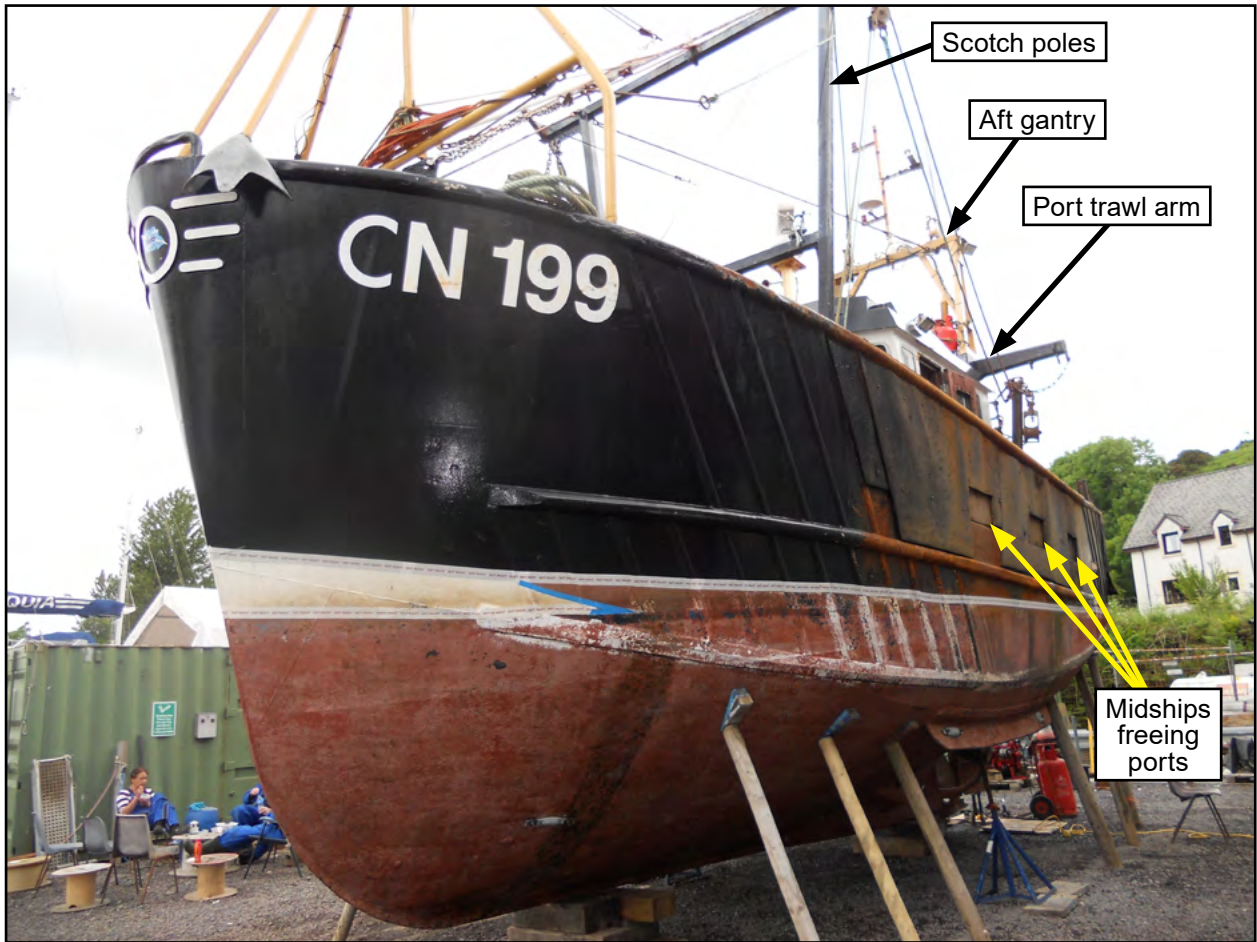
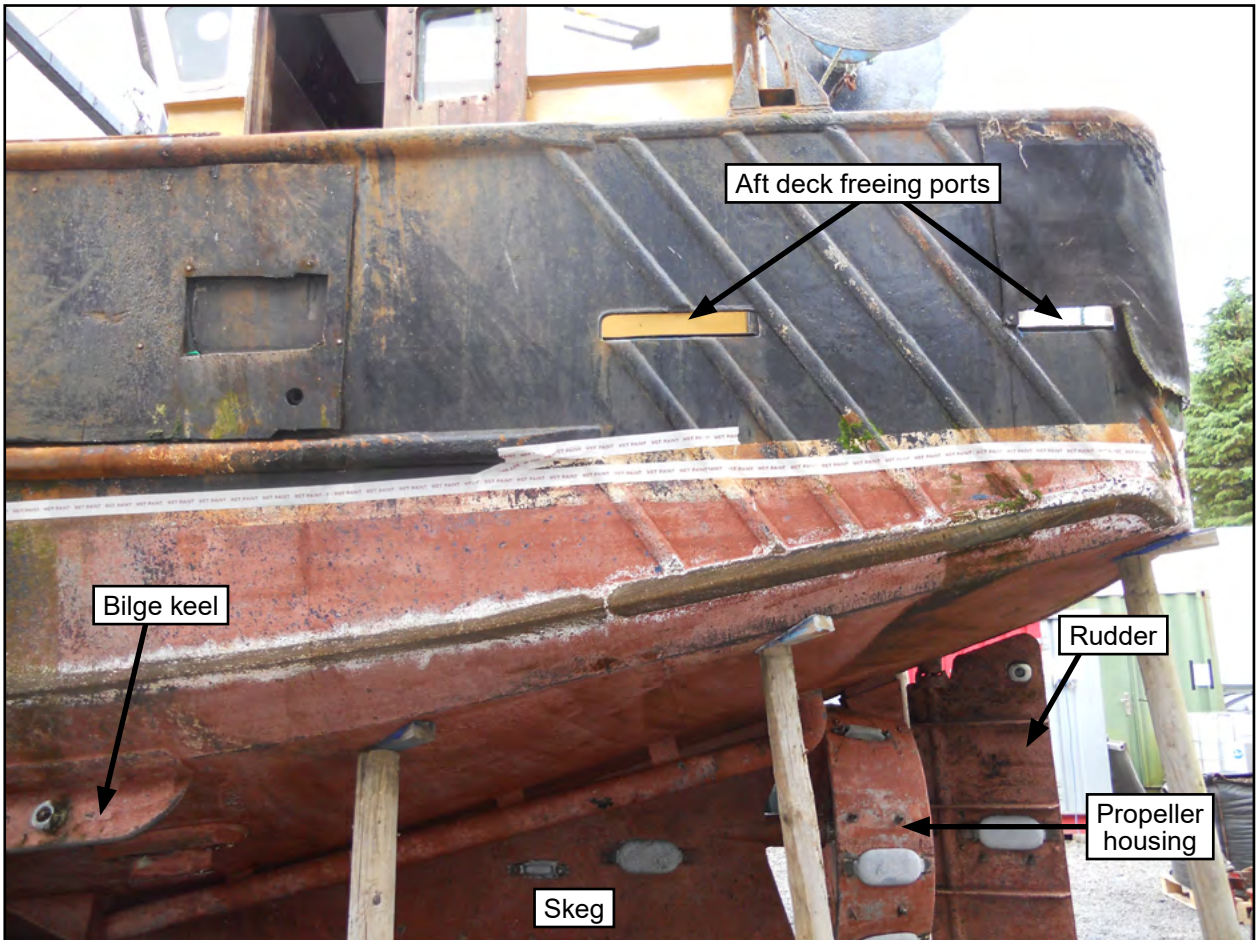
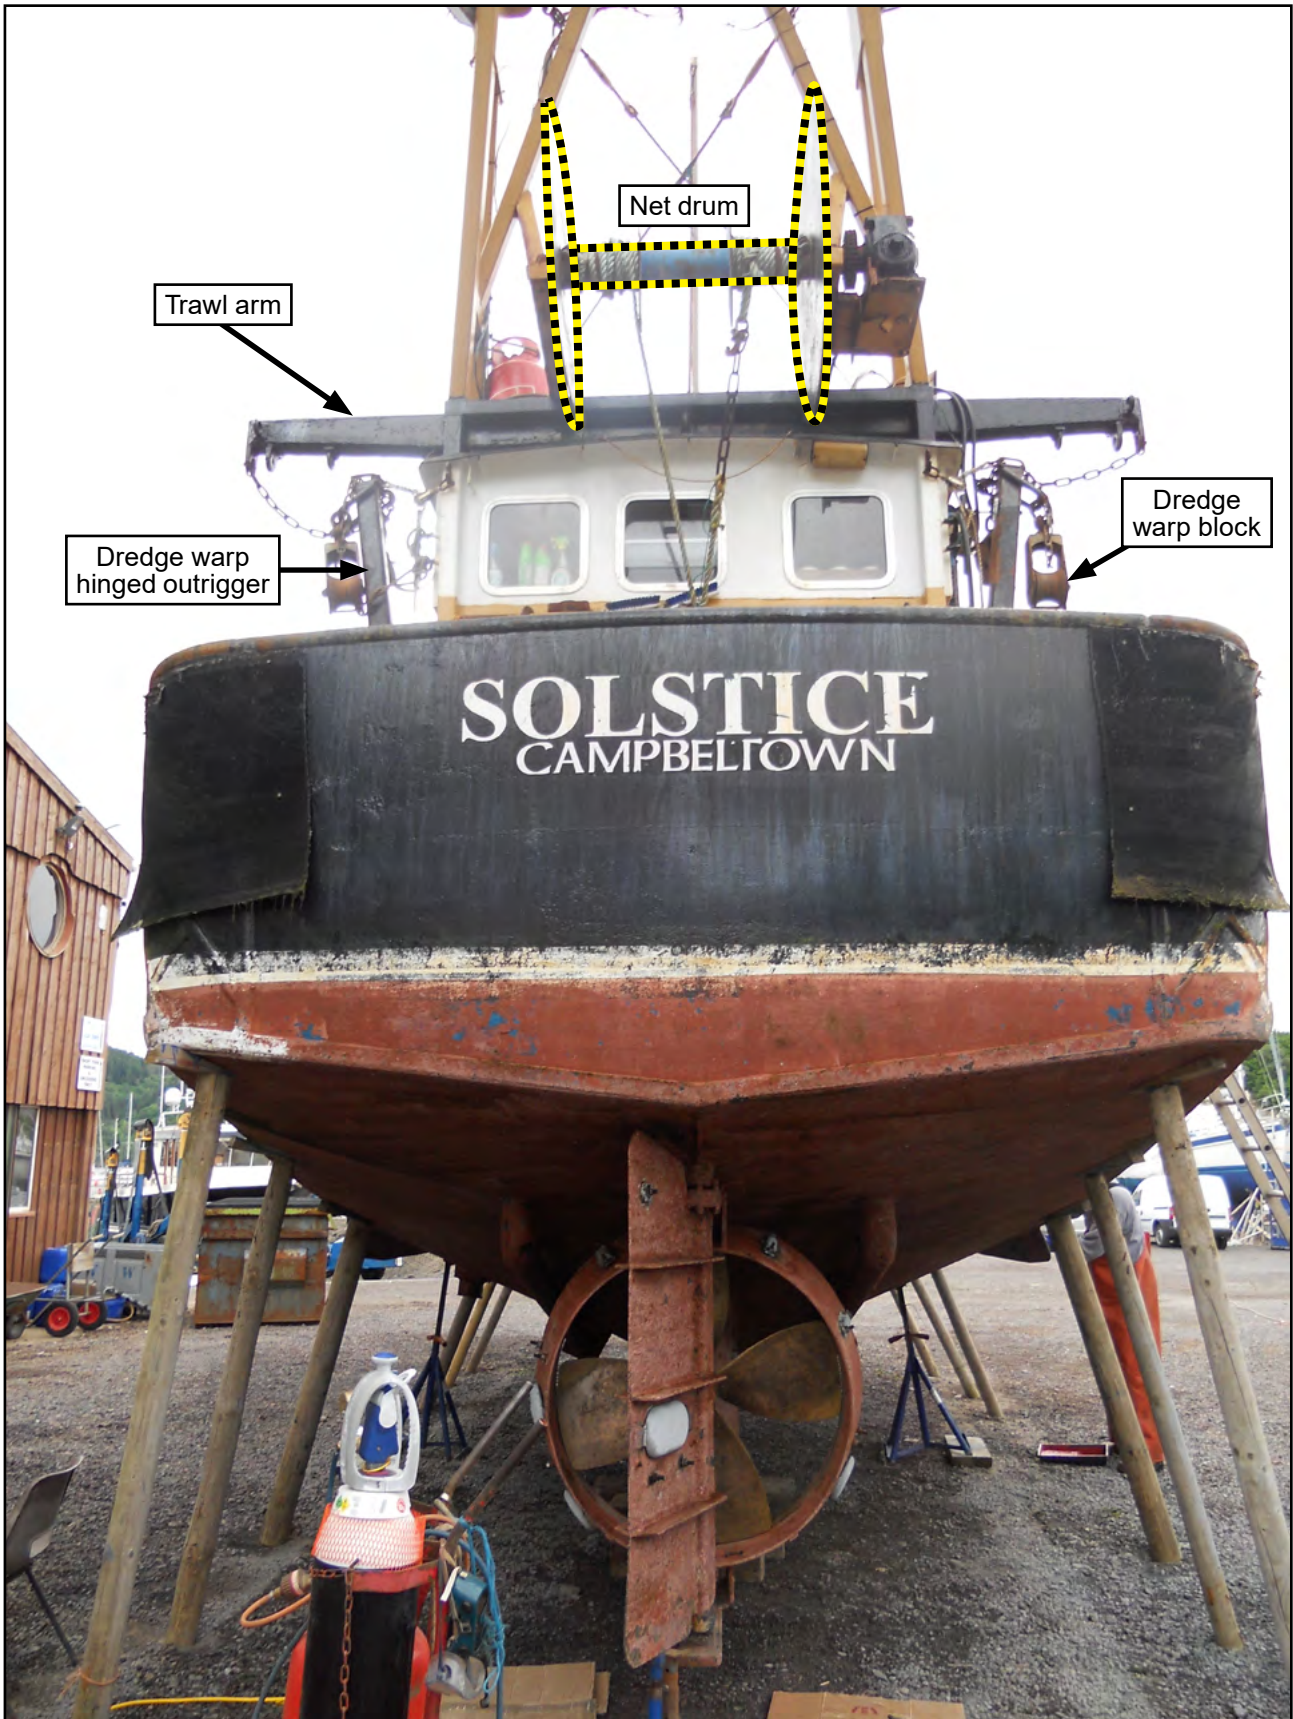
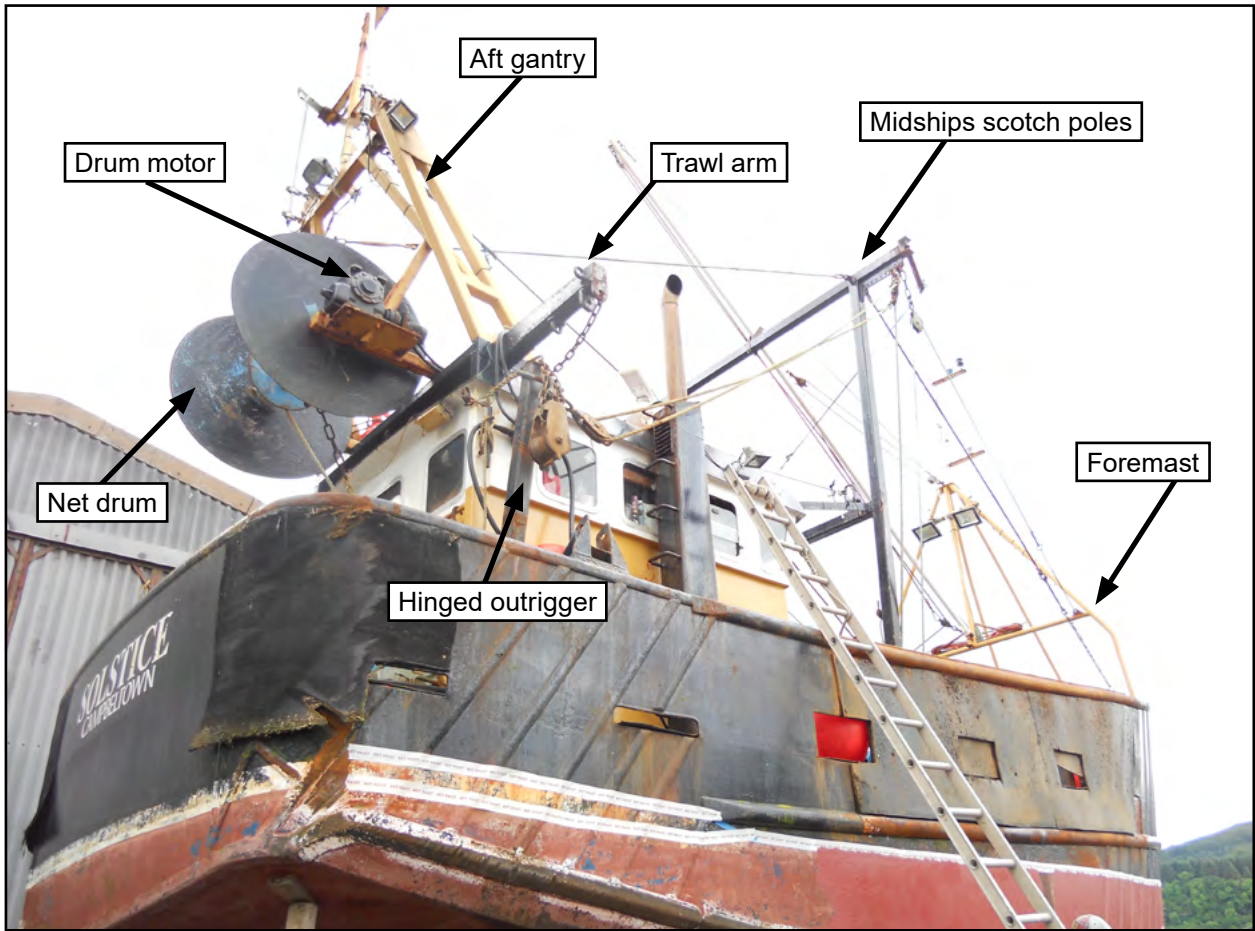
On 13 June 2016, an out of water pre-purchase survey of *Solstice* was conducted in Campbeltown, Scotland by S.C. McAllister & Co. Argyll (**Figures 11, 12, 13 and 14**). The survey report concluded that *Solstice* was in good structural condition and there were no areas of concern that could have affected its seaworthiness.

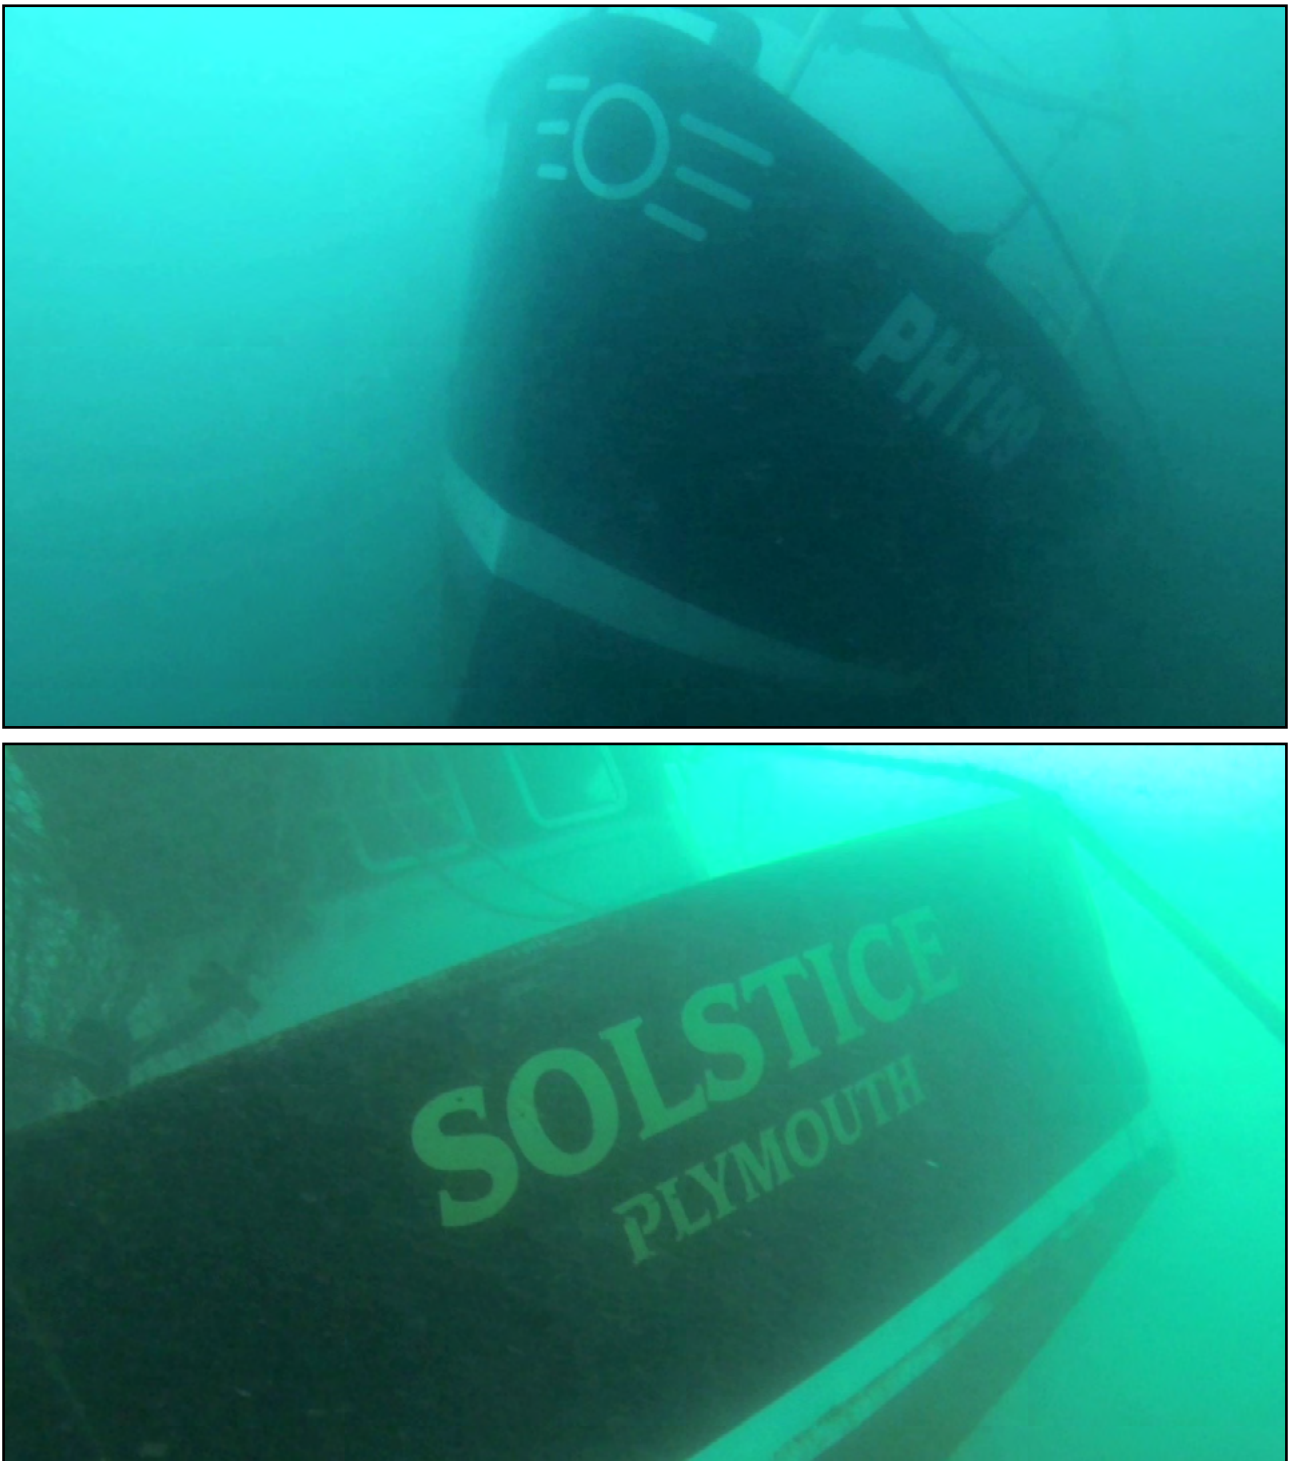
Figure 20: *Solstice* wreck lying upright in 26m of water

- *Solstice* was lying upright on the seabed at a depth of 26m (**Figure 20**).
- Its hull was intact.

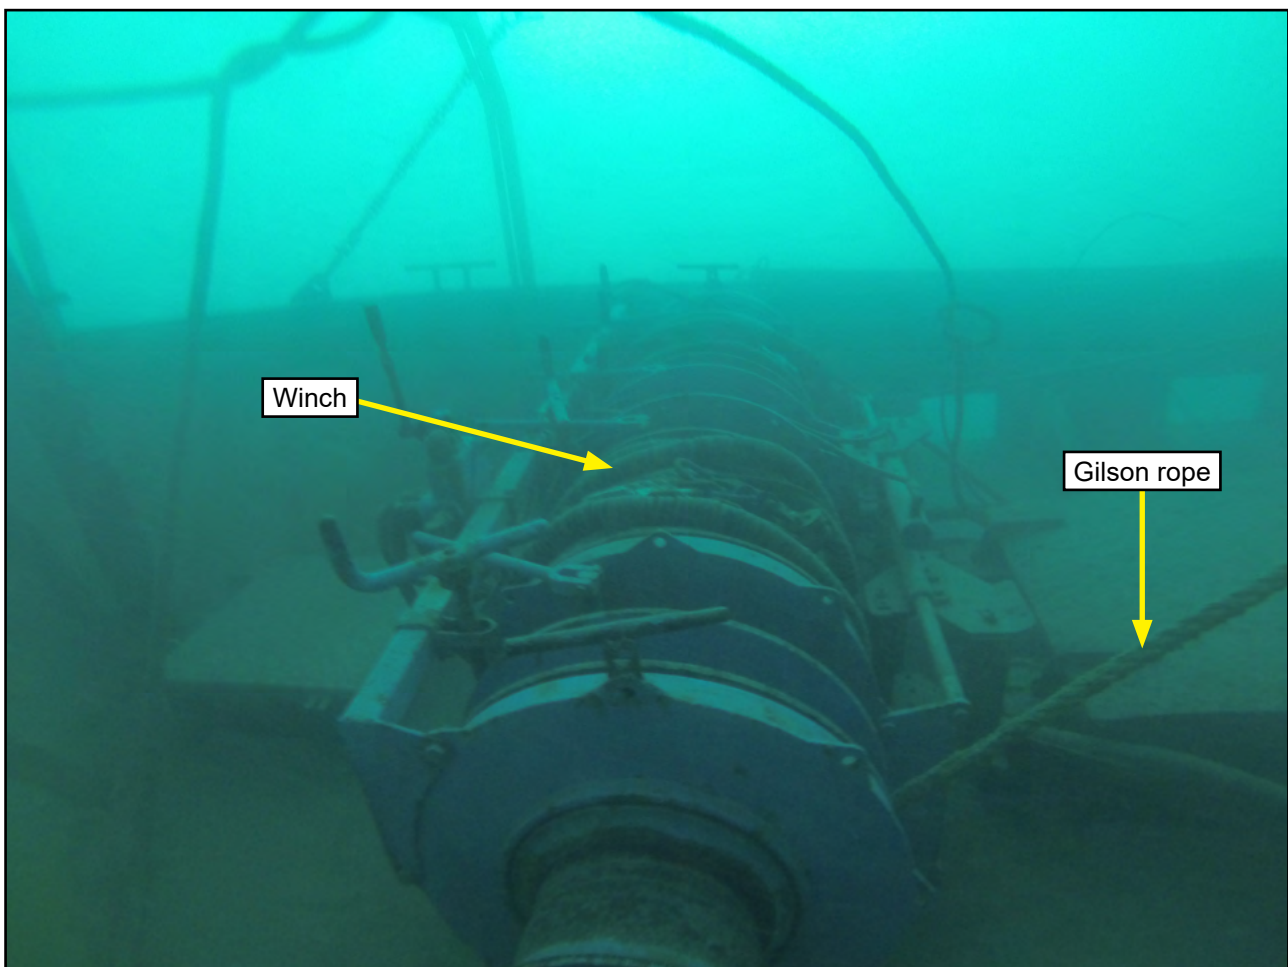
Figure 21: Wreck showing winch and gilson rope

- The gilson rope used to haul the net out of the water was 24mm diameter and was connected to the outer drum on the port side of the forward winch (**Figure 21**). The rope was rove through a block on the port side of the scotch poles to the lifting block at the top of the aft gantry.
- The forward store deck hatch was closed and secured in position by one of its two locking dogs.
- The fish hold hatch cover was in the closed position but was not locked shut.
- The wheelhouse controls (**Figure 22**) indicated that:
 - the forward winch was clutched in;
 - the propeller was de-clutched; and
 - the engine was operating at above idle speed.
- The starboard lifebuoy was still in its cradle (**Figure 23**).
- The aft deck freeing ports were closed and wedged shut (**Figure 24**).
- The mid and forward deck freeing ports were open.

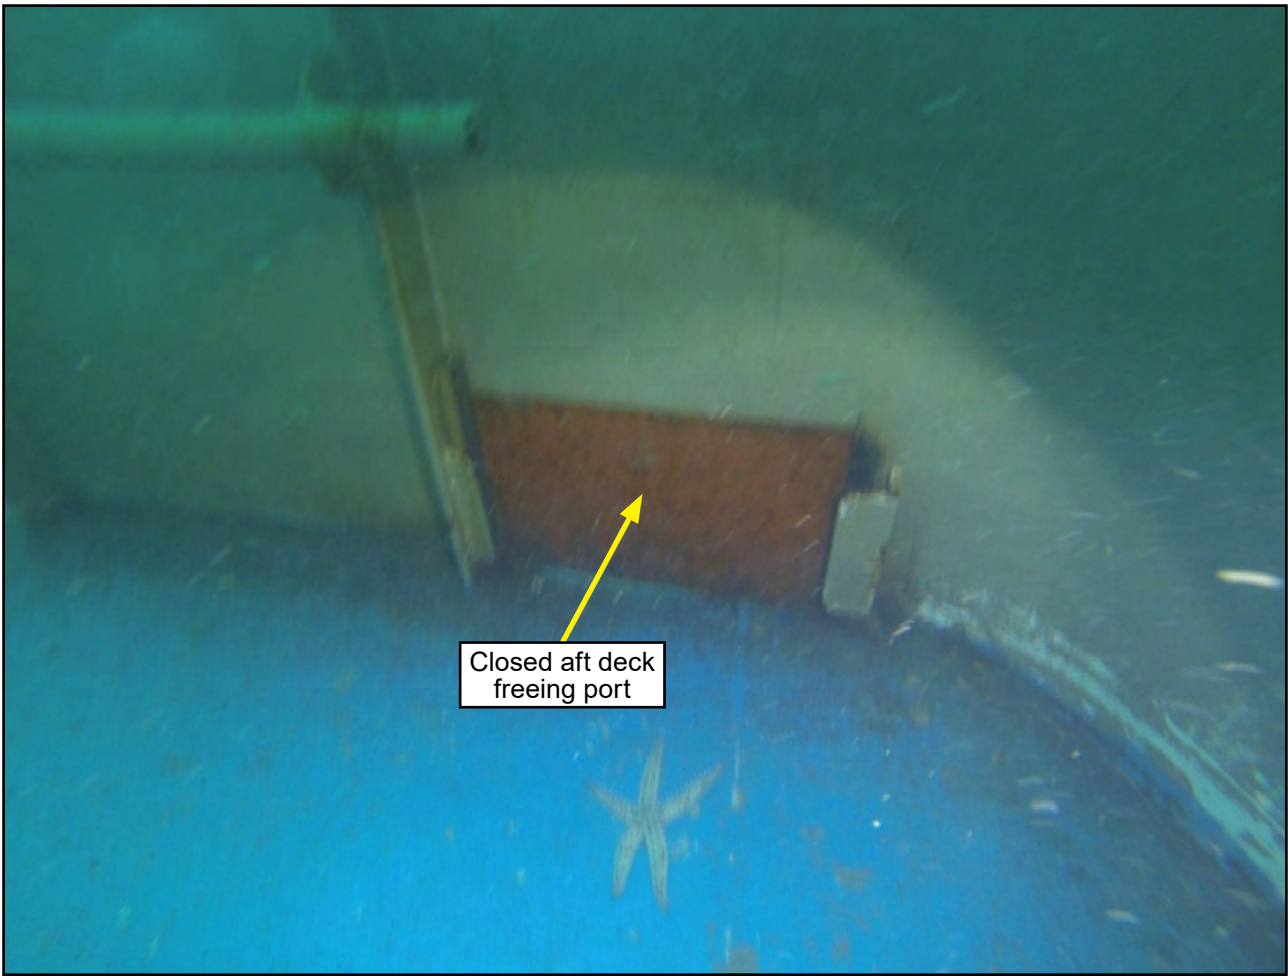
Figure 24: Aft freeing ports, closed and wedged shut

The wreck dive survey identified that the freeing ports on *Solstice's* aft deck had been wedged shut (**Figure 24**). The crew's reasoning for this was understandable as water on the aft deck would have been more problematic to the crew because that was their working area. Furthermore, the likelihood of the aft deck freeing ports being immersed would have been higher when stern trawling. This was because the trawl arms were positioned higher than the hinged dredge warp outriggers, which would have caused the vessel to trim further by the stern and therefore reduce the freeboard aft (**Figure 35**).

It is unlikely that the blockage of the aft freeing ports was a significant factor in this case, given the proximity of *Solstice's* other freeing ports. Nevertheless, any trapped water would have contributed to the capsize.

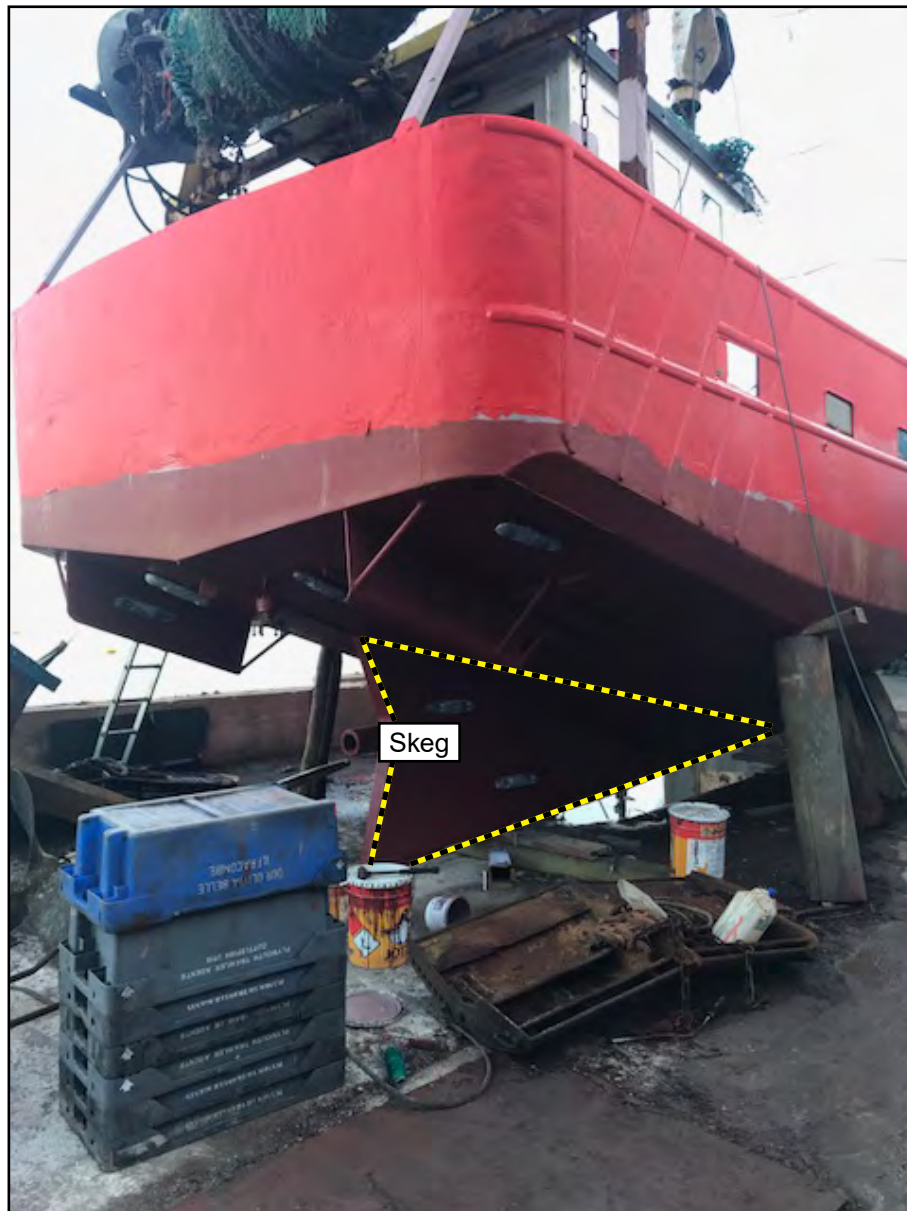
Figure 25: Similar vessel with identical hull design

On 29 September 2017, a fishing vessel with an identical hull design (**Figure 25**) and similar rigging to *Solstice* was roll and heel tested by the MCA at the port of Brixham. The vessel was predominantly engaged as a stern trawler and recovered its catch over the stern.

The roll test identified that the vessel met the requirements for the 'depart port' condition and met the freeboard standards¹⁷, but was deficient when measured against the Heel Test standard.

The report noted that the results did not take account of the type of fishing being undertaken or the loads "seen" by the axis of the net drum or gantry when hauling. The measurements also did not consider the ability of the hull form to provide sufficient reserve buoyancy or stability.

Following the roll test, the vessel owner made several alterations to reduce weight high up. The MCA surveyor recommended the vessel owner to seek additional advice to verify the loadings and limits to the working of fishing gear aft.

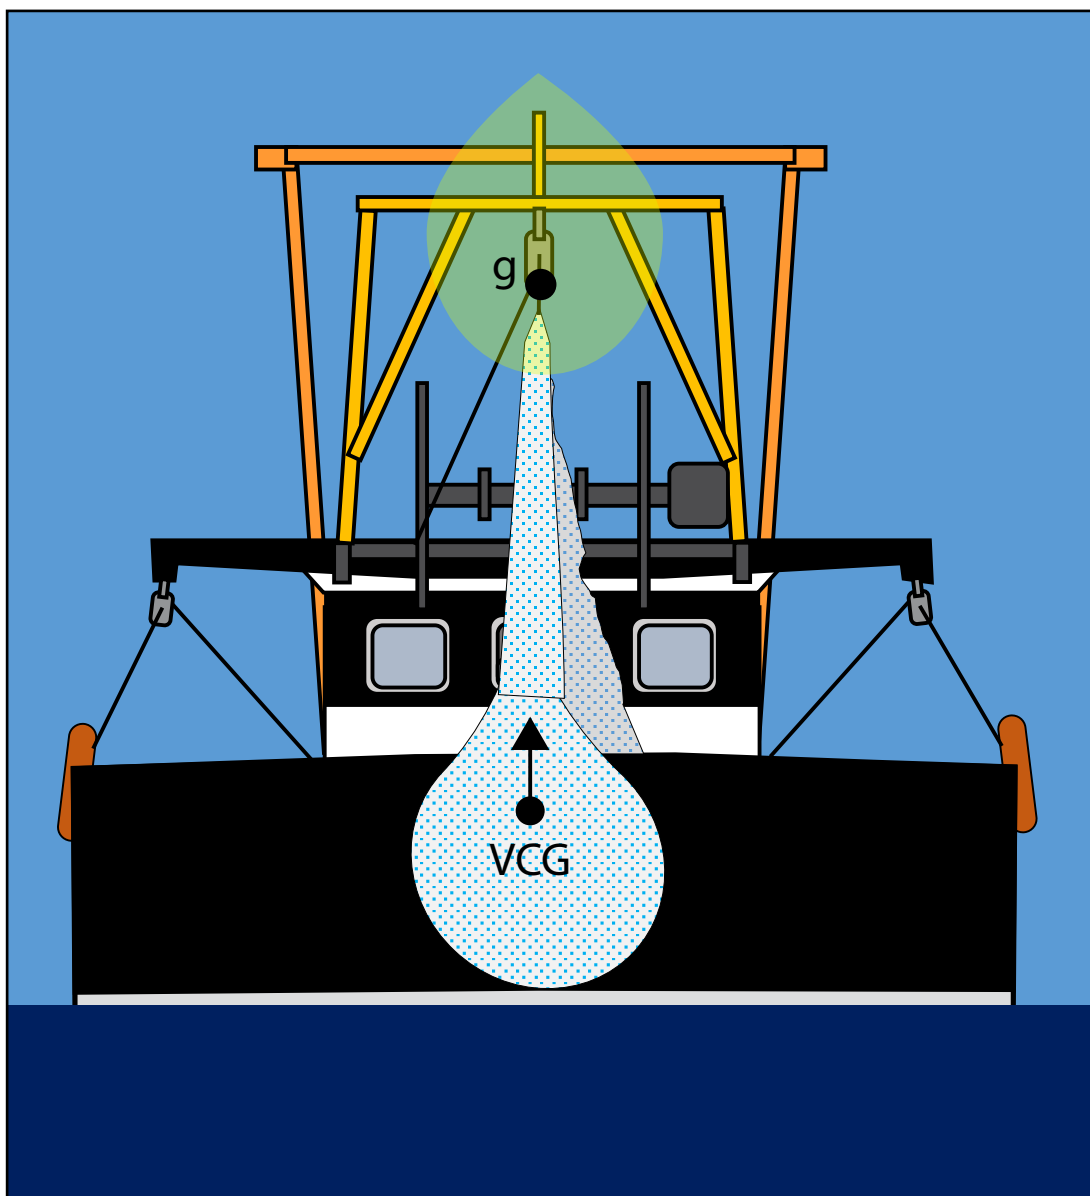
Figure 32: Effect on vessel stability when lifting a weight from a high point

The weight in the net alone would have significantly reduced the vessel's freeboard aft and therefore affected its stability. Using the lifting block rigged at the top of the gantry magnified the problem because the weight of any object acts through the point of suspension. As soon as the cod-end was lifted clear of the water, its VCG and the effect of its full weight would have shifted to the top of the gantry block (**Figure 32**). This would have caused *Solstice's* VCG to move even further upwards, making the vessel dangerously unstable.

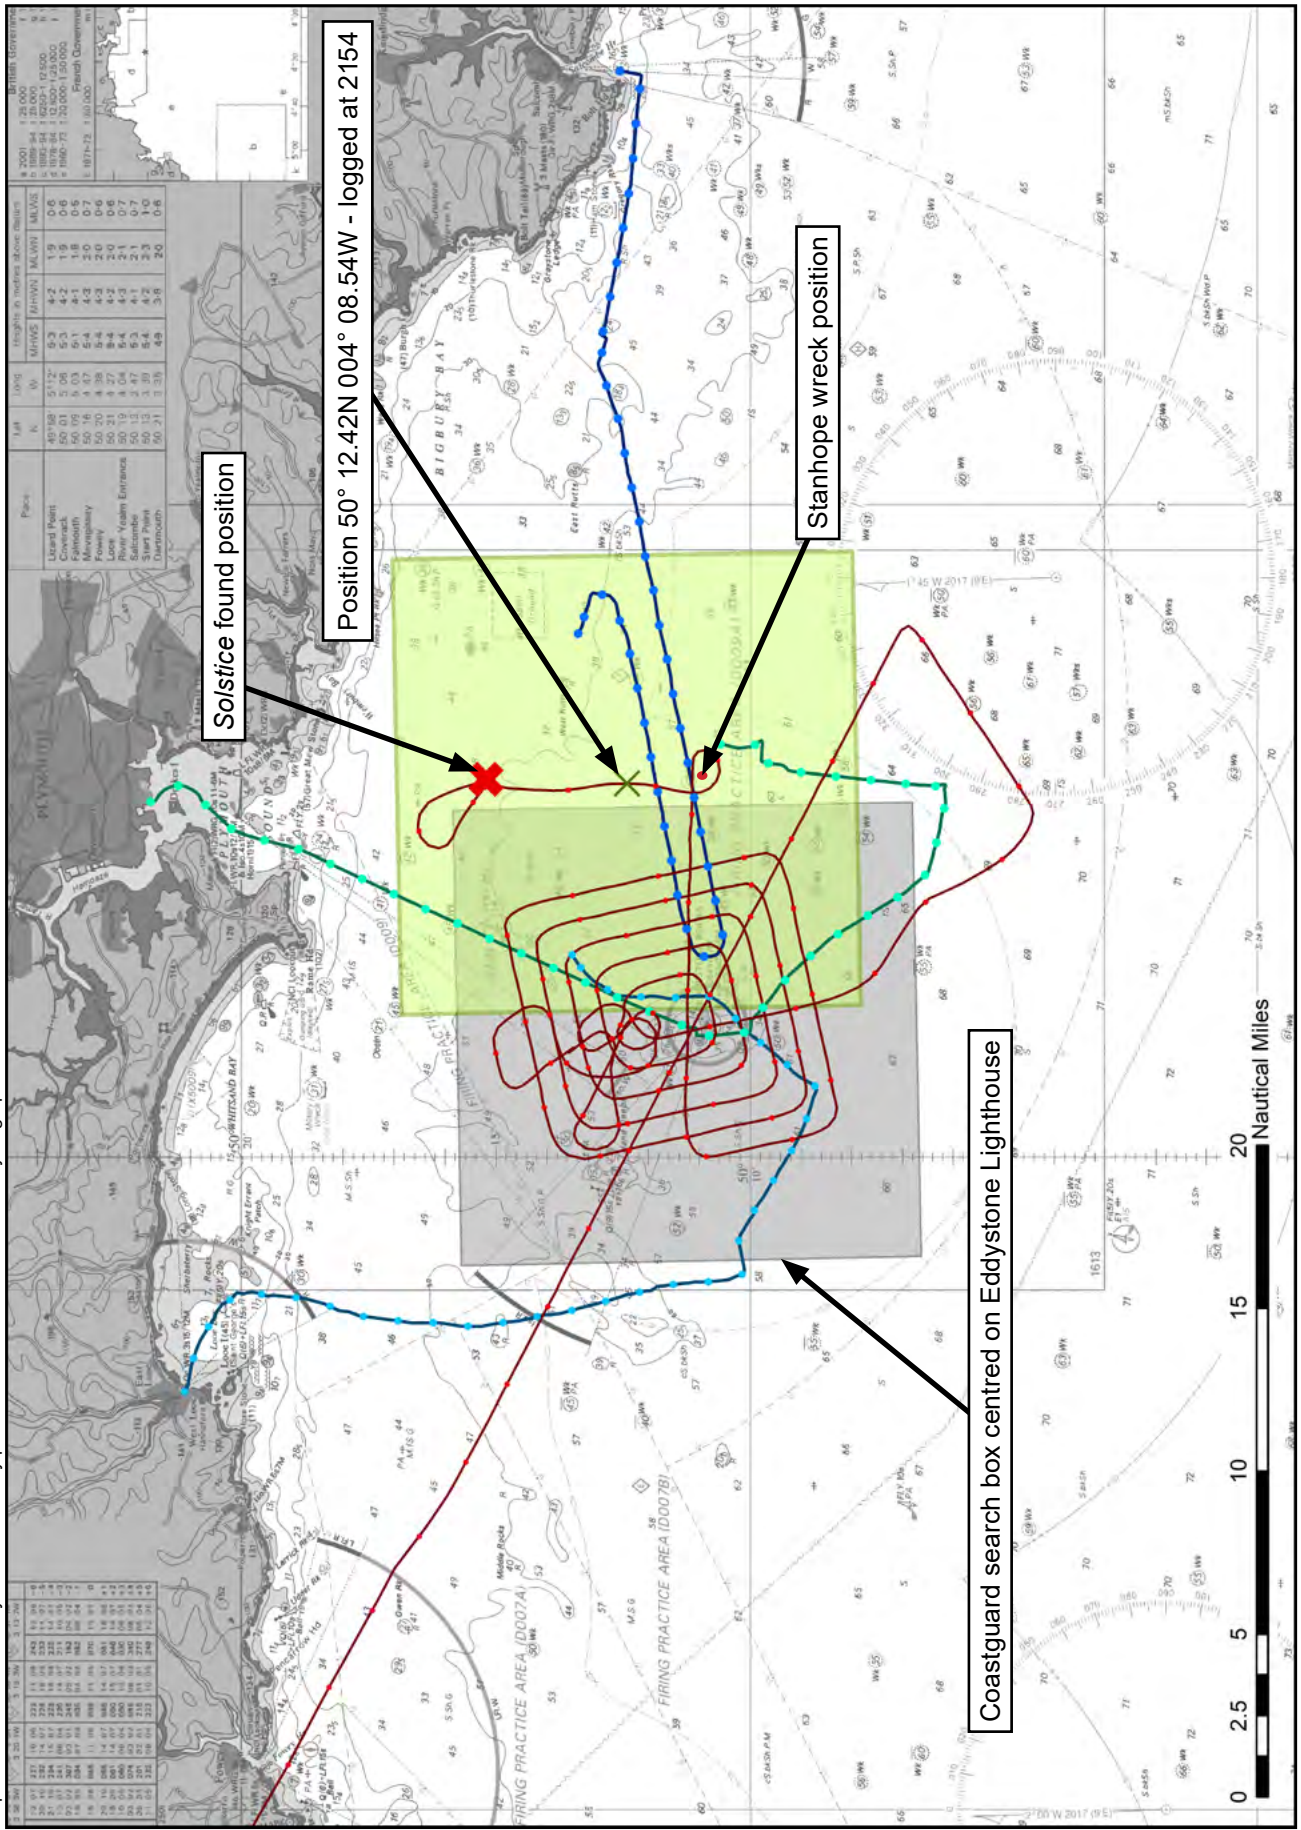
Figure 36: Coastguard search box centred on approximate position logged at 2154

When the lifeboats were launched, and the SAR helicopter tasked, the SMC did not have a detailed plan, so the Eddystone Lighthouse was used as the centre point of the search. This was because the numerous sightings reported by local fishermen (**Figure 28**) were not chronologically logged or charted, and therefore no one had a clear overview of the situation.

The success of a SAR mission often depends on the speed with which the operation is planned and carried out. The prompt collection and evaluation of information, and timely tasking of SAR assets, is therefore critical. In this case the evaluation of the information gathered was slow and the SAR mission planning process was hampered by the SMC's involvement in the initial information gathering and communications search. Had the SMC or the Duty Controller been able to stand back and take an overview, it is likely that the mission would have been escalated to the distress phase much sooner and the search plan centred on *Solstice*'s last reported position (**Figure 36**). In turn, this would probably have resulted in the upturned hull being found and survivors rescued much earlier.
