Extract from The United Kingdom Merchant Shipping (Accident Reporting and Investigation) Regulations 2012 – Regulation 5:

© Crown copyright, 2019

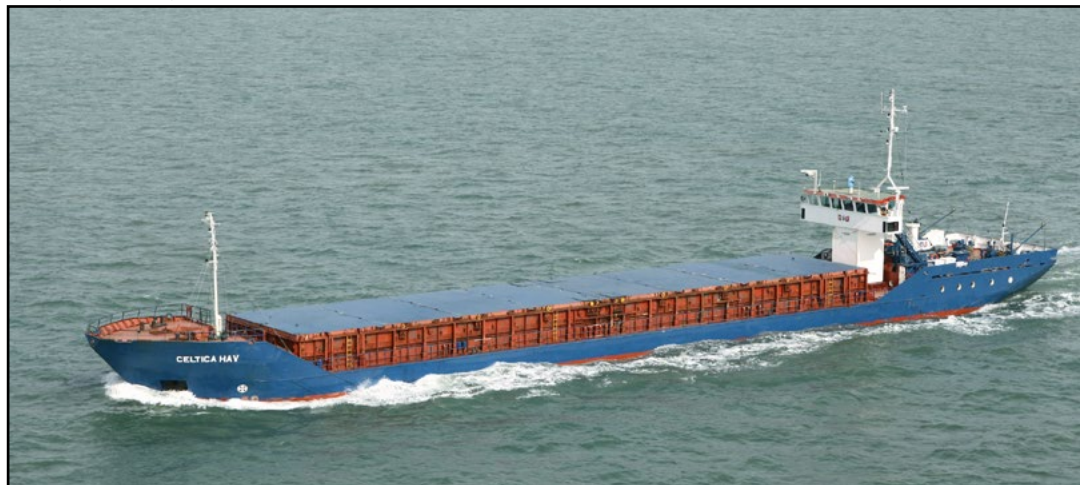
Photograph courtesy of www.fotoflite.com

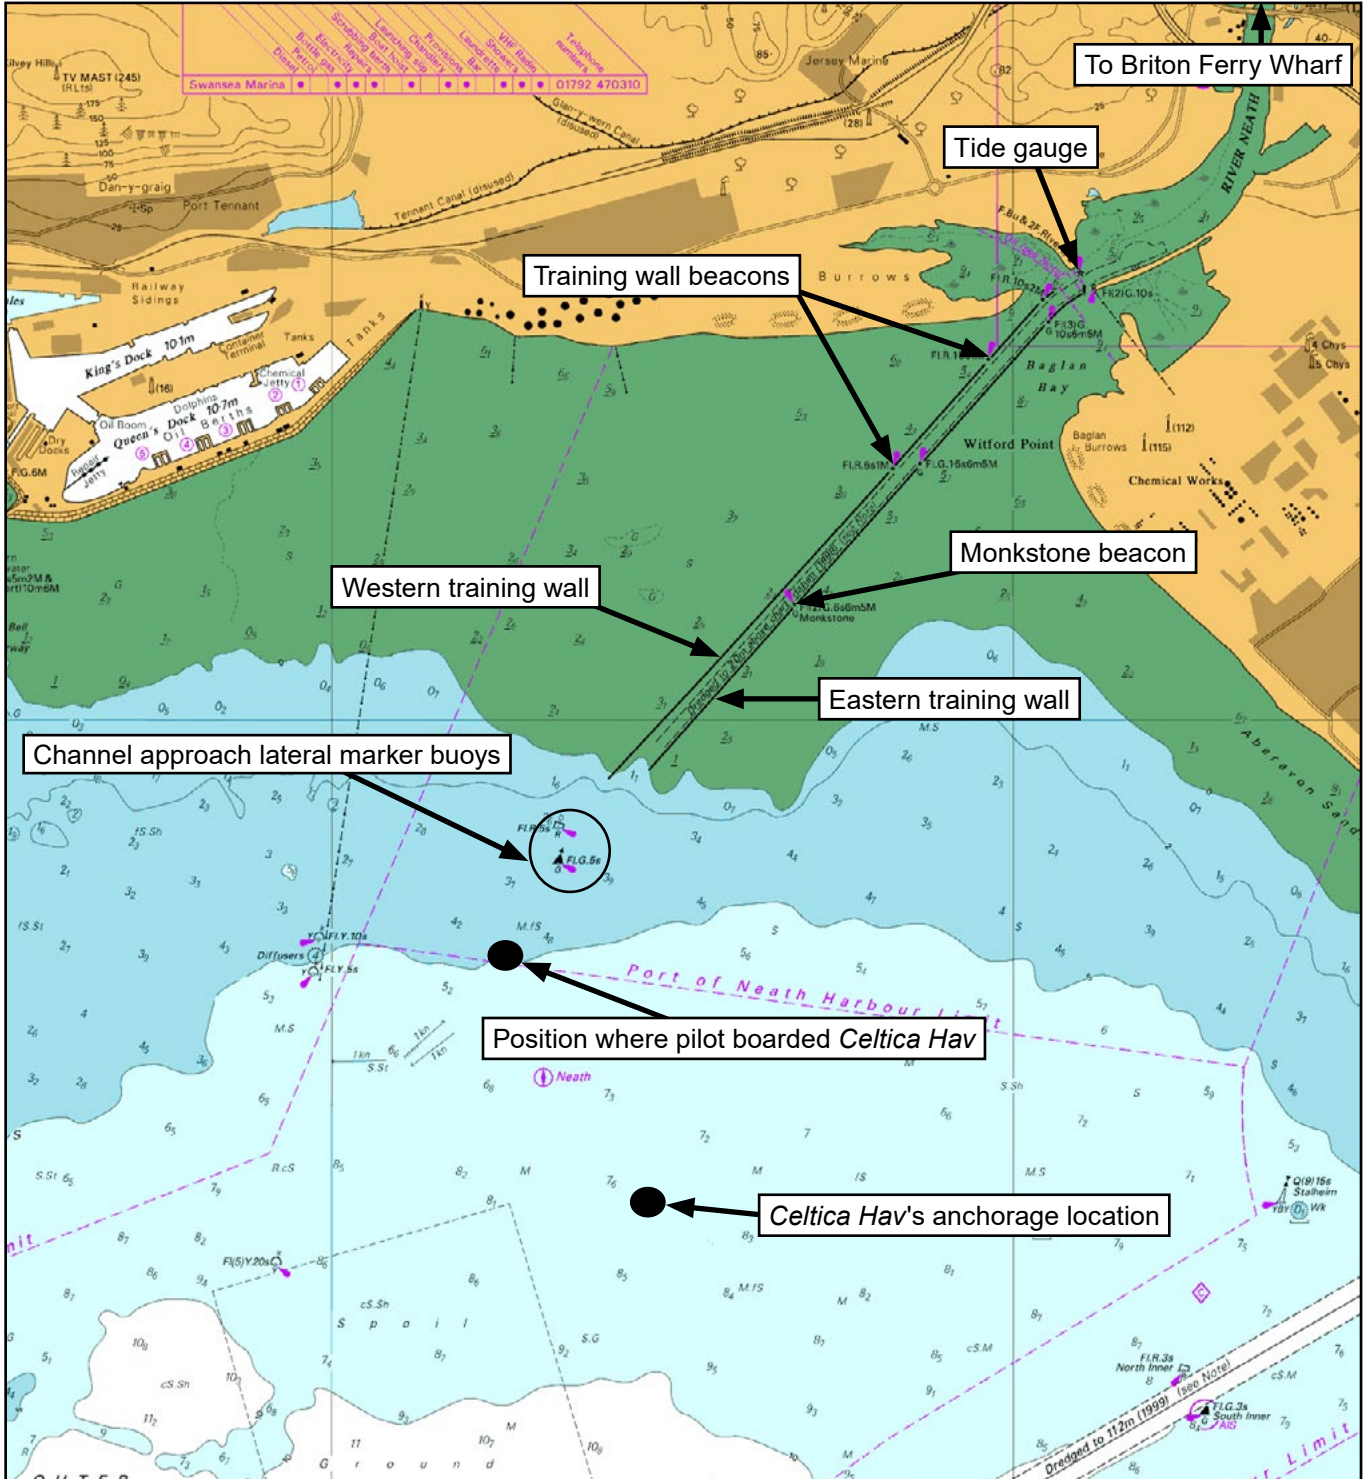
Figure 1: Chart extract showing key locations

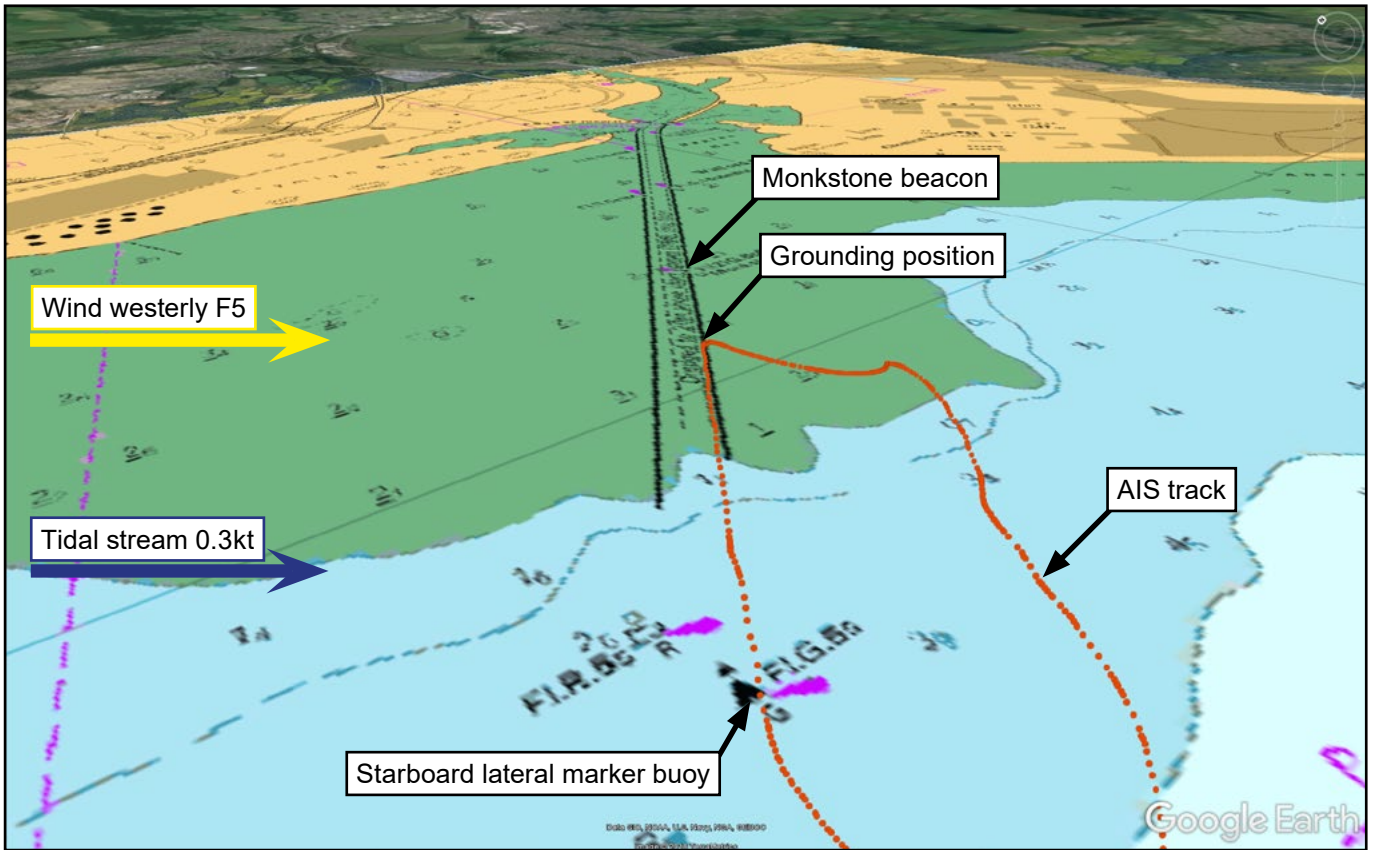
Figure 2: Track of *Celtica Hav*

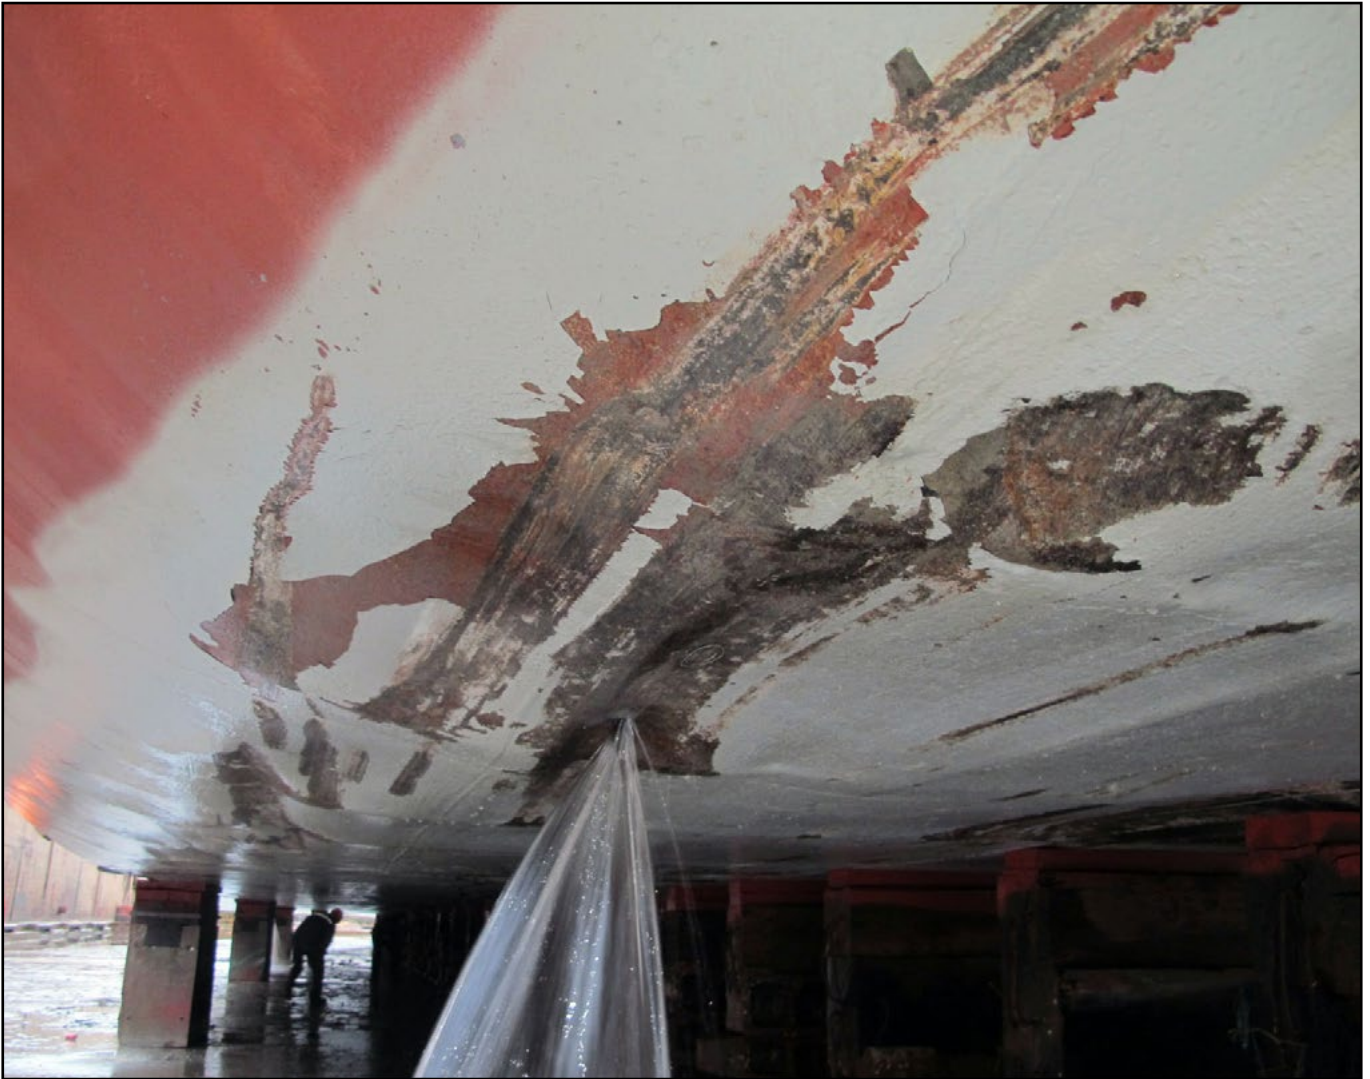
Figure 4: *Celtica Hav* hull damage
