## MARINE SAFETY INVESTIGATION REPORT

Safety investigation into the grounding of the  
Togo registered oil tanker

***HEPHAESTUS***

MARINE SAFETY INVESTIGATION REPORT NO. 03/2018

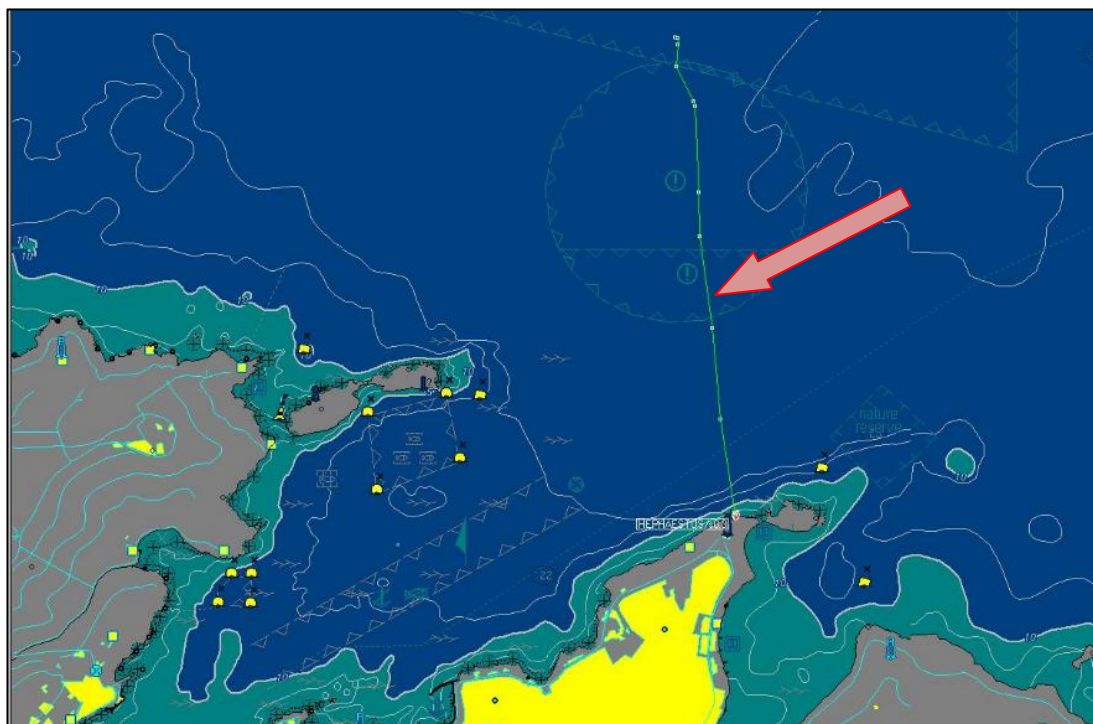
By 0611, the Northerly wind backed to Northwest by North was gusting to Force 10. Valletta VTS called again the vessel and again warned the master that he was running into danger and that he had to manoeuvre further out or drop the second anchor. Valletta VTS also asked the master if he required any assistance but the master replied again that he needs five minutes to start the engine. At this point, Valletta VTS informed the master that in five minutes time, his ship would be on the rocks. The vessel ran aground at about 0615 in position  $35^{\circ} 57.61' N$   $014^{\circ} 25.51' E$ , heeling heavily to her port side. The vessel's AIS track throughout this period is shown in Figure 5 and tabulated in Table 3<sup>11</sup>.

**Figure 5: Hephæstus AIS track**

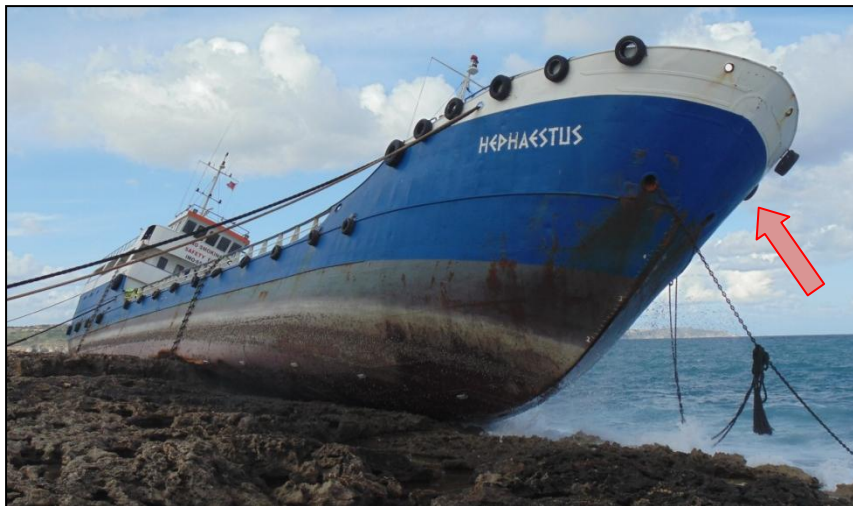
During the course of the safety investigation, the crew members confirmed that the main engine was never started. According to the master, the vessel felt like being hit by a cyclone and she drifted very quickly towards the shoreline, giving the crew members very little time to get the main engine started. No order was given by the master to release of the port anchor to slow down the drift of the vessel. At the time of the grounding, the vessel did not have a port anchor and chain (Figure 6).

**Figure 6: *Hephaestus* ground with her port anchor and chain missing**

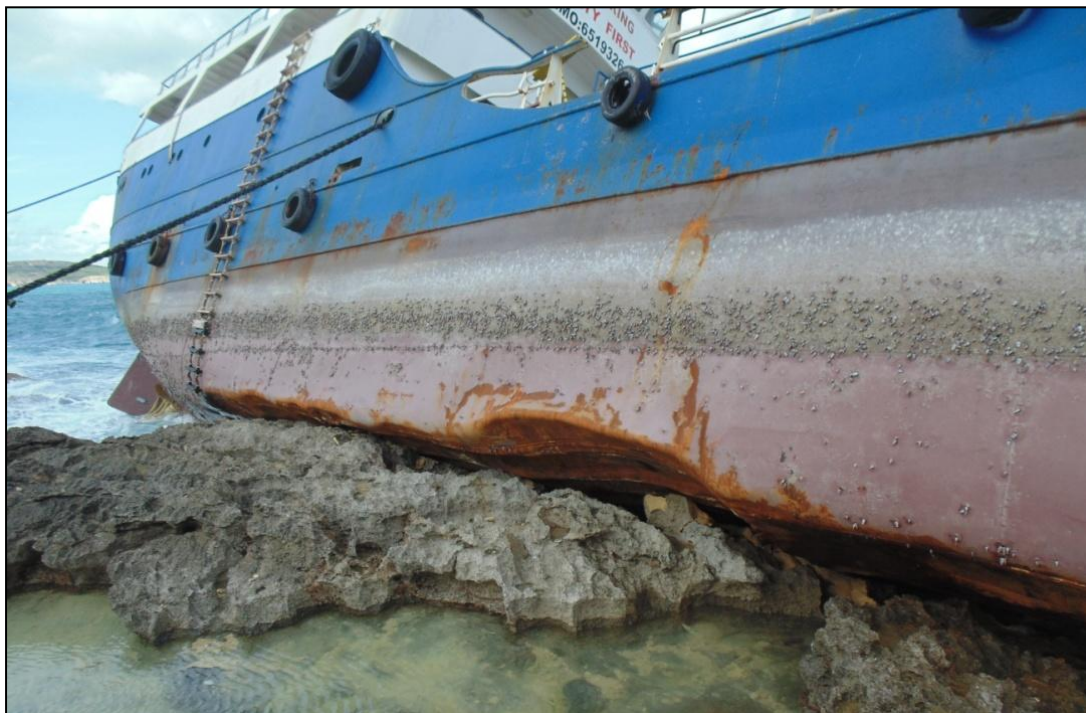
It was evident that the vessel had sustained extensive structural damages as a result of her grounding (Figures 8 and 9). Her starboard side bottom shell plating was deeply set in and buckled with structural damages also to her internal stiffeners.

**Figure 8: Bottom shell plating set in following the grounding**

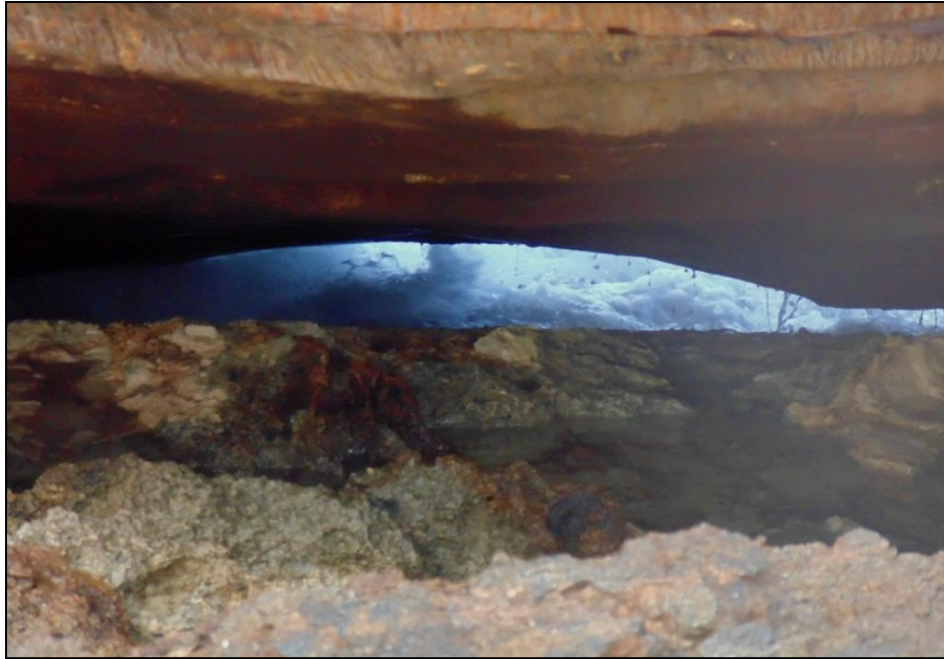
**Figure 9: Bottom shell plating damage**

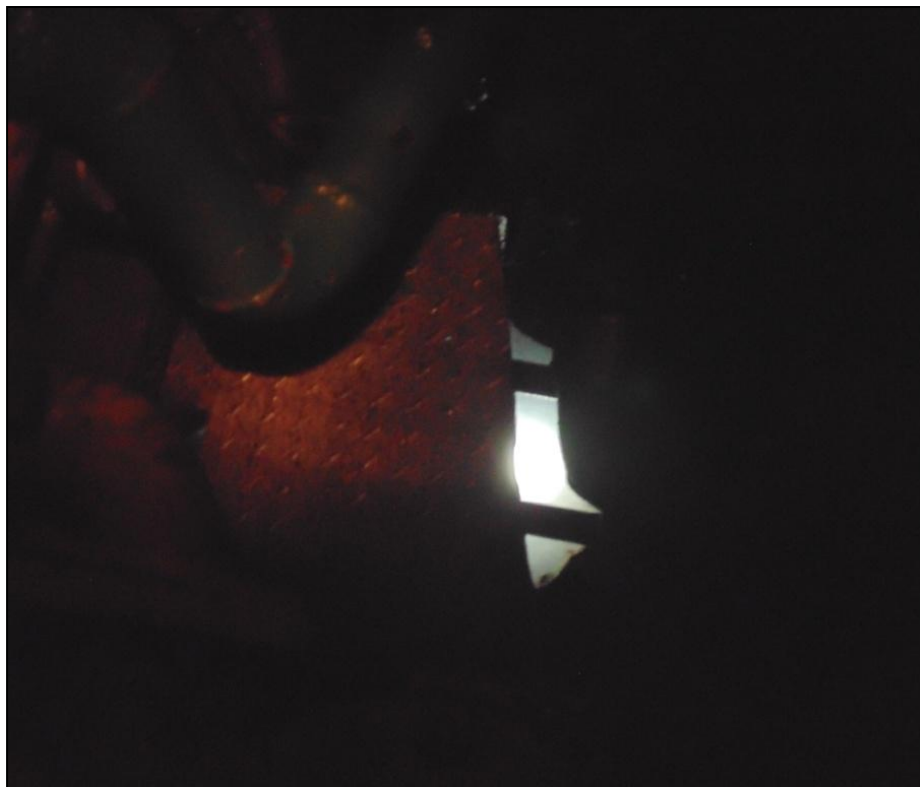
The bottom shell plating in way of the engine-room was also damaged. Natural light was observed coming through the damaged bottom (Figure 10). The access manhole to cargo oil tank (COT) no. 6 port suggested that there was sloshing inside the tank and it was evident that the COT was tidal.

**Figure 10: Damaged bottom shell plating in way of the engine-room**

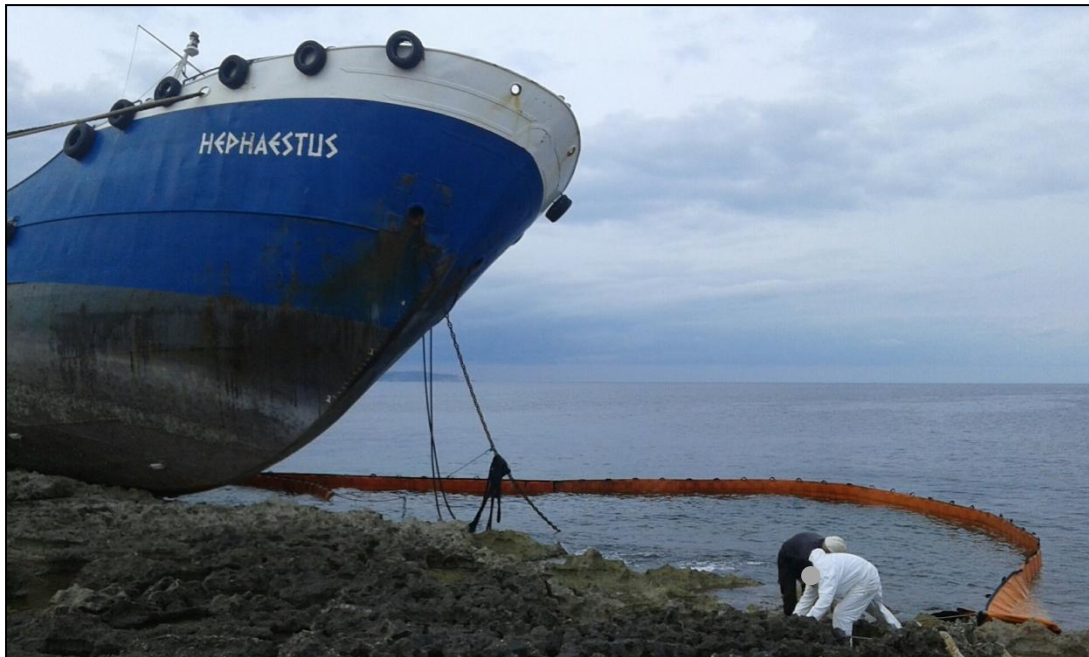
According to the chief engineer, at the time of grounding the vessel had on board around six tonnes of diesel oil in her bunker tanks. Several days after the grounding, a small amount of diesel oil escaped the damaged hull. An oil boom was deployed to contain the spill (Figure 11), which caused damages neither to the surrounding shore line nor to the marine life.

Figure 11: Oil boom being deployed to contain the light oil sheen

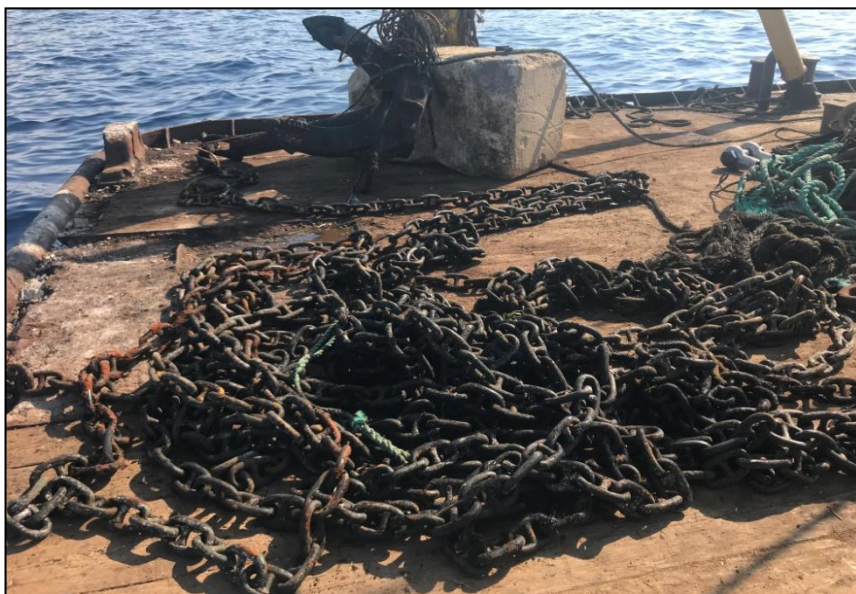
*Hephaestus* was anchored in water depth of around 49.0 m and hence the vessel should have had a length of 294.0 m of cable laid out in fair weather, while 490.0 m of cable would have been required in inclement weather conditions. However, while the vessel had 4.5 shackles of anchor cable in the water, (which is equivalent to a length of 123.75 m), the vessel was only fitted with approximately 165.0 m (Figure 13). To this effect, the anchor holding power was less effective in this depth.

When *Hephaestus* started dragging her starboard anchor, the remaining anchor cable was not paid out.

**Figure 13: Anchor cable and starboard anchor after being retrieved by the salvor**

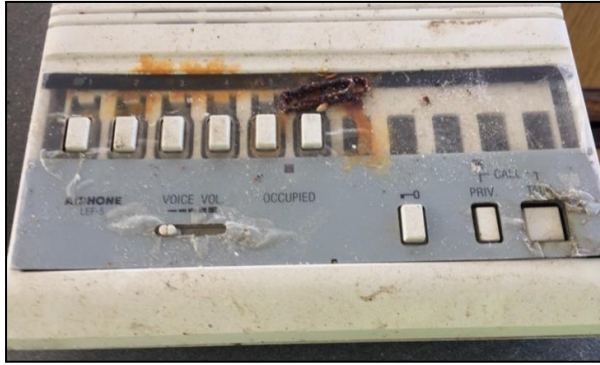
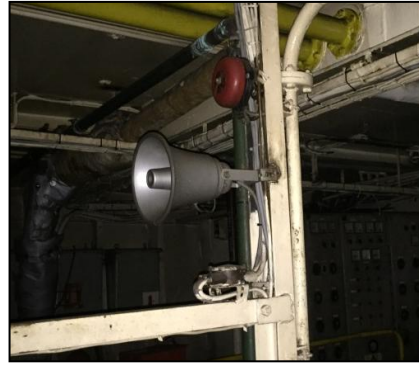
fitted on board (Figures 14a and 14b) was a one-way communication system from the bridge to other areas and not *vice versa*). In fact, when the chief officer eventually requested the chief engineer to start the main engine, the vessel ran aground soon after.

**Figures 14a and 14b: PA system on the bridge and PA loudspeaker in the engine-room**

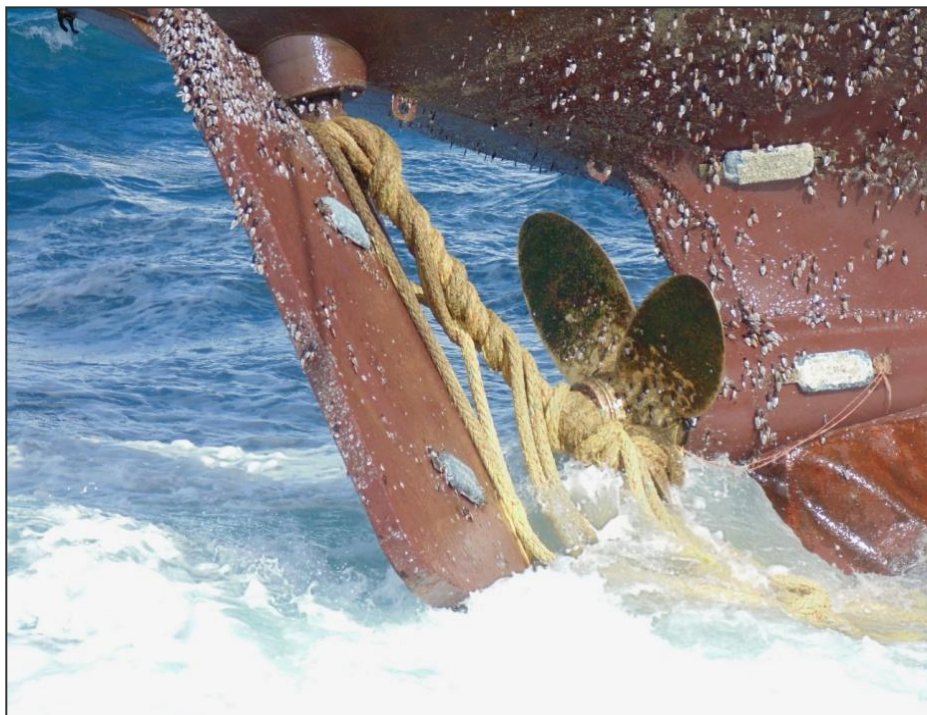
With reference to the propulsion power, the MSIU observed that the rope fouling one of the propeller blades and the rudder stock (Figure 15) was actually a mooring rope which may have been lost from *Hephaestus*' poop deck. While it was not possible to determine at what stage the mooring rope was lost overboard, this did not have a bearing on the outcome of the events, given that the main engine was not started prior to the grounding.

**Figure 15: Mooring rope fouling one of the propeller blades and the rudder stock**

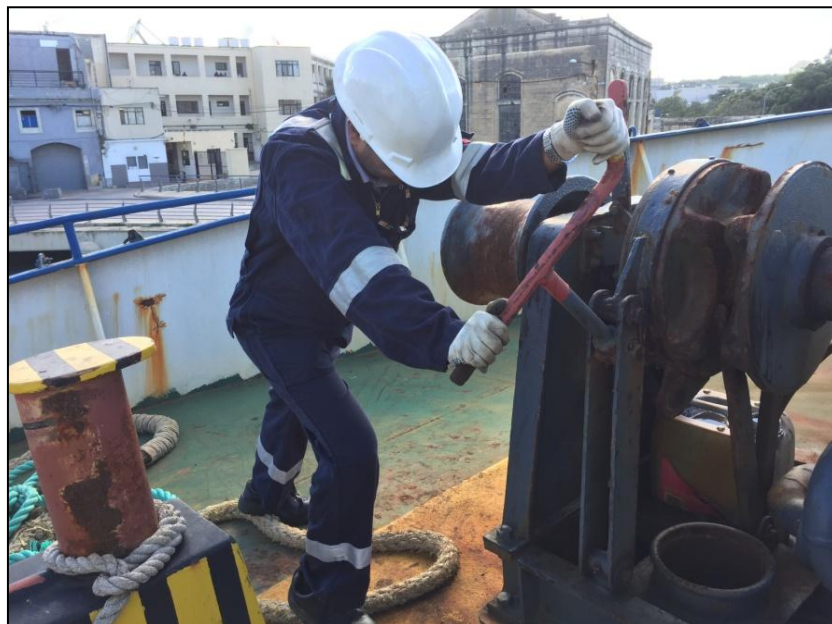
After the vessel was refloated, MSIU safety investigators went on board and further to the missing port anchor and chain, they also found that the port anchor windlass brake was jammed closed (Figure 16) but with no indications of fresh damages which, perhaps, would have been indicative of anchor chain slippage (Figure 17).

**Figure 16: Jammed port side windlass brake**

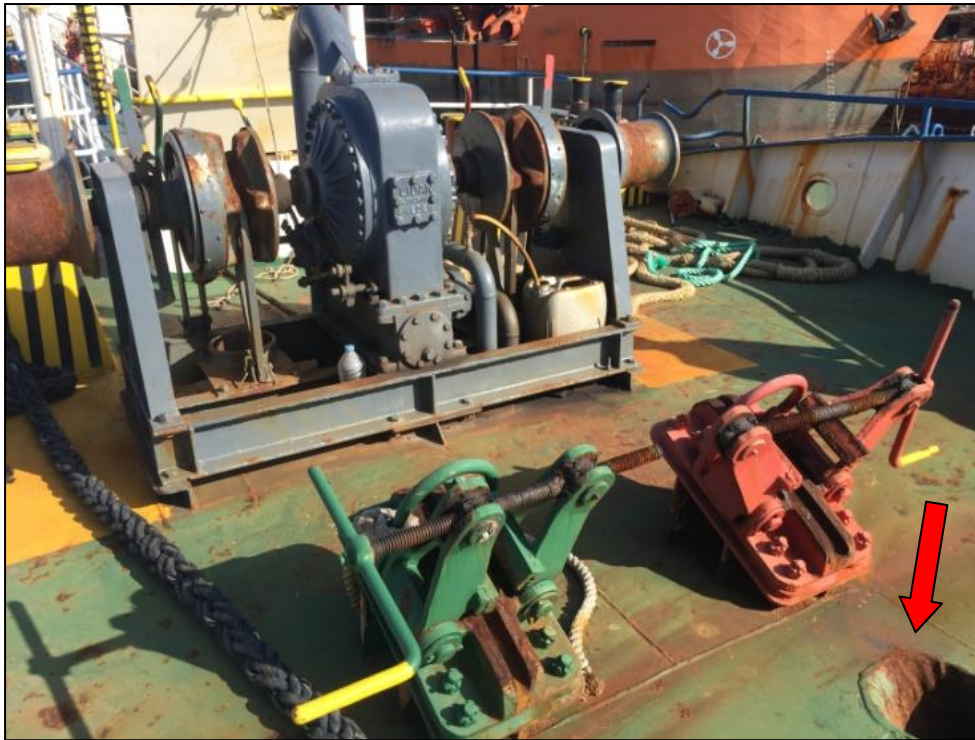
**Figure 17: No visible fresh damages on the port side hawse pipe**

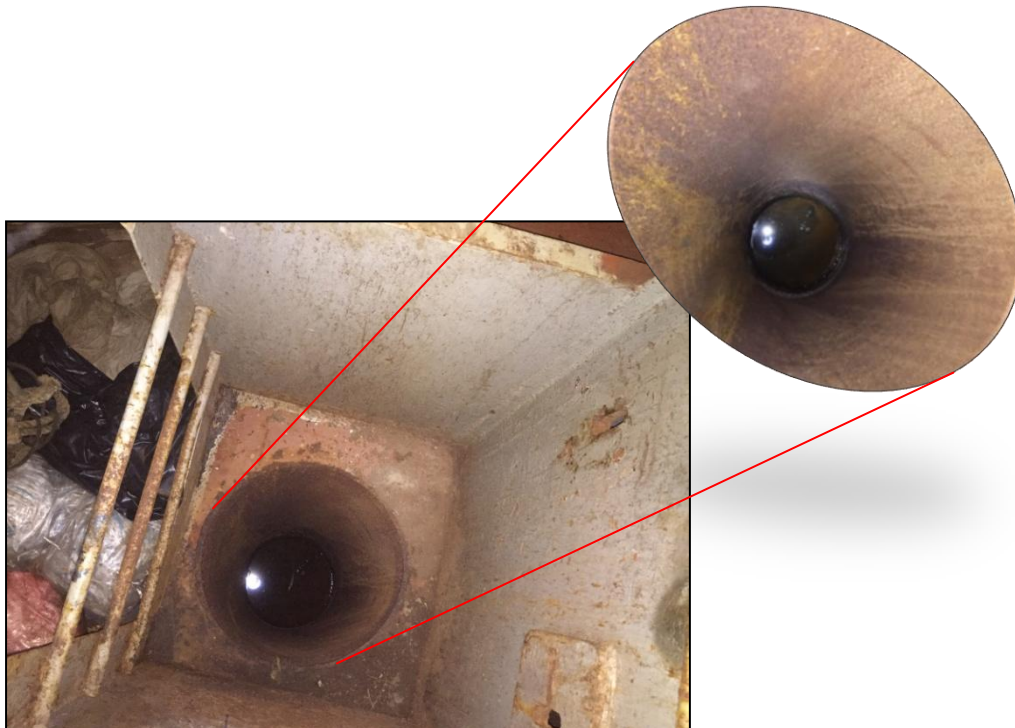
The safety investigators did not have access to the chain locker due to the relatively small diameter and the presence of water and mud. The MSIU was therefore unable to inspect the condition of the bitter end on the port side (Figure 18).

**Figure 18: Port side chain locker**
