MA2019-2

**MARINE ACCIDENT
INVESTIGATION REPORT**

Accident type	Fatality of a crew member
Date and time	Around 17:26 on September 18, 2018 (local time, UTC+9 hours)
Location	Mitsubishi Naoshima wharf, Naoshima-cho, Kagawa Prefecture On a true bearing of approximately 236° and at a distance of 460 meters from Sanuki Terashima lighthouse (approximately 34° 28.7' N, 133° 58.1' E)
Summary of the Accident	At around 17:26 on September 18, 2018, while the cargo vessel ERIK was moored at the Mitsubishi Naoshima wharf, with the master and 14 crew members on board, 4 crew members were performing the cleaning work of the upper hatch coaming of the cargo holds after unloading cargo, and an able seaman fell from the upper deck to the bottom floor of the cargo hold. The able seaman was pronounced dead after being conveyed from the cargo hold.
Process and Progress of the Investigation	(1) Set up of the Investigation On September 19, 2018, the Japan Transport Safety Board appointed an investigator-in-charge and four other marine accident investigators to investigate this accident. (2) Collection of Evidence September 19 and 20: On-site investigations and interviews October 3: Collection of quest

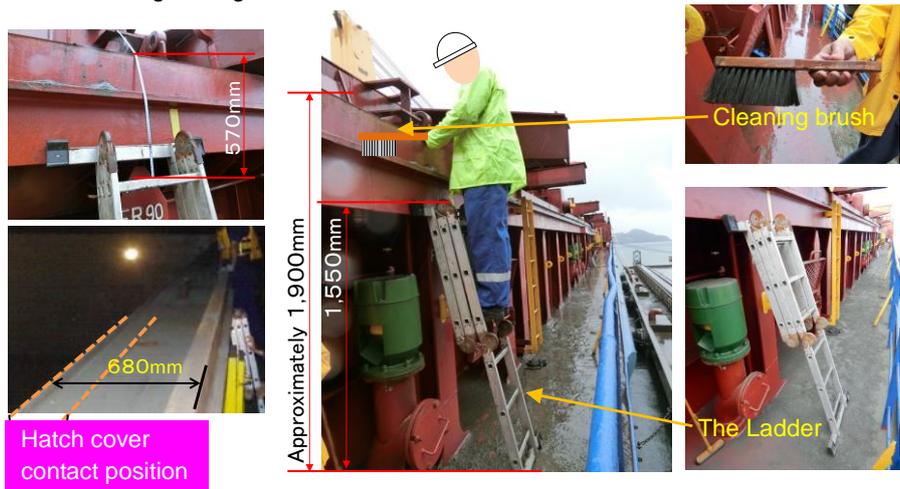
Photo 2 Environment of cleaning work and cleaning tools

The cleaning work was an item of routine works taking about 30 minutes, with the aim of maintaining the watertightness of the cargo hold. To prevent water invasion between the hatch cover of the cargo hold and the hatch coaming, the crew members were sweeping cargo mineral dust using portable ladders (hereinafter referred to as “the Ladder”) and cleaning brushes after the cargo unloading operation. At the time of the accident, the cleaning work was being carried out in the same way as usual. (See Photo 2)

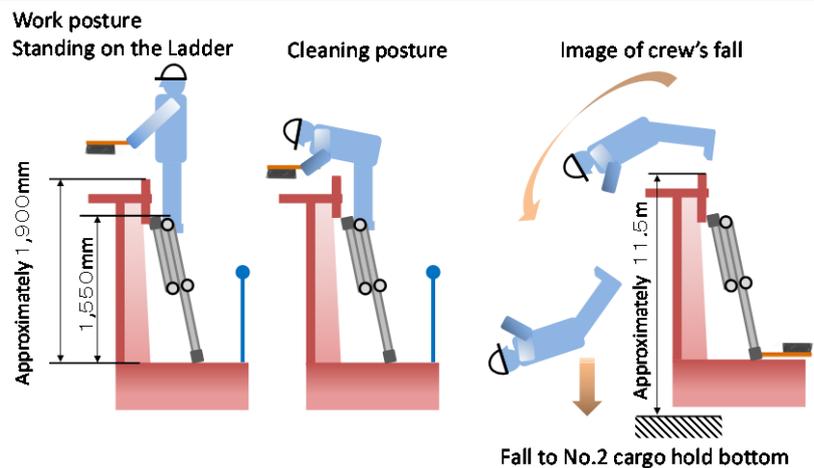
Figure 3 Work posture on the Ladder and situation of fall

When doing the cleaning work, Crew Member D, who was at the aft starboard side of the No. 2 cargo hold, saw that Crew Member A's upper body from his thigh was higher than the top of the hatch coaming on the upper deck starboard side of the No. 2 cargo hold, and that he was doing the cleaning work utilizing the cleaning brush.

Crew Member D looked at Crew Member A, who came to be in an unstable posture and fell forward, then twisted his body and tried to clutch at the upper hatch coaming of the No. 2 cargo hold with his left hand. However, he fell head-first with his back facing downward to the bottom of the No. 2 cargo hold at around 17:26.

④ According to Figure 3 and Photo 3 in “Events Leading to the Accident”, while engaged in the cleaning duty, Crew Member A did not support his body with three points of contact and over-reached on the Ladder.

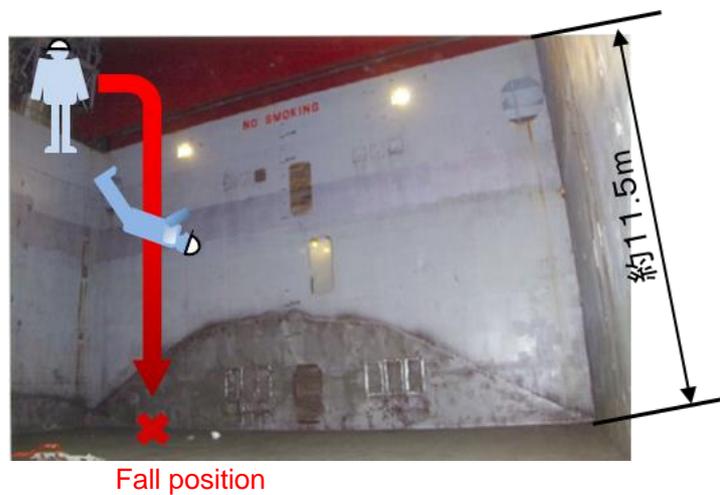
Photo 3 No. 2 cargo hold and fall location of Crew Member A

At the same time, Crew Member B heard the sound of something falling when he was walking toward the stern in the passage of the No. 2 cargo hold port side on the upper deck. Crew Member B then looked out into the interior of the No. 2 cargo hold and noticed Crew Member A lying on his back on the cargo hold floor. Crew Member B descended the stairs to the floor to confirm the condition of Crew Member A, where it appeared that Crew Member A was no longer breathing.

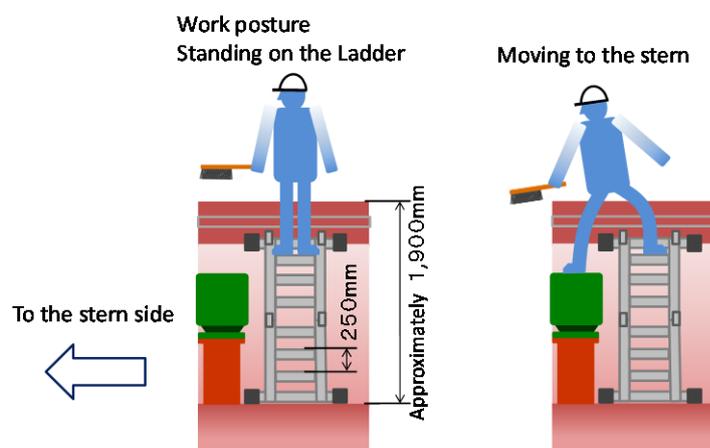
Figure 4 Image of moving the Ladder

N. Officer A and N. Officer B knew that this method of moving the Ladders was being carried out in everyday work. Figure 4 shows the image of moving the Ladder.

⑤ According to item (2)⑥ in “Other Matters”, the Ladder pulling and removing methods did not involve Crew Member A facing the Ladder.

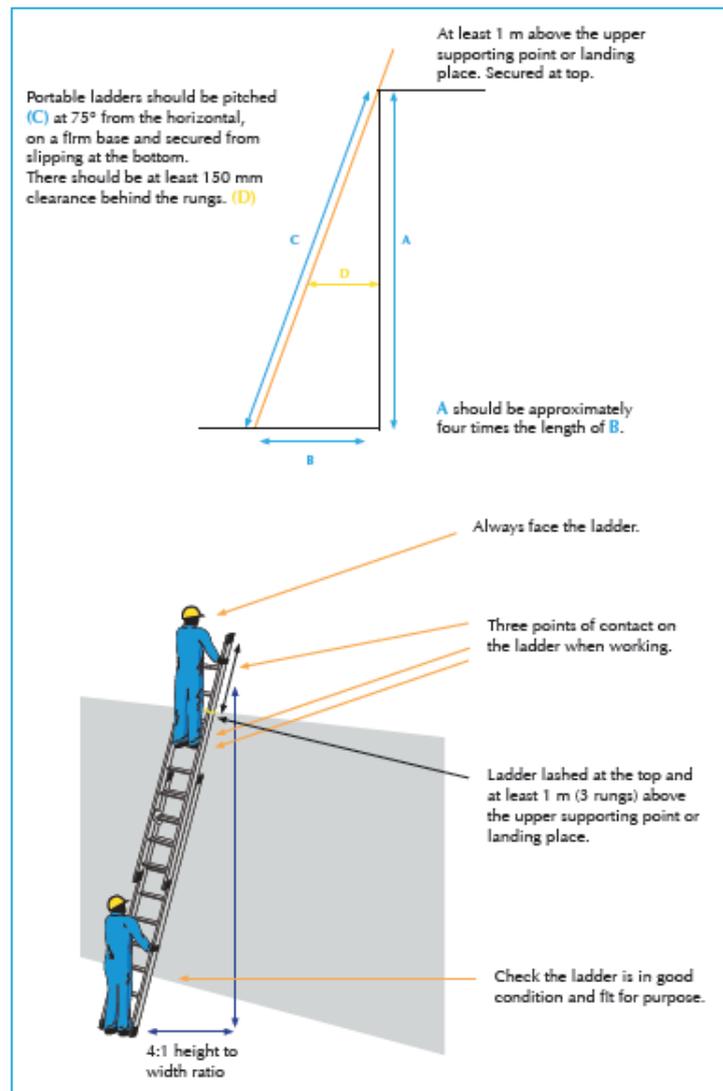
Figure 5 Ladder guidelines in the CSWP
Published by the Maritime & Coastguard Agency, UK

- a. Portable ladders are lashed at the top and the upper supporting point.
- b. Portable ladders should extend to at least 1 m (3 rungs) above the upper supporting point or landing place.
- c. Portable ladders should be pitched at 75° from the horizontal.

- d. There should be three points of contact on a portable ladder when working.
- e. The body should always face the portable ladder.
- f. Personnel must use a safety harness with a lifeline secured above the work position, where practicable.

① The Ladder was not lashed at the top and at the contact point on the deck.

② The Ladder was not extended above the upper supporting point and the top of the cargo hatch coaming, therefore the top of the Ladder was 570 mm lower than the top of the cargo hatch coaming.

③ The Ladder was pitched at around 79° from the horizontal.

3. Krey Schiffahrts GmbH & Co. KG should have all the vessels operated by the Company observe the portable ladder guidelines in the chapter “WORK AT HEIGHT” of the “Code of Safe Working Practices for Merchant Seafarers”. On the other hand, Krey Schiffahrts GmbH & Co. KG should take other safety measures for all the vessels operated by the Company including changing the use of the portable ladder if it seems that it is difficult to conform to the portable ladder guidelines in the cleaning work.
