MA2019-2

**MARINE ACCIDENT
INVESTIGATION REPORT**

Accident type	Fatality of a crew member
Date and time	Around 17:26 on September 18, 2018 (local time, UTC+9 hours)
Location	Mitsubishi Naoshima wharf, Naoshima-cho, Kagawa Prefecture On a true bearing of approximately 236° and at a distance of 460 meters from Sanuki Terashima lighthouse (approximately 34° 28.7' N, 133° 58.1' E)
Summary of the Accident	At around 17:26 on September 18, 2018, while the cargo vessel ERIK was moored at the Mitsubishi Naoshima wharf, with the master and 14 crew members on board, 4 crew members were performing the cleaning work of the upper hatch coaming of the cargo holds after unloading cargo, and an able seaman fell from the upper deck to the bottom floor of the cargo hold. The able seaman was pronounced dead after being conveyed from the cargo hold.
Process and Progress of the Investigation	(1) Set up of the Investigation On September 19, 2018, the Japan Transport Safety Board appointed an investigator-in-charge and four other marine accident investigators to investigate this accident. (2) Collection of Evidence September 19 and 20: On-site investigations and interviews October 3: Collection of quest

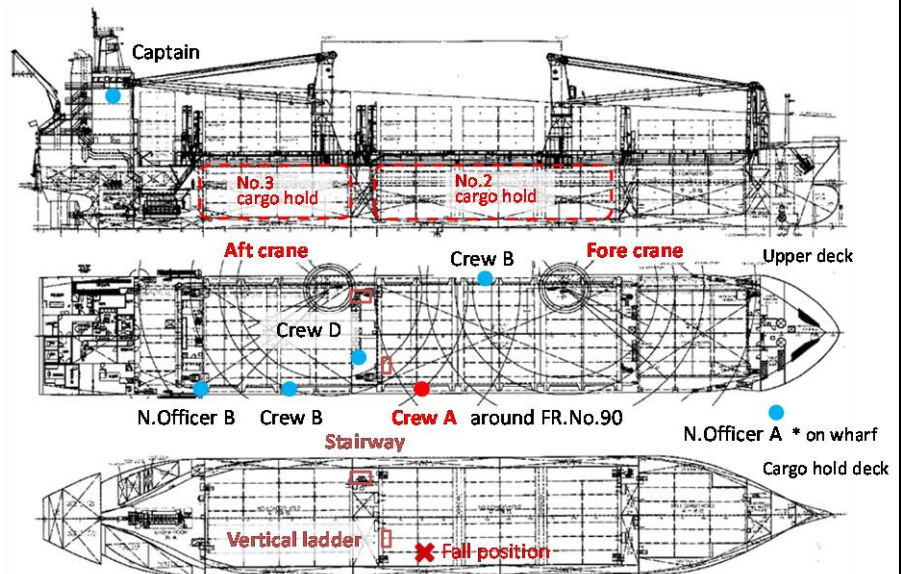
Figure 2 Position of crew members in general arrangement

The four crew members (Crew Member A, the boatswain (hereinafter referred to as “Crew Member B”), the other able seaman (hereinafter referred to as “Crew Member C”) and the ordinary seaman (hereinafter referred to as “Crew Member D”)) started “the cleaning work of the upper hatch coaming of the cargo holds on the upper deck” (hereinafter referred to as “the cleaning work”) at around 17:23 in the arrangement as shown in Figure 3.

A management-level navigation officer (hereinafter referred to as “N. Officer A”) was also measuring the vessel’s forward draft on the wharf while commanding the cleaning work.

The other navigation officer (hereinafter referred to as “N. Officer B”) was keeping the watch duty at a position around the starboard gangway and saw the four crew members working.

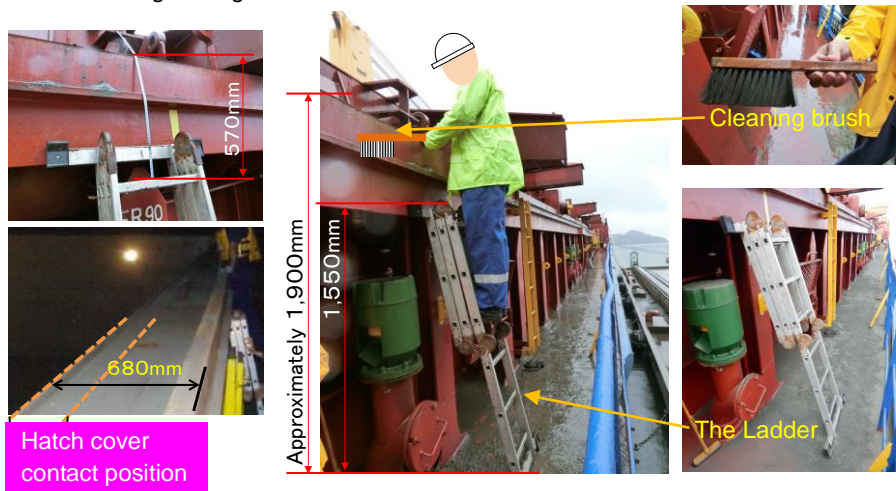
Photo 2 Environment of cleaning work and cleaning tools

The cleaning work was an item of routine works taking about 30 minutes, with the aim of maintaining the watertightness of the cargo hold. To prevent water invasion between the hatch cover of the cargo hold and the hatch coaming, the crew members were sweeping cargo mineral dust using portable ladders (hereinafter referred to as “the Ladder”) and cleaning brushes after the cargo unloading operation. At the time of the accident, the cleaning work was being carried out in the same way as usual. (See Photo 2)

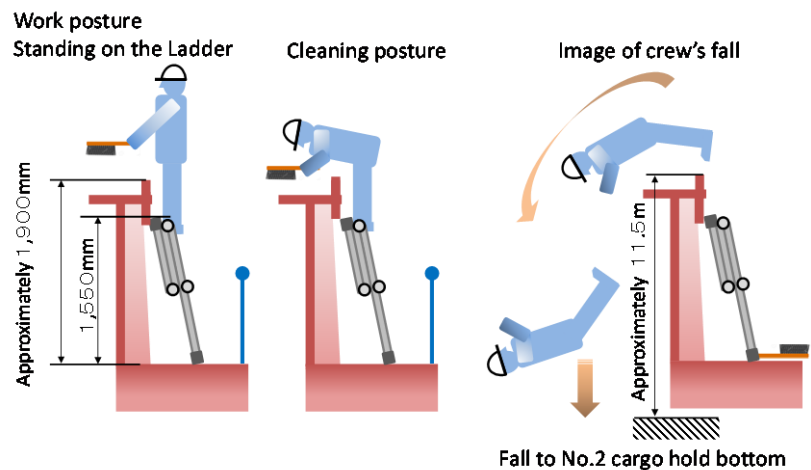
Figure 3 Work posture on the Ladder and situation of fall

When doing the cleaning work, Crew Member D, who was at the aft starboard side of the No. 2 cargo hold, saw that Crew Member A's upper body from his thigh was higher than the top of the hatch coaming on the upper deck starboard side of the No. 2 cargo hold, and that he was doing the cleaning work utilizing the cleaning brush.

Crew Member D looked at Crew Member A, who came to be in an unstable posture and fell forward, then twisted his body and tried to clutch at the upper hatch coaming of the No. 2 cargo hold with his left hand. However, he fell head-first with his back facing downward to the bottom of the No. 2 cargo hold at around 17:26.

② The Ladder was not extended above the upper supporting point and the top of the cargo hatch coaming, therefore the top of the Ladder was 570 mm lower than the top of the cargo hatch coaming.

③ The Ladder was pitched at around 79° from the horizontal.

④ According to Figure 3 and Photo 3 in “Events Leading to the Accident”, while engaged in the cleaning duty, Crew Member A did not support his body with three points of contact and over-reached on the Ladder.

1. Krey Schiffahrts GmbH & Co. KG should have the master of the ERIK supervise the crew members to certainly take preventive measures for fall accident in “the cleaning work of the upper hatch coaming of the cargo holds on the upper deck”.

2. The master of the ERIK and Designated Person Ashore of Krey Schiffahrts GmbH & Co. KG should implement the risk assessment of “the cleaning work of the upper hatch coaming of the cargo holds on the upper deck” on an individual work basis, and Krey Schiffahrts GmbH & Co. KG should take the necessary measures for the ERIK to prevent fall accidents by using a safety harness, etc. based on this assessment.

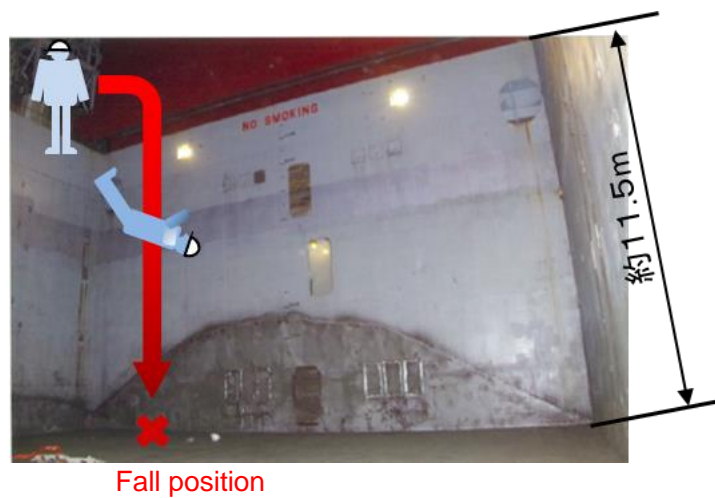
Photo 3 No. 2 cargo hold and fall location of Crew Member A

At the same time, Crew Member B heard the sound of something falling when he was walking toward the stern in the passage of the No. 2 cargo hold port side on the upper deck. Crew Member B then looked out into the interior of the No. 2 cargo hold and noticed Crew Member A lying on his back on the cargo hold floor. Crew Member B descended the stairs to the floor to confirm the condition of Crew Member A, where it appeared that Crew Member A was no longer breathing.

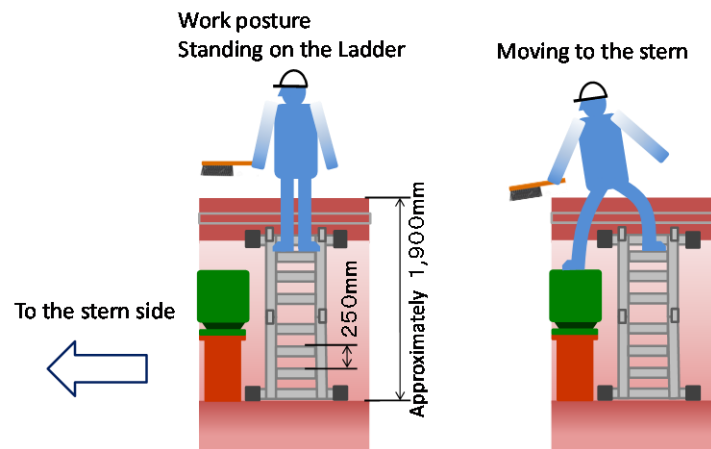
Figure 4 Image of moving the Ladder

N. Officer A and N. Officer B knew that this method of moving the Ladders was being carried out in everyday work. Figure 4 shows the image of moving the Ladder.

⑤ According to item (2)⑥ in “Other Matters”, the Ladder pulling and removing methods did not involve Crew Member A facing the Ladder.

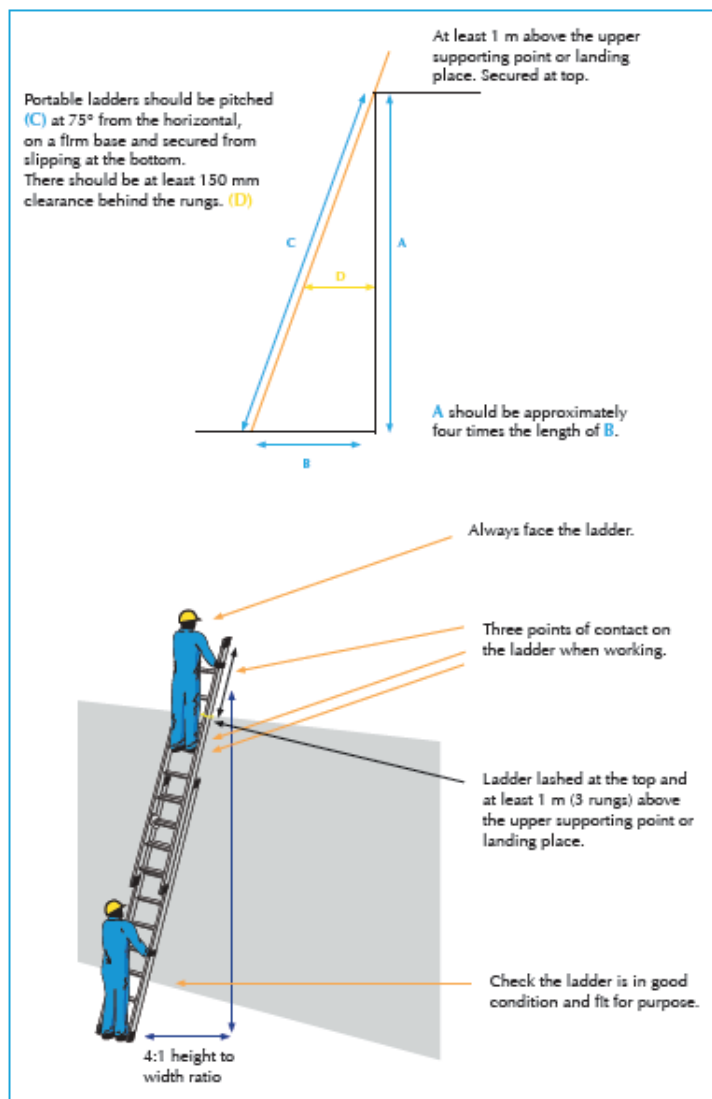
Figure 5 Ladder guidelines in the CSWP
Published by the Maritime & Coastguard Agency, UK

- a. Portable ladders are lashed at the top and the upper supporting point.
- b. Portable ladders should extend to at least 1 m (3 rungs) above the upper supporting point or landing place.
- c. Portable ladders should be pitched at 75° from the horizontal.

- d. There should be three points of contact on a portable ladder when working.
- e. The body should always face the portable ladder.
- f. Personnel must use a safety harness with a lifeline secured above the work position, where practicable.

3. Krey Schiffahrts GmbH & Co. KG should have all the vessels operated by the Company observe the portable ladder guidelines in the chapter “WORK AT HEIGHT” of the “Code of Safe Working Practices for Merchant Seafarers”. On the other hand, Krey Schiffahrts GmbH & Co. KG should take other safety measures for all the vessels operated by the Company including changing the use of the portable ladder if it seems that it is difficult to conform to the portable ladder guidelines in the cleaning work.
