# Marine Transportation Safety Investigation Report M18C0105

## STEERING GEAR FAILURE AND GROUNDING

Product/chemical tanker *Chem Norma*  
Morrisburg, Ontario  
29 May 2018

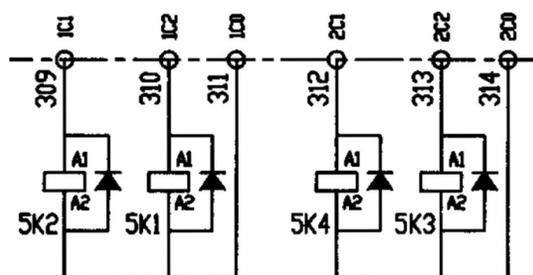
Relay contacts are subject to large voltage and current surges when switching inductive loads, such as to direct-current solenoids. When the contacts open, it is important that surges be absorbed (e.g., with a diode) to protect the contacts. The *Chem Norma's* steering control electrical system did not have provisions or countermeasures to protect the control relays' contacts from voltage and current surges (Figure 2); however, the control relays' power coils were protected by a diode connected in parallel to them (Figure 3).

Figure 3. Abstract from Chem Norma's steering control system drawings, showing diodes as surge protection arrangement connected in parallel to the power coils of relays 5K1, 5K2, 5K3, and 5K4

Although relays 5K1, 5K2, 5K3, and 5K4 are theoretically compatible for use with the 24 VDC/30 watt solenoids they were controlling, this particular model of relay was designed as a general-purpose type C transfer contact relay. This type of relay is not suited for voltages that exceed its 28 VDC rating, which are generated when the contact is broken by the counter-electromotive force inherent to the inductive load created by the solenoid. Other types of relays are specifically designed to better handle the severe conditions produced by these inductive loads.

In this occurrence, although the precise cause for the temporary failure of the *Chem Norma's* steering gear control system could not be determined, a plausible scenario is a temporary mechanical hanging that held contacts 5 and 9 closed on relay 5K3, triggering a hard-a-starboard order on the steering gear.

Following this occurrence, the vessel's Flag State Authority, the Marshall Islands, recommended that the vessel owner review procedures in the company's safety management system regarding emergency steering and loss of steering, with a focus on loss of steering in a narrow waterway and loss of steering with hazards in close proximity to the planned route. The vessel owner also contacted the steering system manufacturer to request a type of control relay that is designed to better handle the severe conditions produced by the inductive loads found in the vessel's steering system.
