SAFETY INVESTIGATION REPORT

REPORT NO.: 04/2019

Adam Asnyk
 Serious injury to crew member
 in position 23° 57.7' N 118° 37.4' E
 15 February 2018

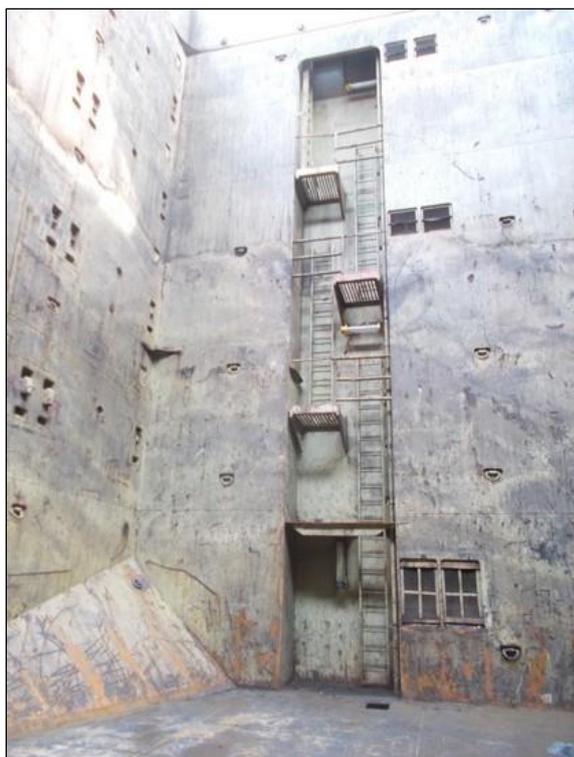
Figure 2: Access ladder to cargo hold no. 4 (starboard)

Even before accessing the cargo hold access hatchway to descend below, both crew members were aware that they would need a longer hose. They therefore took another fire hose and connected the two hoses. AB-2 again opened the valve and AB-1 descended the access ladder. At the first platform (Figure 2), AB-2 passed him the pressurised fire hose (with the nozzle shut). Sufficient length was passed over to AB-1 to grasp it under his left arm.

From this position on the first platform, AB-1 washed the upper parts of the cargo hold's starboard side, including the side brackets and support. As this area was about to be completed, AB-2 descended the ladder and AB-1 stepped aside to allow him to descend to the next level so that the hose could be passed to him at tank top level (Figure 2).

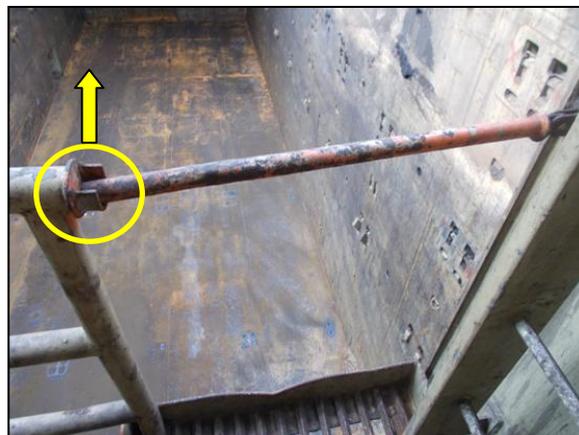
Figure 3: Safety railing on first platform

The extra length of hose fell on AB-1 and since it was charged with water and with considerable weight, it somehow managed to cause the safety railing to dislodge upwards from its position (Figure 3). This also resulted in AB-1 losing his balance and his hold on to the fire hose and consequently he

When AB-1 tugged the fire hose forcibly the second time for more slack, a length of the hose fell on him, and somehow caused the top protective railing to move upwards. As he lost his balance, he fell through the opening in the platform. There were a number of reasons why the railing failed:

- i. the locking pin that would have locked the railing and prevent it from lifting upwards was never in place from the design stage of the ship (Figure 3), although it had been reported locked¹;
- ii. the intermediate railing between the platform floor and the top railing was never in place from the design stage of the ship (Figure 4); and
- iii. an examination of the structure revealed that neither a locking pin nor an intermediate railing had been fitted since the vessel was brought into service in 2009².

It was estimated that the weight of one metre of pressurised hose was about 5.0 kgs. Therefore, even if between four and five metres of fire hose had toppled on AB-1, that would suggest a weight of between 20 kgs and 25 kgs - sufficient to either knock somebody off balance or for that person to instinctively move aside to avoid the falling weight.

1. The S & Q Department, together with the Operation Department has compiled instructions to present a safe and correct way of preparation to clean / wash the cargo hold;
2. Securing pins have been installed on all removable handrails in way of the access platforms in order to ensure unintentional opening;
3. Existing instructions on working at height have been amended;
4. New and more comfortable lifelines and harnesses have been procured to replace the existing ones.
