## MARINE SAFETY INVESTIGATION REPORT

Safety investigation into the collision involving the  
Maltese registered general cargo

***BRITANNICA HAV***

***Z121 DEBORAH***

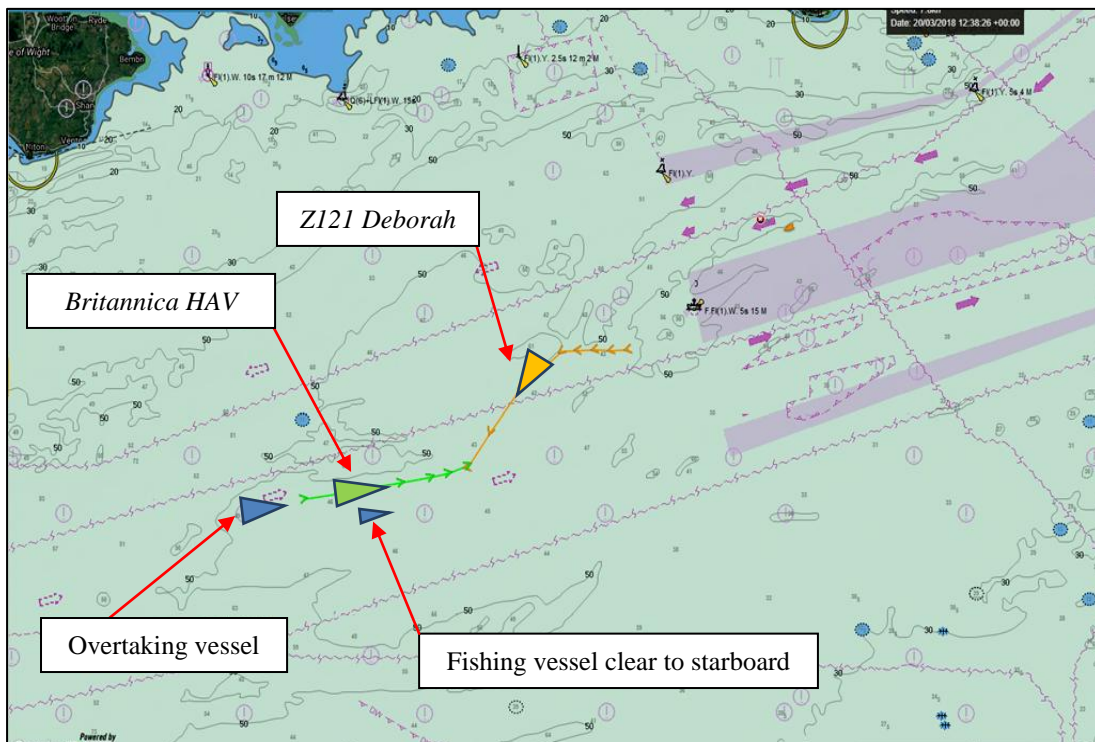
Figure 9: Approximate reported navigational situation of Britannica HAV (positions and distances are illustrative only)

First, a tanker was overtaking *Britannica HAV* and was around one nautical mile astern of the vessel. Second, a fishing vessel was passing clear at least 0.5 nautical miles to starboard. The third vessel, a fishing vessel (*Z121 Deborah*), was on his vessel's port bow. The chief mate further reported that he believed that she was shaping up to pass ahead of *Britannica HAV*'s bow, at a range of about 0.5 nautical miles (by ATA).

At some stage, following the alteration of course to port, the navigational OOW noticed that the CPA to *Z121 Deborah* had decreased to almost zero, indicating risk of collision. It is likely that the prevailing environmental conditions at the time may have affected the movement and / or direction, appearing to the OOW that the fishing vessel had altered her course to starboard, although he could not see her wake clearly. He was also using relative trails on radar, making the extent of alteration difficult to estimate.

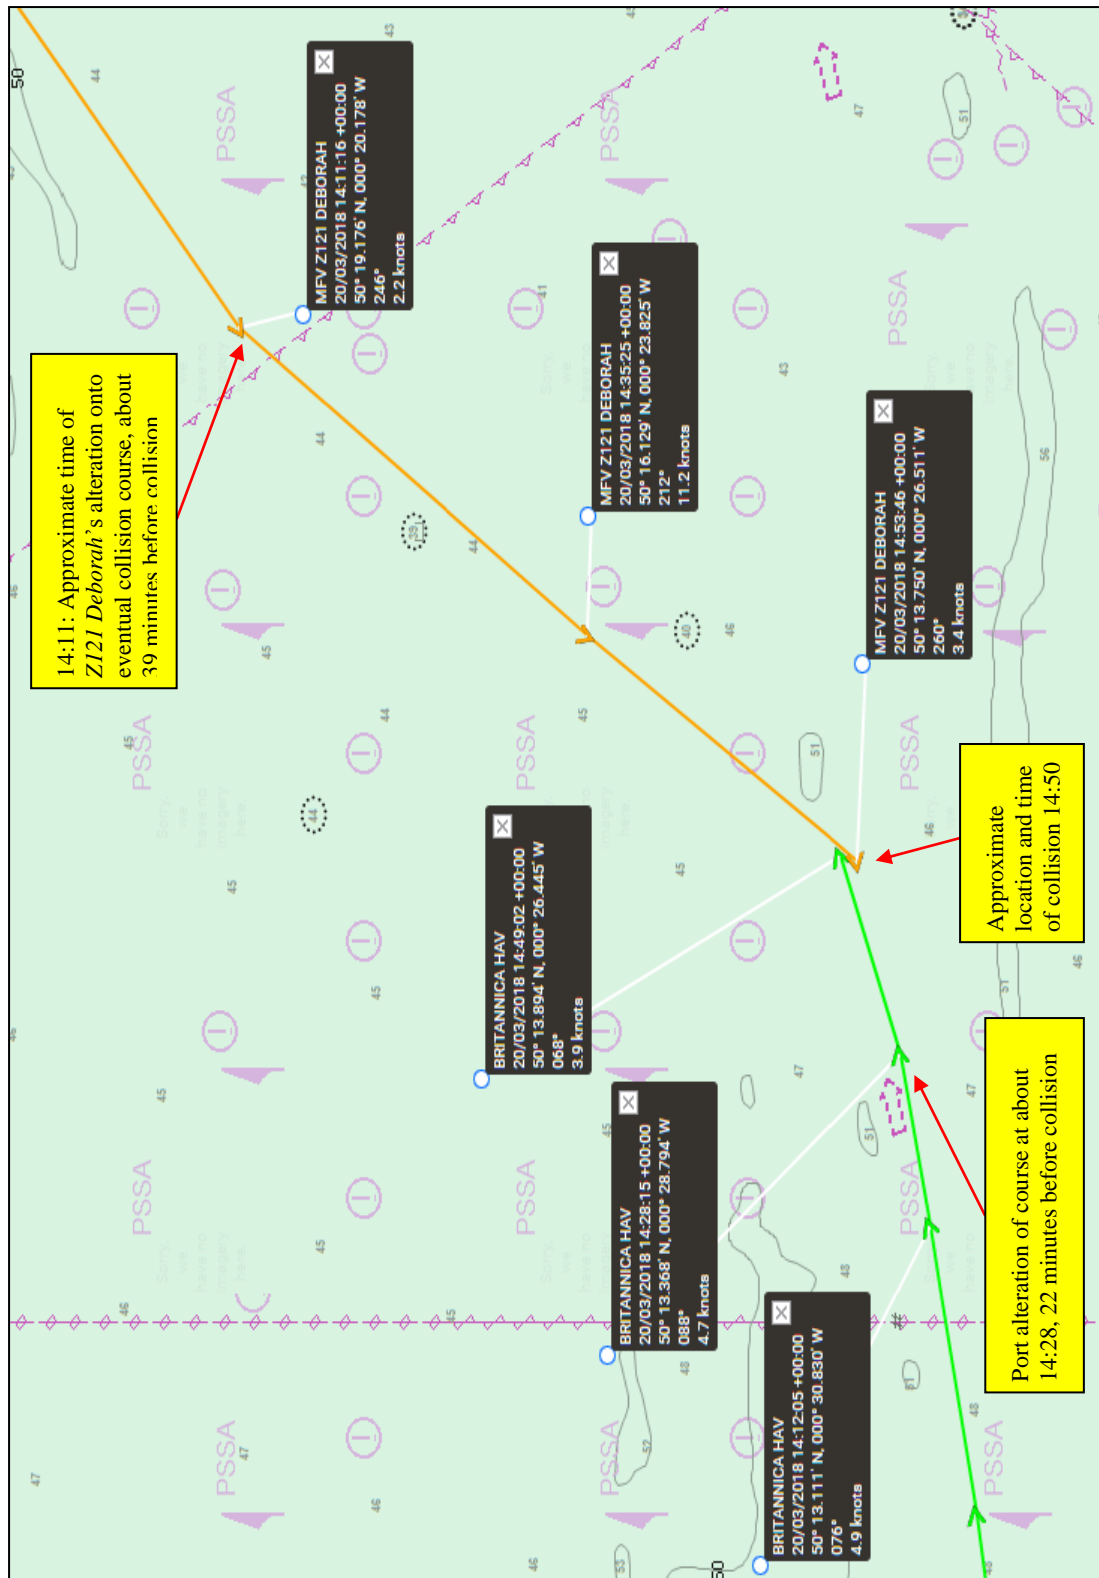
Figure 10: AIS data leading to the time of the collision

At about 1450, less than a minute after *Britannica HAV* sounded her whistle signal, *Z121 Deborah*'s bow collided with *Britannica HAV*'s port side in way of wing ballast tank no. 3. It was evident that the impact had damaged the cargo hold hatch cover and

the vessel's side shell plating. Soon after the collision, the chief mate pulled the main engine's telegraph to stop. Figure 10 shows AIS data leading to the collision.

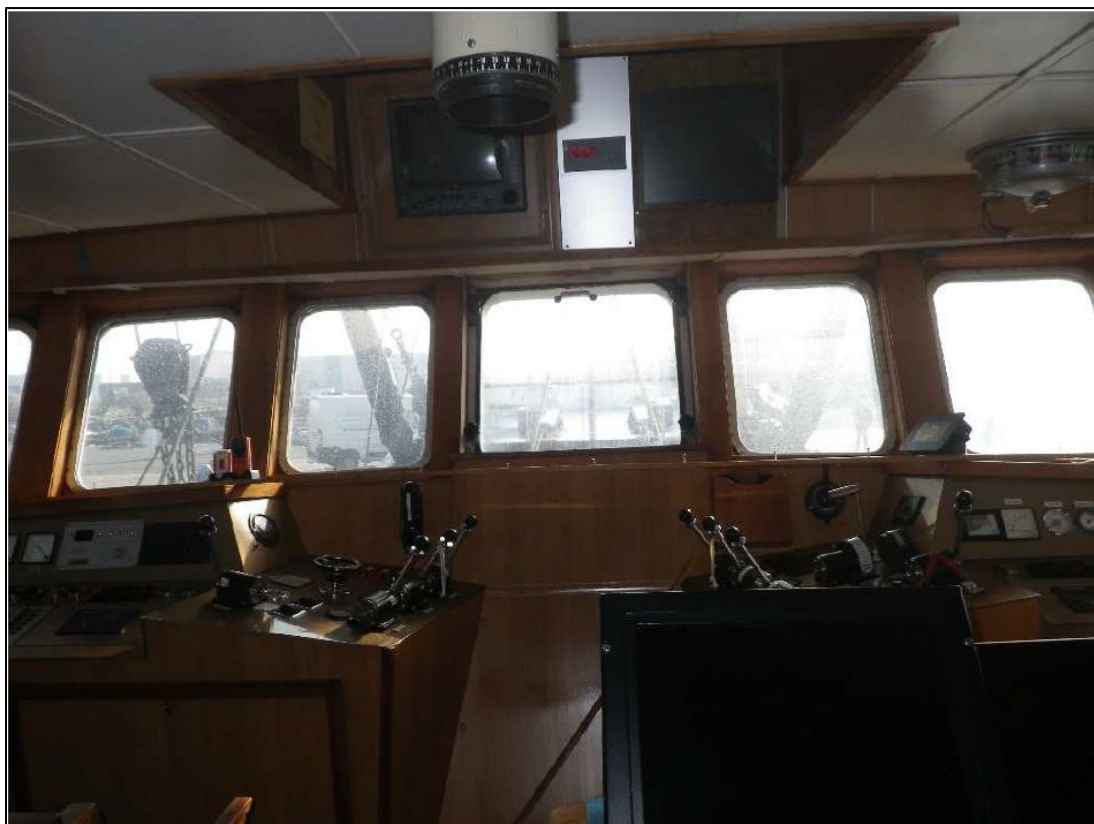
Figure 11: *Z121 Deborah* wheelhouse

The skipper on board *Z121 Deborah* stated that prior to the collision, he had left the wheelhouse (Figure 11) and proceeded to the galley to make a cup of coffee. At this point, the wheelhouse was unmanned, with the rest of the crew either processing the last catch or maintaining the fishing gear in other parts of the vessel.

**06/2019\_R1** Issue an information notice to fishing vessel registered in Belgium to highlight the significant hazards of inadequately manned wheelhouses, in particular when the vessel is in close proximity of busy shipping lanes and TSS zones.

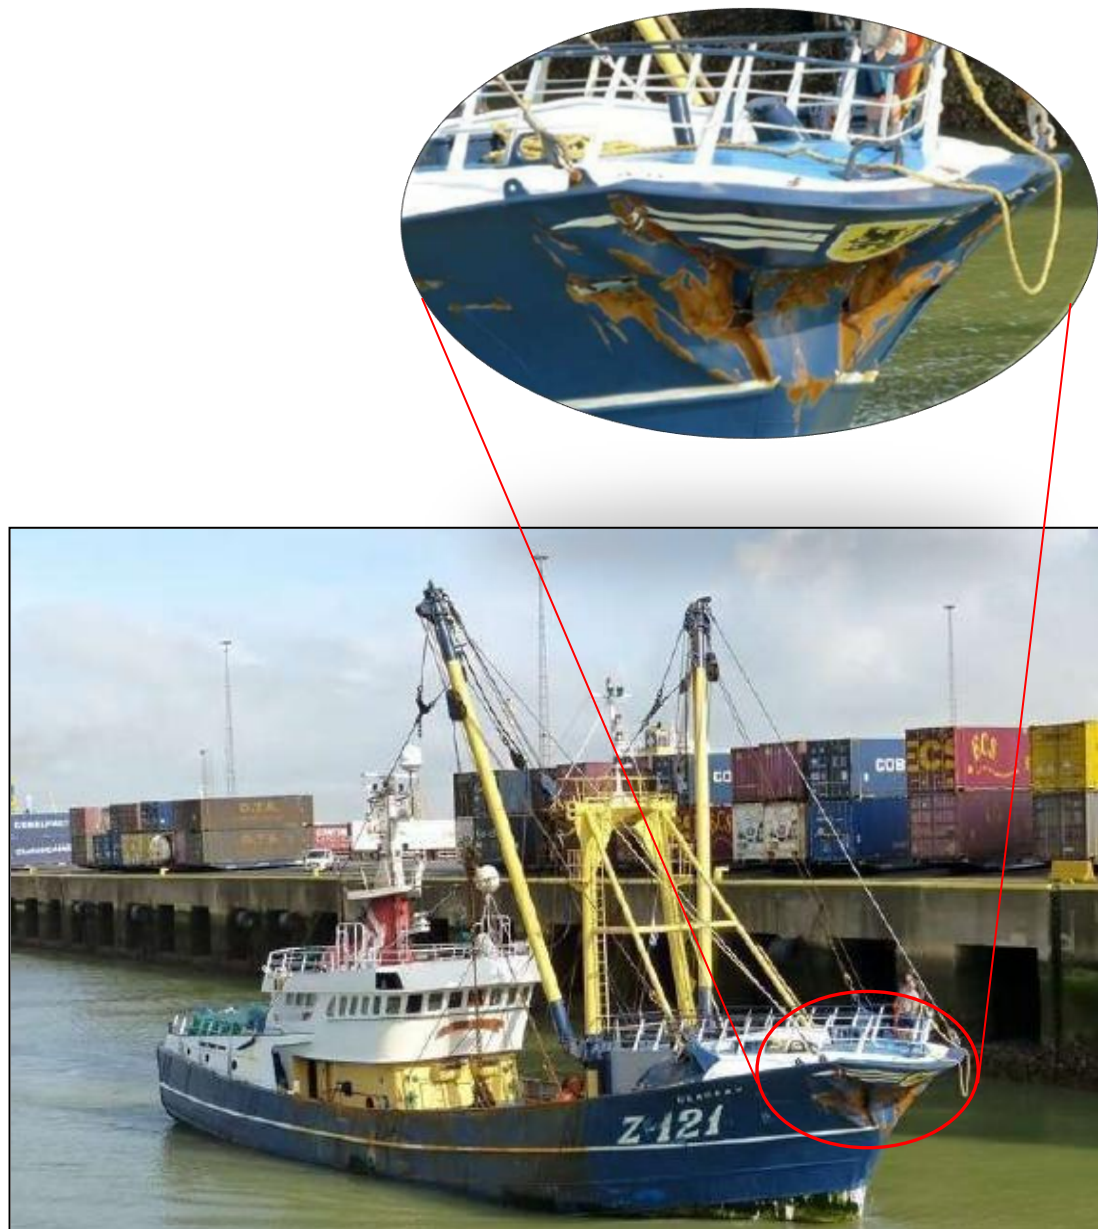
**Figure 12: Damages to the fishing vessel's bow area**

The damages sustain by the fishing vessel seemed to be confined to the forward part, *i.e.*, her forecastle and forecastle deck (Figure 12). This damage was comparable to an impact almost at right angles to *Britannica HAV*'s side shell<sup>6</sup>. The fishermen did not report any water ingress and it was confirmed that there were no damages below the waterline.

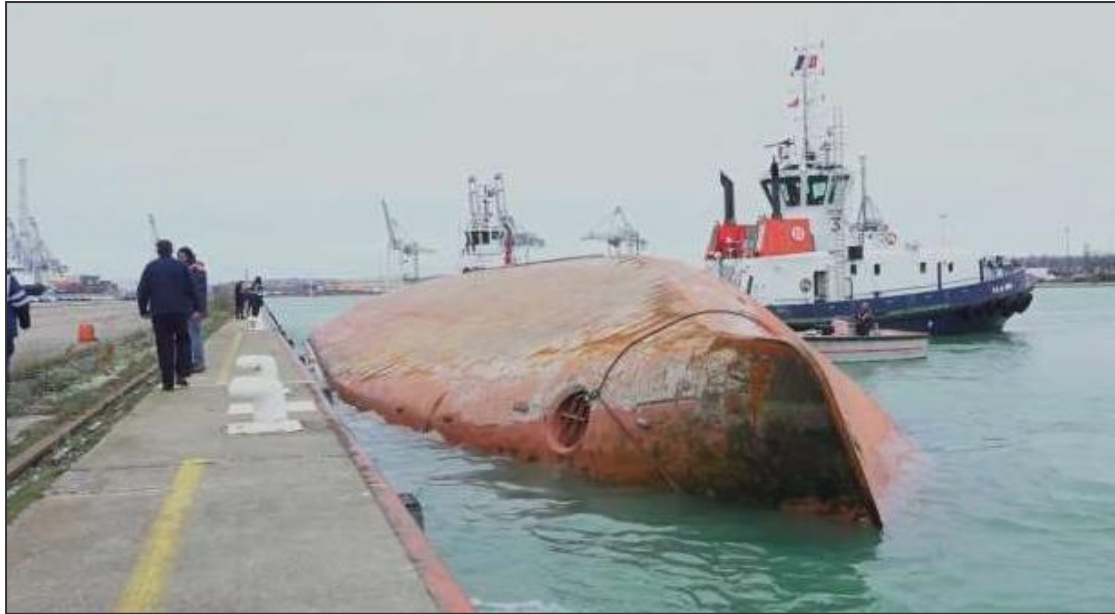
**Figure 14:** *Britannica HAV* alongside at Le Havre

*Britannica HAV* remained afloat, albeit capsized. She was watched closely by a French tug, and eventually towed to Le Havre, brought alongside (Figure 14) and righted (Figure 15). In the meantime, her hatch covers were continuously monitored, being a potential hazard to navigation.
