UNITED STATES COAST GUARD

**REPORT OF THE MARINE BOARD OF INVESTIGATION
INTO THE
COMMERCIAL FISHING VESSEL DESTINATION
SINKING AND LOSS OF THE VESSEL
WITH ALL SIX CREWMEMBERS
MISSING AND PRESUMED DECEASED
APPROXIMATELY 4.4 NM NORTHWEST OF
ST. GEORGE ISLAND, ALASKA
ON FEBRUARY 11, 2017**

16732
27 February 2019

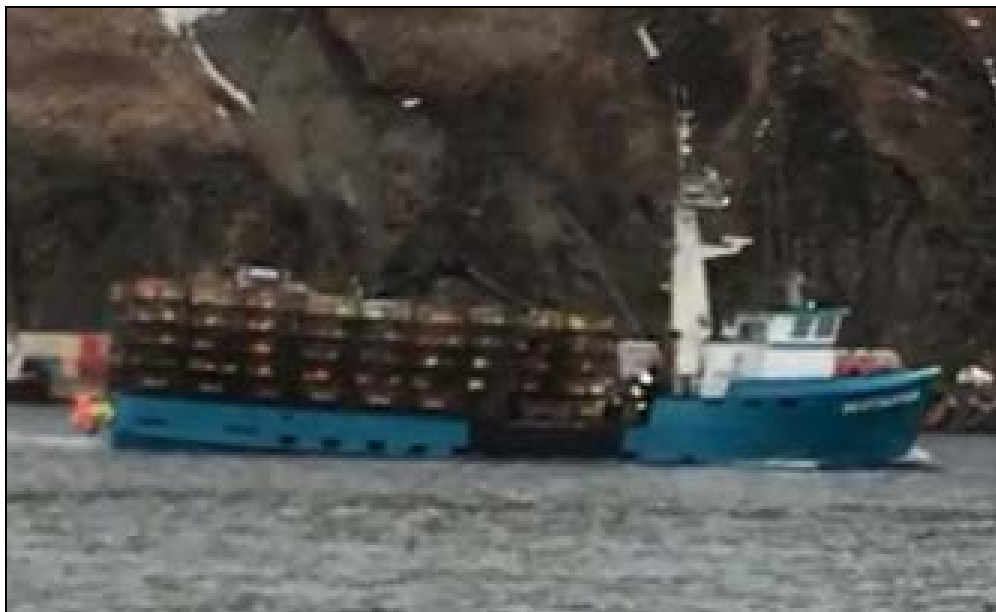
4.1.14. During the DESTINATION’s transit into Dutch Harbor, the crew of the nearby CFV APRIL LANE noticed the vessel’s arrival and proceeded to take a video using a crewmember’s cell phone (see Figure 3). The captain of the APRIL LANE asked his deckhand to take the video because he was “alarmed” about the DESTINATION’s loaded condition given the National Weather Service (NWS) forecasted freezing spray warnings. The captain of the APRIL LANE did not relay or communicate his observation and concerns to the captain of the DESTINATION.

Figure 3. Still image from video taken by a crewmember onboard the APRIL LANE of the DESTINATION’s transit into Dutch Harbor on February 9, 2017, at approximately 1830.

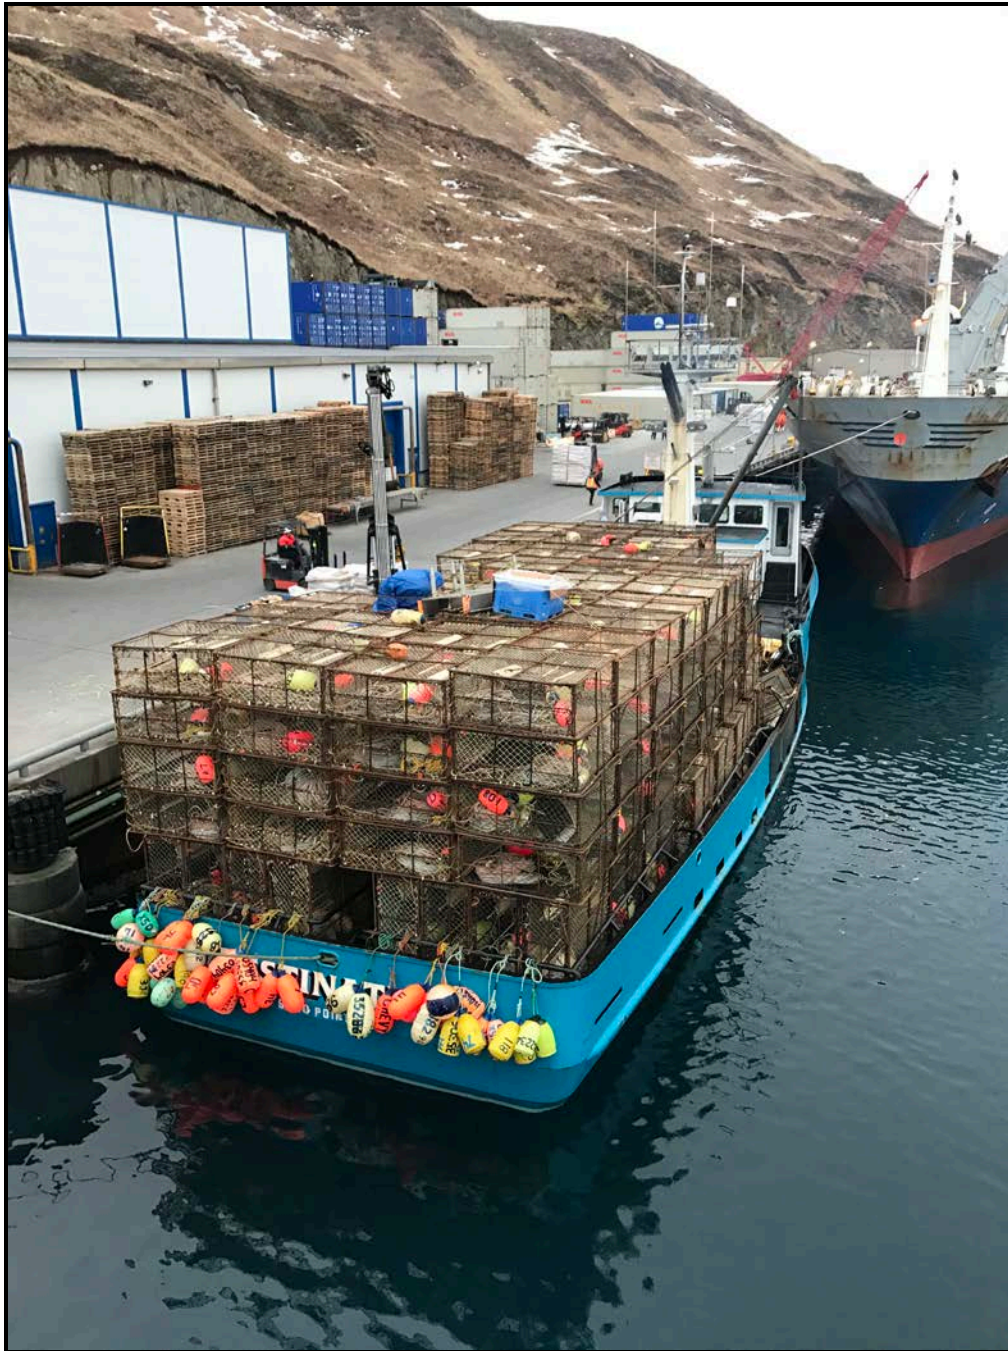
4.1.15. Just prior to the DESTINATION loading the squid bait, a crewmember from the motor vessel OCEAN ROVER, also moored at the Kloosterboer Facility, took two photos of the DESTINATION (see Figures 4 and 5). The crewmember indicated that he took the pictures after he noticed the “enormous” amount of crab pots loaded onboard the DESTINATION.

Figures 4. Photo of the DESTINATION moored at Kloosterboer on February 9, 2017, at approximately 1840.

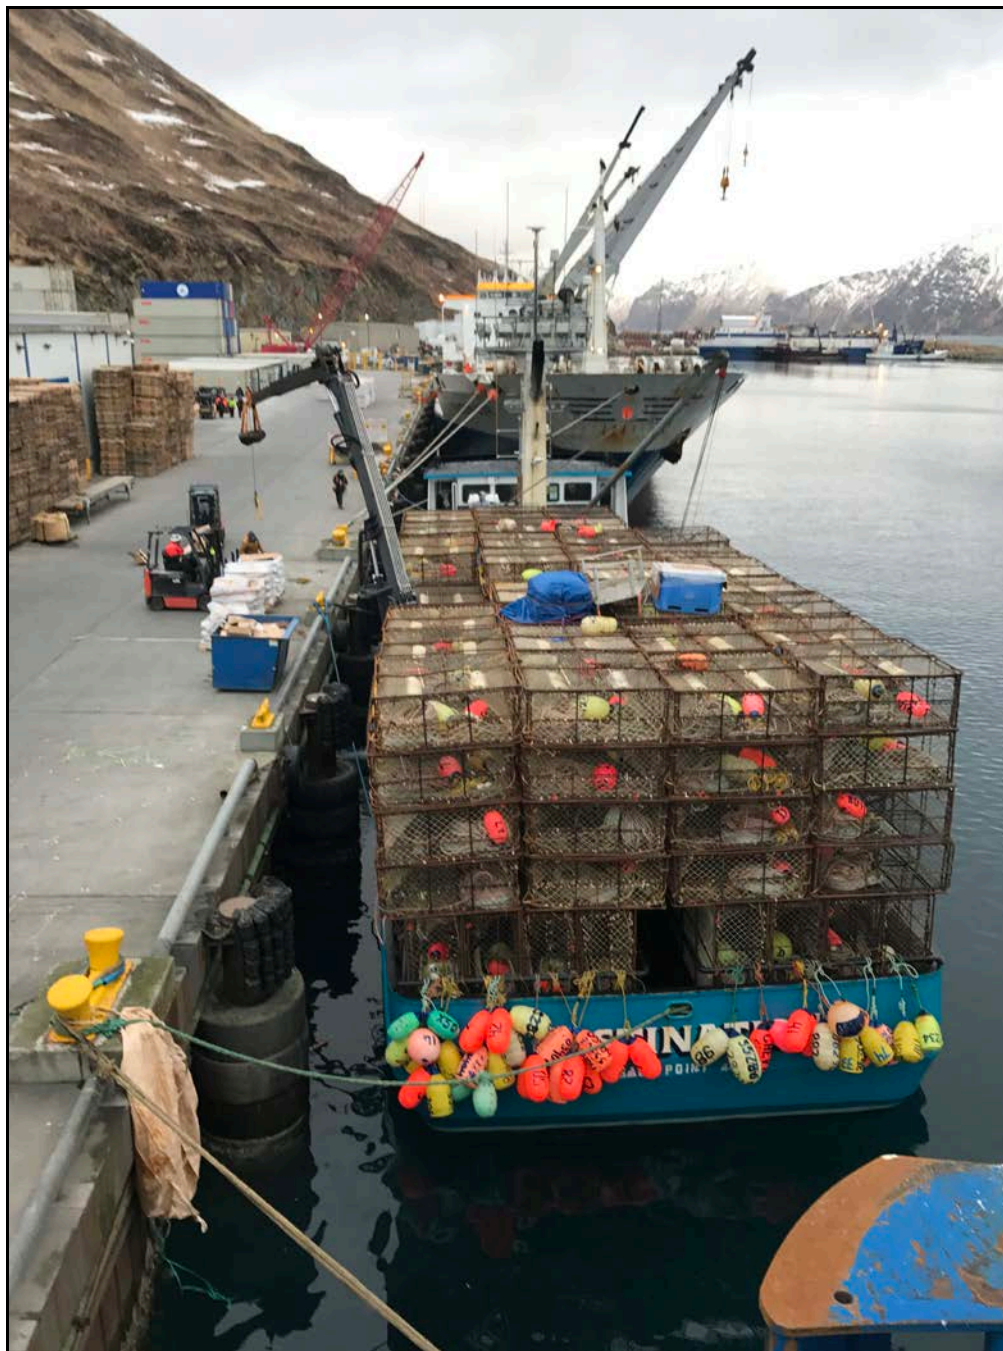
Figures 5. Photo of the DESTINATION moored at Kloosterboer on February 9, 2017, at approximately 1840.

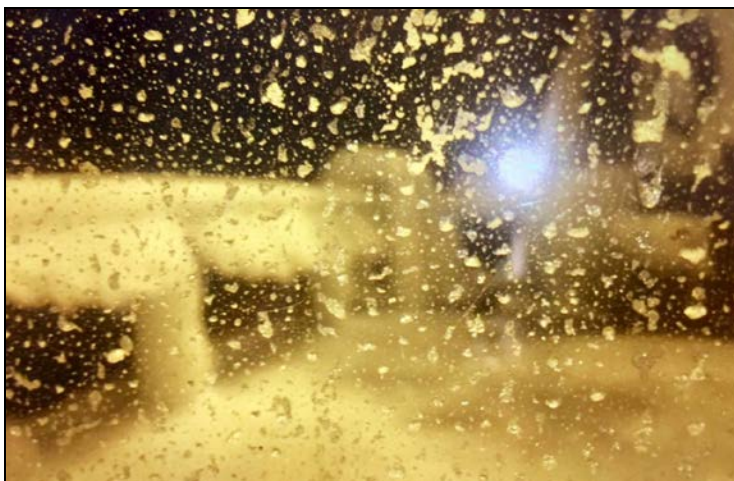
4.3.12. The captain of the BERING ROSE stated when his vessel was operating around St. George Island, it experienced weather "out of the northeast, 35, 40, heavy freezing spray" and 15-foot seas. The vessel had ice accumulations of "over a quarter of an inch per hour." Figure 24 is a photo taken by a crewmember onboard the BERING ROSE of the ice accumulation on the deck aft of the wheelhouse during the early morning hours of February 11, 2017.

Figure 24. Photo taken by a crewmember onboard the BERING ROSE on the morning of February 11, 2017.

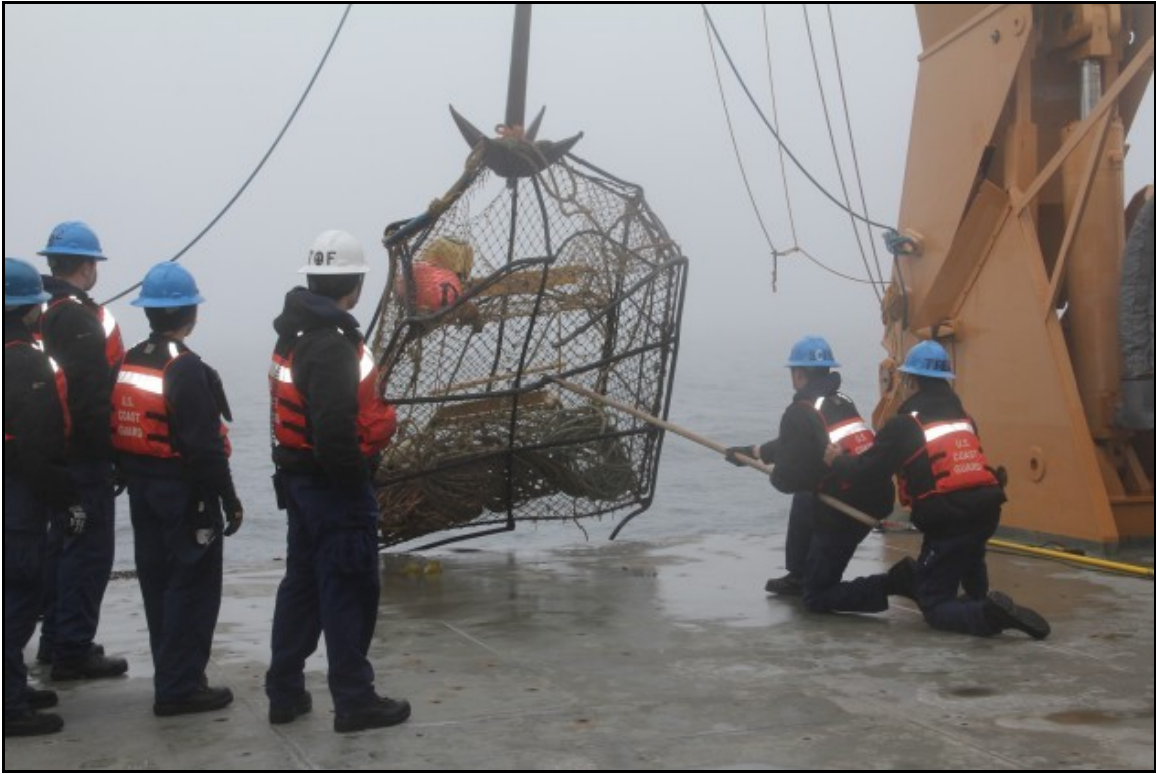
Figure 44. Crewmembers onboard the HEALY recovered a crab pot located near the wreck of the DESTINATION on the sea floor. Photo taken by Coast Guard Public Affairs on July 25, 2017.

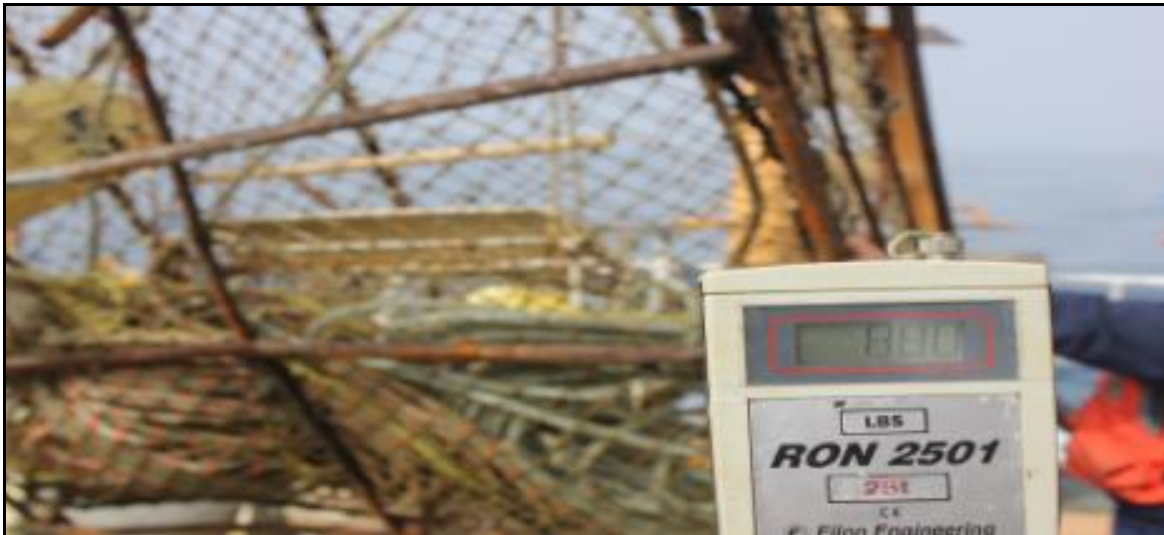
Figure 45. The HEALY weighed the recovered crab pot at 880 pounds with gear. Photo taken by Coast Guard Public Affairs on July 25, 2017.

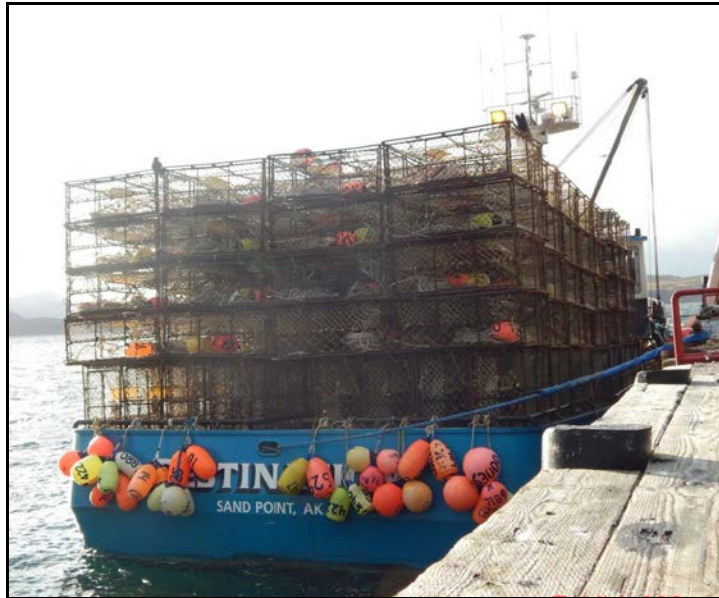
Figure 56. DESTINATION's typical pot loading condition. Undated photo taken and provided by former crewmember.

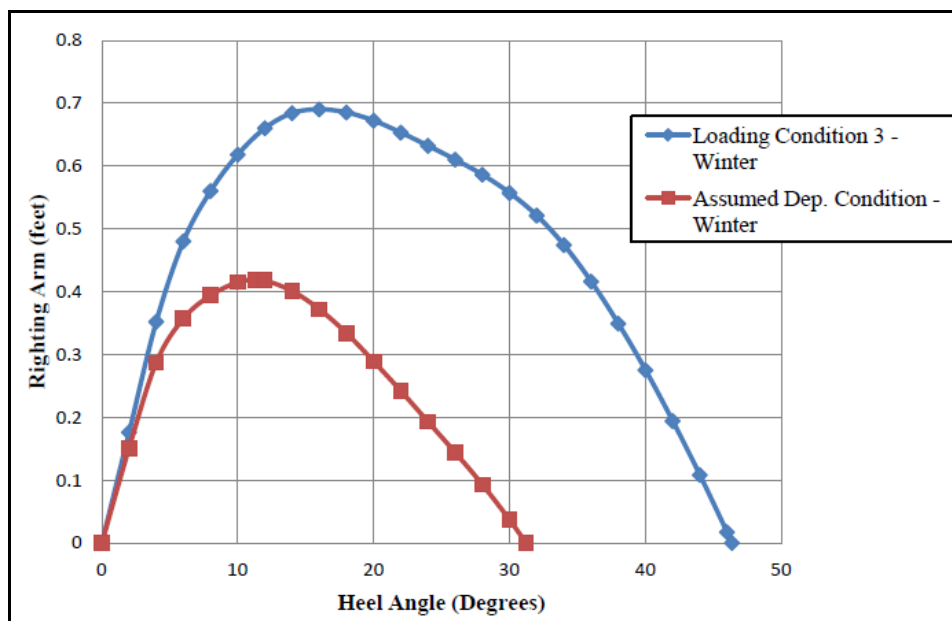
Figure 79. DESTINATION’s righting arm curves - departure condition compared to the stability instructions. Provided by MSC.

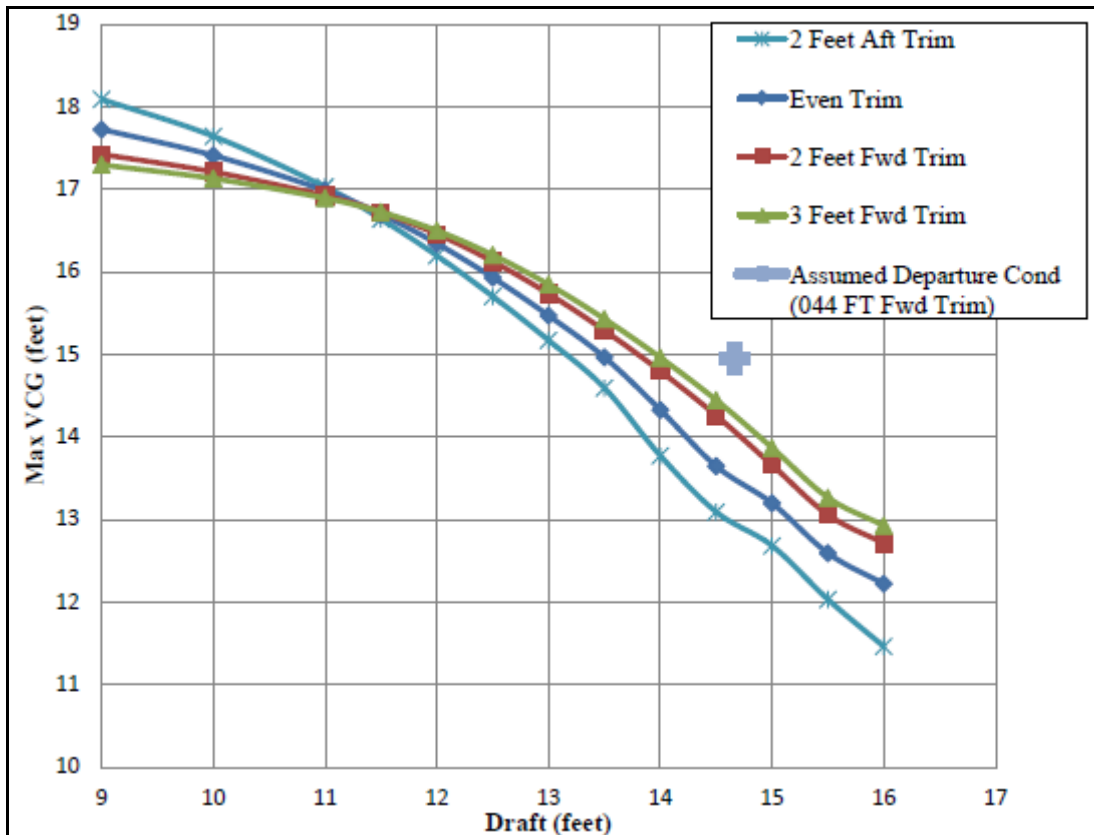
Figure 80. DESTINATION’s maximum VCG curves compared to its assumed departure condition. Provided by MSC.

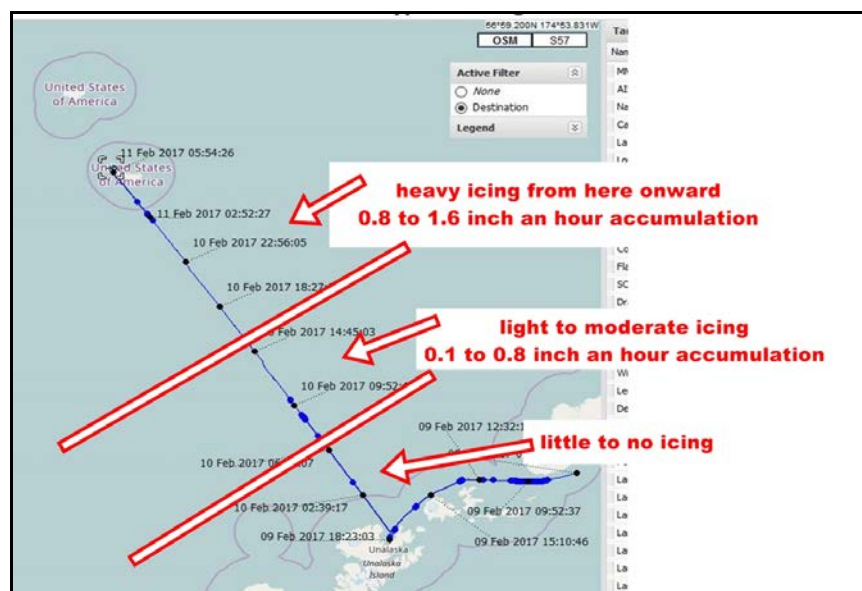
Figure 81. Calculated ice accumulation during the DESTINATION's transit. Provided by NTSB.

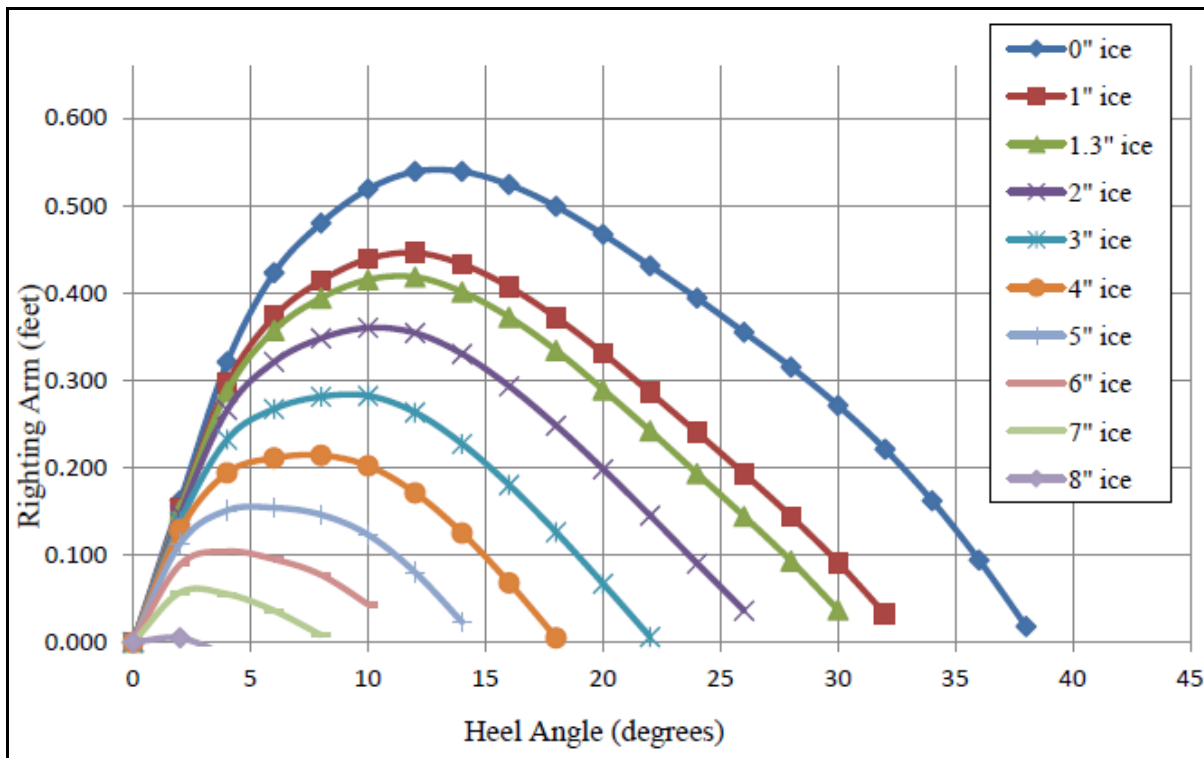
Figure 83. DESTINATION’s righting arm curves for incremental ice loads in departure load conditions from Dutch Harbor. Provided by MSC.

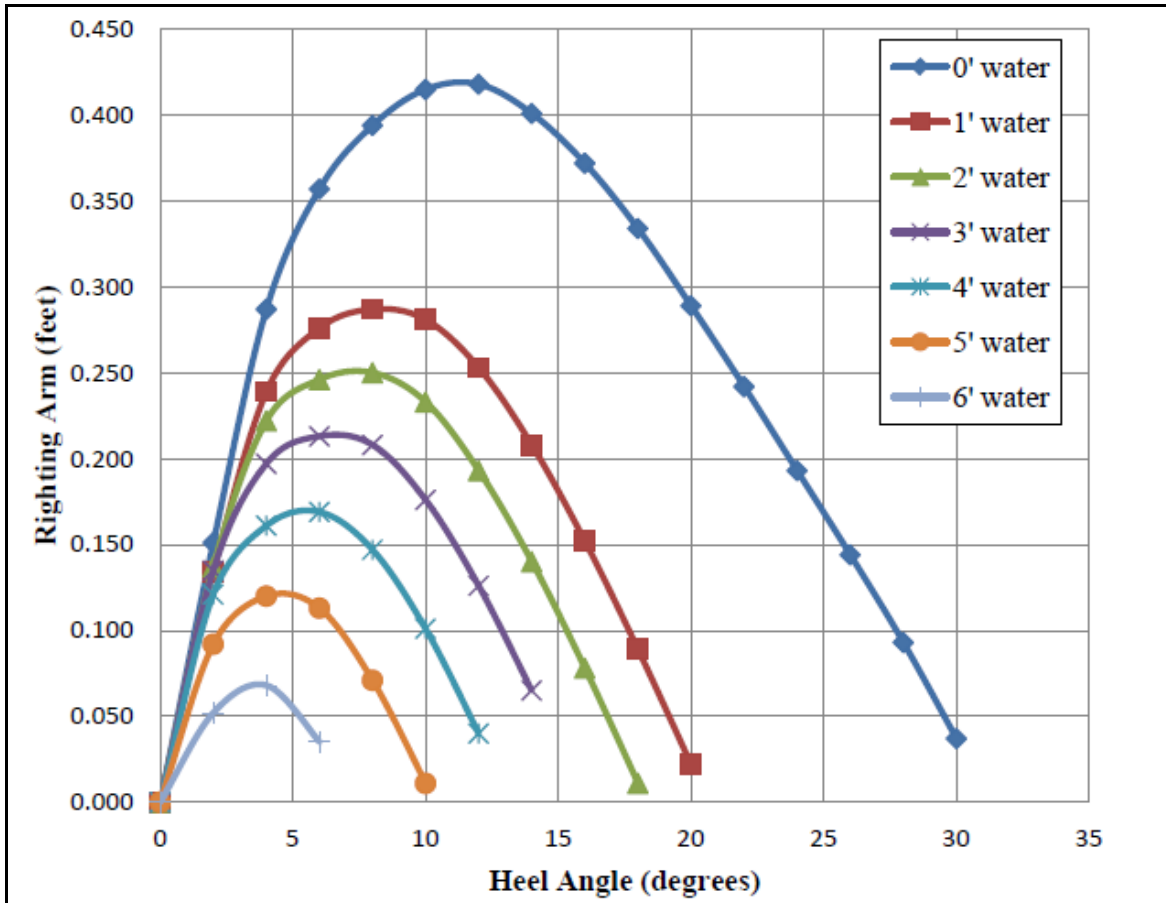
Figure 84. DESTINATION's righting arm curves for incremental filling of number 3 hold in departure load conditions from Dutch Harbor. Provided by MSC.

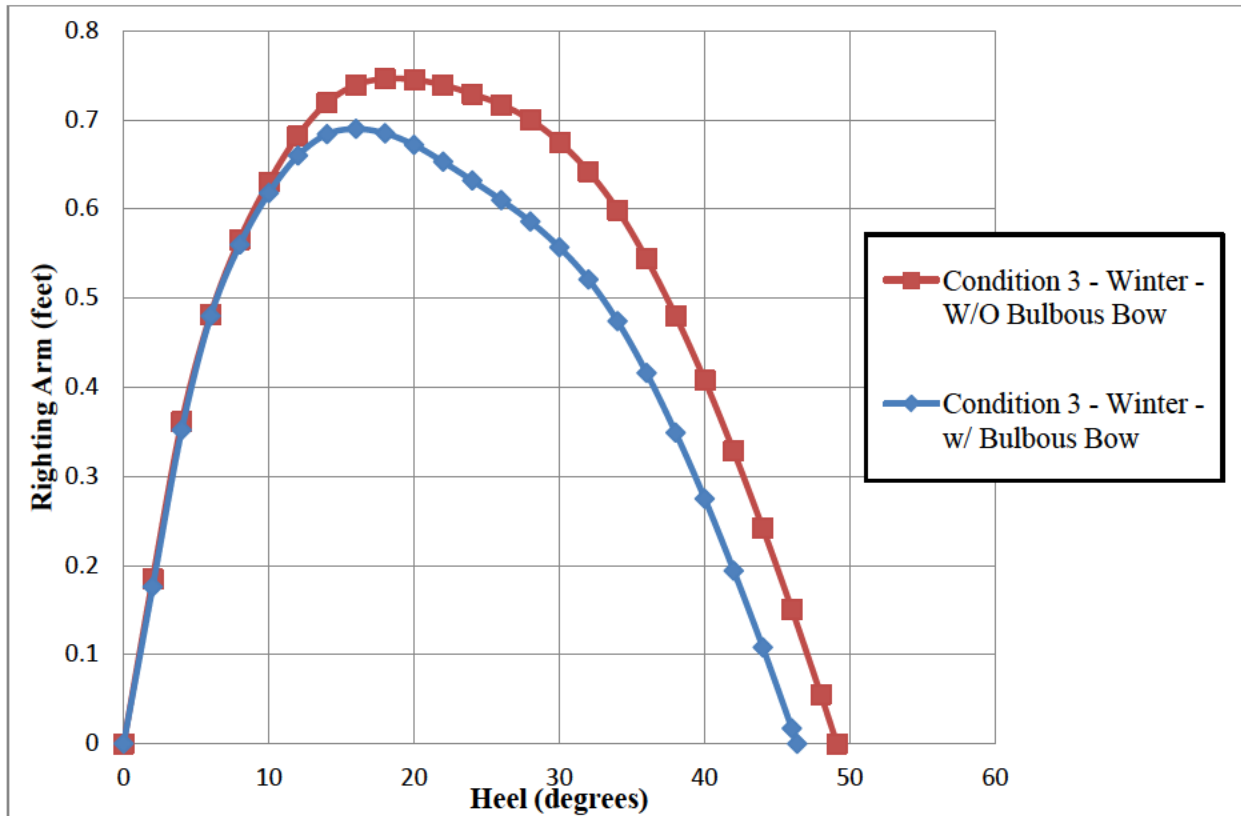
Limits from 170.173 (c)	Required	Attained Condition 3 w/o Bulbous Bow	Attained Condition 3 w/ Bulbous Bow
Initial Metacentric Height (GM)	> 0.49 ft	5.29	5.02
Angle of Maximum Righting Arm	> 15°	18.00	16.00
Area up to 40° or Downflood Angle	> 16.9 ft-deg	23.79	21.05
Area between 30° and 40°	> 5.6 ft-deg	5.62	4.35
Area at Max Righting Arm	> 12.54 ft-deg	9.49	7.76

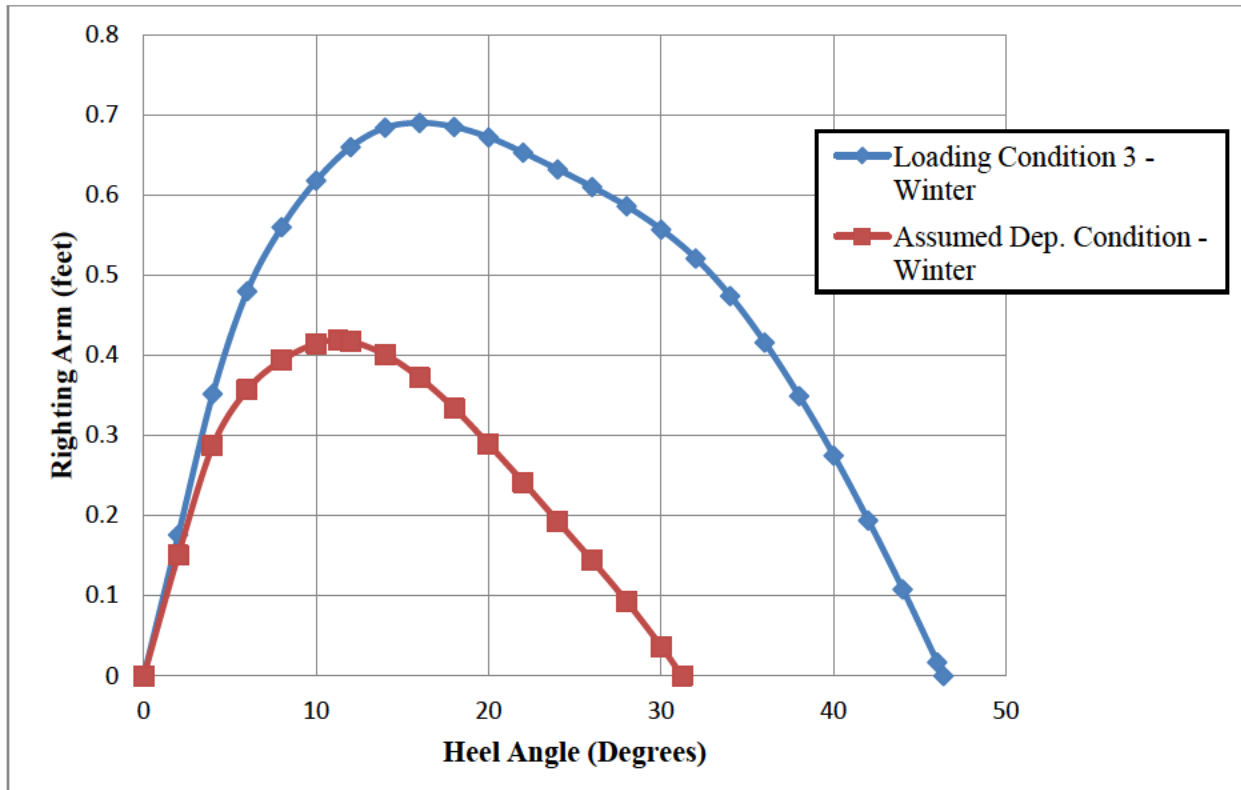
Limit	Required	Attained Condition 3 - Winter	Attained Assumed Dep. Condition
Initial Metacentric Height (GM)	> 0.49 ft	5.02	4.32
Angle of Maximum Righting Arm	> 15°	16.00	11.27
Area up to 40° or Downflood Angle	> 16.9 ft-deg	21.05	8.27
Area between 30° and 40°	> 5.6 ft-deg	4.35	0.02
Area at Max Righting Arm	> 12.92 ft-deg	7.76	3.34

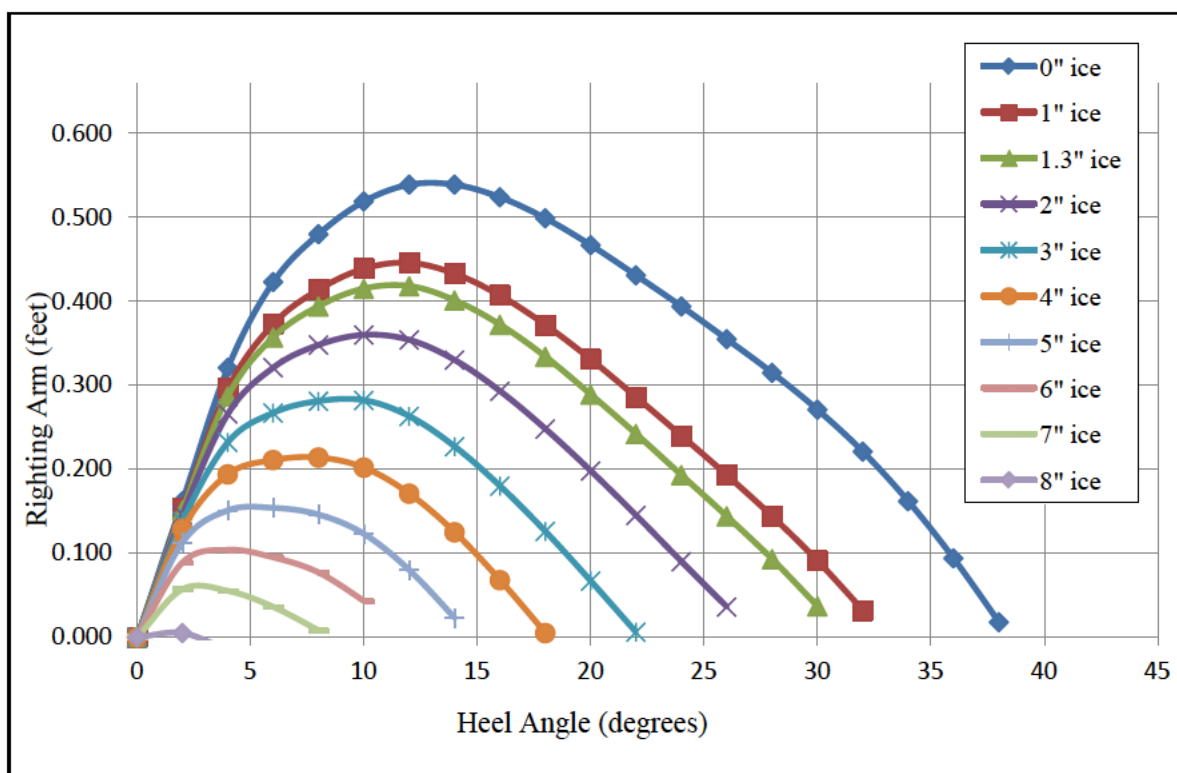
Figure (8): Righting Arm Curves for Incremental Ice Loads

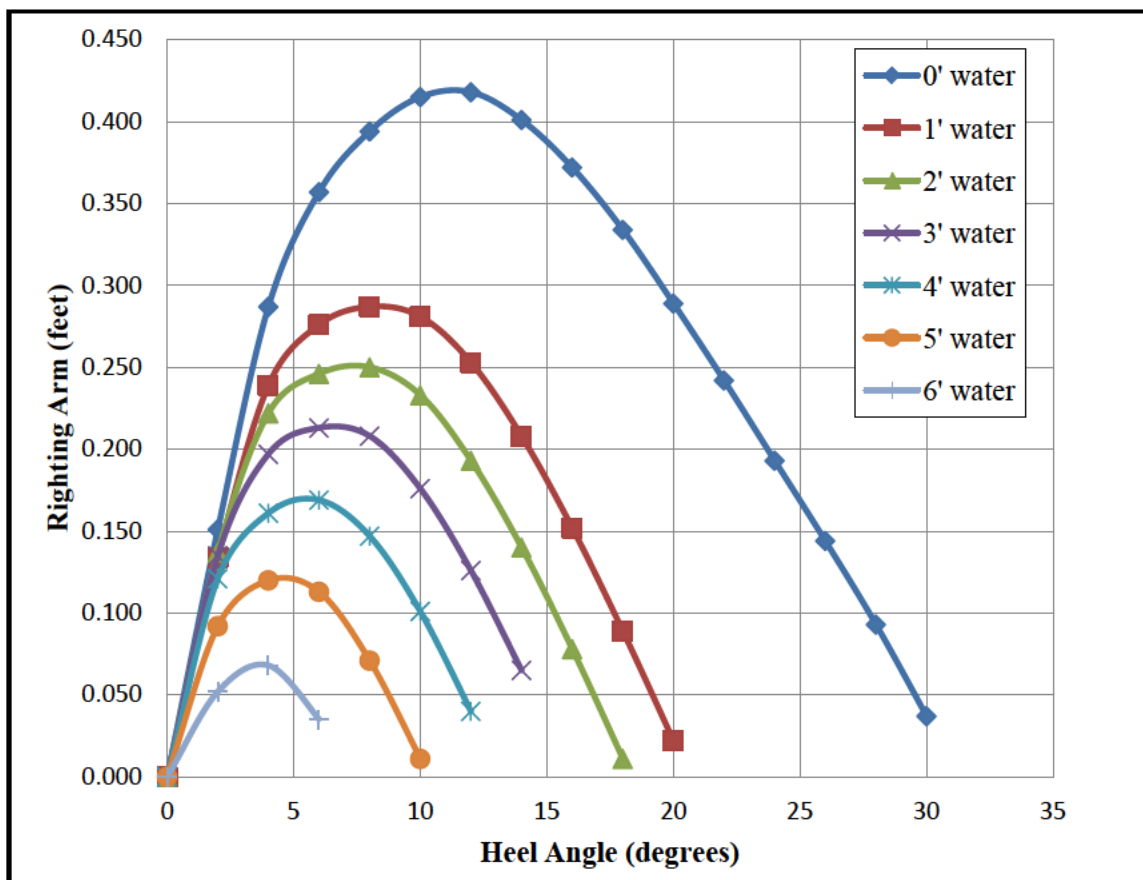
Figure (9): Righting Arm Curves for Incremental Filling of No. 3 RSW Hold
