**MARINE ACCIDENT
INVESTIGATION REPORT**

Vessel type and name: Chemical Tanker GOLDEN SUNNY HANA

Accident type: Explosion (Cargo oil tank)

Date and time: Around 10:05, April 8, 2018 (local time, UTC+9 hours)

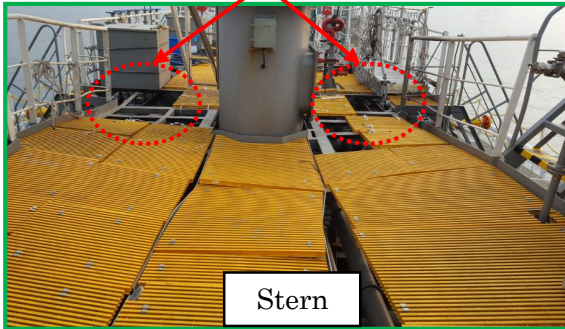
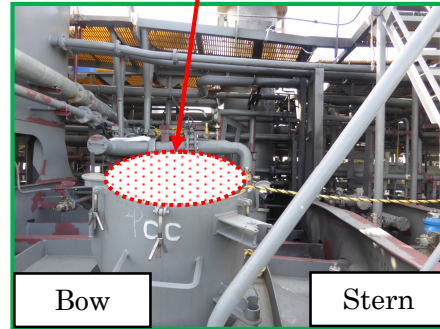
- (1) There were deformations together with cracks running longitudinally and transversely on the trunk deck as well as cracks and holes near the No. 1 tank, the Tank, and the No. 2 starboard tank.
- (2) There were cracks and deformations in the forward transverse bulkhead of the Tank, cracks in the upper and lower portions of the longitudinal bulkhead between the Tank and the No. 2 starboard tank as well as a roughly 100-mm deformation running toward the starboard side, and holes and deformations in the floor at the lower part of the forward transverse bulkhead. The hatch cover fell into the sea.
- (3) The hatch covers of No. 1 tank and the No. 2 starboard tank fell into the sea.
- (4) There were cracks and deformations in the forward transverse bulkheads of No. 3 port tank and No. 3 starboard tank and holes and deformations in the floor at the lower part of the

Damage to the passageways on the trunk deck
(The Tank and the No. 2 starboard tank are below the damaged locations.)

Place where the hatch cover had been

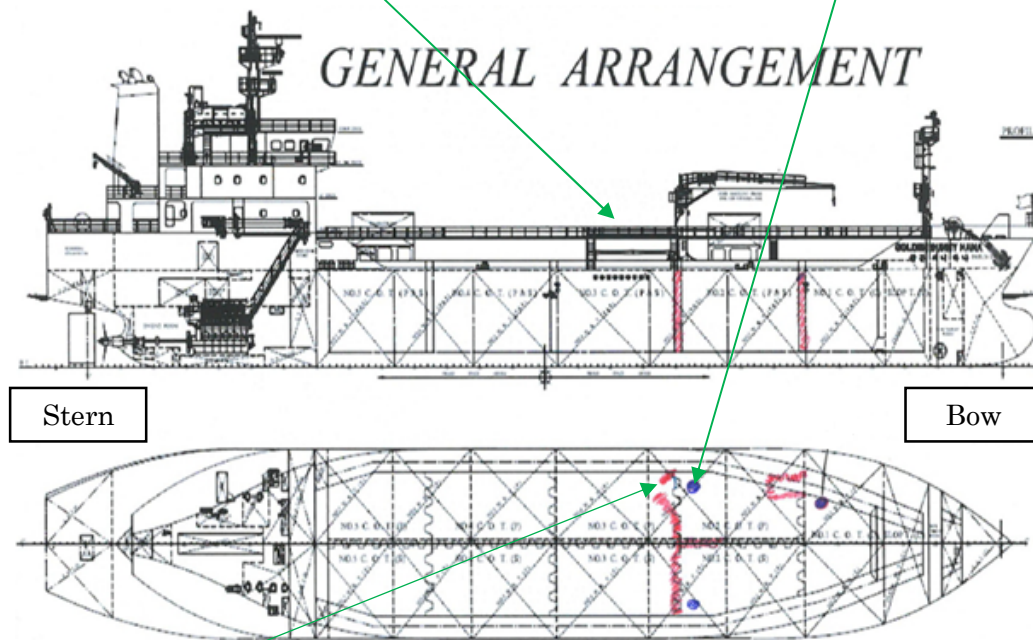
Damage looking from the top of No. 3 tank toward the bow

Holes and deformations

Cracks

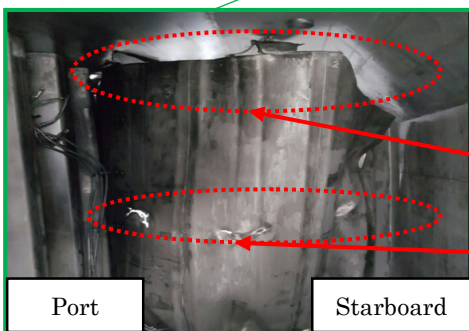
Damage to the Tank
(The hatch cover fell into the sea.)

cracks in the upper and lower portions of the longitudinal bulkhead between the Tank and the No. 2 starboard tank as well as a roughly 100-mm deformation running toward the starboard side, and holes and deformations in the floor at the lower part of the forward transverse bulkhead. The hatch cover fell into the sea.
