REPUBLIC OF THE MARSHALL ISLANDS

STELLAR DAISY CASUALTY INVESTIGATION REPORT

Loss of Buoyancy and Foundering with Multiple Loss of Life

South Atlantic Ocean | 31 March 2017

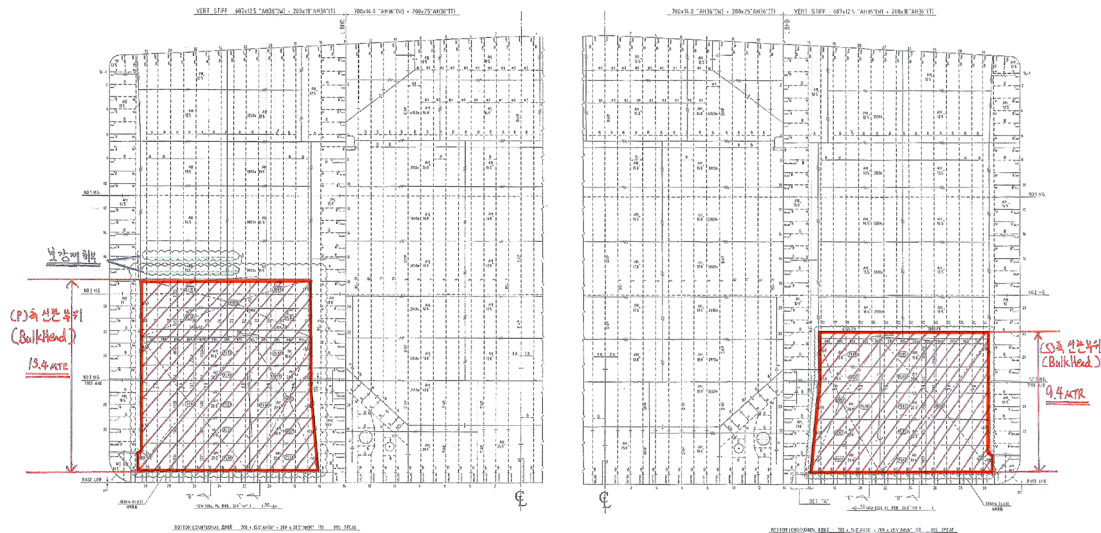
Figure 8: Transverse bulkhead at frame No. 65 starboard (left) and port (right). The side shown is the No. 3 P/S WBTs. The hatch marks denote the damaged area.

54. Based on the findings of the damage survey conducted by the KR surveyor who attended STELLAR DAISY at the Zesco Shipyard in August 2016 and the Master's Statement of Facts, KR conducted a failure analysis to determine the cause of the observed damage of the transverse bulkhead at frame No. 65.⁹⁴ During the Administrator's marine safety investigation in the loss of STELLAR DAISY, KR informed the Administrator it determined the damage of the transverse bulkhead at frame No. 65 was caused by the force of buoyance pushing against the bottom shell as the ship worked in the seas and that the damage should be renewed to original scantlings.⁹⁵ KR also informed the Administrator it considered the damage of the transverse bulkhead at frame No. 65 to be isolated.

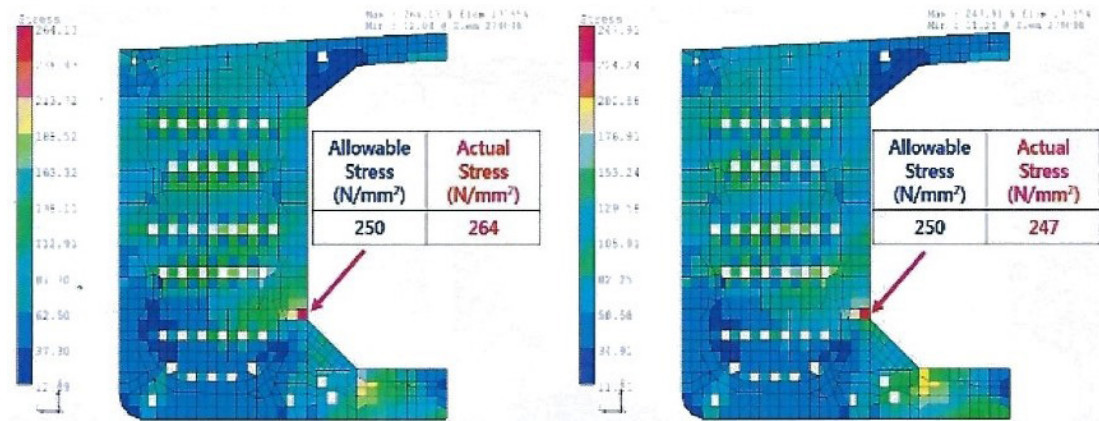
111. KR determined that the FEA results indicated that the stresses in way of Cargo Holds Nos. 3F and 3A was within the limits allowed by the KR Rules for Steel Ships. An area of stress exceeding the allowed limits was identified in the web of the swash bulkhead located at frame No. 79 in way of where the hopper plate is welded to the longitudinal bulkhead. This frame is located at the middle of Cargo Hold No. 2 (see Figure 15). Similar areas of stress were not identified in the other frames included in the model of the half-breadth of the hull in way of Cargo Hold No. 2. KR determined that the stress was localized. The FEA was also conducted, using the as built scantlings, to determine if the results were related to the diminution of the structure due to corrosion. The stress in this area was determined to be slightly below the allowed limits and in compliance with KR Rules for Steel Ships.

Figure 15: Stresses at frame No. 79 based on 2015 thickness measurements (left) and at time of conversion (right).

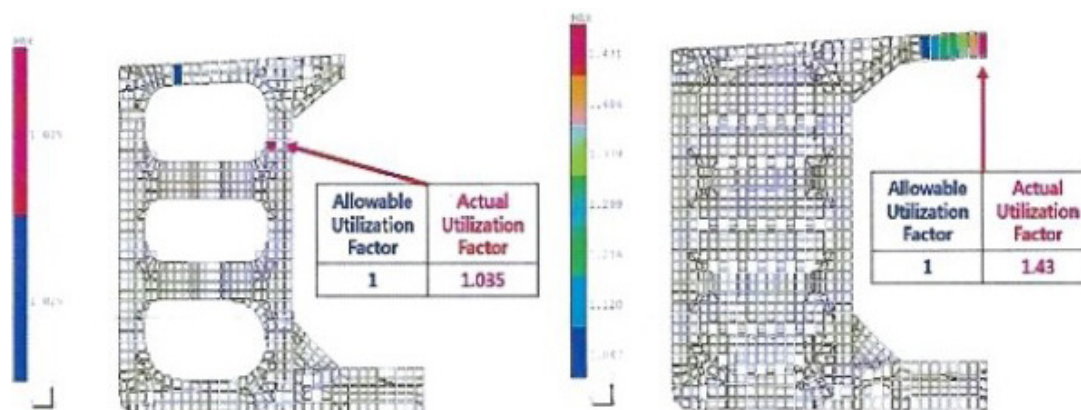
112. A buckling analysis in hogging and sagging conditions using the 2015 thickness measurements was conducted to determine if the transverse structure in way of Cargo Holds Nos. 2, 3F, and 3A met the buckling criteria in the KR Rules for Steel Ships. This analysis identified an area in the transverse web at frame No. 68 that slightly exceeded the allowed criteria. It also identified a portion of the transverse structure at frame No. 79, which was between the forward and aft hatches for Cargo Hold No. 2, that exceeded the allowed buckling criteria (see Figure 16).¹⁴⁶

Figure 16: Locations where the structure did not meet the buckling criteria at frame No. 68 (left) and frame No. 79 (right).

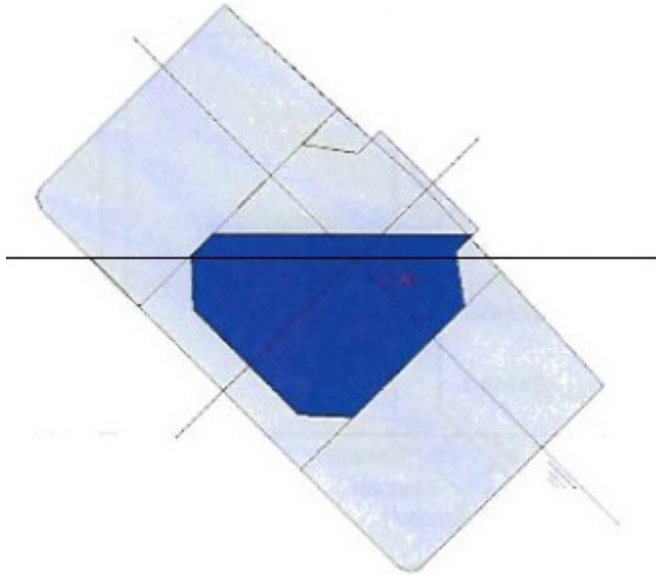
plate and longitudinals exceeded the scantlings required to support the increased pressure, the as built scantlings for the longitudinal bulkhead plate and longitudinals did not meet the required scantlings. Based on this analysis, KR determined that the longitudinal bulkheads could fail between transverse frames following a cargo shift.

Figure 17: Assumed shape of cargo pile after shifting when ship's list was 45° to port. The change of draft due to flooding is not shown.

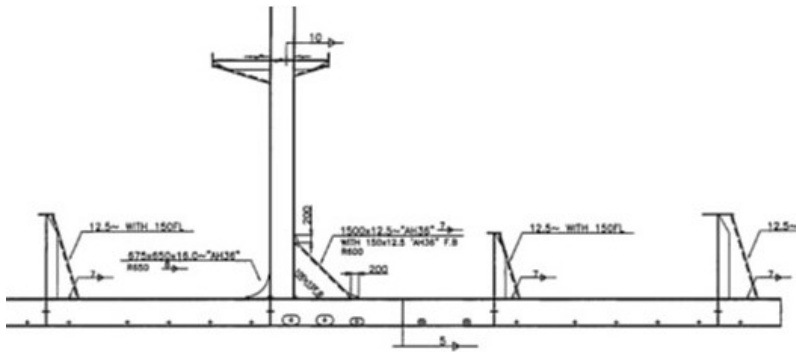
120. Cracks were found in bottom longitudinals in way of a transverse bulkhead on other ships that either had brackets forward of the bulkhead only or had brackets on both sides of the bulkhead. STELLAR DAISY had 1,500 x 1,500 x 12.5 mm brackets fitted with a 150 x 12.5 mm buckling plate on the forward side of the transverse bulkheads and smaller 675 x 650 x 16 mm soft toe brackets on the aft side of the bulkheads (*see Figure 18*). KR determined that 21 of the cracks reported in bottom longitudinals were not fitted with a bracket. The other 17 extended from the toe of the bracket. In addition, on some of the converted VLOCs two or more adjacent bottom longitudinals were found cracked in the same tank.

Figure 18: Bottom longitudinal brackets in way of the transverse bulkhead in the wing tanks.

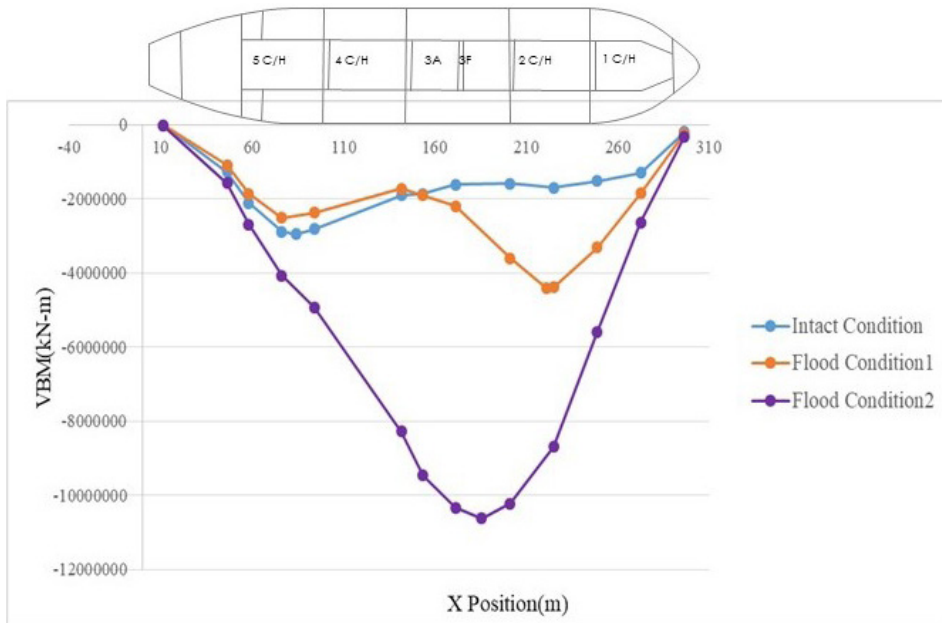
122. KR determined that with No. 2 P WBT flooded, the bending moment would have been 81% and the shear force would have been 66% of the maximum at-sea values. With Nos. 2 and 3 P WBTs flooded, the calculated bending moment was 192% and the shear force was 80% of the allowed at-sea values. Using the calculated bending moments based on the ship's loaded condition as a reference, the maximum still water bending moment increased by approximately 100% when No. 2 P WBT was flooded and by 400% when Nos. 2 and 3 P WBTs were flooded. The location of the maximum bending moment was at frame No. 55 when the ship was in an intact condition, between frame Nos. 78 and 79 when No. 2 P WBT was flooded and between frame Nos. 78 and 79 when Nos. 2 and 3 P WBTs were flooded (see Figure 19).

Figure 19: Still water bending moments.

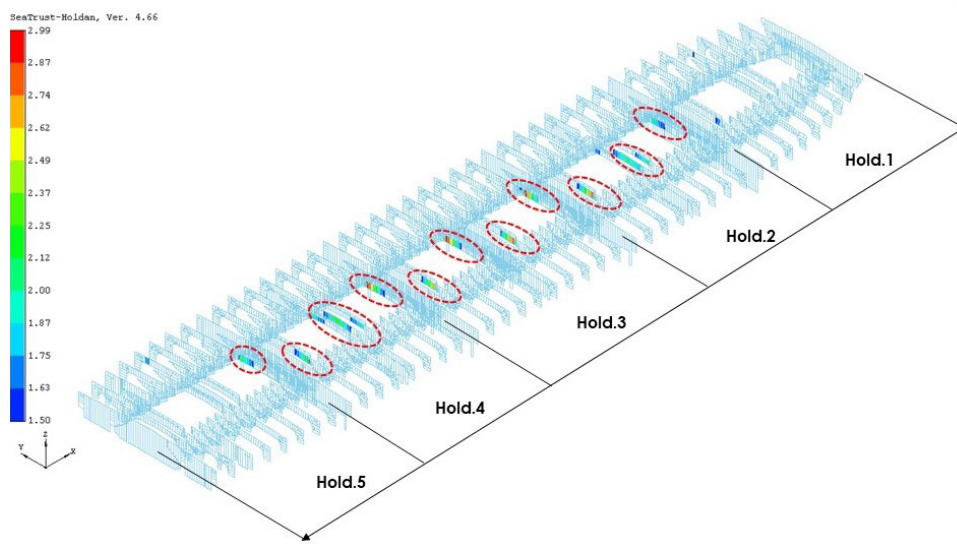
123. KR evaluated the potential for the ship’s transverse structure to buckle when No. 2 P WBT was flooded to the point where the ship would have been in equilibrium per ICLL 1966 as amended by the Protocol of 1988, regulation 27(13). Taking into consideration the ship’s loaded condition and the weather conditions that existed from 29–31 March 2017, it was determined that portions of the transverse structure between the hatch openings for Cargo Holds Nos. 2-5 would likely buckle (*see Figure 20*). KR also determined that buckling of the transverse structure would likely have begun before the tank was flooded to the point where the ship would have been in equilibrium.

Figure 20: Areas of potential buckling of the transverse structure with No. 2 P WBT flooded.

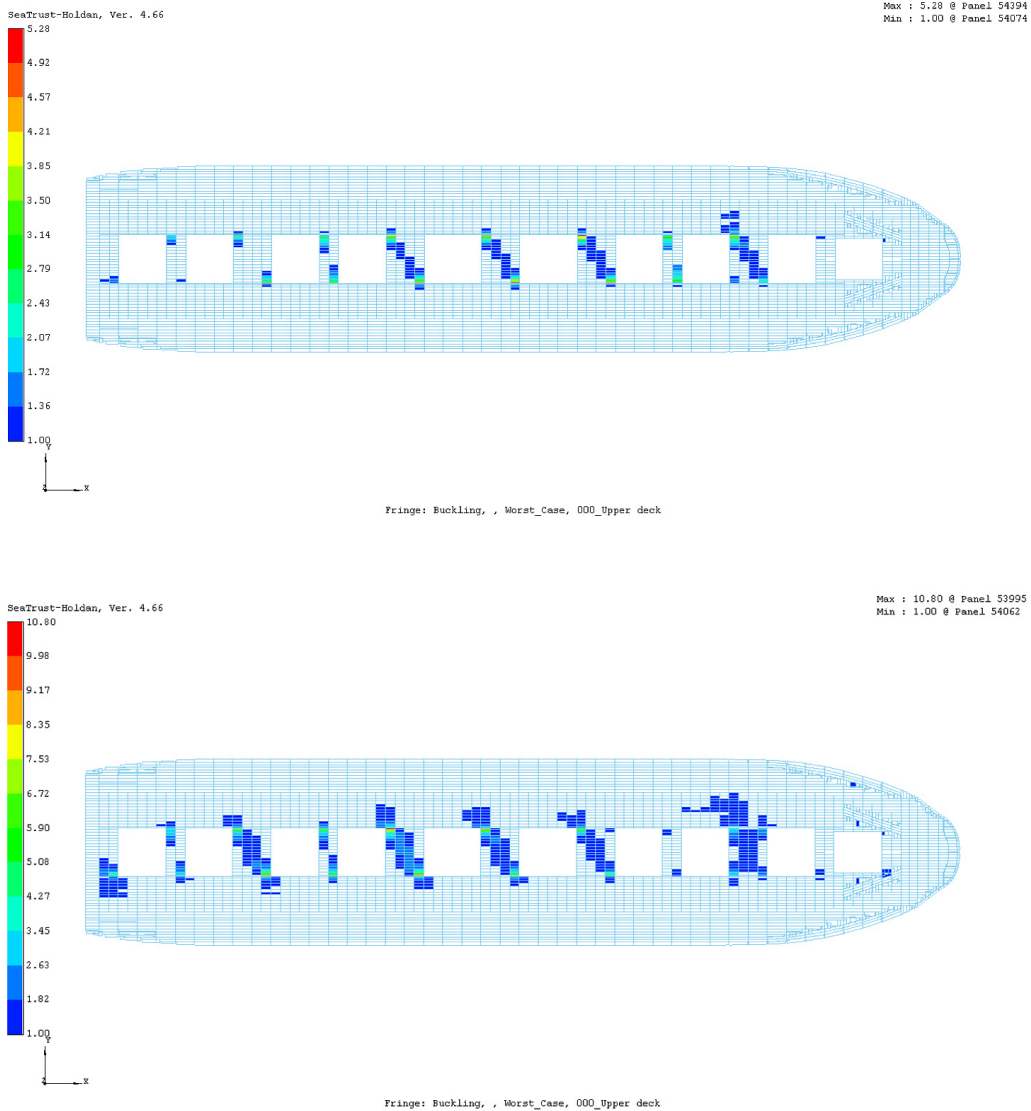
- 125. The buckling analysis was also conducted with both the No. 2 P and No. 3 P WBT flooded. The analysis indicated that buckling of the transverse structure between hatch openings would be more severe than with only the No. 2 P WBT flooded. It was also determined that multiple transverse bulkheads between cargo holds would likely collapse. The analysis also indicated that deck plate outside of the line of hatch openings would also be damaged. In addition, the deflection of the hatch coamings and covers would become more severe (see Figure 21).

Figure 21: Areas of the deck where the buckling criteria was exceeded with No. 2 P WBT flooded (upper) and with Nos. 2 and 3 P WBTs flooded (lower).

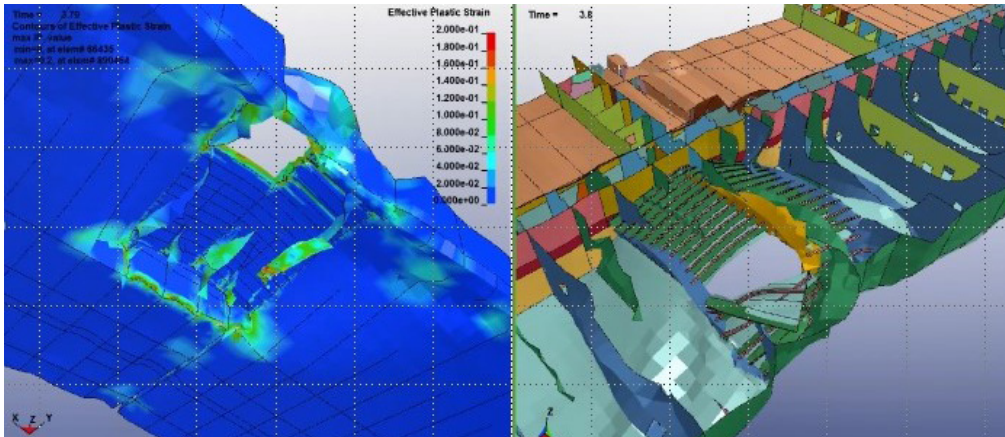
Taking into consideration STELLAR DAISY’s repair history and the number of cracks in bottom longitudinals that were identified on other converted VLOCs, managed by Polaris Shipping and classed by KR, after the loss of STELLAR DAISY, the flooding of No. 2 P WBT likely was the result of one or more cracks in bottom longitudinals that either were not detected when the tank was last inspected in October 2016 or that developed after the inspection. As the crack, or cracks, grew, the pressure on the bottom shell as the ship rolled under the influence of the high GM₀ would have imposed additional stresses on the hull structure that could cause latent cracks in other bottom longitudinals to grow or for a fatigued bottom longitudinal to fail. As a result, the size of the crack would likely increase and potentially lead to a loss of shell plate and cause massive, uncontrollable flooding (see Figure 22).

Figure 22: Graphic showing potential damage to the bottom plate and internal structure based on a transverse brittle fracture originating forward of the transverse bulkhead at frame No. 75. The hole in the bottom of No. 2 P WBT is approximately 15 m².
