Final report RS 2019:01e

DECLAN DUFF – Accident in conjunction with discharging of cargo in Oxelösund, Södermanland County on 16 March 2018

File no. S-42/18

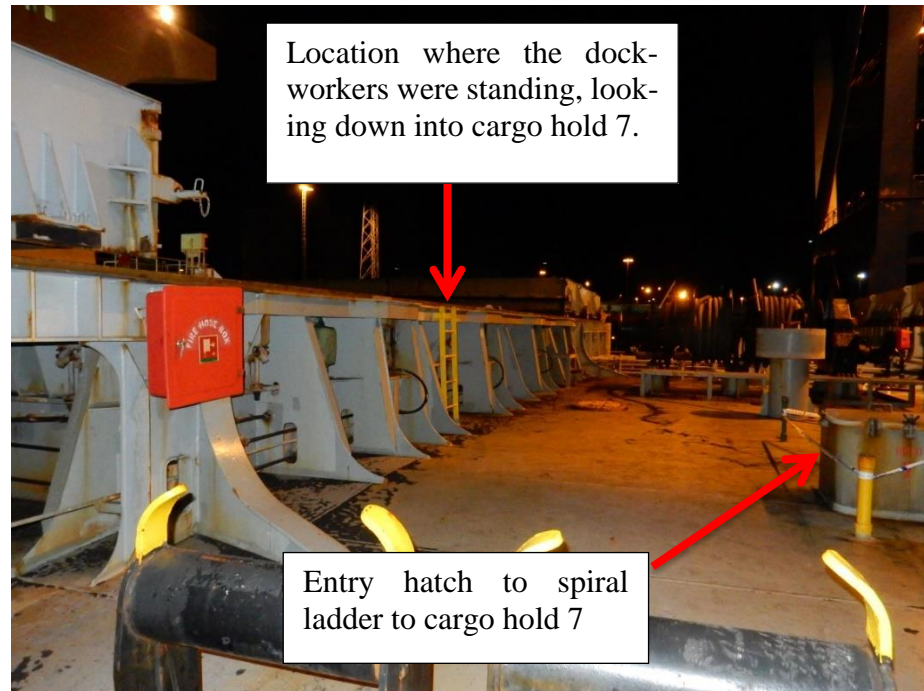
Figure 3. The deck of the DECLAN DUFF between cargo holds 6 and 7.

The hatch foreman and the dockworker that would be operating the loader in the cargo hold (worker A) boarded the DECLAN DUFF at around 22:00 to prepare and start the work before the remaining team members arrived. They went to the fore edge of cargo hold 7, and the hatch foreman told worker A how he was to operate the loader inside the cargo hold (see figure 3).

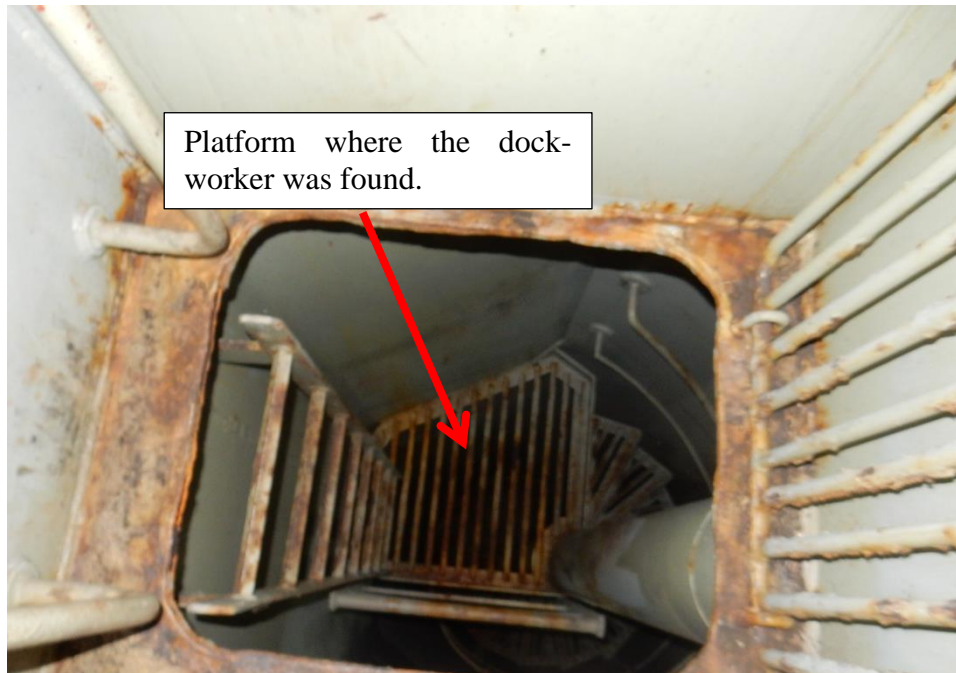
Figure 4. Entry hatch to cargo hold 7.

The hatch foreman looked down into the cargo hold to see when worker A would enter the space. When he did not appear, the shift leader called him on the radio, but there was no response. The hatch foreman then headed to the entry hatch to the spiral ladder and went down. On the platform before the spiral ladder begins (see figure 4), he found worker A, who appeared to be lifeless.

The hatch foreman does not believe that the dockworker had opened the entry hatch himself, as he should have noticed this. In addition, the time between the dockworker leaving and the hatch foreman starting to look for him was short, and would not have been sufficient to unscrew the four lock nuts (see figure 5).

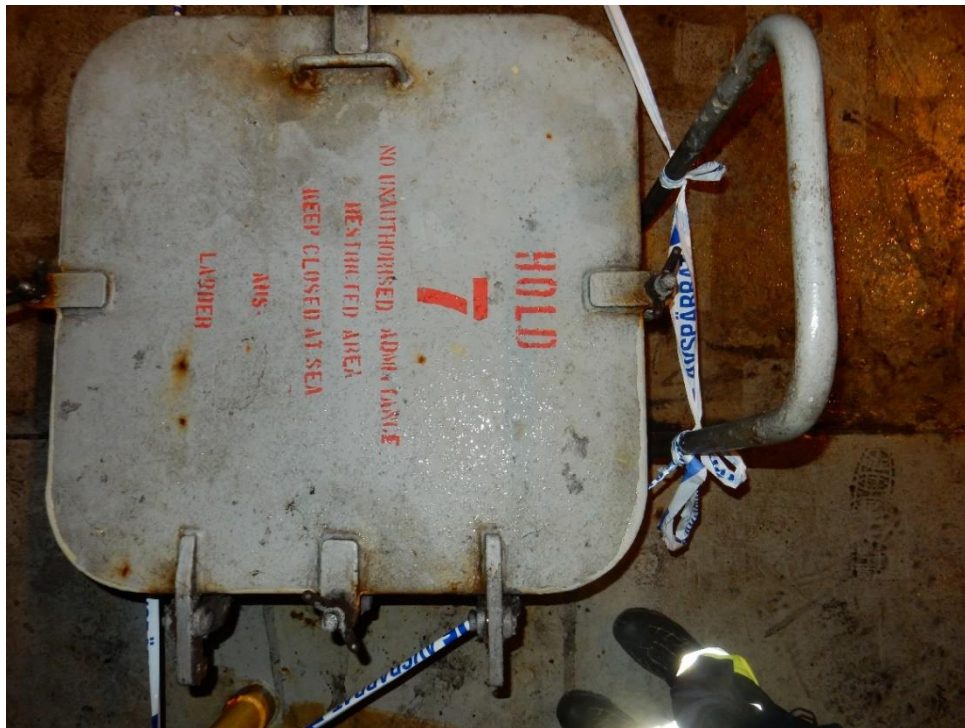
Figure 5. Entry hatch to spiral ladder.

Despite this, a dockworker died from oxygen deficiency at a later stage of the discharging operation when he went down one of these spiral ladders. The hatch foreman at the time has stated that he was unaware of the risks of enclosed spiral ladder, and it can certainly be assumed that the deceased dockworker was also unaware of those risks. Nor did the dockworkers who arrived to attempt a rescue realise the danger entailed by entering the enclosed ladder.

The port's instruction had thus not taken precautions for the fact that spiral ladders can be designed differently and thereby be associated with different risks. It is therefore SHK's opinion that the instruction should be reviewed. It is SHK's perception that this is also included in the measures that the port intends to take. For this reason, no safety recommendation in this regard needs to be issued here.

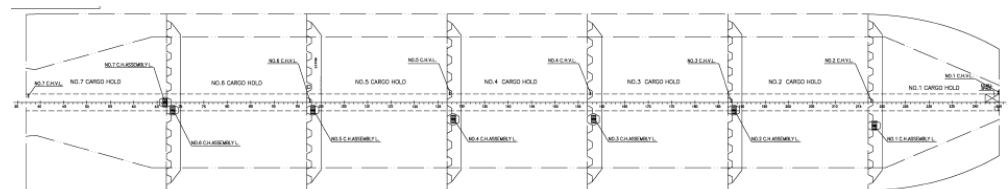
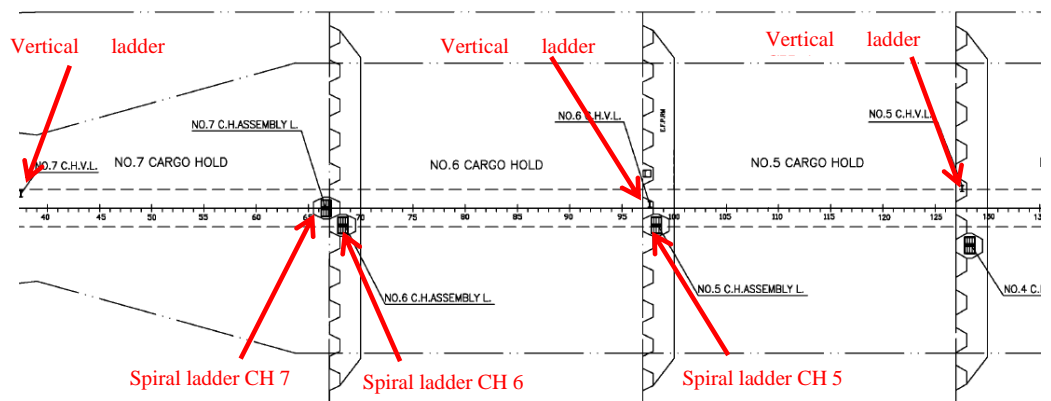
For each cargo hold, there are two entry hatches: one vertical ladder and one enclosed spiral ladder (see figures 7–11). All the ladders are placed in the same way in relation to the cargo hold, except in cargo hold 7 where the accident occurred, where the position is the reverse compared to cargo holds one through six. The enclosed spiral ladders had no ventilation.

Figure 7. DECLAN DUFF's cargo hold entry hatches.

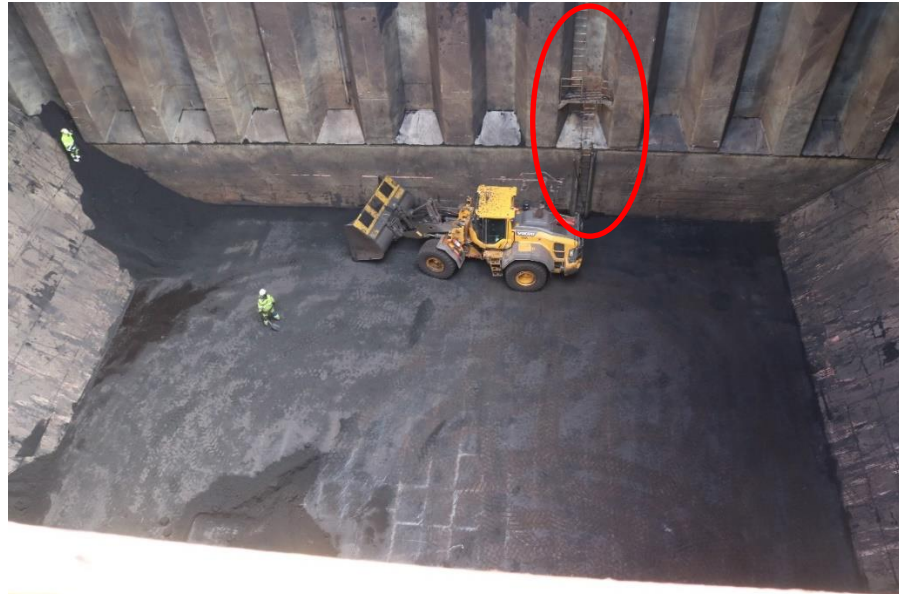
Figure 11. DECLAN DUFF, cargo hold 7. The vertical ladder is circled in red. Image: Swedish Police.
