Final report MO-2017-204: Passenger vessel *Seabourn Encore*, breakaway from wharf and collision with bulk cement carrier at Timaru, 12 February 2017

Marine inquiry MO-2017-204

Passenger vessel *Seabourn Encore*

Breakaway from wharf and collision with bulk  
cement carrier at Timaru

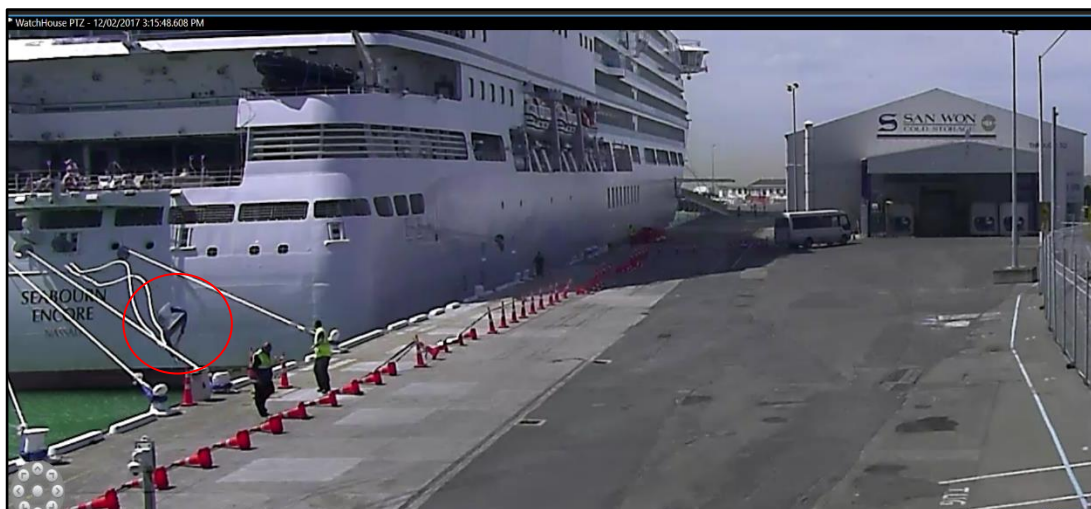
**Figure 2**  
Failure of bollard 26 with two mooring lines attached

- 3.1.16. Seconds later a shore mooring bollard holding a forward spring failed, rendering the mooring line ineffective. This was followed seconds later by the failure of an aft shore mooring bollard holding two stern lines (see Figure 2). Both lines became ineffective. Seconds later the bollard holding the second forward spring failed, rendering that line also ineffective.

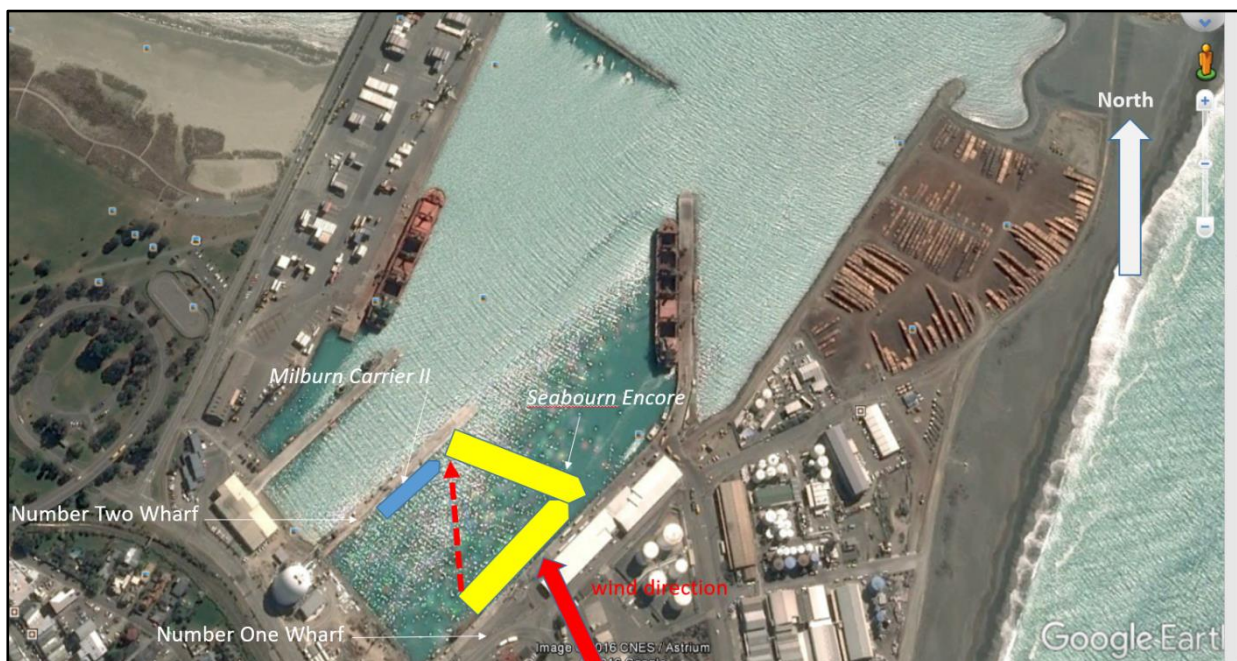
- 3.1.20. The port quarter of the *Seabourn Encore* continued swinging around, cleared the *Milburn Carrier II* and came to rest on the quay side of Number Two Wharf. The master used all four thrusters to keep the vessel wedged between Numbers One and Two Wharfs.

**Figure 3**  
**Movement of the *Seabourn Encore*'s stern after breaking away from Number One Wharf**

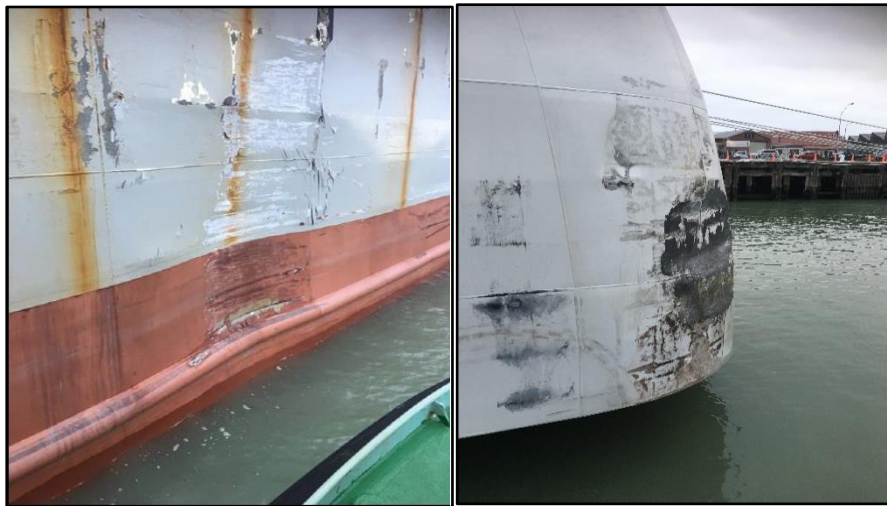
- 3.3.2. The *Milburn Carrier II* suffered damage to the shell plating in way of the number three top wing saltwater ballast tank. The hull was penetrated and saltwater ballast was emptying into the harbour from below the waterline. The tank was pumped dry and the damage to the shell plating rose above the waterline (see Figure 4).

Figure 4  
Damage sustained by the *Milburn Carrier II* (left) and the *Seabourn Encore* (right)

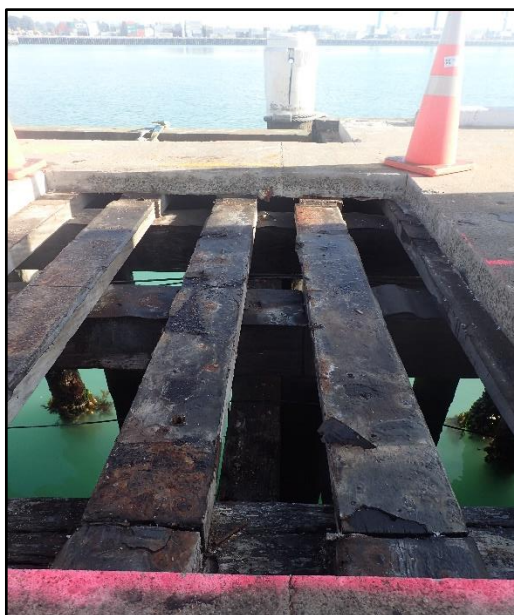
- 3.7.1. Number One Wharf was constructed in 1878 and there had been a number of modifications, additions and repairs carried out since. With a length of 380 m and a width of 10 m, the wharf had been constructed using hardwood timber piles, timber beams and stringers, and more recently a 100 mm thick concrete deck had been laid over the wooden ‘hit and miss’<sup>16</sup> deck (see Figure 7).

**Figure 7**  
**Number One Wharf – ‘hit and miss’ decking under concrete**

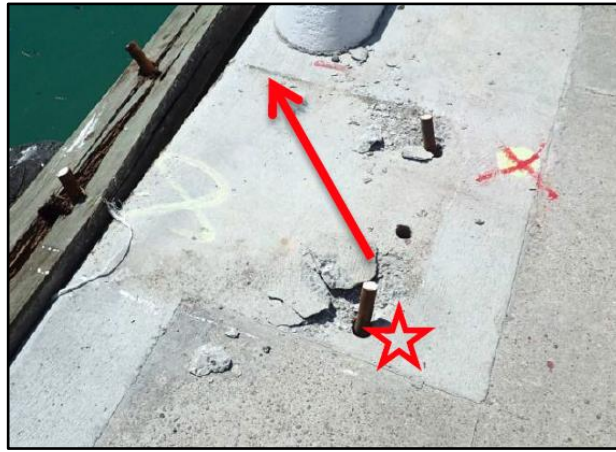
**Figure 9**  
Bollard 26 after the failure, showing the direction of mooring lines to the ship

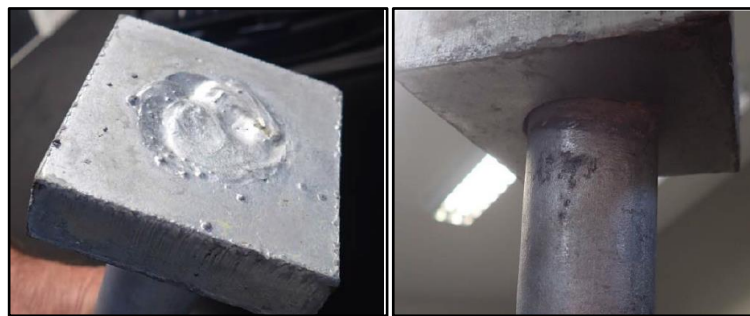
**Figure 10**  
The top (left) and bottom (right) welded bolt head plates, same design used to secure bollard 26

- 4.3.11. The metallurgical analysis confirmed that there was no significant loss of section due to corrosion, but that the shearing had occurred at the weld material, which had a total area of about half the cross-sectional area of the bolt shank. The welded head had therefore become the weakest point in the securing arrangement (Figure 10).
- 4.3.12. The mooring ropes had an elevation of approximately 30° to the horizontal and therefore had a vertical component creating an uneven distribution of load. It is likely that the loads being applied to the bolt heads on bollard 26 were not equal. As a result, it is likely that the shearing force required to cause failure was less than that envisaged at design.

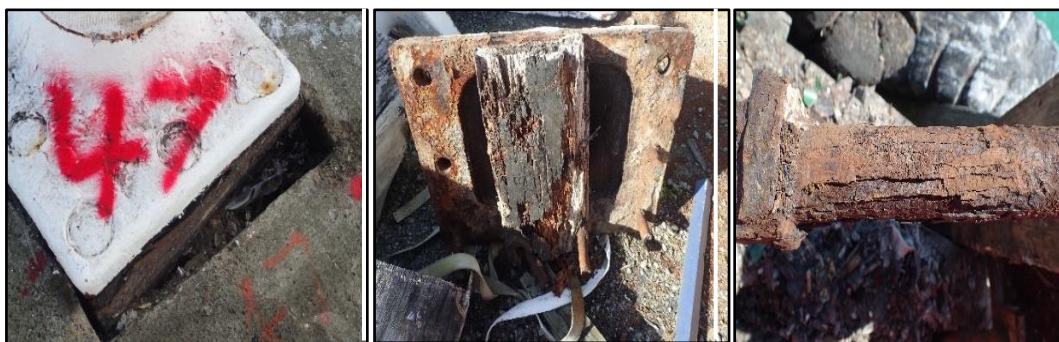
**Figure 11**  
Decaying timber and corroded bolts supporting bollards 47 (left) and 46 (centre and right)

- 4.3.15. Another factor was that some bollards were secured through decaying timber at the face of the wharf (Figure 11), which was the weakest point in the securing arrangement. The load on the mooring ropes was transferred to the bollard securing bolts that passed through the supporting timber structure. The timber was unable to withstand the loads being applied and gave way, causing the bollards to fail.

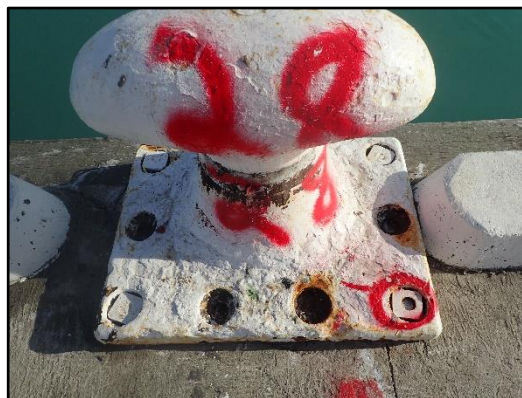
- 4.3.16. Another factor was the inconsistency in how bollards were secured. There were a number of different bollard designs and securing methods in use. No bollard contained the maximum possible number of securing bolts and the bolt head design for securing them was inconsistent (Figure 12). As a consequence, the bollards were not secured in a way consistent to achieve their designed safe working load, making it virtually impossible to establish a known safe working load for each.

Figure 12  
Underutilisation of the bollard securing arrangement

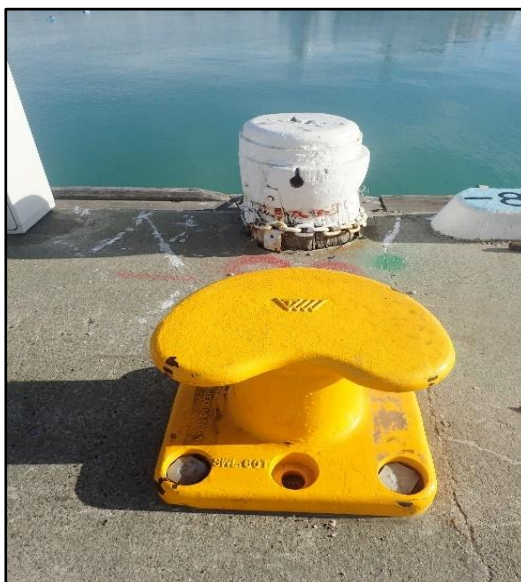
**Figure 13**  
**Newly installed steel bollard**
