Independent Observer summary report on *MV Al Shuwaikh*

Sheep and cattle exported to Kuwait, Qatar and United Arab Emirates in June 2018

Report 7, May 2019

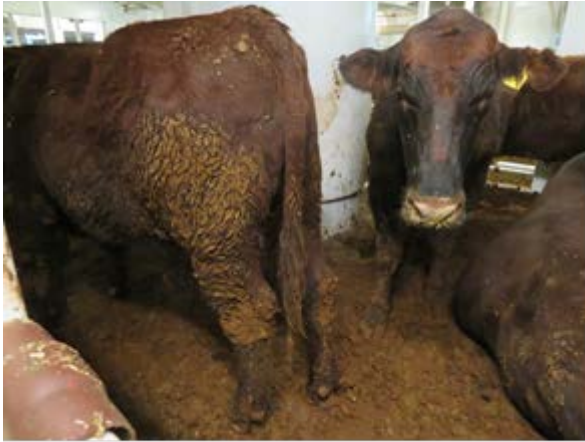
Day 5 Cattle in pen—no issues identified

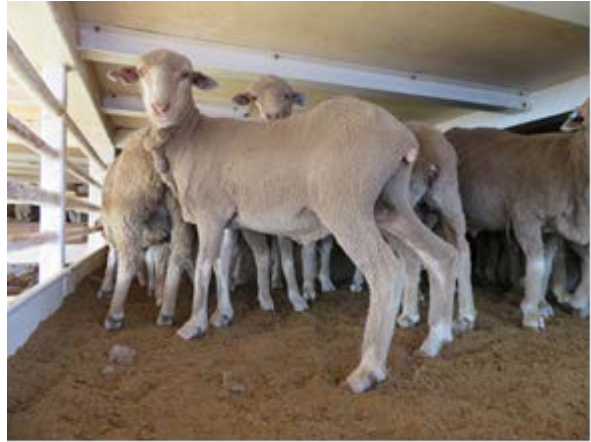
Day 5 Sheep in pen—no issues identified

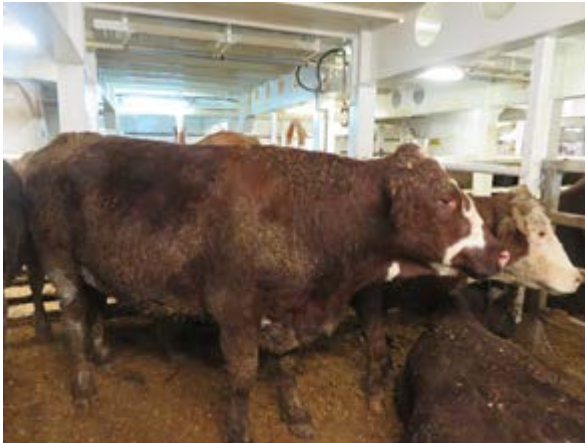
Day 13 Cattle in pen—no issues identified

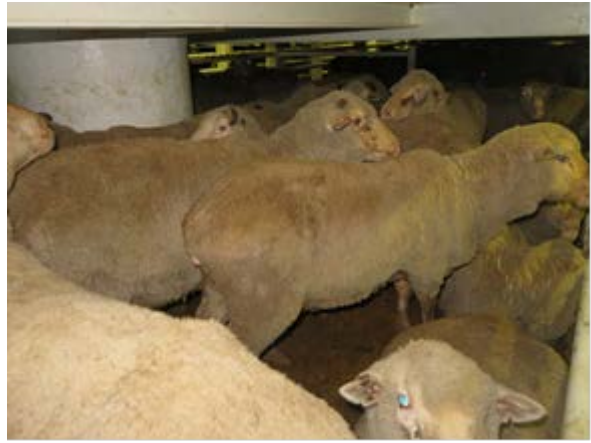
Day 13 Sheep in pen—no issues identified

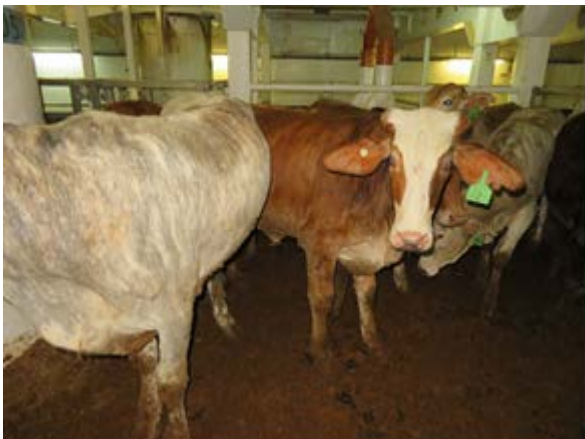
Day 23 Cattle in pen—no issues identified

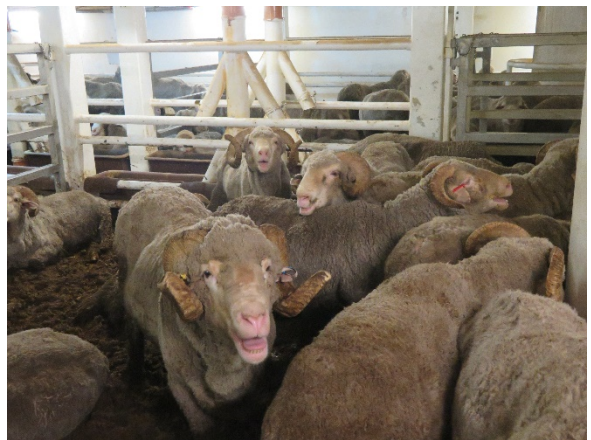
On approximately eight days of the voyage, the IO observed sheep open mouth breathing and attempting to gain position around the ventilation vents on all open and closed decks. This was more notable on hot days with higher humidity. In these instances, death by smothering was an observed outcome and six to eleven of the observed mortalities around the ventilation vents could have been attributed to smothering. This situation appeared to be more apparent in pens with higher density.

Day 20 Sheep in pen—open mouth breathing
