**REPUBLIC OF CYPRUS  
MARINE ACCIDENT AND INCIDENT  
INVESTIGATION COMMITTEE**

**Investigation Report No: 4E/2018**

**Very Serious Marine Casualty**

**Manoverboard fatality from “ELBTRADER”, in the Port of  
Dublin - South Ireland, on 12/01/2018**

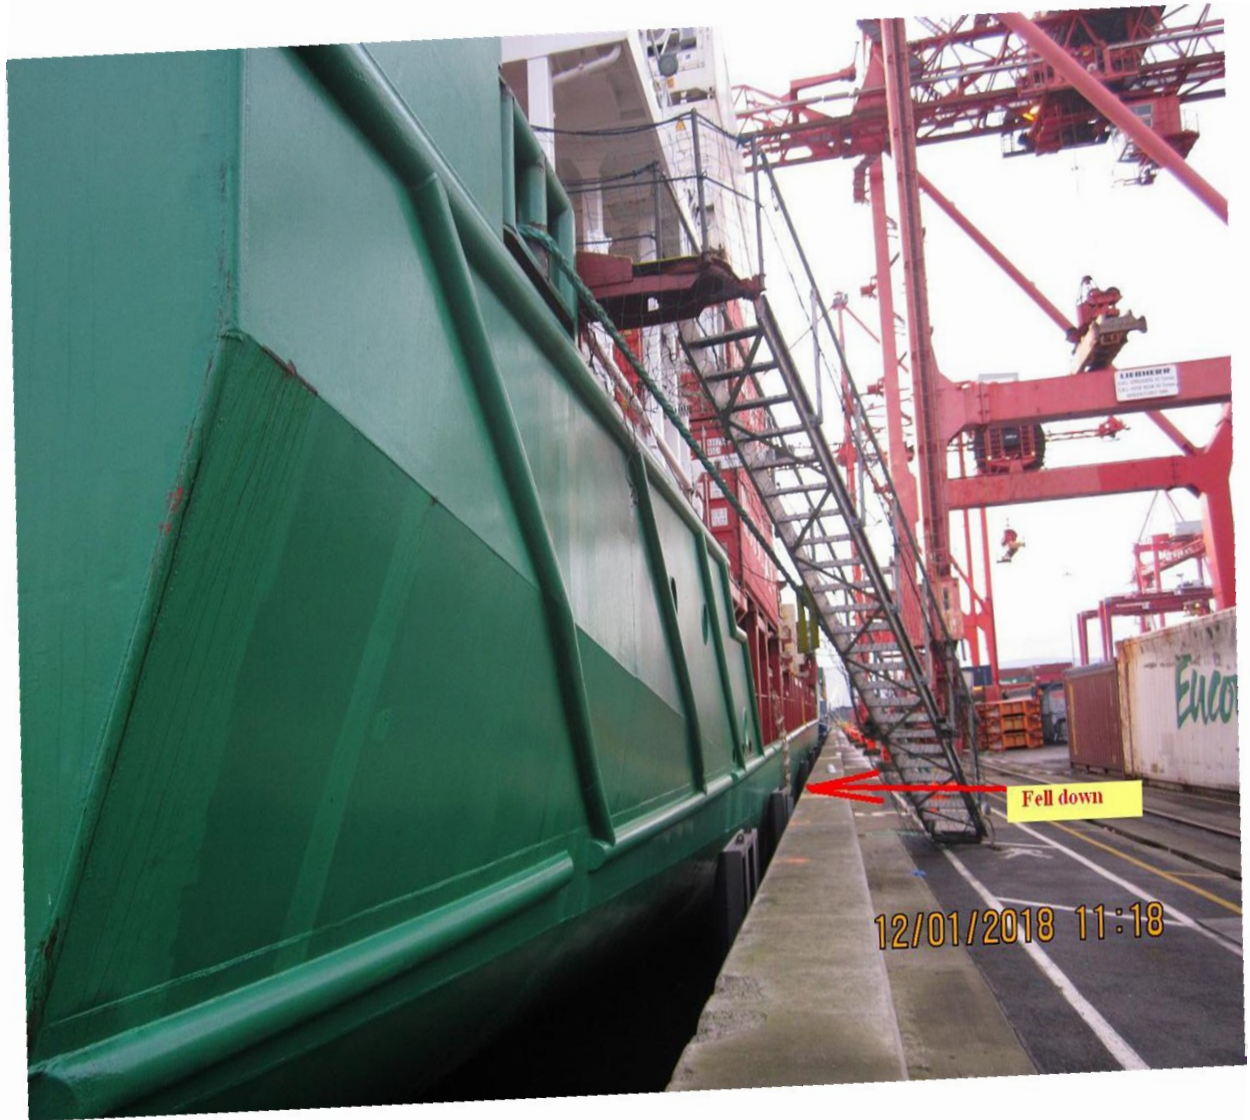
**Vessels aft stbd side. Gangway's Upper and Lower Platform. Monkey Ladder at the point of fall.**

Before the accident, the gangway was hoisted up. It was hanging 3-4m over the quay. The two visitors were waiting for a while, at the Poop Deck, near the gangway's upper platform.

At about 05:42 Hrs LT, they attempted to jump over the vessel's stbd bulwark to the quay. On jumping over the bulwark, one of them, fell overboard, in the gap between the vessel and the quay.

- Proper safety attitude.
- Proper assertiveness.
- Proper supervision.
- Proper gangway controlling.
- Using always the appropriate equipment (gangway) for ship access.

- Using always the appropriate equipment (gangway) for ship access.
- Proper safety attitude.

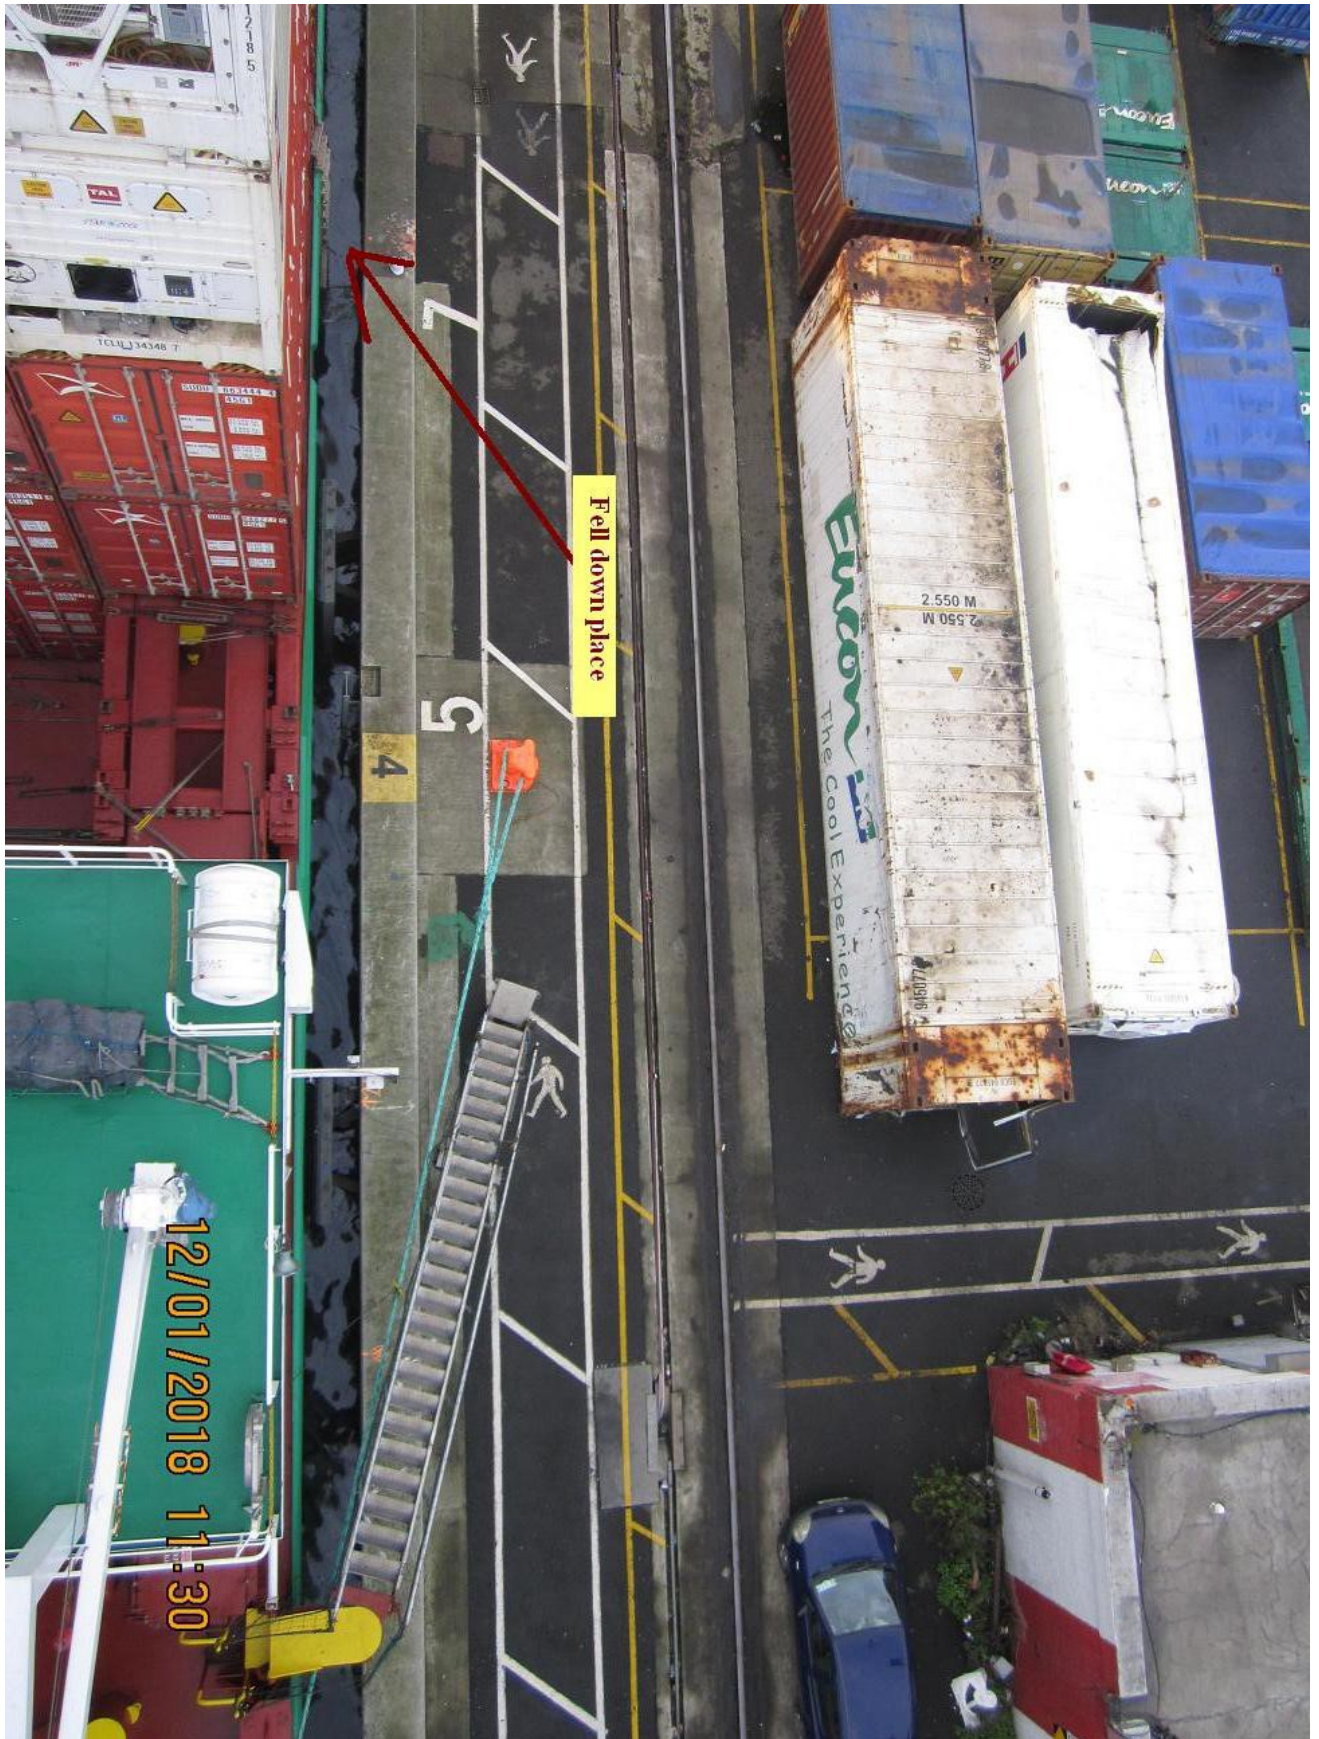
Fall down place indicated by arrow. A rope attached on the gangway's lower platform can be pulled for gangway's positioning on the quay.

***The environmental conditions (Tide) in conjunction with cargo operations were a contributing factor to the accident.***

***A Work-Around Violation by hoisting up 3-4m and under-controlling the gangway was a contributing factor to the accident.***

Continuous monitoring and necessary adjustments should and could had been made by the OS / Gangway Watchman. He could adjust the gangway every half an hour, without needing assistance from the AB on watch. Nevertheless, he opted to hoist the gangway 3-4m over the berth. When the need arose to lower it, the AB of the watch was required to go to the berth to heave the gangway's rope which was fixed on the lower platform, in order to properly place the gangway on the berth.
