Marine Casualty Investigation Board  
*Bord Imscrúdú Taisní Muirí*

**REPORT INTO THE  
FATAL INCIDENT INVOLVING  
THE KILKEE  
IRISH COAST GUARD  
RIGID INFLATABLE BOAT  
AT KILKEE, CO CLARE  
12th SEPTEMBER 2016**

**REPORT NO. MCIB/266  
(No.7 OF 2018)**

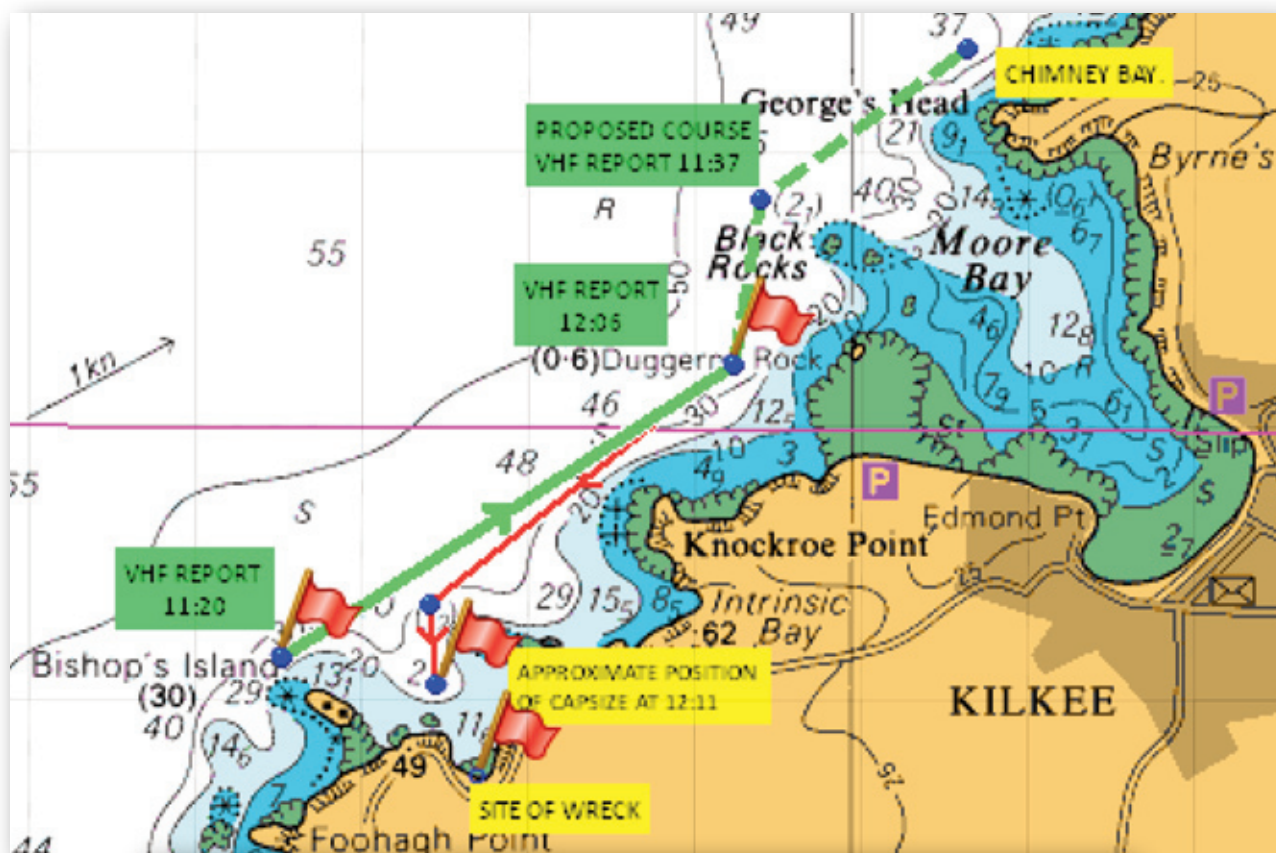
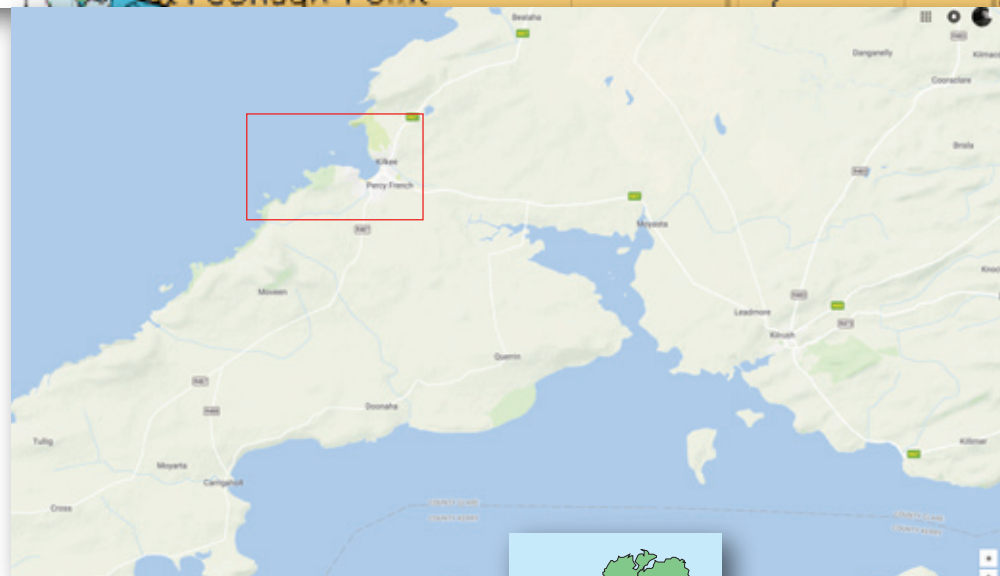
Appendix 7.4 Chart of area of incident.

4.6 The incident occurred in a small cove at the base of a cliff to the north and east of Fohagh Point. The area is covered by the chartlet as shown in Appendix 7.4. Local knowledge is that the seabed in the area rises in sharp cliff faces rather than a gradual shelving of the seabed. This can cause a sudden uprising in certain sea conditions and large swells can appear as if from nowhere.
