National Transportation Safety Board

Marine Accident Brief

Explosion and Fire aboard Articulated Tug and Barge *Buster Bouchard/B. No. 255*

Accident type	Fire/explosion	No. DCA18FM002
Vessel names	<i>Buster Bouchard, B. No. 255</i>	
Location	Aransas Pass Fairway Anchorage, 3.25 miles ¹ off Port Aransas, Texas 27°49.80' N, 096°59.40' W	
Date	October 20, 2017	
Time	0430 central daylight time (coordinated universal time – 5 hours)	
Injuries/fatalities	Two fatalities	
Property damage	>\$5 million est.	
Environmental damage	About 2,000 barrels (84,000 gallons) of crude oil released to the sea and atmosphere	
Weather	Visibility 8 miles, winds north at 6 knots, seas 3–4 feet, air temperature 75°F, water temperature 78°F	
Waterway information	Open waters of the Gulf of Mexico; charted depth at the accident site was 45 feet.

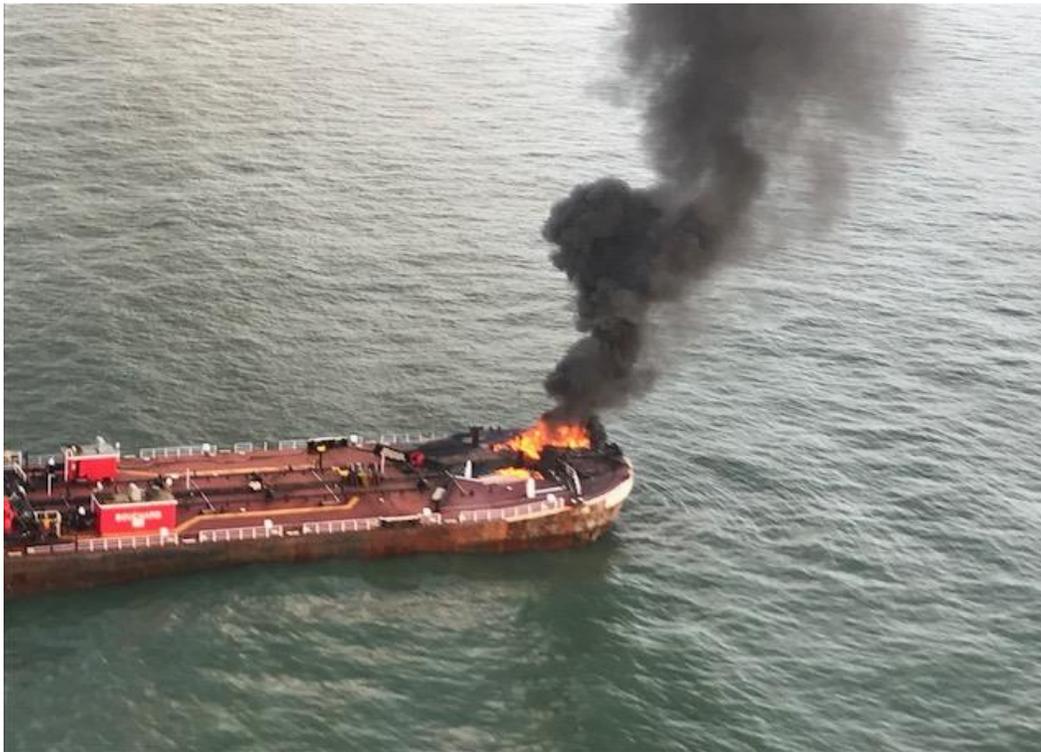
B. No. 255 bow on fire. (Photo by Coast Guard)

A majority of the damage to the *B. No. 255* was found in the forepeak of the barge, and photographs showed the post-explosion fire in the same location. This evidence aligns with the *Buster Bouchard* mate's statement about the explosion he witnessed. Based on these factors, the NTSB concludes that the initial explosion on board the *B. No. 255* originated in the forepeak of the barge.

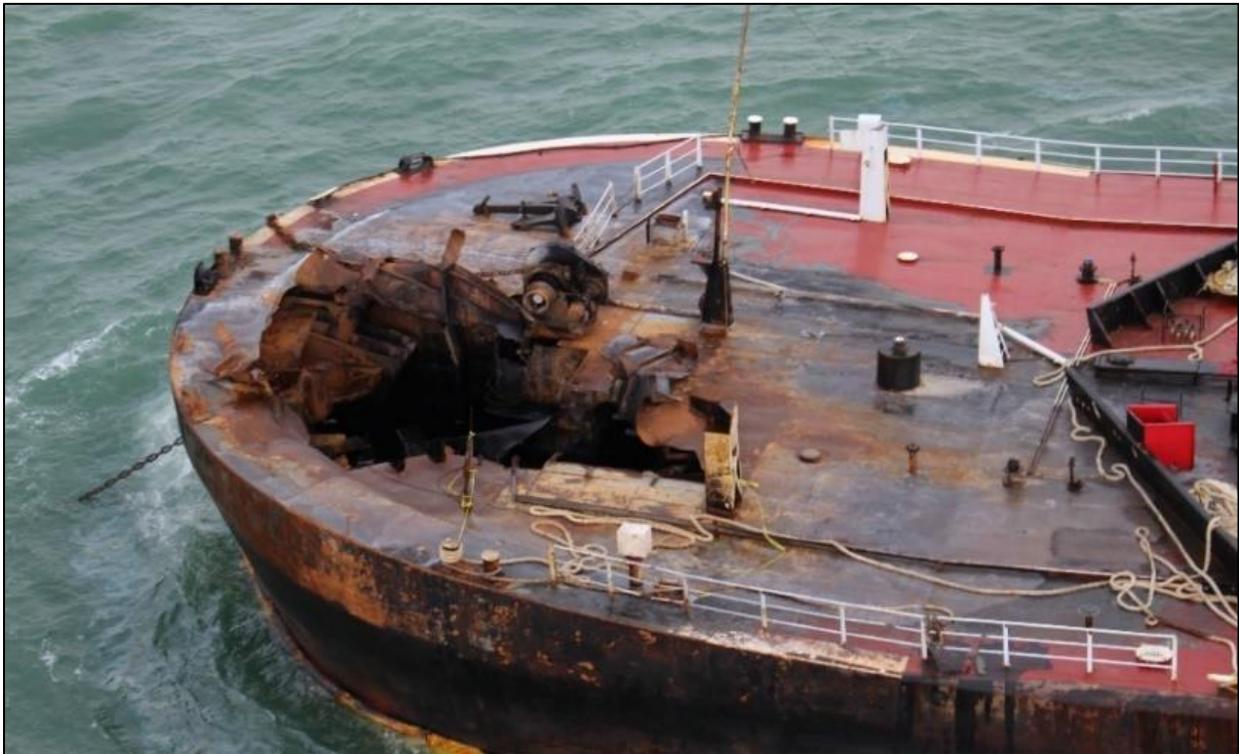
As shown in the below photos, the blasts caused significant damage to the bow of the *B. No. 255*, primarily to the port side of the forepeak and to the no. 1 port cargo tank. A large hole was opened in the deck where the doghouse was located.

Explosion and fire damage to port bow of *B. No. 255*. (Photo by Coast Guard)

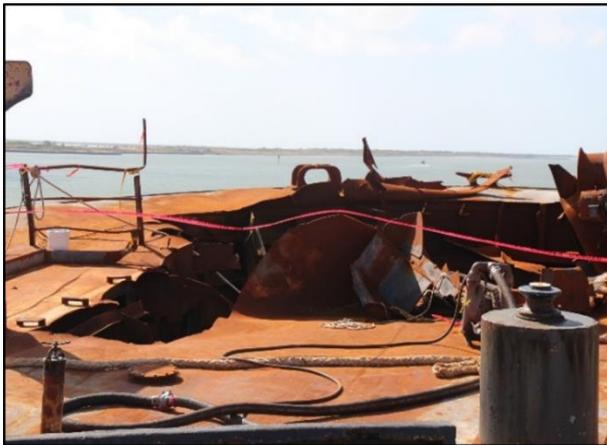
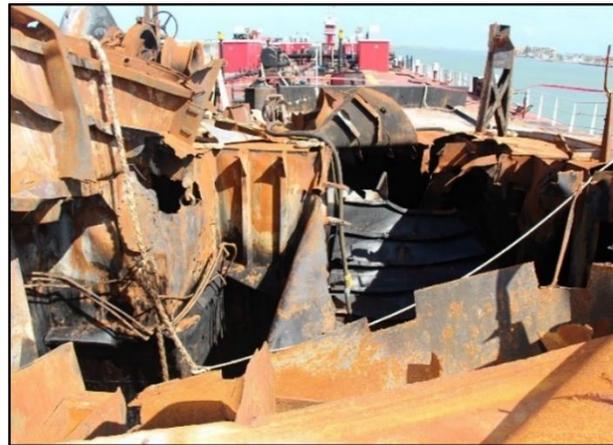
Deck level views of damage to *B. No. 255* looking forward from the main deck (left) and aft from the bow (right). (Photos by Coast Guard)

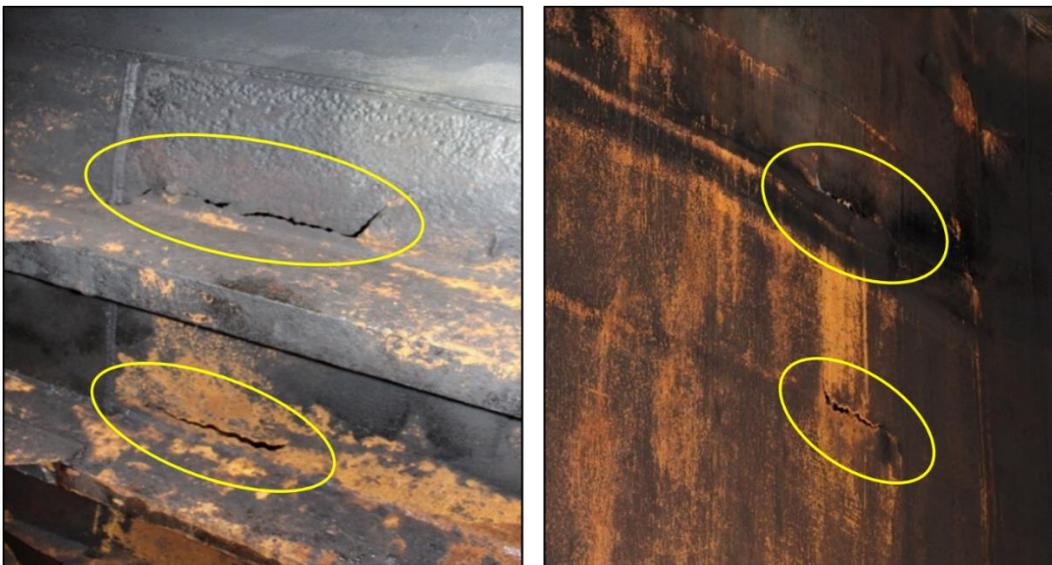
During a postaccident internal examination of the barge on December 7, 2017, investigators discovered two horizontal through-cracks in the bulkhead separating the forepeak and the no. 1 port cargo tank. The cracks were approximately 15 feet from the bottom of the tank and about two inches above transverse framing welded to the forepeak side of the bulkhead. The horizontal length of the higher crack was 13.8 inches and the horizontal length of the lower crack was 13.5 inches. A 3-foot-by-4-foot section of the bulkhead containing the cracks was removed for further examination and testing by the NTSB Materials Laboratory.

Cracks in bulkhead separating the forepeak from the no. 1 port cargo tank, as viewed from the forepeak (left) and the cargo tank (right). (Photos by Coast Guard)

The bulkhead between the forepeak and the no. 1 port cargo tank had previously experienced significant corrosion, as evidenced by the repairs documented by ABS to portions of the bulkhead that were conducted 8–10 years prior to the accident. During postaccident examination, through-cracks were found in the area of the original bulkhead that had not been previously repaired, and the steel in the areas around the cracks was pock-marked and pitted. Other areas of through-corrosion were also discovered during the NTSB's Materials Laboratory examination.

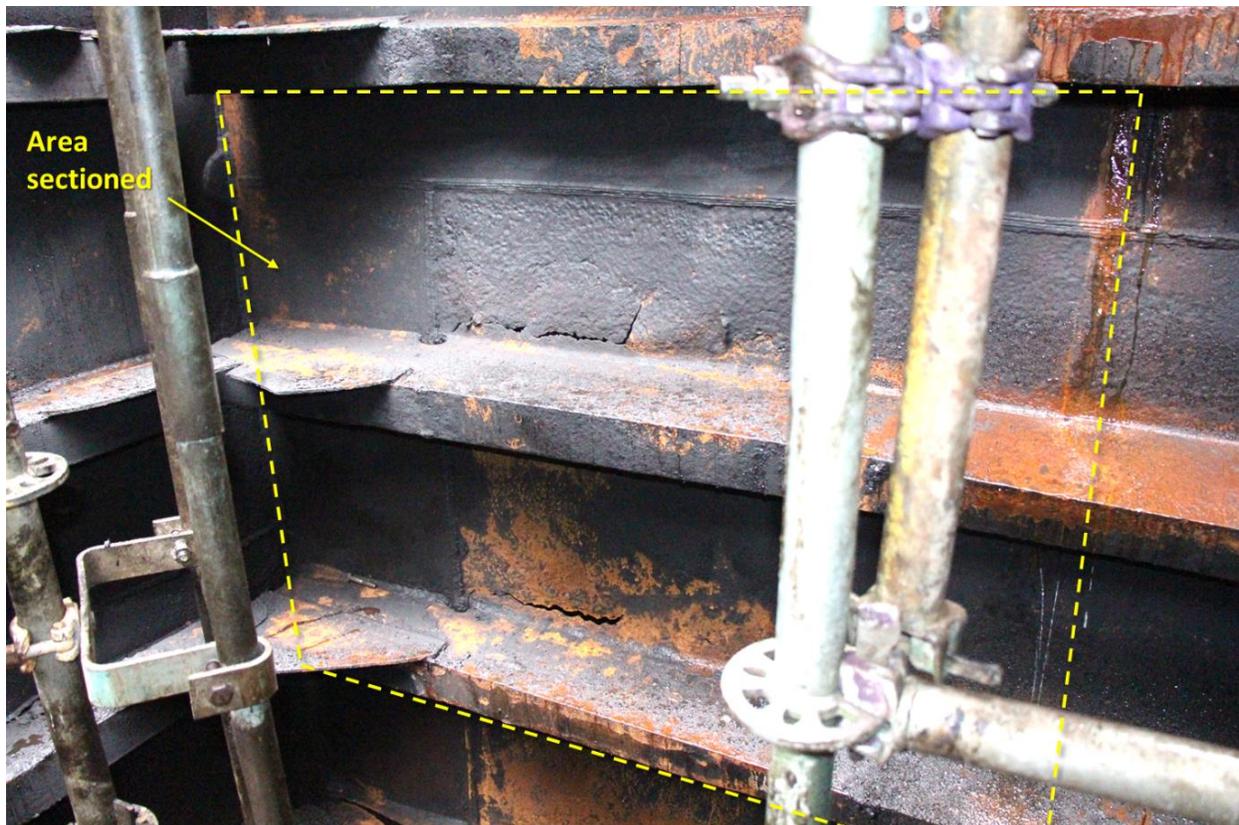
Cracks in bulkhead separating the forepeak from the port no. 1 cargo tank. The dashed section was removed and sent to the NTSB Materials Laboratory for analysis. (Photo by Coast Guard)

Examination by the Materials Laboratory of the tips of metal along the through-cracks revealed two broad categories of features: those with an enveloping oxide/corrosion layer and those without. Examined cross sections of the first crack tip category exhibited relatively thick (0.003 inch [75 μm]) layers. The thickness of this oxide layer was consistent not just over and around the crack tip, but also over the areas away from the crack tip. The fact that the oxide exhibited a consistent thickness over all the cross-sectioned areas of the crack tips and that the oxide was of a thickness of 0.003 inch indicate that this corrosion was present before the accident explosion.

Portions of the crack tips examined by the laboratory revealed areas where the oxide had fractured and spalled. These spalled and fractured oxide regions were consistent with having occurred from the explosion forces. Thus, some damage to the bulkhead likely occurred during the explosion. However, based on the presence of corrosion on the crack tips before the accident as well as the pitted and pock-marked metal around the cracks, the NTSB concludes that two through-cracks and other holes in the bulkhead between the forepeak and the no. 1 port cargo tank on barge *B. No. 255* were primarily a result of corrosion that existed prior to the accident and compromised the integrity of the cargo containment in the no. 1 port tank.

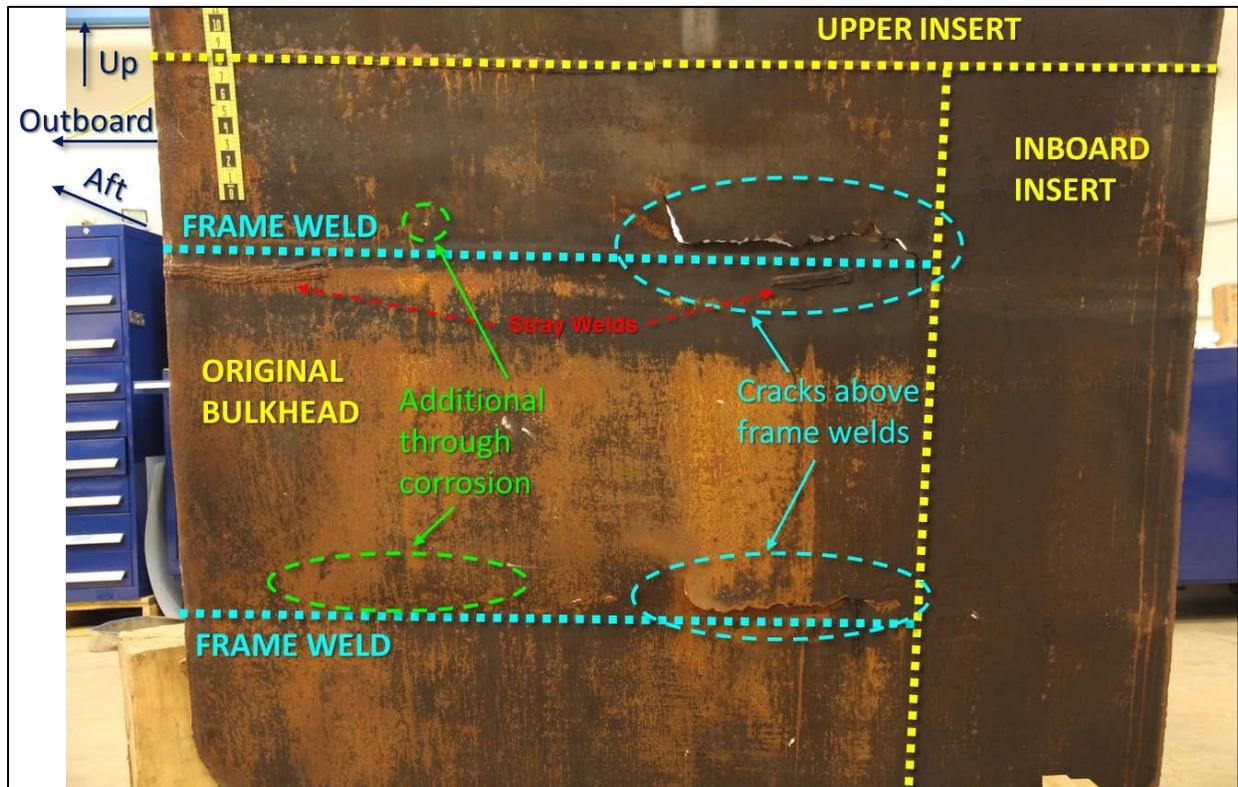
During the NTSB Materials Laboratory examination, the inboard, lower and upper areas of the bulkhead section were found to be newer steel consistent with the repairs in the ABS records. The central portion of the bulkhead section, which contained the two cracks, was older steel. This steel was pock-marked and pitted on the forepeak side of the bulkhead, and the metal was corroded and thinned in the areas around the cracks. Two additional areas of through-corrosion, located outboard of the cracks, were discovered during the laboratory examination.

Bulkhead section between the forepeak and no. 1 port cargo tank, as viewed from the tank side.

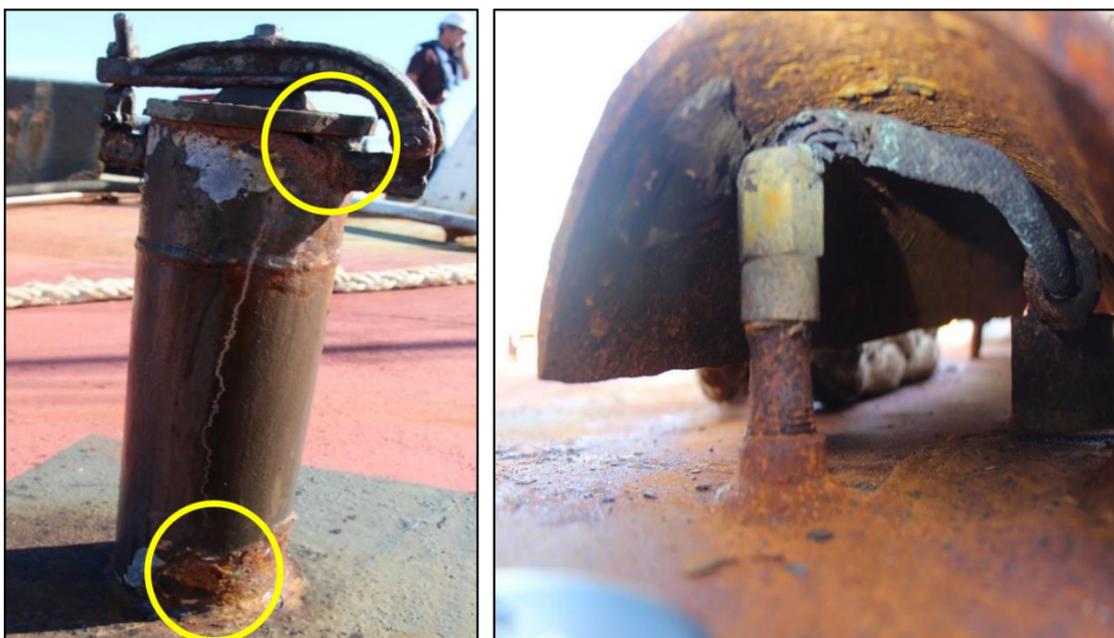
In addition to the forepeak/no. 1 port cargo tank bulkhead cracks, investigators found several areas of material wastage and corrosion on the main deck of the barge. Of note, an ullage tube for the no. 1 starboard cargo tank had significant corrosion at the base and around the top, and an armored electrical wire conduit aft of the explosion area had wastage that left wiring exposed. The wasted areas discovered during the investigation were determined by the Coast Guard to predate the accident.

Postaccident photos of corroded no. 1 starboard cargo tank ullage tube (left) and wasted armored protected electrical cable with exposed wiring (right). (Photos by Coast Guard)

In addition, an exposed electrical wire on an energized circuit on the cargo deck could have created an electrical arc capable of igniting fuel vapor. Exposed wires had been identified by ABS and corrected during previous surveys; however, investigators found additional exposed wires during the postaccident examination of the vessel that were not the result of the explosion and fire. Because there was no flame protection on the vents into the forepeak and the door to the doghouse was open at the time of the accident (likely due to the anchor windlass controller umbilical cable being routed through the door), oil vapor escaping the forepeak could have been ignited by other sources on the cargo deck, such as metal-on-metal contact during the raising of the anchor. The specific ignition source for the explosion on the *B. No. 255* could not be determined. However, the NTSB concludes that the explosion in the forepeak of the barge was caused by the ignition of flammable vapor that formed from oil that had leaked into the space from the no. 1 port cargo tank through a corrosion-compromised bulkhead.
