## MARINE SAFETY INVESTIGATION REPORT

Safety investigation into the grounding  
of the bulk carrier

***OLIVA***

MARINE SAFETY INVESTIGATION REPORT NO. 14/2012

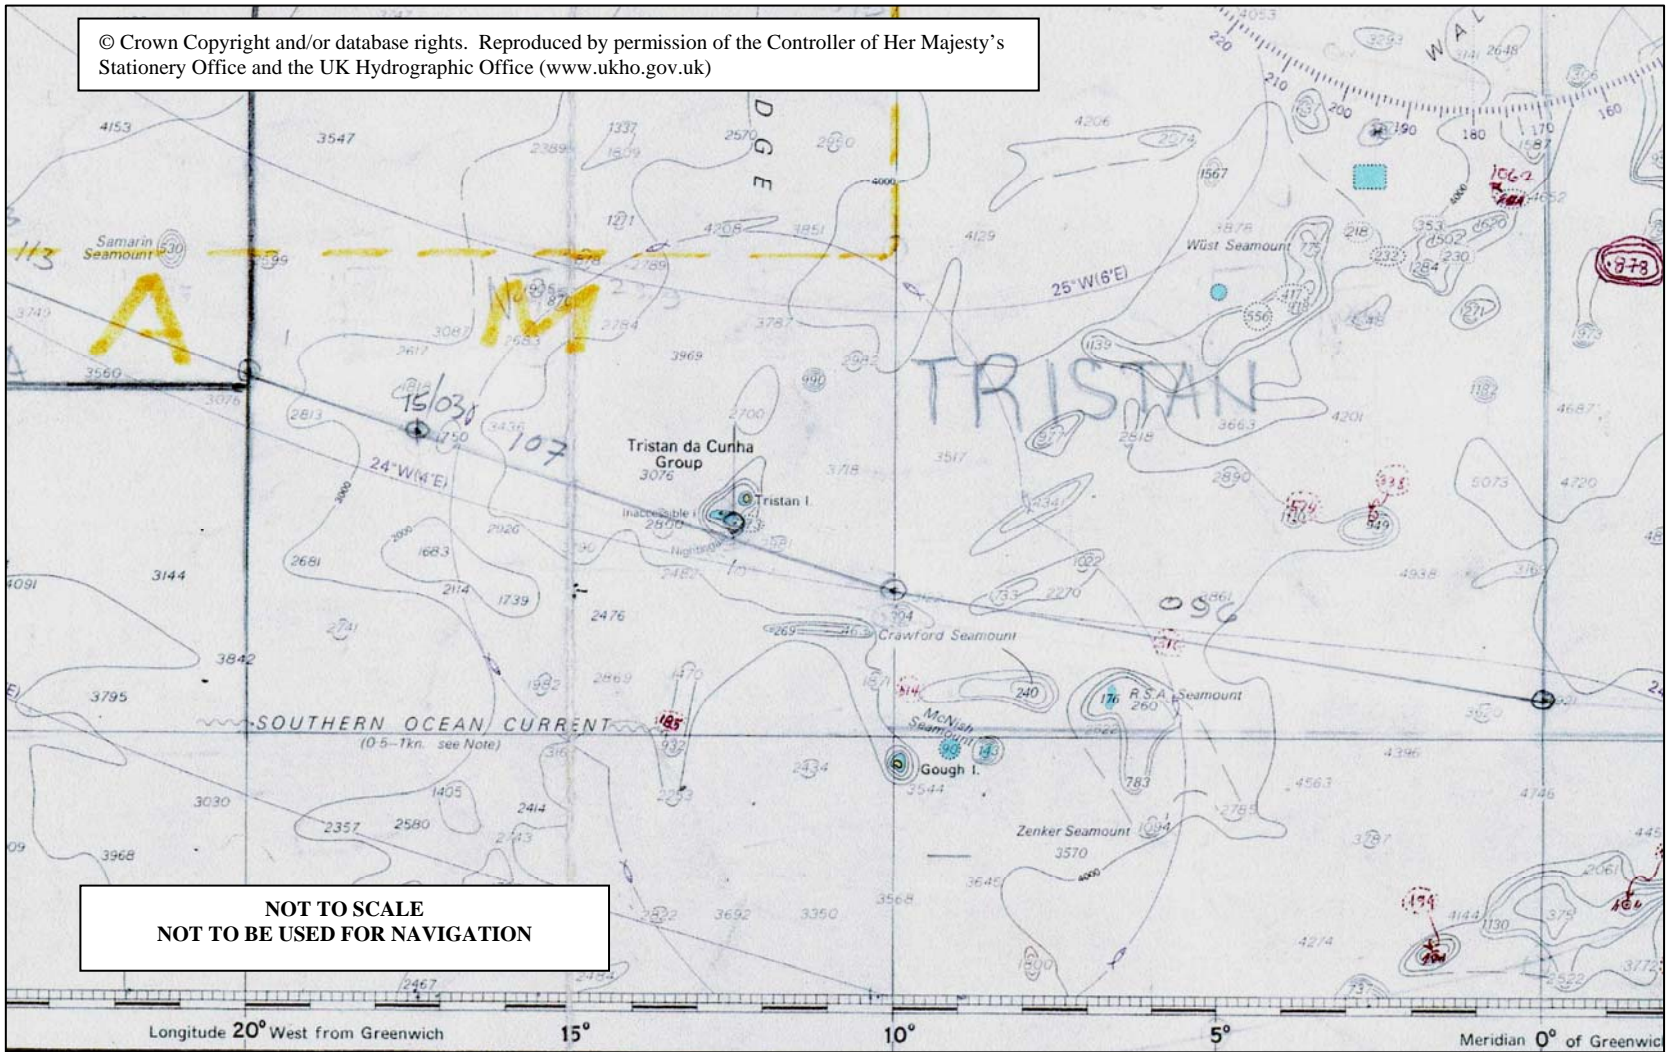
Figure 3: Extract of BA Chart 4022

At 0215 on 15 March, the second mate altered the vessel's course to 107° towards waypoint no. 5. He also transferred the vessel's position onto the plotting sheet covering 36° to 39° of latitude. The vessel's noon position was noted on BA chart 4022 (Figure 3).

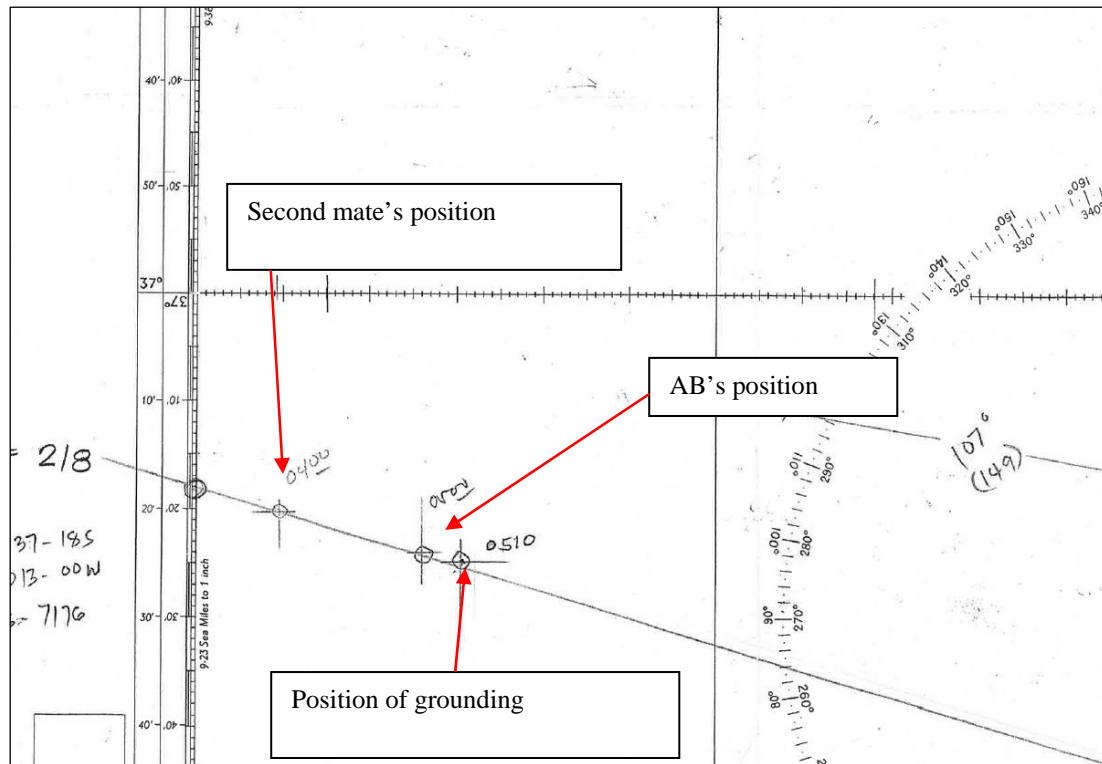
**Figure 4: Extract of plotting sheet in use**

The chief mate then sat down on the pilot chair located next to the radar in use. He recollected observing some fuzzy echoes which he thought were scattered rain showers. The starboard bridge door was open and the bridge window wipers were switched on because of rain. There was no indication that either the second mate and later the chief mate switched to the X band radar when they were approaching land or when they were expected to make landfall.

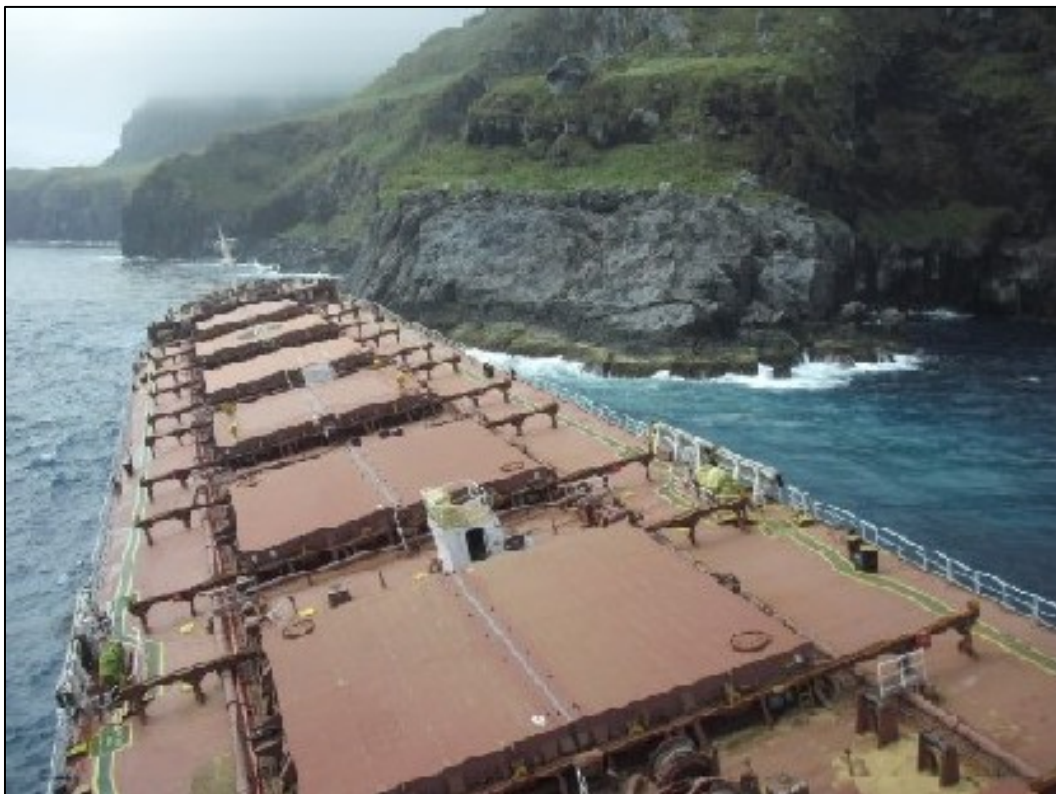
Figure 5: *Oliva* aground on Nightingale Island with a port list

The vessel developed a port list of 12° and assumed a heading of 091°. The master ordered the second mate and chief mate to take soundings of the ballast tanks. The third mate plotted the position of the ship (Figure 6) which placed the vessel on Nightingale Island, one of the three large islands that forms the Tristan Da Cunha Group.

The chief mate soon reported to the master that all the double bottom tanks (nos. 1 to 4) on the port side were full as well as double bottom no. 1 starboard. Sometime later,

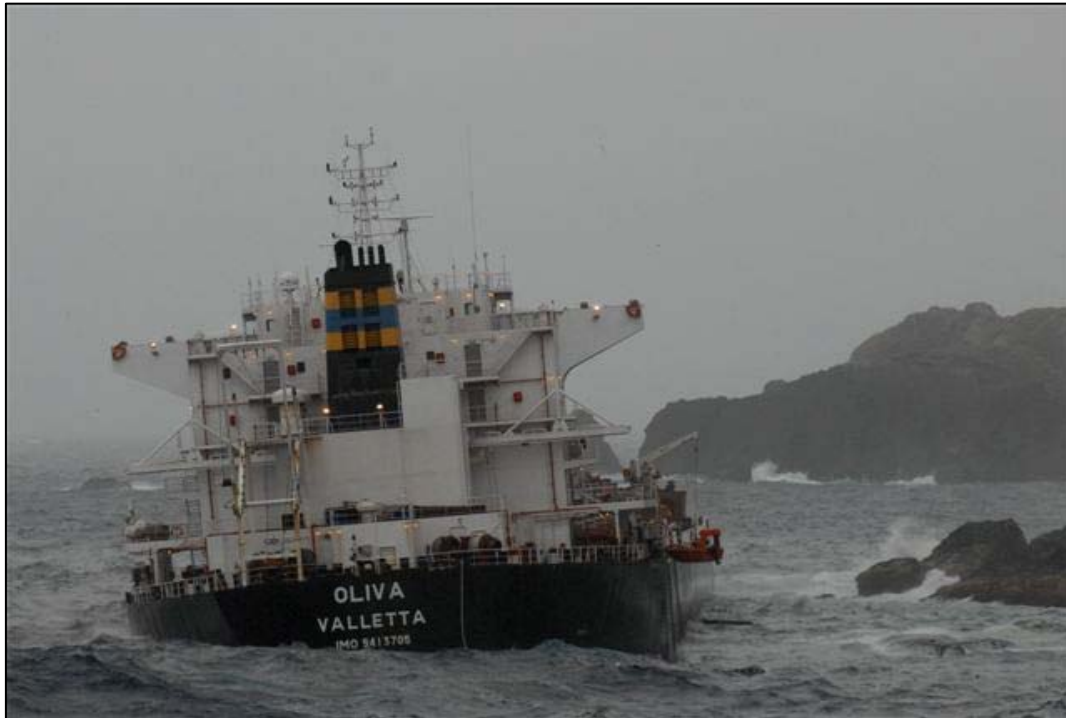
**Figure 8: *Oliva*'s close proximity to the rocks**

At about 0200, the lifeboat painters parted and the boat drifted away. At about 0300, *Oliva* struck a large rock in way of hold no. 7 (Figure 8). By 0405, the chief engineer reported ingress of water into the engine room which soon reached the level of the bottom platform. In daylight conditions, the crew noticed an oil slick on the vessel's starboard side.

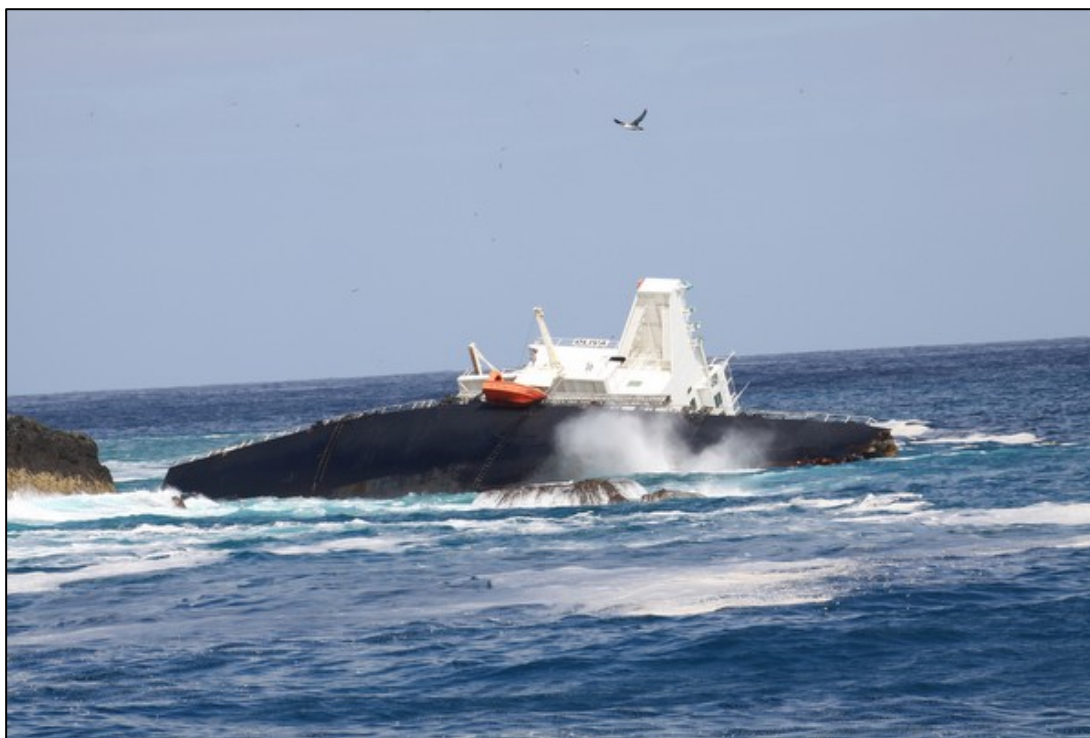
**Figure 9: *Oliva*'s aft section following the hull failure**

Eventually, at about 0230 on 18 March, *Oliva* broke up into two sections in the wake of the deteriorating weather and heavy swells (Figure 9). The forward section of the vessel from hold no. 7 onwards, separated from the aft section of the hull and drifted away. The aft section subsequently capsized and sank. This resulted in the spill of soya beans cargo and a wide spread pollution around the area because of the diesel and fuel oil that escaped from the vessel's bunker tanks.

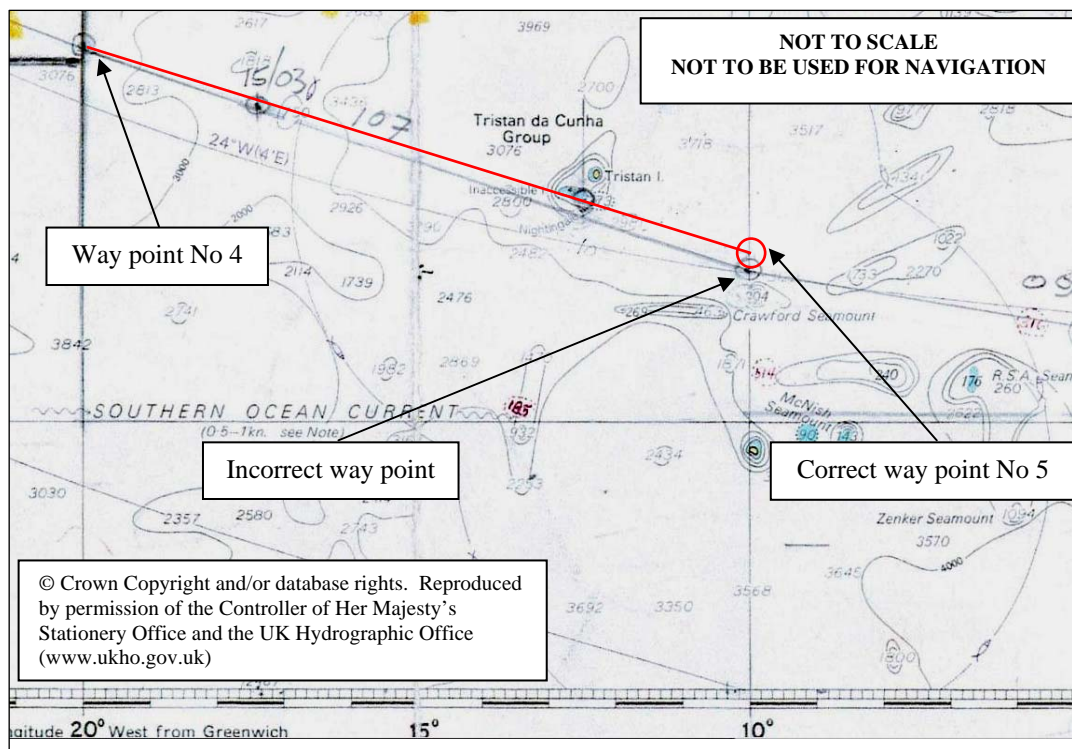
Figure 11: Extract of BA Chart 4022 showing correct way point

When the second mate had initially drawn the course line on BA chart 4022, he made an error in plotting 'waypoint no. 5' (Figure 11). This resulted in a course line indicating that the vessel would clear the group of islands by about 10 nm. As indicated in Figure 11, if the correct waypoint (shown in red) had been plotted, the resulting course line would have indicated that it passed directly over one of the islands.

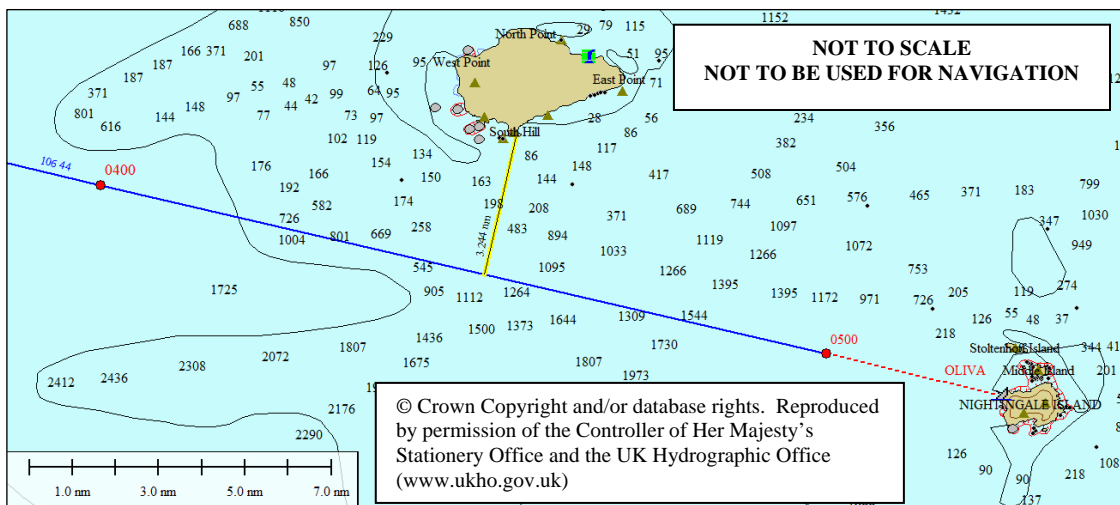
Figure 12 - Extract of BA chart 1769 showing vessel's positions

Soon after 0400, the second mate noticed a large defined echo on the radar screen which he failed to identify or investigate as a possible land mass. The plot in Figure

12 indicates that the vessel passed Inaccessible Island on her port side within 3.25 nm. This important information was not passed to the chief mate and neither did the chief mate notice it on the radar screen.

At about 0430, soon after the chief mate took over the watch, the Island would have been on the vessel's port beam and Nightingale Island right ahead at about 9.9 nm. Although he noticed some echoes on the radar screen, he did not investigate them as he dismissed them as rain clouds because it had been raining. Both officers did not grasp the significance of large echoes in open waters.
