Report on the investigation of
work undertaken in a dangerous enclosed/confined space
and the consequent attempted rescue on board

ERRV Viking Islay

resulting in the loss of three lives
at the Amethyst gas field, 25 miles off the East Yorkshire coast, UK

Report No 12/2008
July 2008

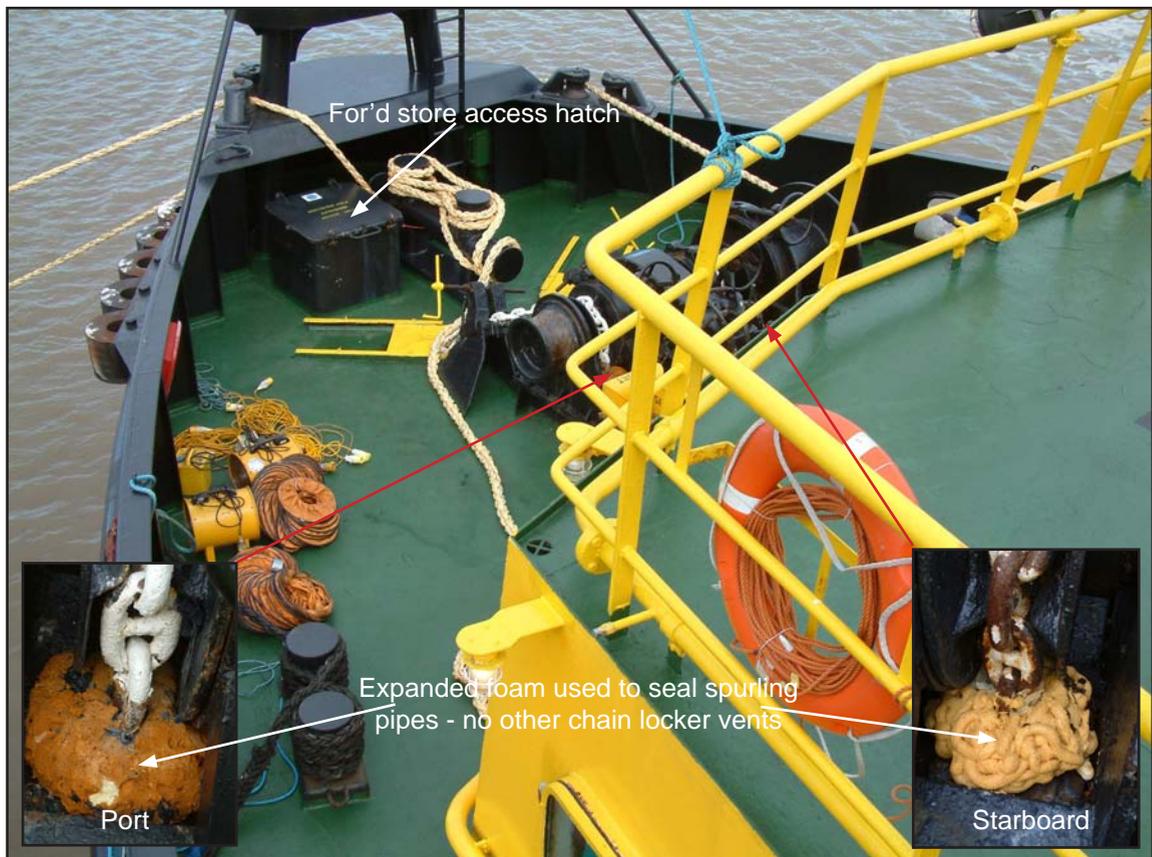
Figure 1

As was normal in preparation for arrival, *Viking Islay*'s starboard anchor had been walked out a short distance; it was not dropped clear of the hawse pipe, but just moved enough to confirm that it was free and clear to be run out in case of any emergency. Possible impediments to the anchor chain running free included the expanded foam, that was routinely used to seal the top of the spurling pipe¹ on the foredeck, and light rope lashings used to secure the anchor chain within the chain locker (**Figure 1**).

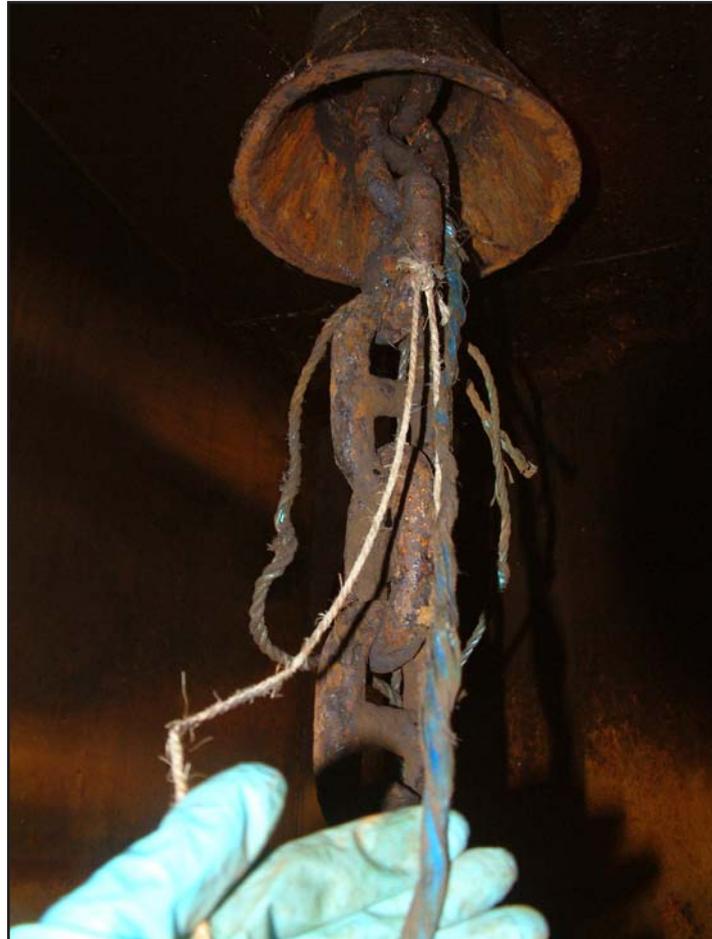
Figure 2

The foam was used to prevent water entering the chain locker via the spurling pipe. Light lashings were sometimes applied inside the chain locker by the crew, in order to prevent the hanging part of the anchor chain from moving in rough weather (**Figure 2**). Such movement could cause the chain to bang noisily against the spurling pipe, or other steelwork.

Chain locker - showing rope lashings used to stop anchor chain rattling

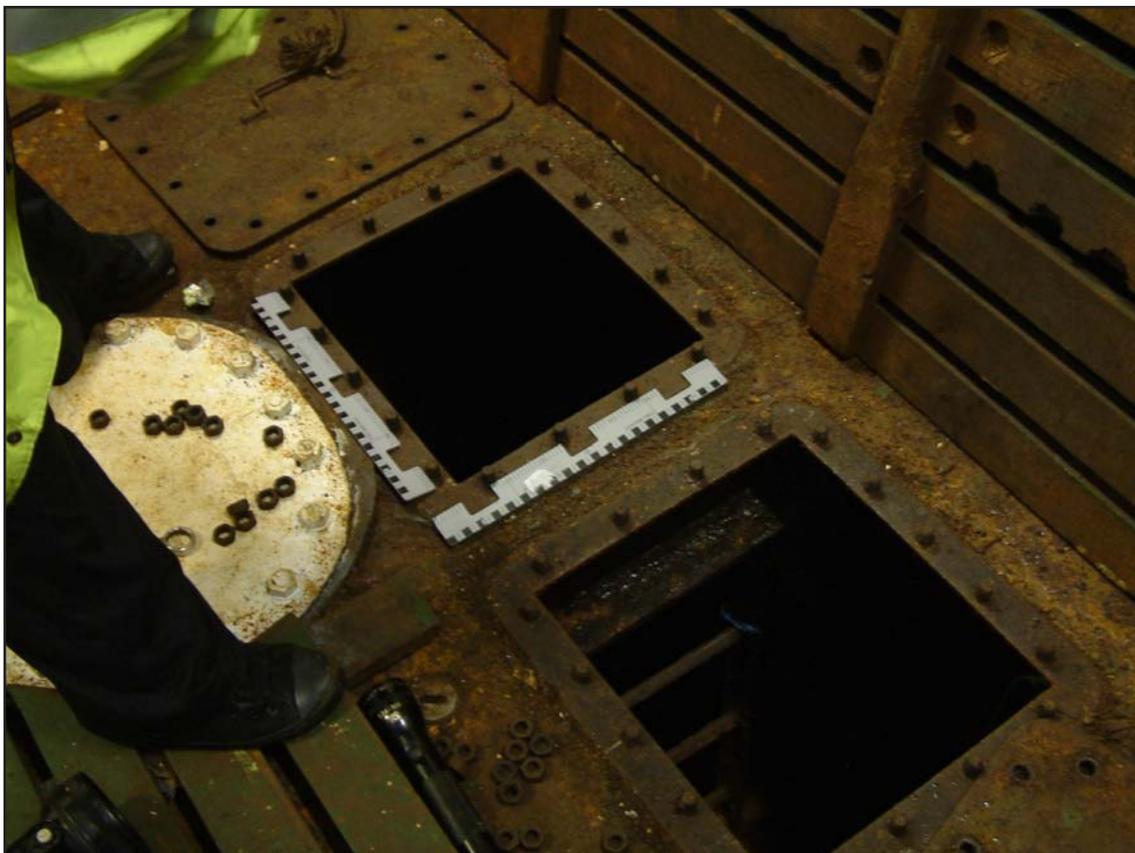
The two day workers went to the aft part of the foc'sle store and lifted the loose duckboards, beneath which were three access manholes. The forward hatch served the fore peak water ballast tank, and the after two gave access to the port and starboard sides of the anchor chain locker. Although there were two manholes, the internal dividing bulkhead which separated the two anchor chains only extended to about half the height of the chain locker, and the upper parts of the spaces were common. The manholes serving the chain locker were smaller than that serving the ballast tank, and were square in shape rather than the more conventional oval found at the ballast tank access. The heavy steel manhole covers were secured with eighteen 24mm nuts and bolted down onto a rubber gasket, so forming a watertight seal (**Figure 5**).

Foc'sle store - showing access hatches to chainlocker

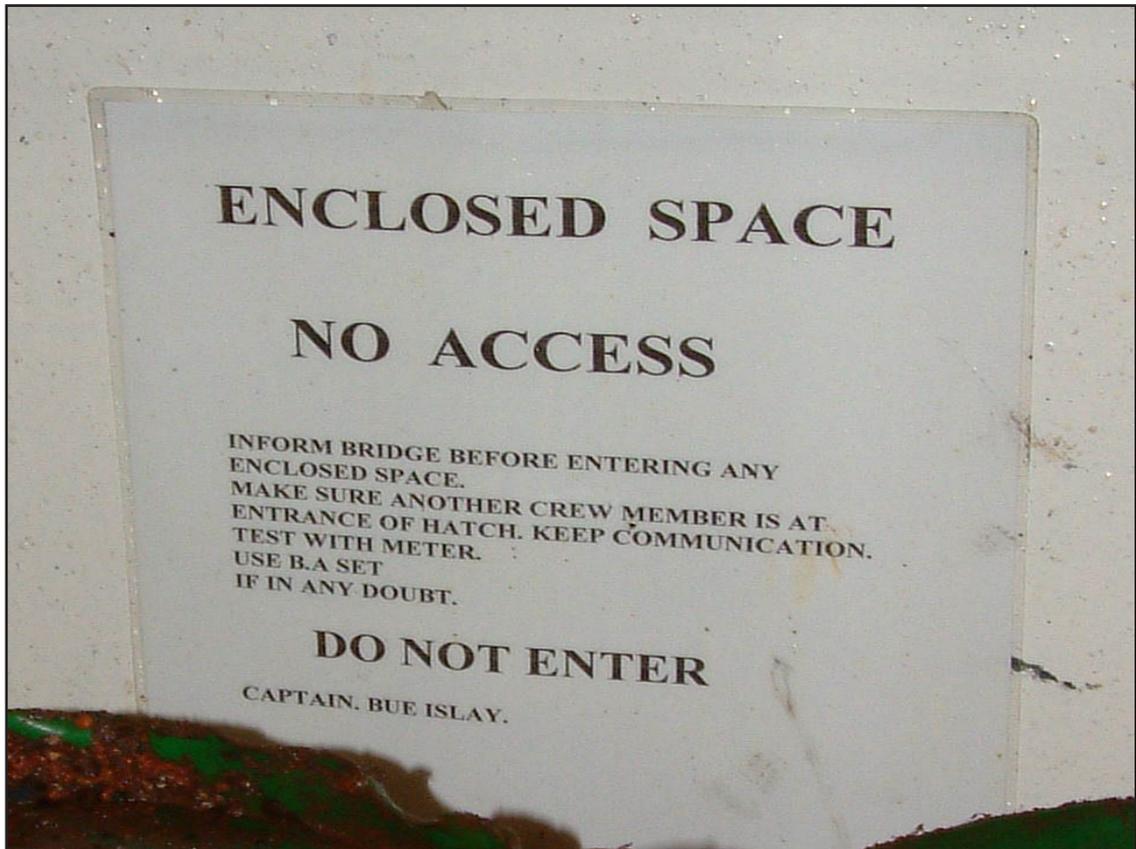
Figure 6

On entering the foc'sle store an empty EEBD was found, and a notice was seen posted up on the aft bulkhead of the compartment, near to the manholes (**Figure 6**). The notice appeared to have been made onboard during the period 2002 – 2005. The ship's crew did not know when the notice had been posted.

Sign attached to aft bulkhead of foc'sle store

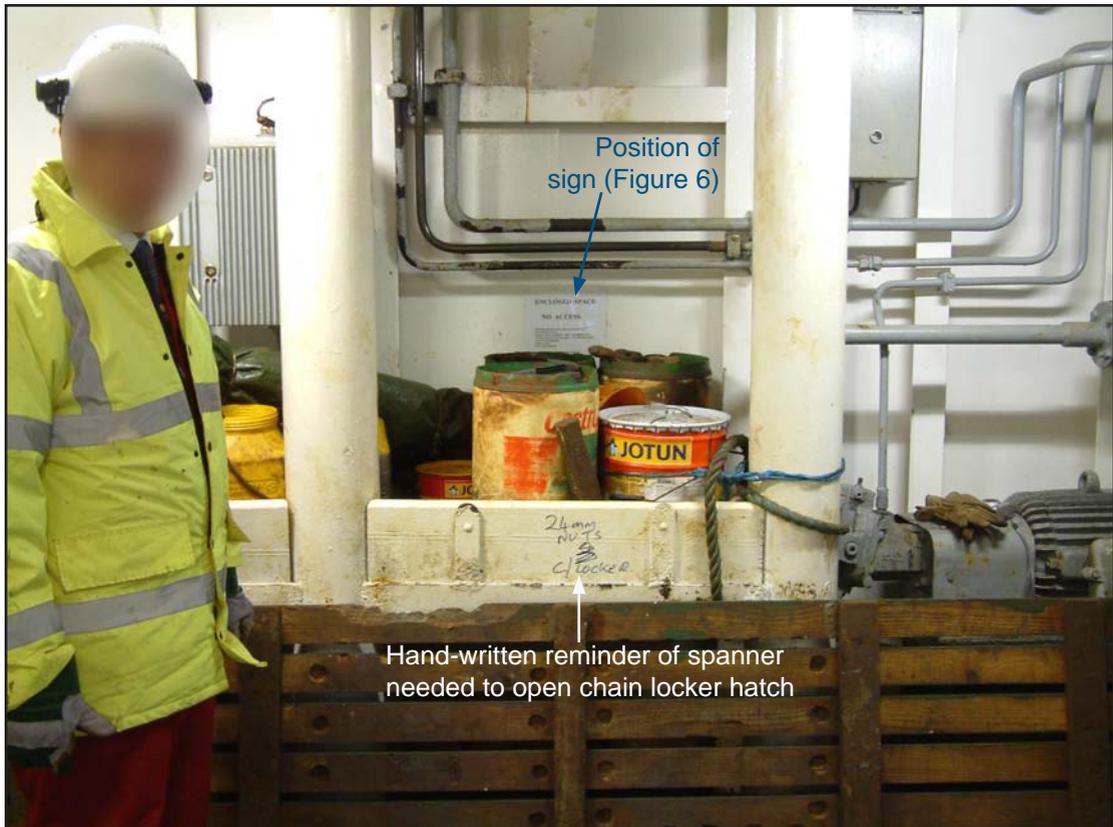
Figure 7

A reminder of the correct size of spanner needed to open the manhole covers was seen, handwritten in marker pen, near the openings (**Figure 7**).

Hand-written reminder of spanner needed to open chain locker hatch

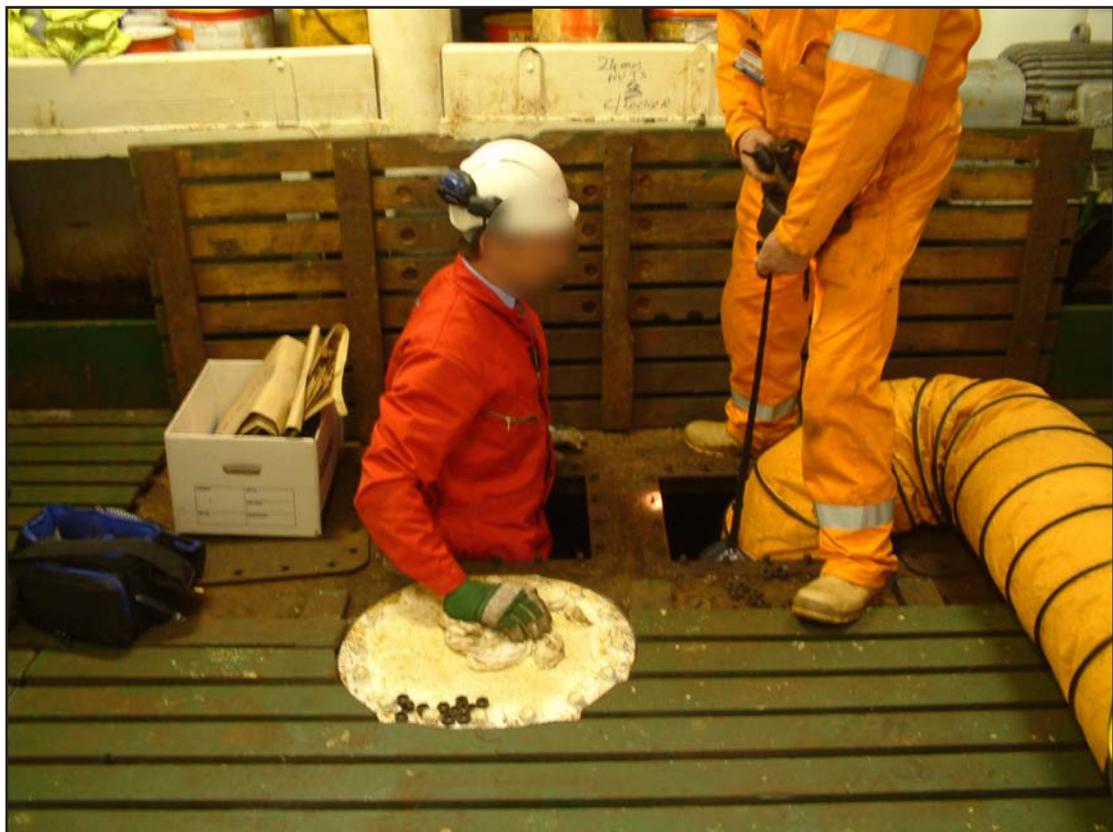
Figure 8

Being aware of the most probable cause of the accident, both chain locker manhole covers were removed, the foam broken out of both spurling pipes and the space was force ventilated. The analyst re-tested the space and certified it safe to enter; the manhole openings were noted to be particularly small (**Figure 8**).

Foc'sle store - showing cramped access to chain locker

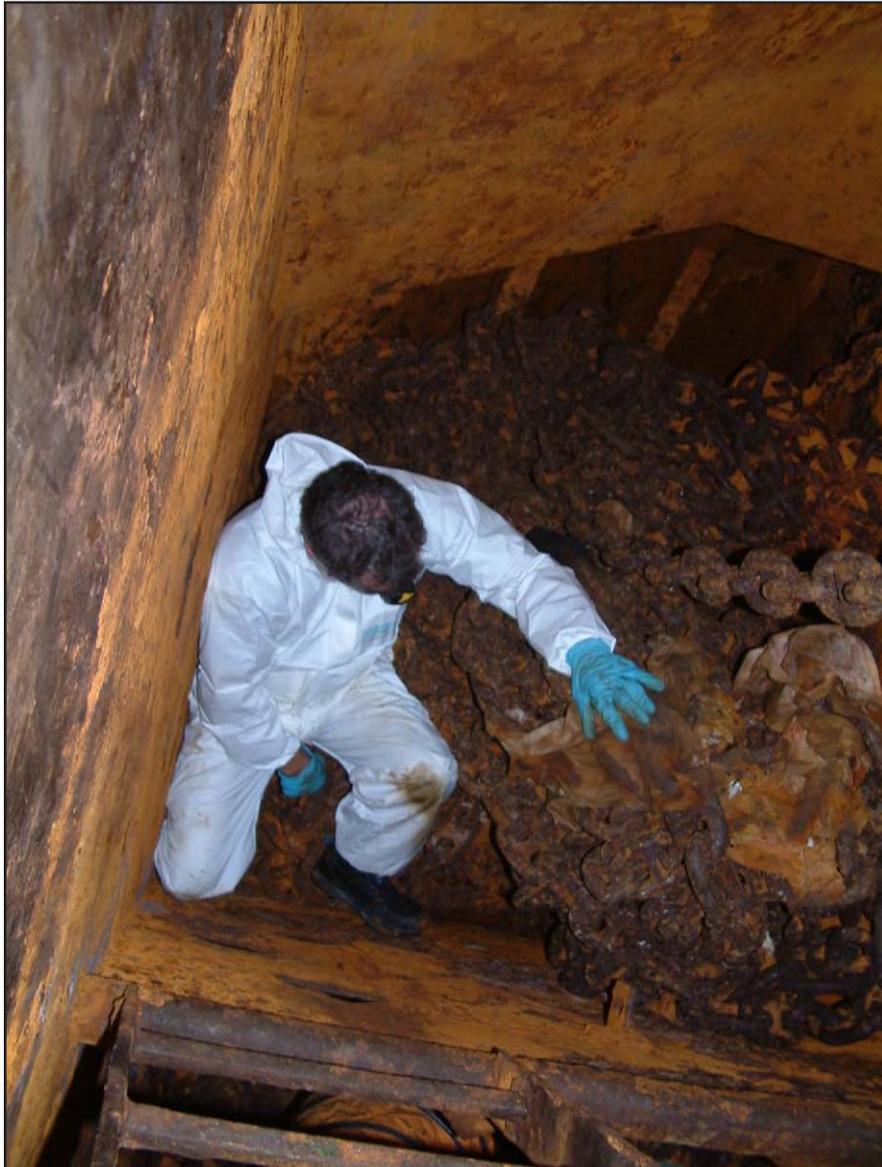
Figure 9

There were no significant amounts of toxic gases in the chain locker, and the internal steel surfaces (including the anchor chains) were heavily rusted.

Iron and steel when exposed to moist air will react with O₂ in the air to form iron oxide (rusting). Rusting requires both O₂ and water and is accelerated in the presence of salt. The corrosion of the steel within the chain locker caused the O₂ to be consumed in the process of rust formation, and this resulted in an O₂ deficient atmosphere.

The inside of the chain locker was inspected, measured and photographed. The main part of the chain was found piled in the middle of the space in a fairly solid lump, probably indicating that it had not moved for an extended period of time. No significant foreign objects were found, other than small amounts of textile material, probably rags used to plug the spurling pipes prior to applying expanded foam. Some salt water was present in the bilges at the bottom of the chain locker, below the false floor (**Figure 9**).

Chain locker - showing anchor chain
