Editorial

Removal of heat protection from machinery

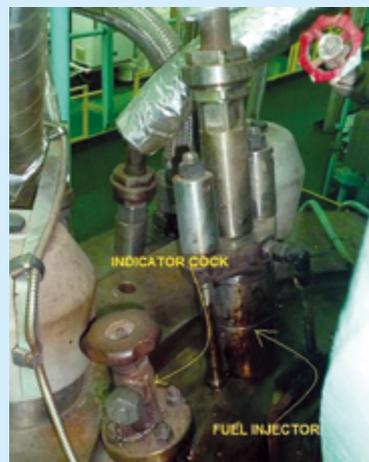
Recently, I noticed that indicator cock covers had been removed from the engine which was in an operational mode. When I questioned this, I was told that it was too troublesome and too hot to remove the cocks with the engine running. During my next watch, I noticed all the indicator cocks had been removed and hidden to prevent re-fitting. I attempted to raise the matter with the Company, but I did not receive a positive response. I am now reluctant to contact the DPA. I will continue to challenge this unsafe behaviour and amend the checklists to include the line "Fit Indicator Cock Covers". The next time there is an ISM audit or classification survey, the surveyors can see that it was a conscious decision to ignore using them.

An unprotected indicator cock – non-compliant and a high-risk area for igniting a fire

From the technical viewpoint, indicator cocks are steel valves that are fitted to the cylinders of an engine. The valve is a direct link to the combustion space of each cylinder which allows compression and firing pressures to be taken from an engine in service for maintenance/diagnostic purposes. Due to their nature, indicator cocks are extremely hot when the engine is in operation and need to have protection to avoid becoming a source of ignition from any fuel that may impinge upon the surface.

SOLAS Reg. II-2/15.2.10 states that **“All surfaces with temperatures above 220 °C which may be impinged as a result of a fuel system failure shall be properly insulated.”**

CHIRP would highlight that it is good practice to have a regular thorough inspection of all equipment to ensure that any deficiencies may be rectified, and any potential sources of leakage identified. Searching for hot spots and insulation defects with infra-red thermal imaging equipment is also useful.

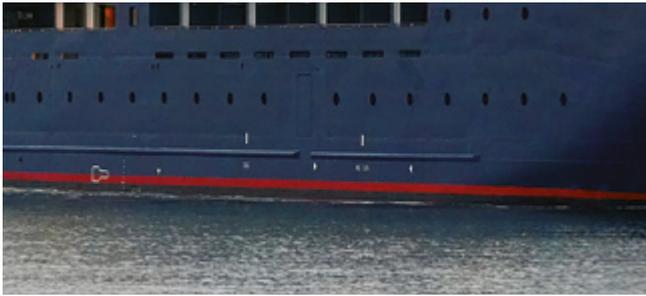
When disembarking from this new passenger vessel (built in 2018), the pilot boat was caught momentarily on the ship's belting which caused it to dislodge the pilot boat's fendering. As the sea conditions were slight it was not a

The gap in the ship's belting was estimated to be approximately 1 metre, significantly less than the requirements of IMO Resolution A1045(27) which states "Where rubbing bands or other constructional features might prevent the safe approach of a pilot boat, these should be cut back to provide at least 6 metres of unobstructed ship's side." See photo below. There are currently a series of new builds joining the fleet, and online images indicate they are all configured in the same way.

New build passenger vessel – and non-compliant
