Fatal man overboard from the tender of *Fram of Shieldaig* Loch Torridon off Ardherslaig, Scotland 7 August 2018

SUMMARY

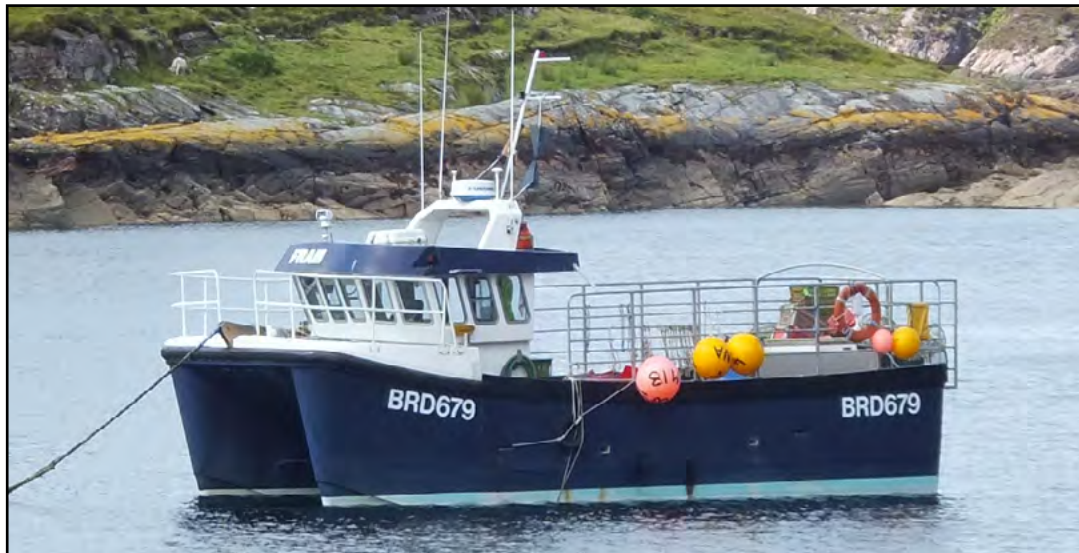
Fram of Shieldaig (Fram) was a 9.8m UK registered fishing vessel that was rigged to operate as a self-shooting potter. It was crewed by a skipper and a deckhand and used during daylight hours to fish for langoustines.

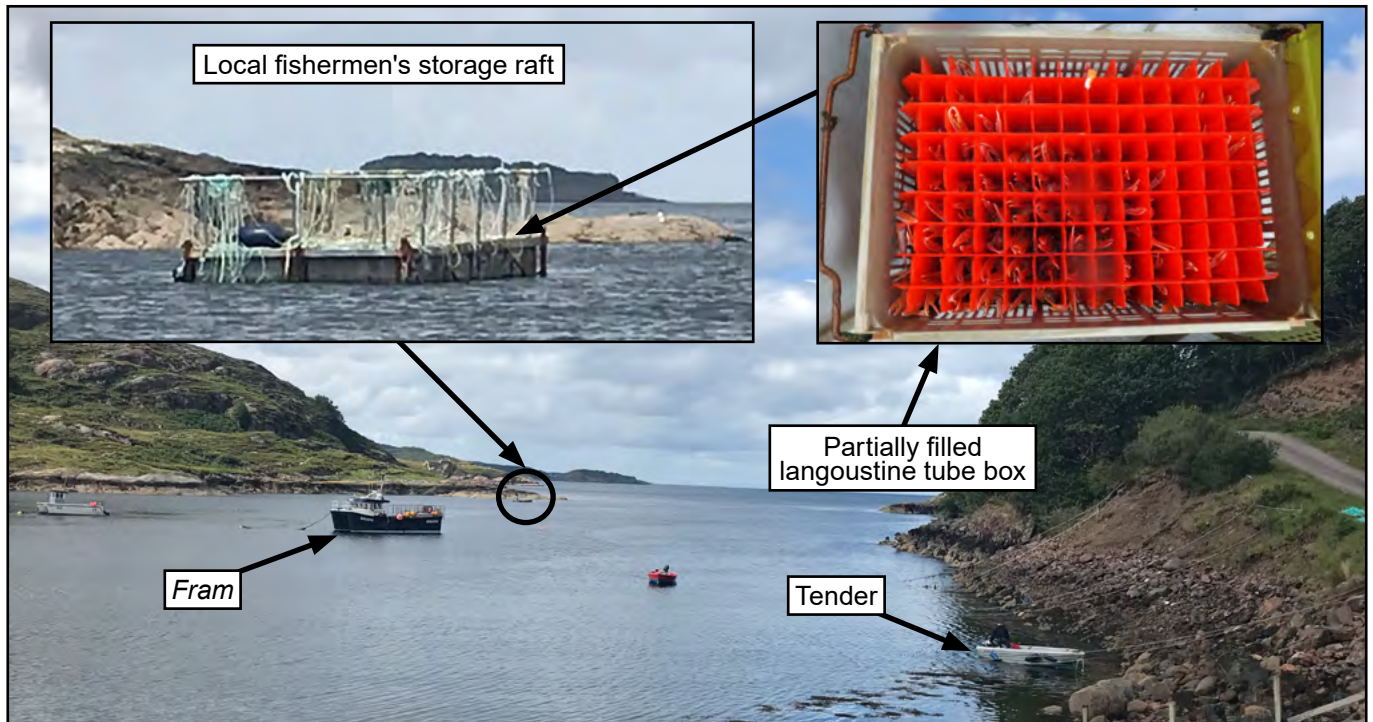
Figure 1: Location of *Fram of Shieldaig*, its tender and the local fishermen's storage raft

Fram was secured overnight to a swinging mooring in Loch Torridon, Scotland (**Figure 1**) and its crew used a small tender to board and leave the vessel (**Figure 2**). The tender was also used to land the catch ashore and transport partially filled langoustine tube boxes (partials) between the vessel and a local fishermen's storage raft (**Figure 1**).

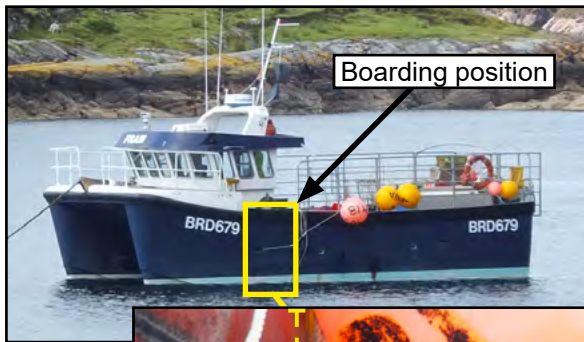
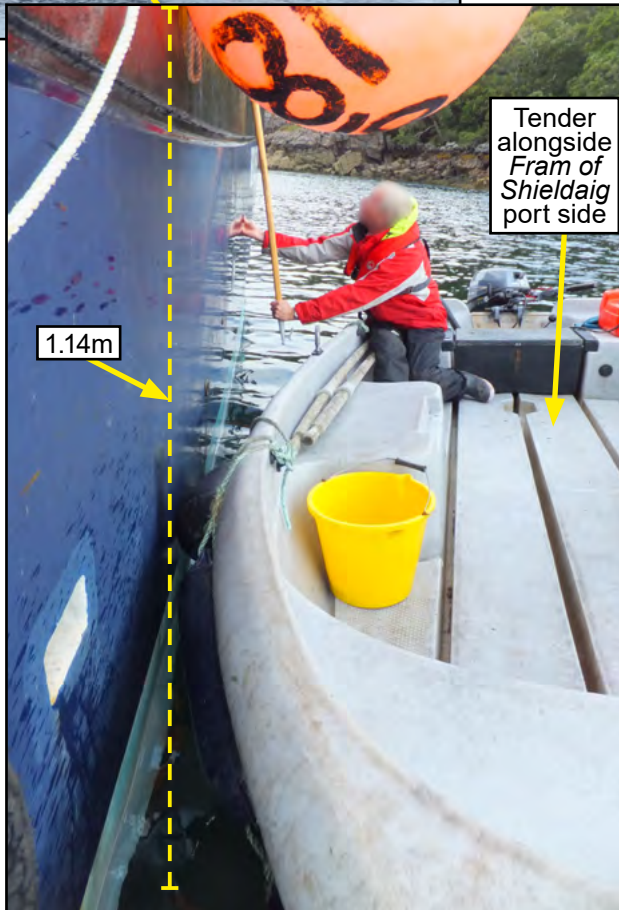
Figure 2: Boarding *Fram of Shieldaig* from the tender

Fram's stern shooting gate was located on the port side of the vessel, where the freeboard was 0.78m. The boarding position was also on the port side and the crew always used it when boarding and leaving *Fram* (**Figure 2**). The height of the bulwark from the waterline at the boarding position was 1.14m. Except at the boarding, shooting gate and hauler positions, the working deck was enclosed by high railings extending to a height of 1.90m above the deck.

The precise circumstances of the accident are unknown as the skipper, who was on deck at the time, did not see or hear the deckhand enter the water. The skipper last saw the deckhand when the tender left the raft after collecting the partials. Although the skipper saw the tender pass *Fram's* stern, he could not see the helming position at that time, and he next saw the unmanned tender adjacent to *Fram's* port side with its outboard engine on tick-over.

The deckhand's location in the water, between the tender and *Fram*, suggested that he entered the water either as he rose from his seated position by the outboard engine or as he moved forward to pass the boat's painter to the skipper. It is possible that the deckhand's foot became caught in the deckwell just forward of his seated position or that he tripped over the partials. It is also possible that he just lost his balance or slipped on the deck.

- Purchased new compact 150N automatic inflation lifejackets and implemented a policy that crew must always wear them while working on deck, and while boarding and leaving the vessel.
- Ceased the practice of lone working in the tender.

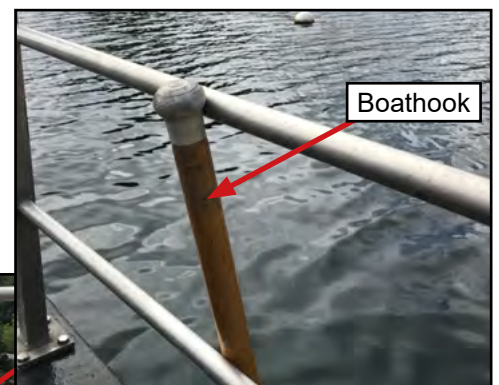
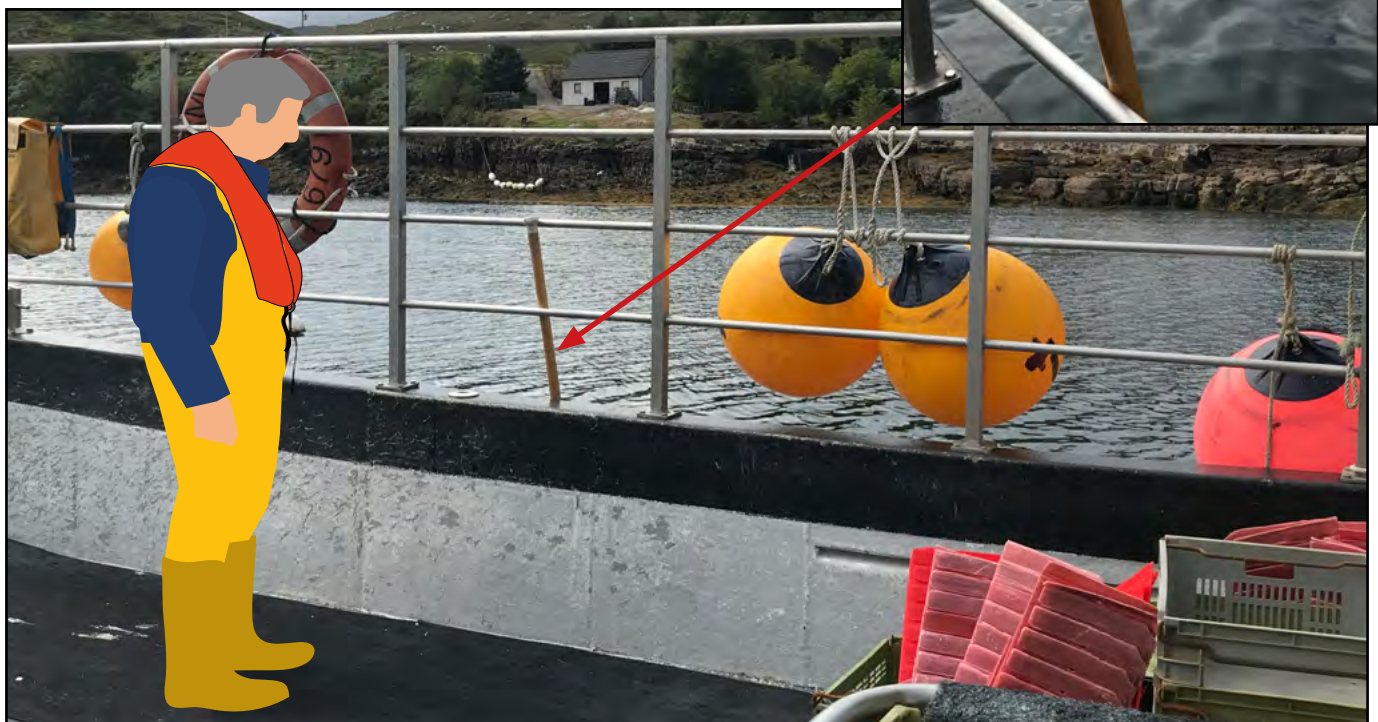
Figure 3: Boathook jammed in railings

Using a boathook, the skipper caught the back of the deckhand's oilskin trousers and pulled him alongside. The skipper then tried to haul him on board, but the deckhand was too heavy for him to lift out of the water alone. Thinking it would be easier to lift the deckhand out of the water from the storage raft, the skipper decided to manoeuvre *Fram* up to the raft. To prevent the deckhand sinking or drifting away, the skipper jammed the upper part of the boathook between the vessel's bulwark railings (**Figure 3**). He then released *Fram* from its mooring and, using the main engine controls on the starboard side of the main deck, slowly manoeuvred the fishing vessel alongside the storage raft.

Once *Fram* was secured to the raft, the skipper used the boathook to move the deckhand to an opening in the raft's railings and tried again to pull him out of the water. Although the freeboard of the raft was lower, the skipper was still unable to lift the deckhand out of the water.

Fram's person overboard rescue sling, like its lifebuoys, required the person in the water to assist in their own recovery. As the deckhand was unconscious, the skipper had to use one of the vessel's boathooks to recover him alongside. Once alongside, the deckhand was too heavy and *Fram's* freeboard too high for the skipper to recover him from the water unaided.

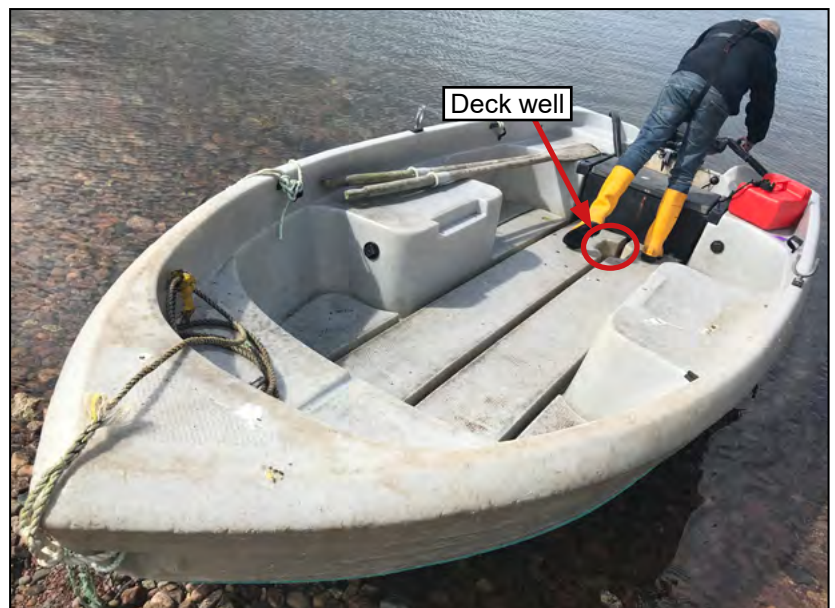
Figure 4: *Fram of Shieldaig* tender

Fram's tender was a 4.5m long Pioner 15 open boat, built in Norway. It was constructed from moulded polyethylene and had a freeboard aft of 0.5m. The tender was fitted with a Yamaha four stroke tiller-controlled 6 horsepower¹ outboard engine. Forward of the helming position there was a deck well that measured 27cm x 19cm (**Figure 4**).

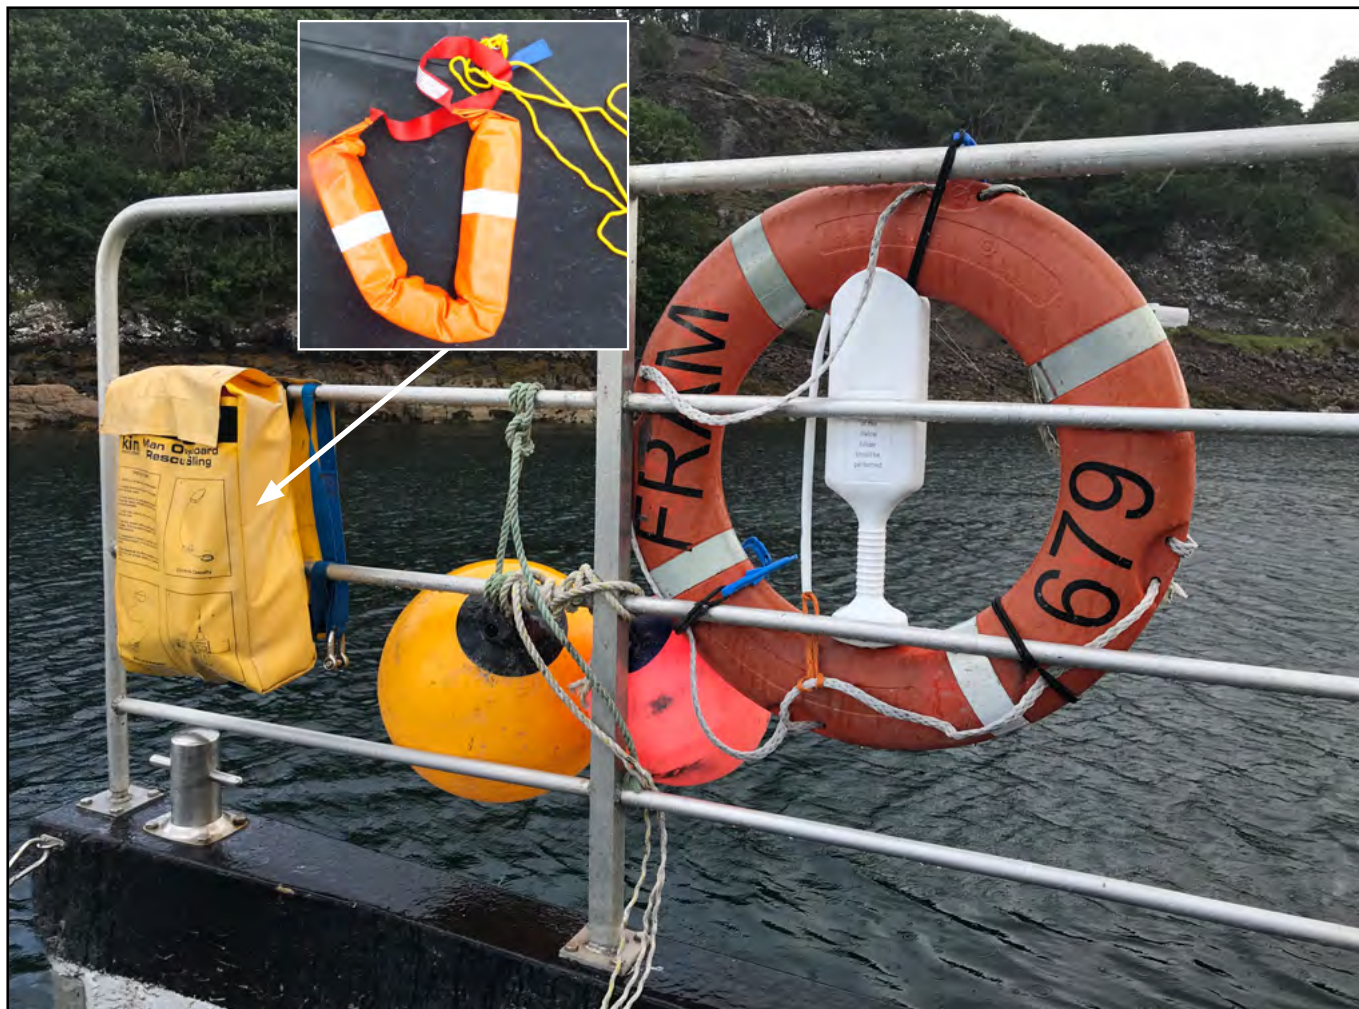
Figure 5: Person overboard rescue sling and lifebuoy with 18m rope line

Nevertheless, had *Fram's* crew conducted regular, realistic person overboard drills, they would have fully appreciated the difficulty of recovering an unconscious person back on board and the effectiveness and usefulness of the vessel's procedures and person overboard recovery equipment.
