## SAFETY INVESTIGATION REPORT

REPORT NO.: 13/2019

### **MV SHARK** Collision and subsequent foundering of fishing vessel *Mohammed Badry* in position 37° 19.44' N 008° 29.47' E 25 July 2018

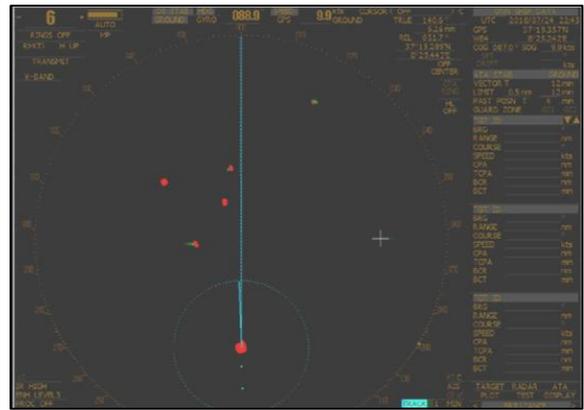
Figure 2: Radar target of fishing vessels on *Shark*'s port bow at 0045

The distinct radar trail (Figures 2 and 3) indicated that *Mohamed Badry* was making

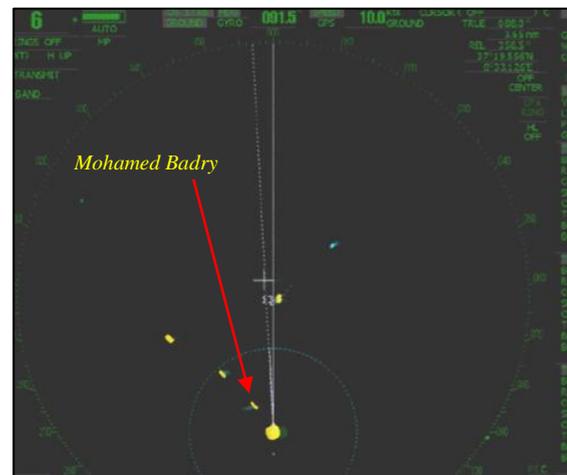
Figure 3: Radar image showing the fishing vessels at 0101

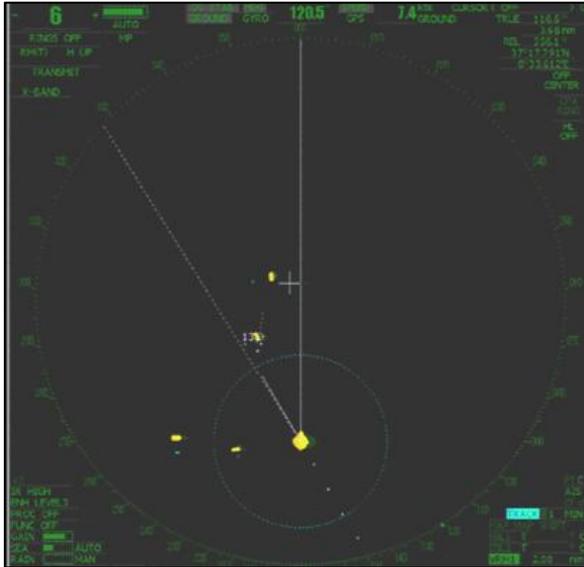
Although, the vessel had turned and reached a heading of 120.5°, her course over ground was 090°. At 0105, *Shark* collided with *Mohamed Badry* in position 37° 19.44' N 008° 29.47' E (Figure 4).

Figure 4: Radar image showing collision at 0105

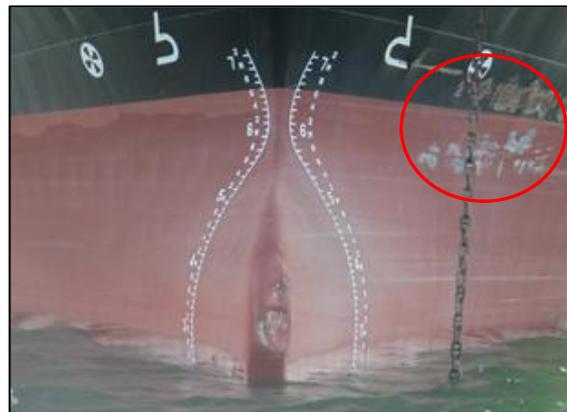
A few minutes after the vessel's helm was set to amidships and the main engine was stopped, *Mohamed Badry* became free from the vessel's port anchor and foundered soon after. No serious structural damages were found on *Shark*, except for a slight indentation on its bulbous bow, and minor scratch marks below the port anchor's hawse pipe (Figure 5).

Figure 5: Photo showing minor structural damage in the bow area

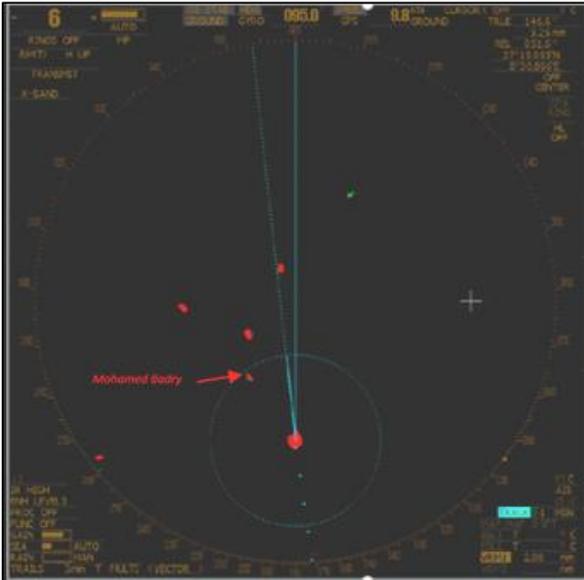
Figure 6: Radar image at 0055 showing *Shark* on a heading of 095°

An analysis of the images indicated that targets were neither acquired on the ARPA nor were compass bearings taken to determine the risk of collision. It was also evident that the alteration of 5° to starboard that the OOW reportedly made had no significant effect on the relative position of the fishing vessels and the vessel was brought back on the original course.

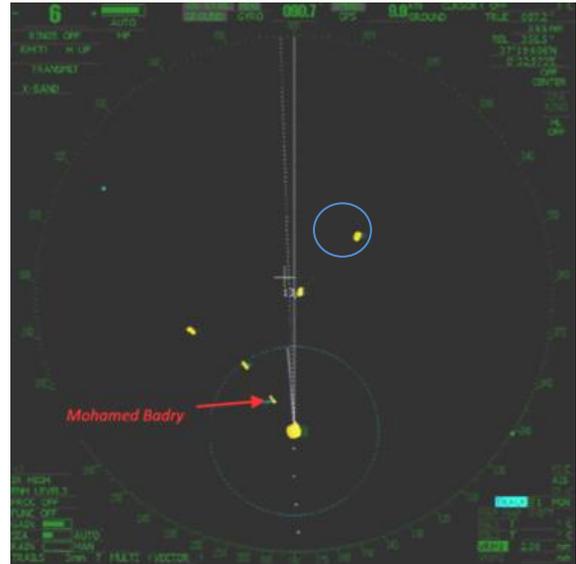
In fact, the VDR radar display showed that none of the four fishing vessels had passed clear of the vessel and a new target had actually appeared on the starboard side (Figure 7). Although the MSIU found no evidence of either the OOW or OS being away from the bridge, it is not known what

Figure 7: Radar image at 0000 showing *Mohamed Badry* on *Shark*'s port bow

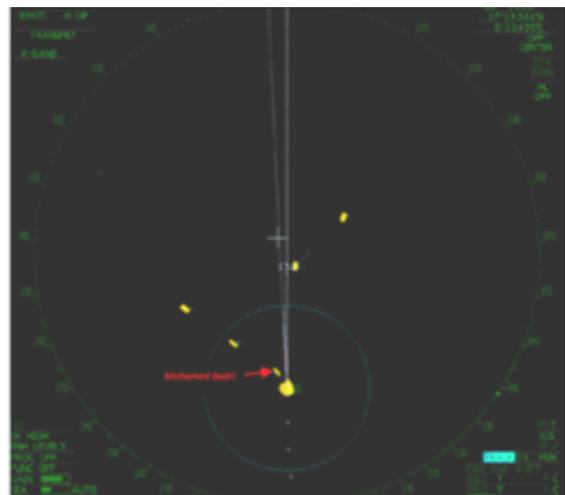
It was apparent that *Mohamed Badry*'s advance, both visually and on the radar, was missed by the bridge team. It was only after plotting the vessel's position on the chart and returning to the bridge front that the OOW noticed *Mohamed Badry*. By then, the fishing vessel was so close off the port bow that a collision was unavoidable. In spite of the OOW switching the steering controls to manual and altering to starboard, it was far too late for *Shark* alone to avoid the collision (Figure 8).

Figure 8: Radar image at 0103 showing *Mohamed Badry* just before the collision (red arrow)
