Collision between US Navy Destroyer *John S McCain* and Tanker *Alnic MC*
Singapore Strait, 5 Miles Northeast of Horsburgh Lighthouse
August 21, 2017

Marine Accident Report

NTSB/MAR-19/01
PB2019-100970

**National
Transportation
Safety Board**

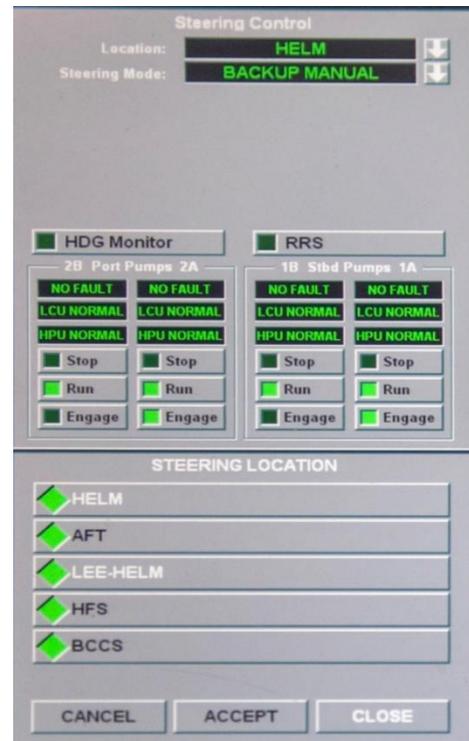
Figure 5. Steering control region of IBNS GUI display, with opened steering location menu. (From US Navy photo)

Per the technical manual and as demonstrated to National Transportation Safety Board (NTSB) investigators on another Navy destroyer equipped with the IBNS, at any time that steering was in backup manual mode, a watchstander at any of the other stations could unilaterally take steering control. When this occurred, the steering mode automatically shifted to the computer-assisted manual mode, and control shifted to that station. This type of transfer was noted in the IBNS technical manual, but it was not provided as a standard procedure.

After the accident, the Navy issued an advisory message to IBNS-equipped ships providing a "recommended action" that mitigates the risk of unintended transfers in backup manual mode. However, given that the steering control directive is provided as a "recommended action" only, the NTSB recommends that the Navy issue permanent guidance directing destroyers equipped with the IBNS to operate in computer-assisted steering modes, except during an emergency.

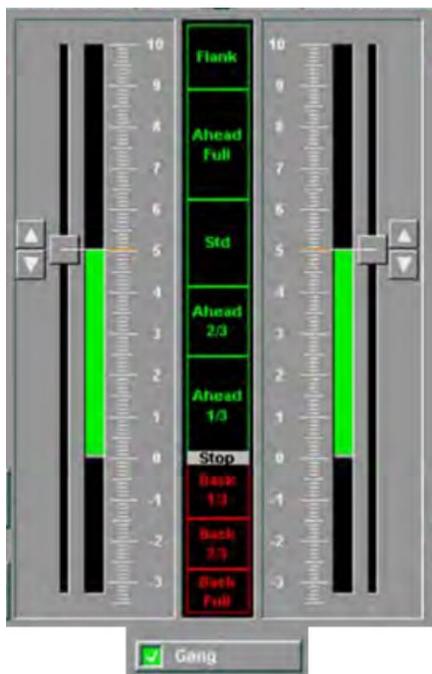
Figure 6. Port and starboard throttles and gang button on IBNS GUI display. (Image from IBNS technical manual)

In addition to the control stations, the *John S McCain* had numerous displays on the bridge and on the bridge wings that showed the propeller pitch and turns. When NTSB investigators visited a similarly equipped Navy destroyer, they noted that the displays were visible from almost anywhere on the bridge. During the accident sequence, the throttles remained mismatched for over a minute, but the CO, OOD, conning officer, and other bridge watchstanders did not recognize the lee helmsman's error, and, consequently, no actions were taken to correct it. The NTSB concludes that the *John S McCain* bridge team was not monitoring the lee helmsman's response to orders and therefore did not recognize that the throttles were mismatched.

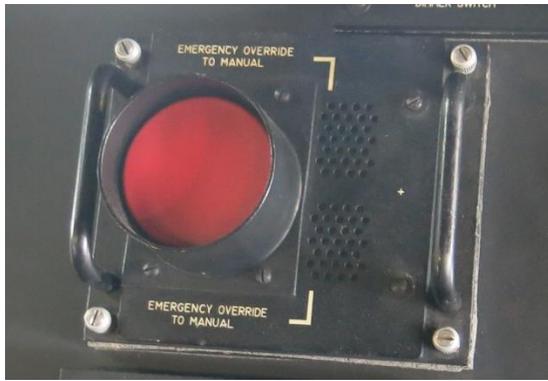
Figure 7. *John S McCain* emergency-override-to-manual button on the SCC.

mode. However, the helmsman told investigators that, during the accident, he did not press the emergency-override-to-manual button because he believed that this sent steering control to aft steering (an opinion shared by other bridge watchstanders interviewed by investigators). The OOD told investigators that she did not order the helmsman to press the emergency-override-to-manual button because the steering system was already in the backup manual mode. Instead, she ordered the conn, who in turn ordered the helmsman, to switch hydraulic power units (HPUs).¹⁸ The helmsman told investigators that he tried to switch HPUs from the SCC helm station, but he “could not gain control of them.” The steering log showed that steering control remained at the lee helm station in computer-assisted mode for over 2 minutes, until 05:23:02.

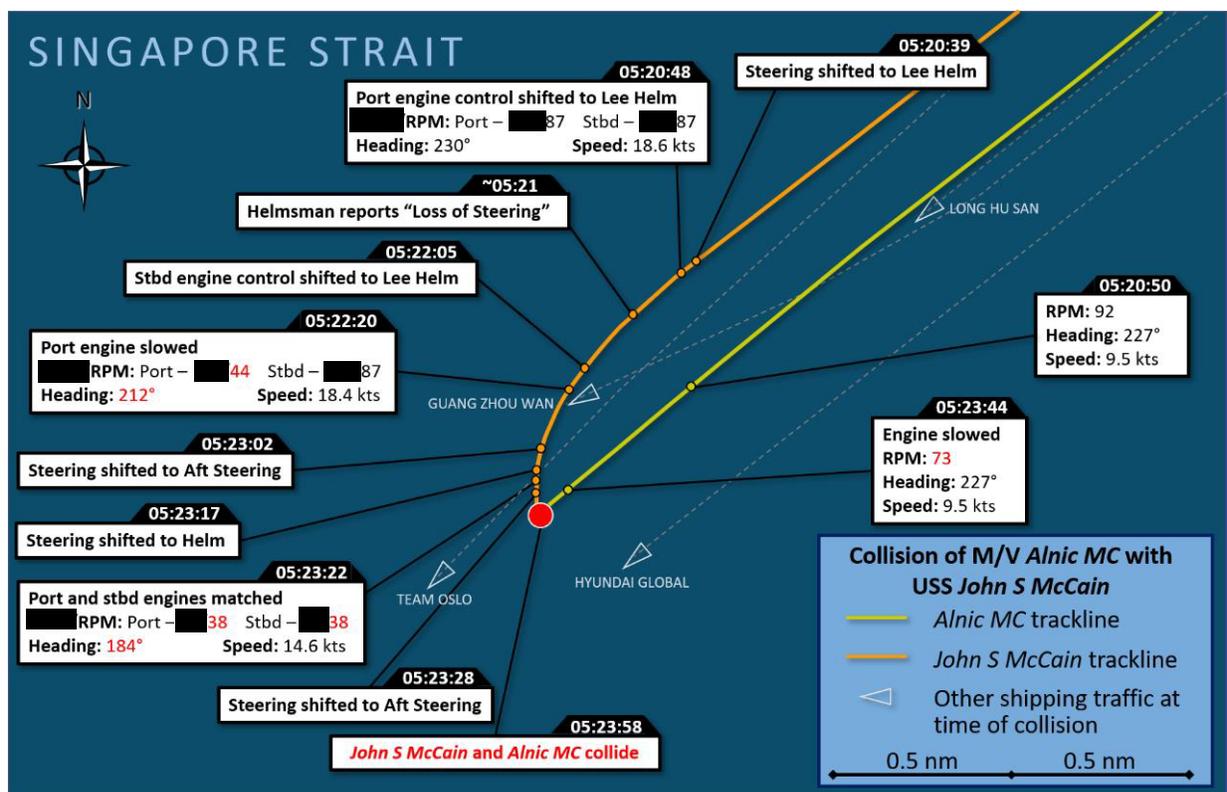
In the 1-minute time span from 05:21:19.5 to 05:22:19.5, the *John S McCain*'s heading changed 13.3 degrees to port, toward the *Alnic MC*. The destroyer's rudder angle remained at 0 degrees during this time. According to radar pictures downloaded from the *Alnic MC*'s VDR, the destroyer was nearly abeam of the *Alnic MC* when it began to move toward the tanker.

Figure 11. Vessel tracks and accident events.

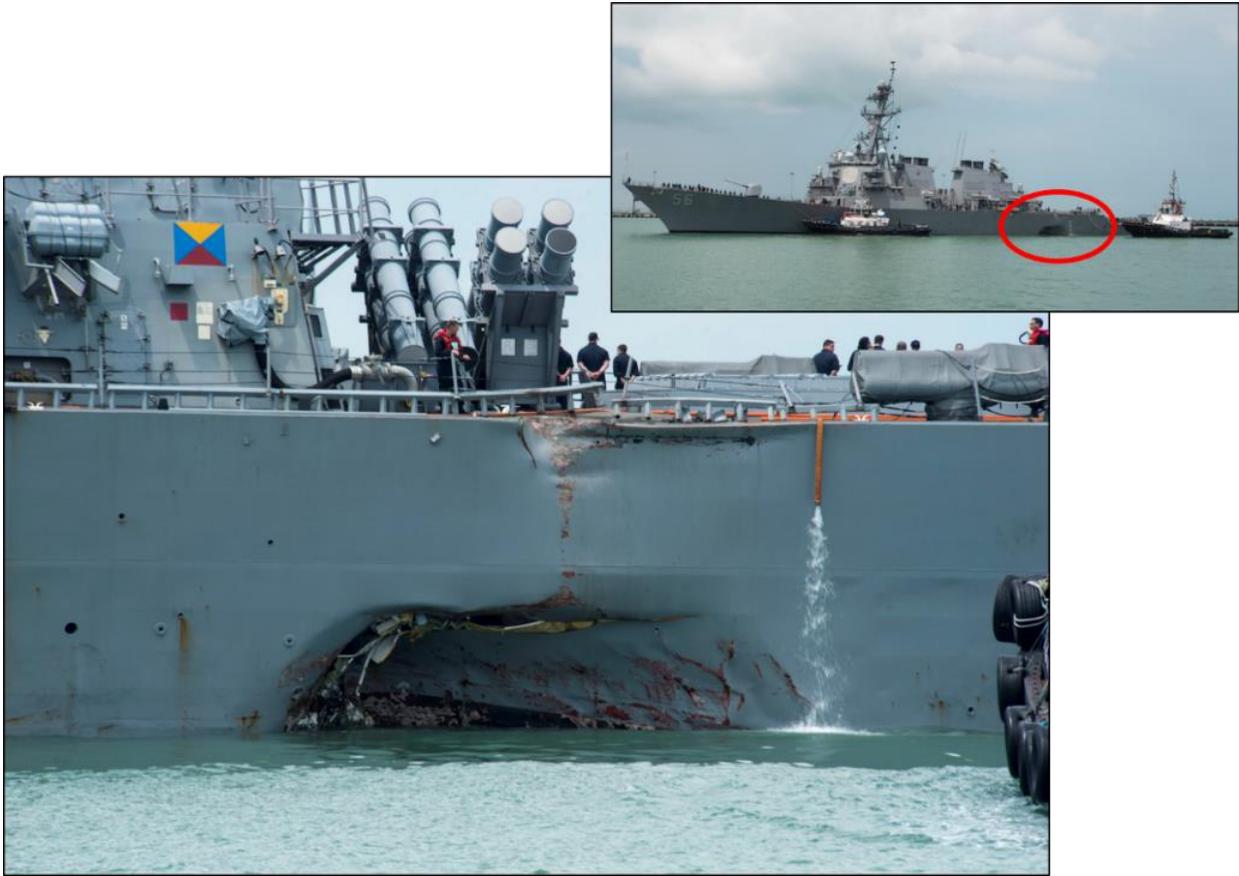
When the vessels collided, the *Alnic MC*'s bulbous bow opened a 28-foot-diameter hole in the *John S McCain*'s hull, above and below the waterline, resulting in significant structural and flooding damage to several spaces, including crew berthing. Repairs to the hull, internal structures, and equipment were estimated at over \$100 million.

Figure 12. Hull damage to *John S McCain*. (Photos by Navy Mass Communication Specialist 2nd Class Joshua Fulton)

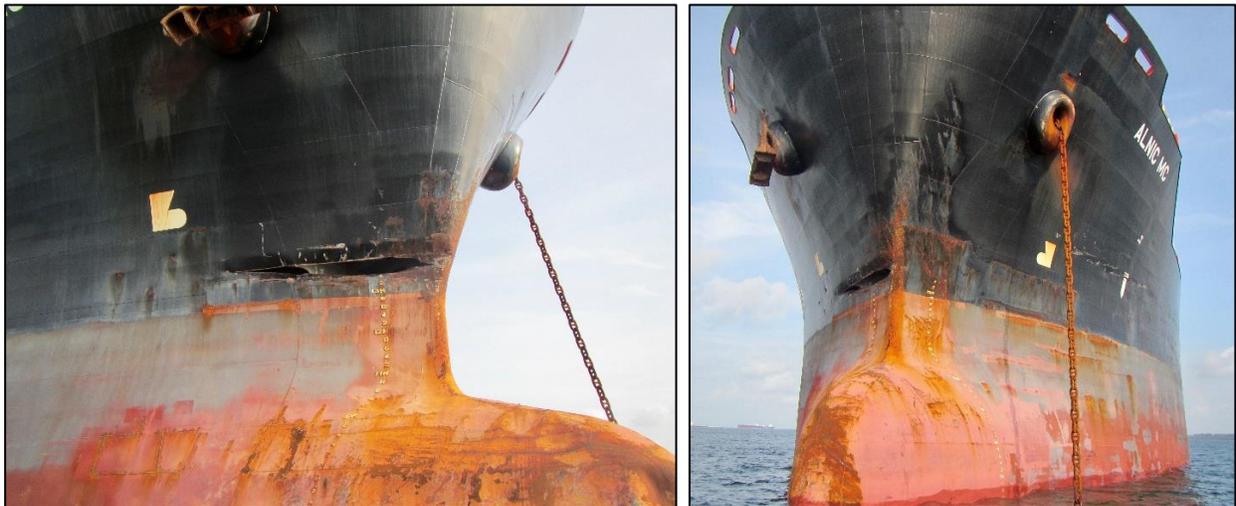
Damage to the *Alnic MC* included a breach of the hull, about 8 feet long, on the starboard bow about 20 feet above the waterline and indentation in the plating on the bulbous bow, bow stem, and just aft of the bow stem on the port and starboard sides. Repair costs totaled about \$225,000.

Figure 13. Hull damage to *Alnic MC*. (Photos by Coast Guard)
