National Transportation Safety Board

Marine Accident Brief

Fire aboard and Subsequent Sinking of Fishing Vessel *Master D*

Accident type	Fire/Explosion	No. DCA18FM037
Vessel name	<i>Master D</i>	
Location	Gulf of Mexico, 45 miles southeast of South Padre Island, Texas 26°07.82' N, 096°27.41' W	
Date	August 31, 2018	
Time	0030 central daylight time (coordinated universal time – 5 hours)	
Injuries	None reported	
Property damage	>\$162,000 est.	
Environmental damage	Oil sheen observed	
Weather	Clear, visibility 10 miles, winds southeast 15 mph, air temperature 80°F, water temperature 70°F	
Waterway information	Gulf of Mexico, open water

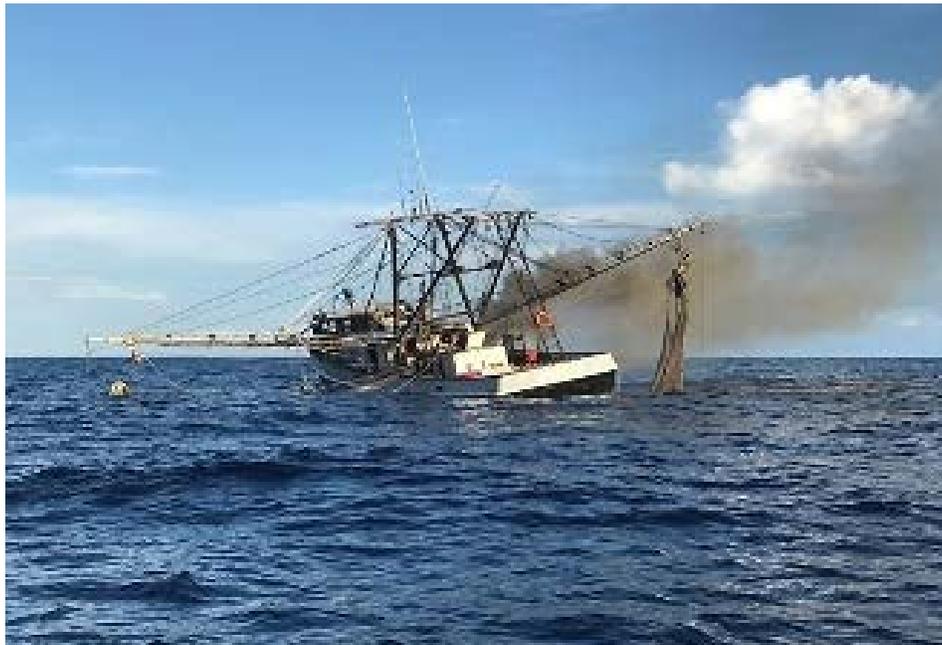
Master D burning on the day after the crew rescue. (Photo by Coast Guard)

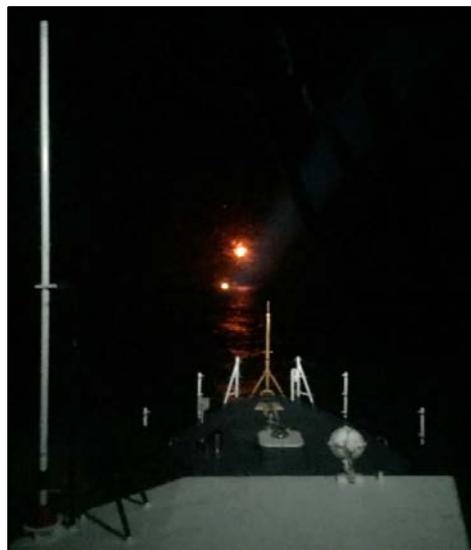
The red parachute flare above the *Master D* seen by the Coast Guard cutter. (Photo by Coast Guard)

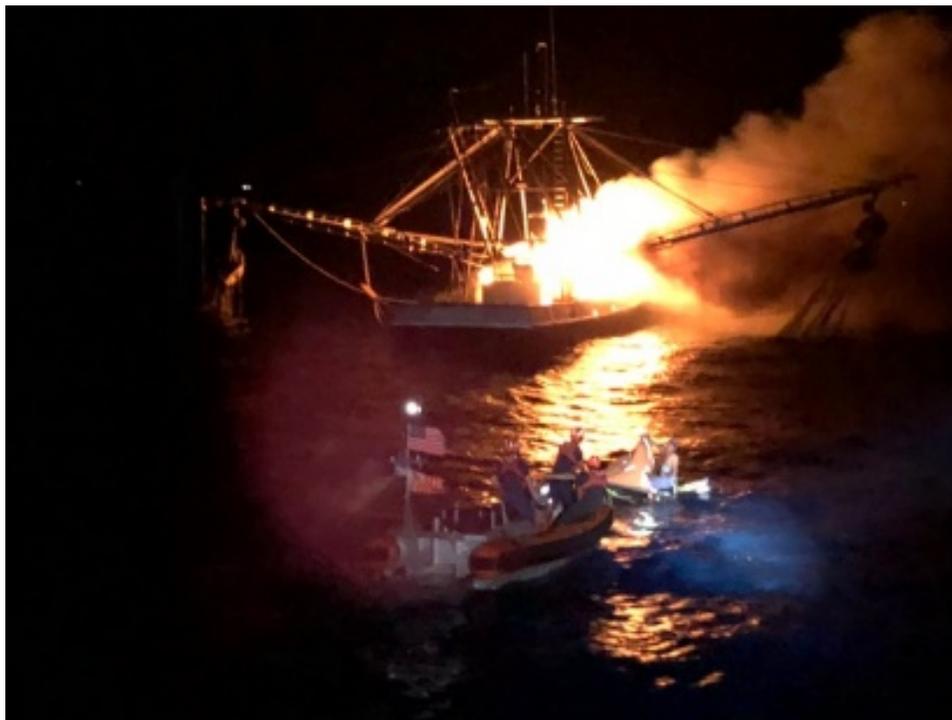
***Master D* on fire while the crew is rescued by the Coast Guard. (Photo by Coast Guard)**
