Final report MO-2018-204: *Dolphin Seeker*, grounding, 27 October 2018

Marine inquiry MO-2018-204  
Dolphin Seeker, grounding  
27 October 2018

Approved for publication: July 2019

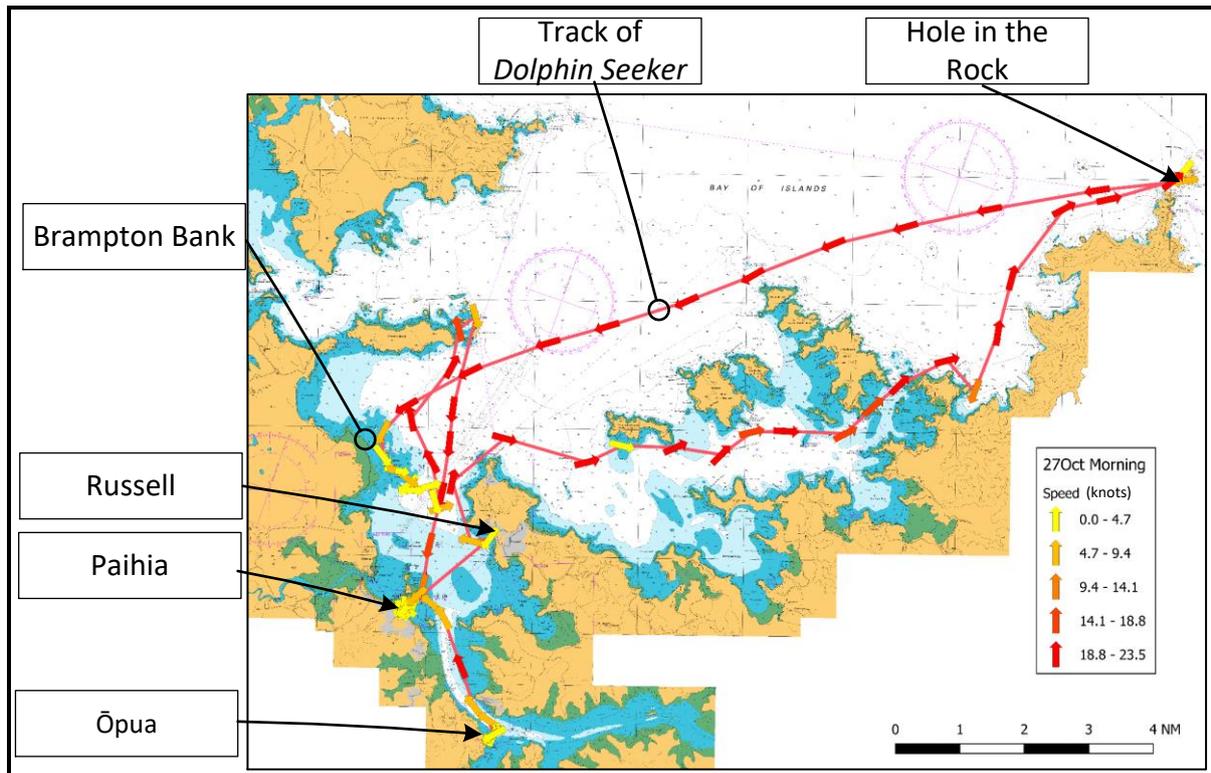
Figure 2  
Excerpt from chart of the Bay of Islands showing the morning voyage of the *Dolphin Seeker*

- 3.2.1. On the morning of 27 October 2018, the *Dolphin Seeker* was at its overnight berth in Ōpua (see Figure 2). The skipper and crew went on board and prepared the vessel for the day.
- 3.2.2. At about 0805 the *Dolphin Seeker* departed its berth in Ōpua for Paihia, where it boarded 100 passengers. The vessel then departed Paihia for Russell, where it boarded another 30 passengers. The *Dolphin Seeker* then departed Russell at about 0920 for the morning 'Hole in the Rock Dolphin Cruise'. The trip was completed without incident. During the trip the skipper had a radio call from another vessel, informing them that dolphins were in the region of Brampton Bank.

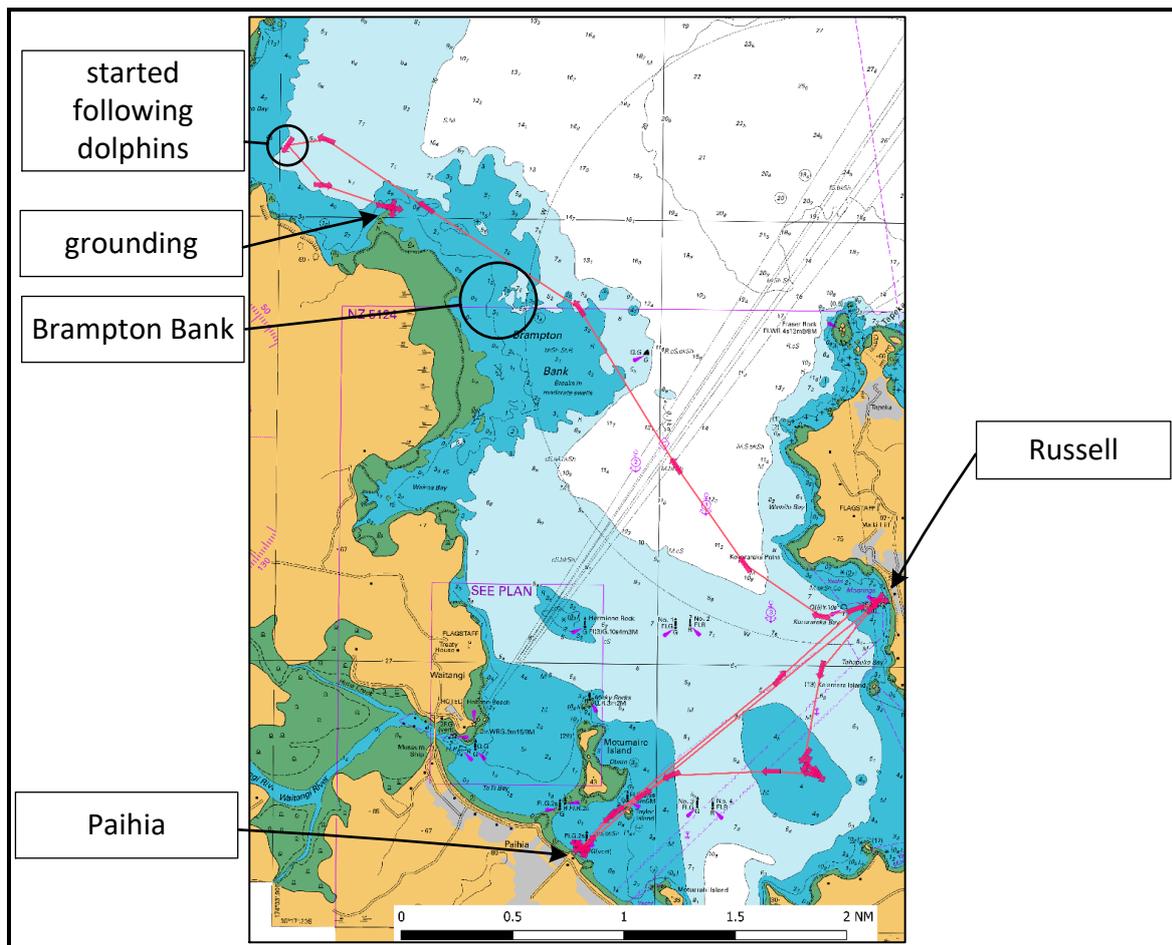
**Figure 3**  
 Excerpt of chart of the Bay of Islands showing the afternoon voyage of the *Dolphin Seeker*

- 3.2.6. The *Dolphin Seeker* departed Russell for its afternoon voyage at about 1346, with 47 passengers on board. The skipper took the vessel directly to the area near Bampton Bank where they had found the dolphins on the morning trip (see Figure 3). A pod of dolphins was located at about 1400.

- 3.2.8. Having been following the dolphins for about 15 minutes, the *Dolphin Seeker* entered an area of shallow water and ran aground on rocks at low speed. The skipper was not able to manoeuvre the vessel off the rocks. The crew made an internal inspection of the hulls and found no evidence that the vessel was taking on water.
